CRITICAL AREA STUDY

Headrick Garage and Pool Addition – 8822 SE 62nd St Mercer Island, WA

Wetland Resources, Inc. Project #18303

Revision 2: December 16, 2020

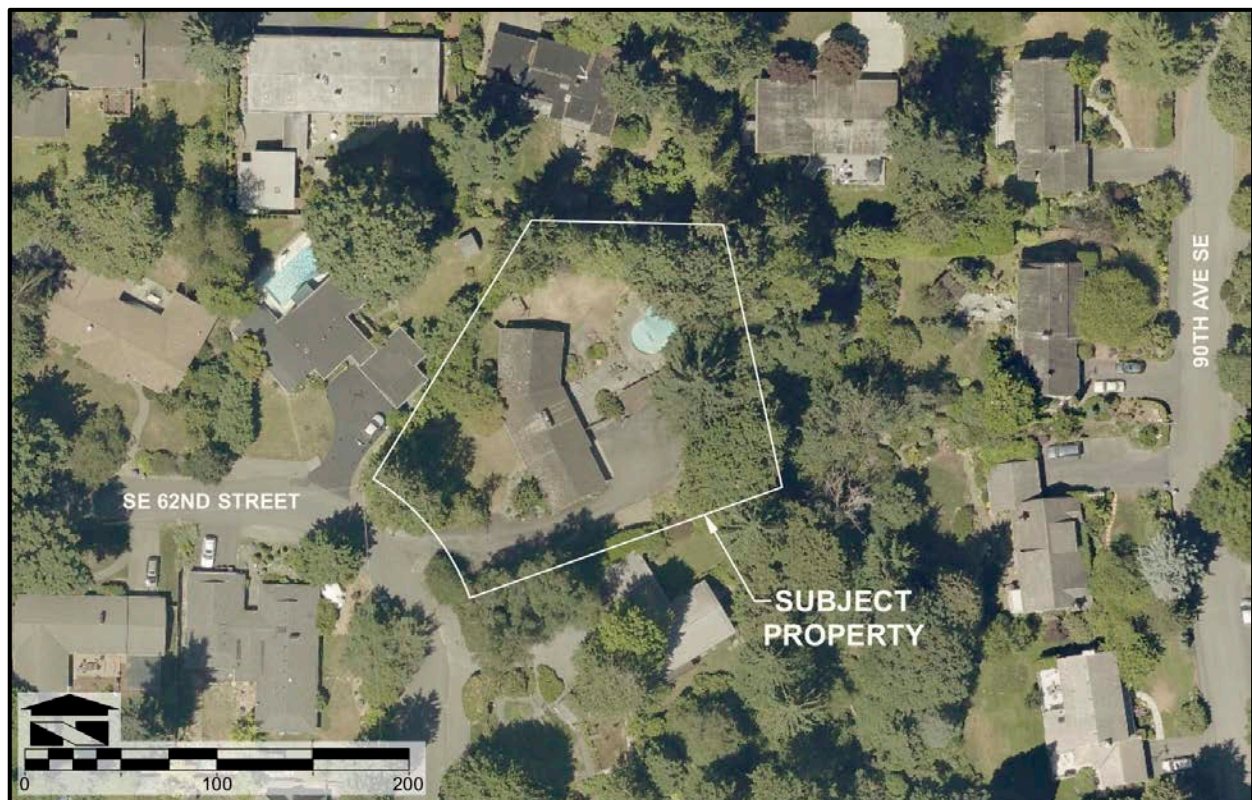
Figure 1: Aerial Overview of Subject Property

The subject property is a relatively level lot that slopes towards a shallow north-to-south oriented ravine in the eastern portion of the property. The level portion of the site is developed with a single-family residence and appurtenant structures/uses, including access/parking, storage sheds, ornamental landscaping, lawngrass, paved areas, and a pool. A seasonal stream channel and a 123 square-foot wetland were identified along the east property line. The stream originates from a large-diameter culvert located near the northeast property boundary, and enters another culvert near the southeast property boundary. The small wetland is supported by groundwater discharge at the toe of the ravine, along the face of an existing retaining wall. The wetland also receives hydrology from a hyporheic connection with Stream A.

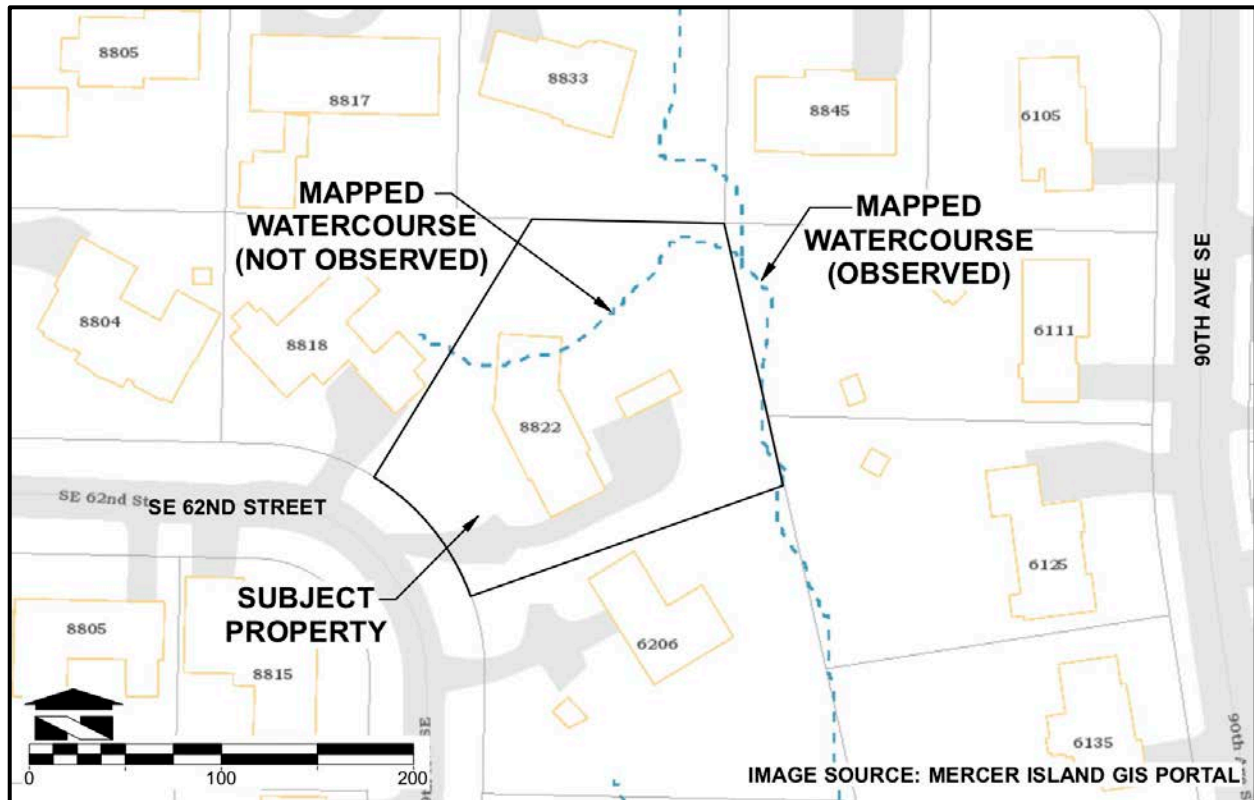
Figure 2: City-Mapped Watercourses

The City of Mercer Island Development Services Group relies on data compiled in the City of Mercer Island GIS Portal to approximate critical areas presence and locate stormwater features (among many other things). This resource was used by WRI staff prior to the site investigation, to determine potential critical areas on and in the vicinity of the subject property. This resource depicts two Type 3 watercourses within the boundaries of the subject property; Stream A, which

flows through the aforementioned ravine along the east property line, and a tributary to Stream A, which is shown passing through maintained lawn, the primary residence, and impervious surfaces in the northern portion of the site. Based on the developed condition of the site, the existence of the mapped Type 3 watercourse (flowing through the primary residence) was thought to be unlikely. Special care was taken during the site inspection to confirm or deny the presence of the mapped tributary. See Figure 2 below, which shows the location of City-mapped watercourses in the vicinity of the subject property.

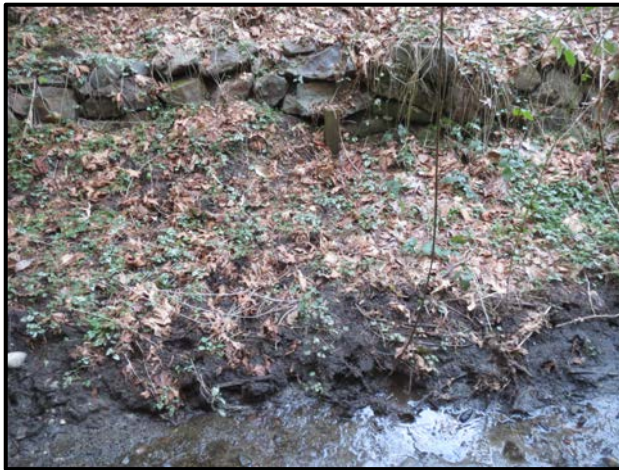
Figure 4: Facing East Towards Wetland A

Wetland A is 123 square feet in total area. The feature is located along the east property line of the subject property, on the left bank of Stream A. The feature forms from groundwater discharge at the toe of an existing retaining wall, and is also supported by the hyporheic zone associated with Stream A. Groundwater was observed in data site S-1 at the same elevation as the stream bed. Wetland A was rated as a slope wetland due to lack of evidence of overbank flooding. Vegetation was not flattened or otherwise marked, scour marks and recent or layered sediment deposits were not observed in the soil profile.

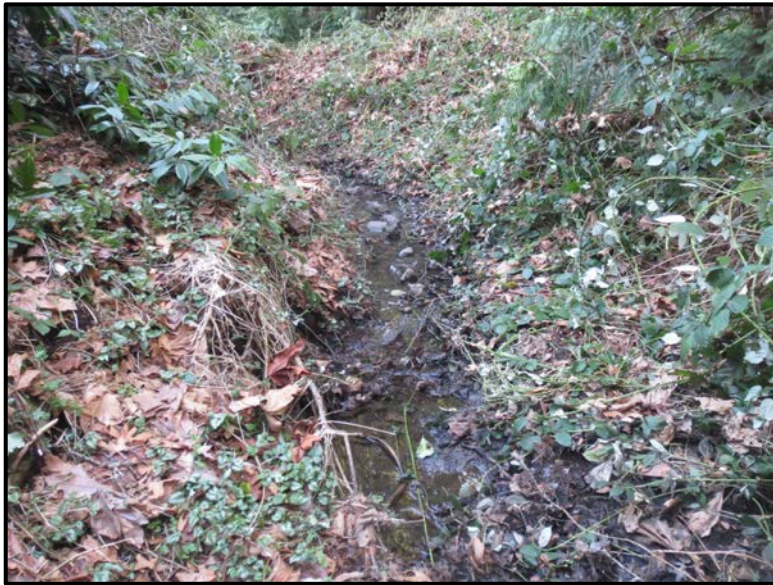
Figure 6: Facing South Along Stream A

The open channel of Stream A originates at the outlet of a large-diameter culvert located near the northeast corner of the subject property. The channel terminates where it enters another culvert located in the southeast corner of the subject property. The open channel consists of mixed cobble, bricks, and mud. The feature is an intermittent stream based on physical observation of a dry bed during the March site visit. Piped watercourses require 25-foot protective buffers, and Type 3 watercourses require 35-foot protective buffers. Based on comparison with the Mercer Island GIS Portal, it appears that Stream A outlets directly to Lake Washington on the east side of Mercer Island.

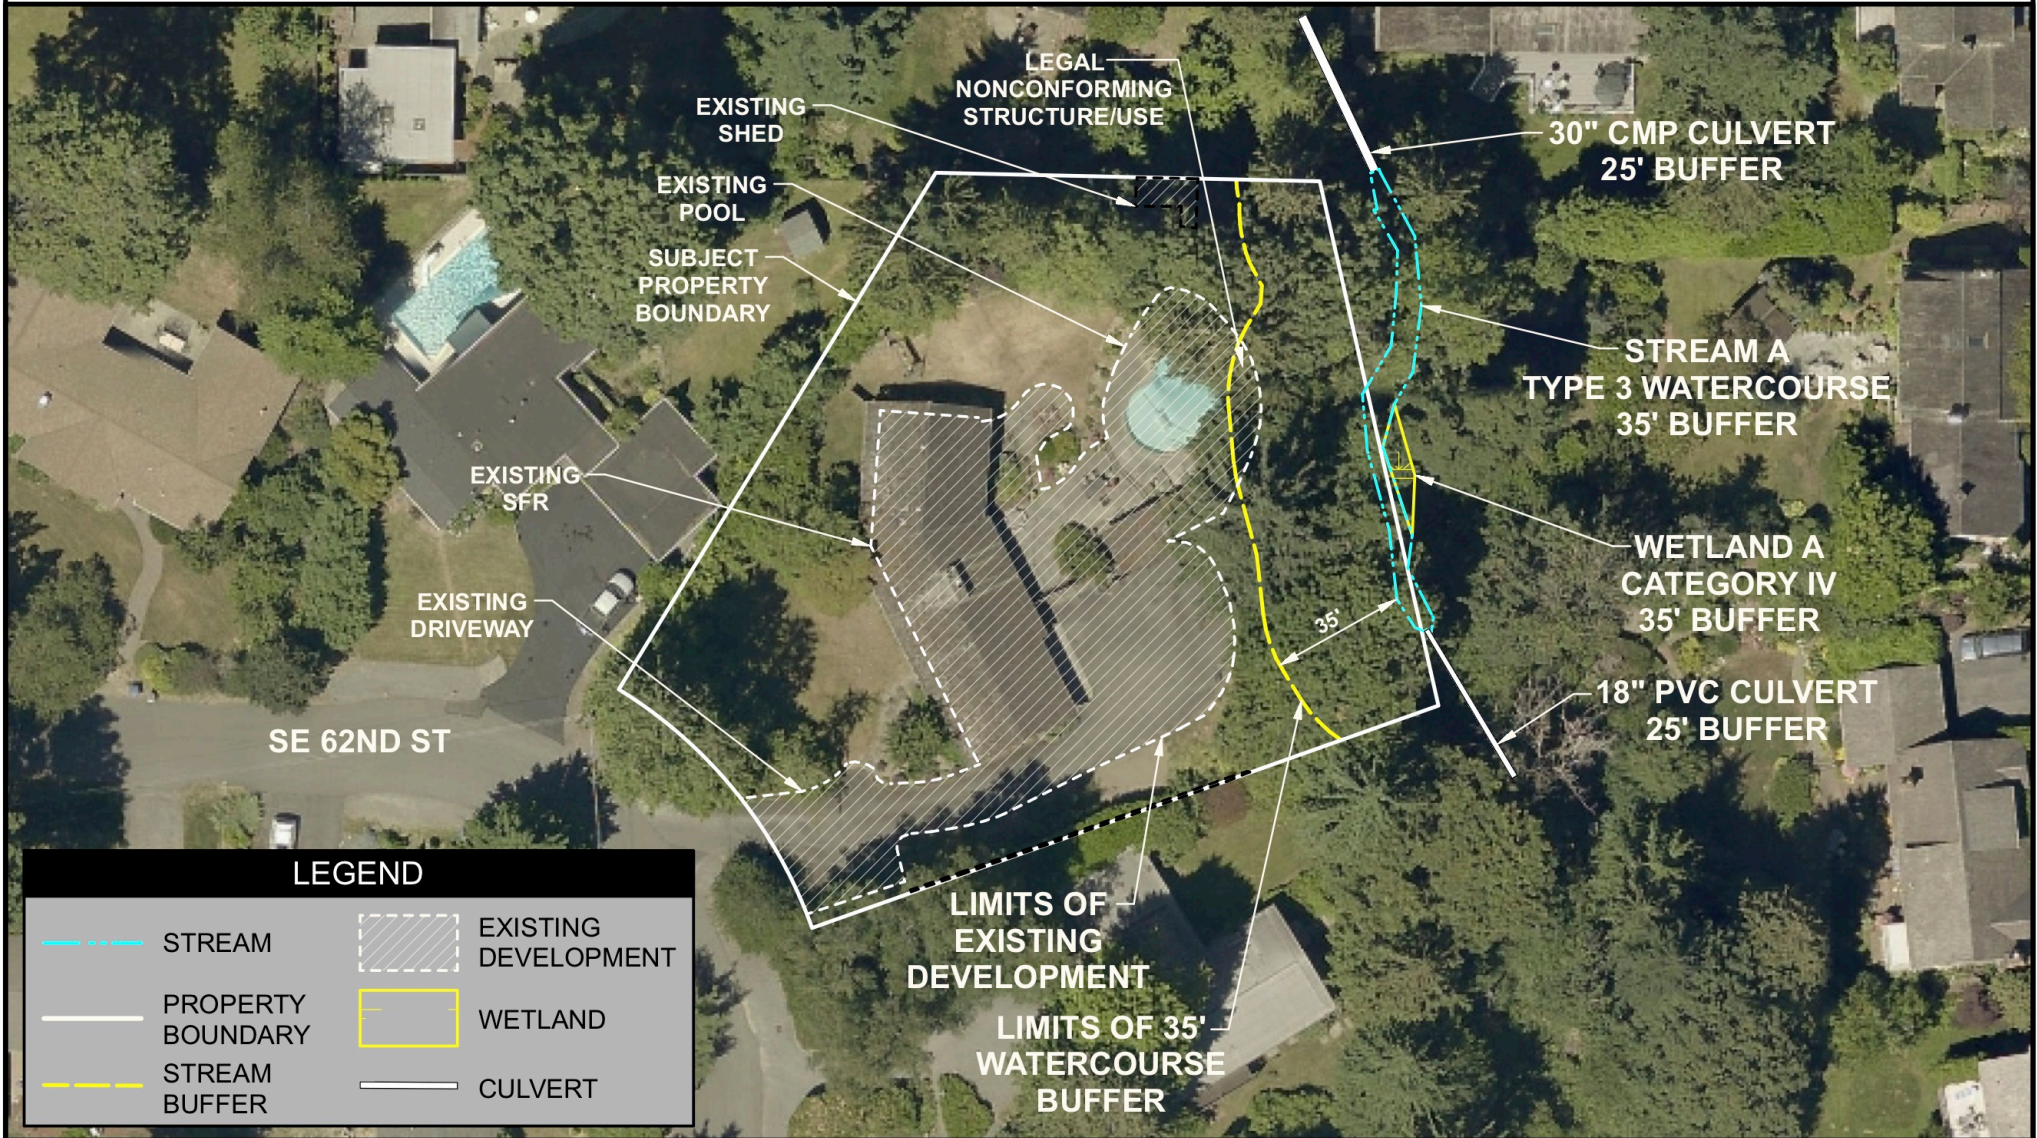
CRITICAL AREA STUDY MAP
HEADRICK GARAGE AND POOL ADDITION - 8822 SE 62ND ST
EXISTING CONDITIONS

Critical Area Study Map
Headrick Garage and Pool Addition
8822 SE 62nd St
 Existing Conditions Sheet 1/3
 Greg & Jennifer Headrick Project Number: 18303
 8822 SE 62nd St Drawn by: NP
 Mercer Island, WA 98040 Rev. 2: 12/16/2020

WRI was contracted to delineate regulated features within and in the vicinity of the subject property. One wetland (Wetland A) was observed in the study area. One watercourse (Stream A) was observed. These features are depicted in the attached critical area study maps (See Appendix C). Wetland A is a small Category IV wetland that requires a 35-foot protective buffer. Stream A originates from a culvert and drains to a culvert, both of which are classified as piped watercourses. Piped watercourses require 25-foot protective buffers. The open channel is a Type 3 watercourse that requires a 35-foot protective buffer.

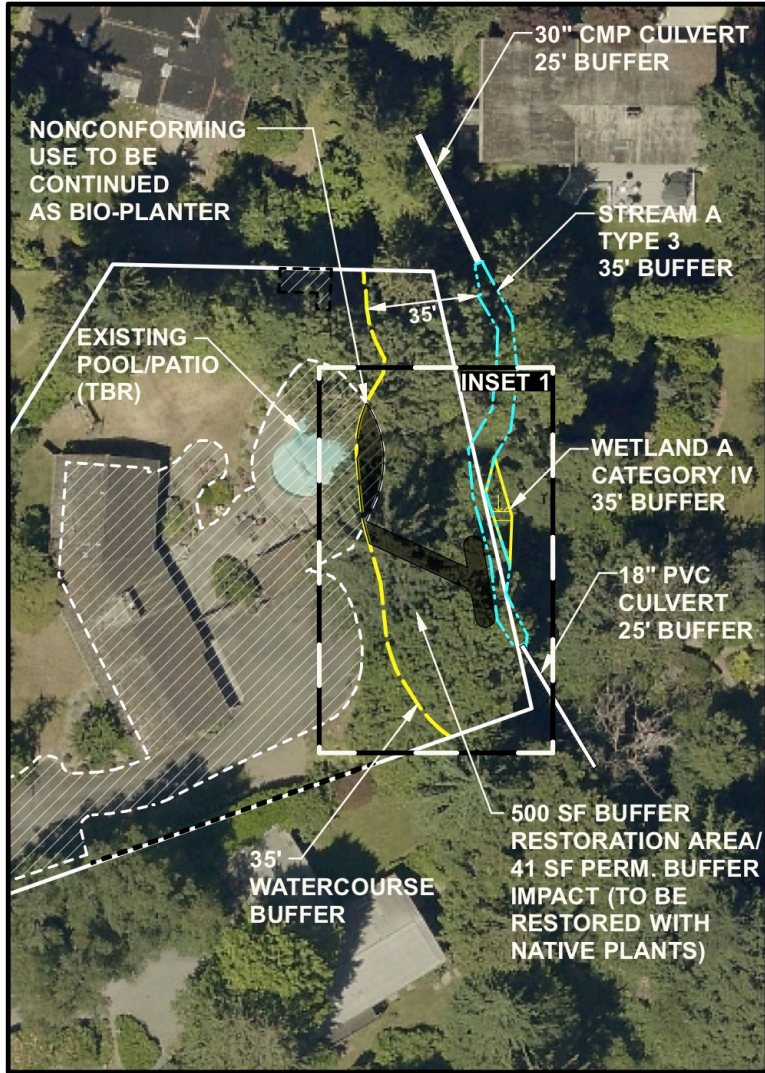
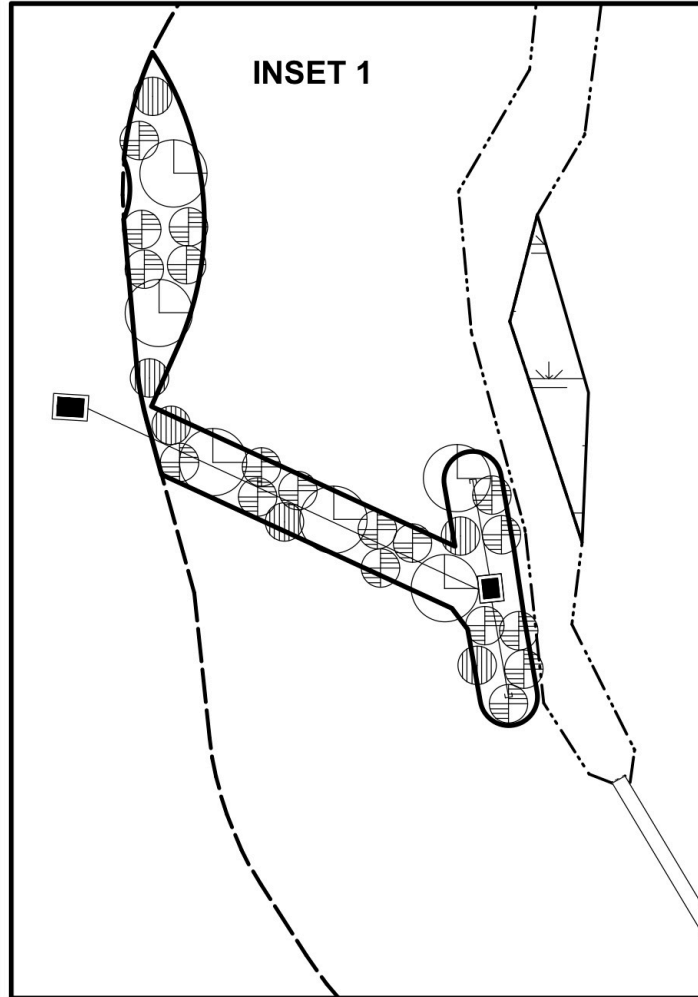
BUFFER RESTORATION PLAN

- WESTERN RED CEDAR
- SALMONBERRY
- VINE MAPLE
