## **CRITICAL AREA STUDY**

### **Headrick Garage and Pool Addition – 8822 SE 62<sup>nd</sup> St Mercer Island, WA**

*Wetland Resources, Inc. Project #18303*

First Submittal: May 1, 2019  
Revision 1: October 25, 2019  
Revision 2: December 16, 2020  
Revision 3: March 8, 2021  
**Revision 4: April 29, 2021**

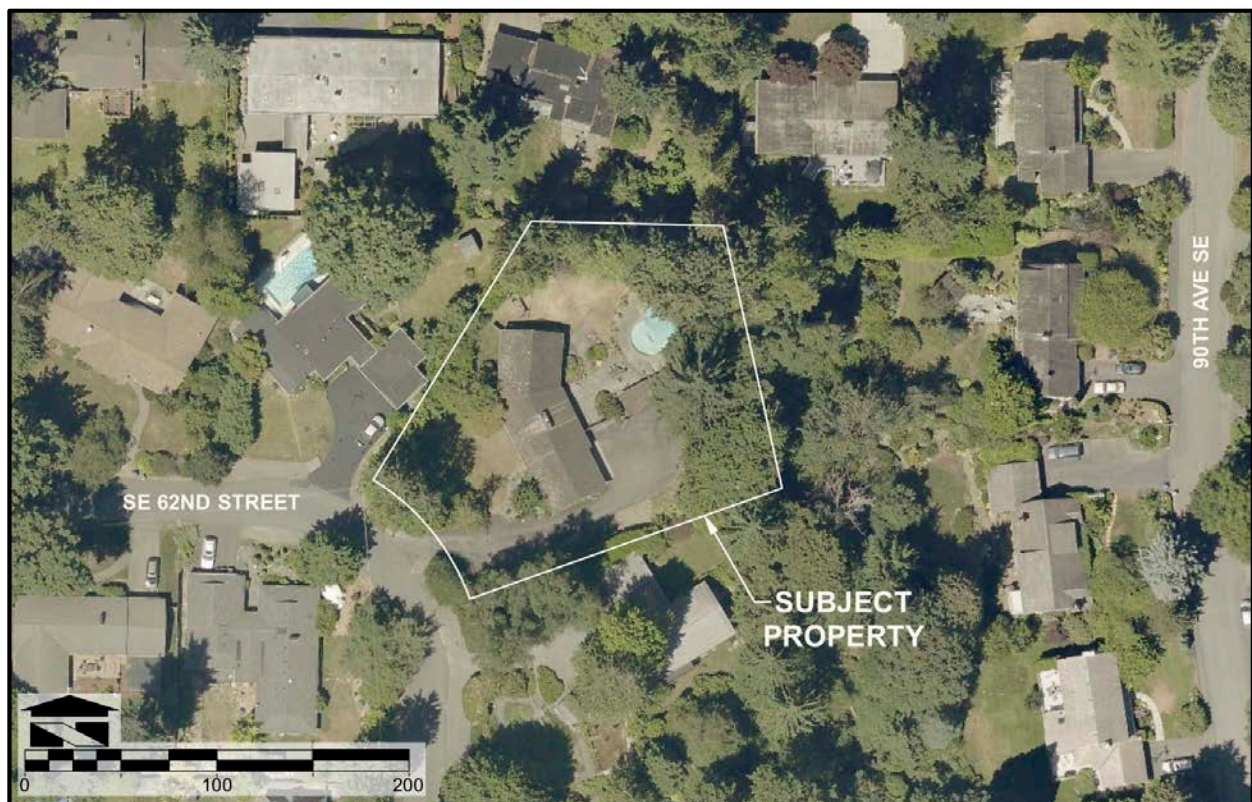
Figure 1: Aerial Overview of Subject Property

The subject property is a relatively level lot that slopes towards a shallow north-to-south oriented ravine in the eastern portion of the property. The level portion of the site is developed with a single-family residence and appurtenant structures/uses, including access/parking, storage sheds, ornamental landscaping, lawngrass, paved areas, and a pool. A seasonal stream channel and a 123 square-foot wetland were identified along the east property line. The stream originates from a large-diameter culvert located near the northeast property boundary, and enters another culvert near the southeast property boundary. The small wetland is supported by groundwater discharge at the toe of the ravine, along the face of an existing retaining wall. The wetland also receives hydrology from a hyporheic connection with Stream A.

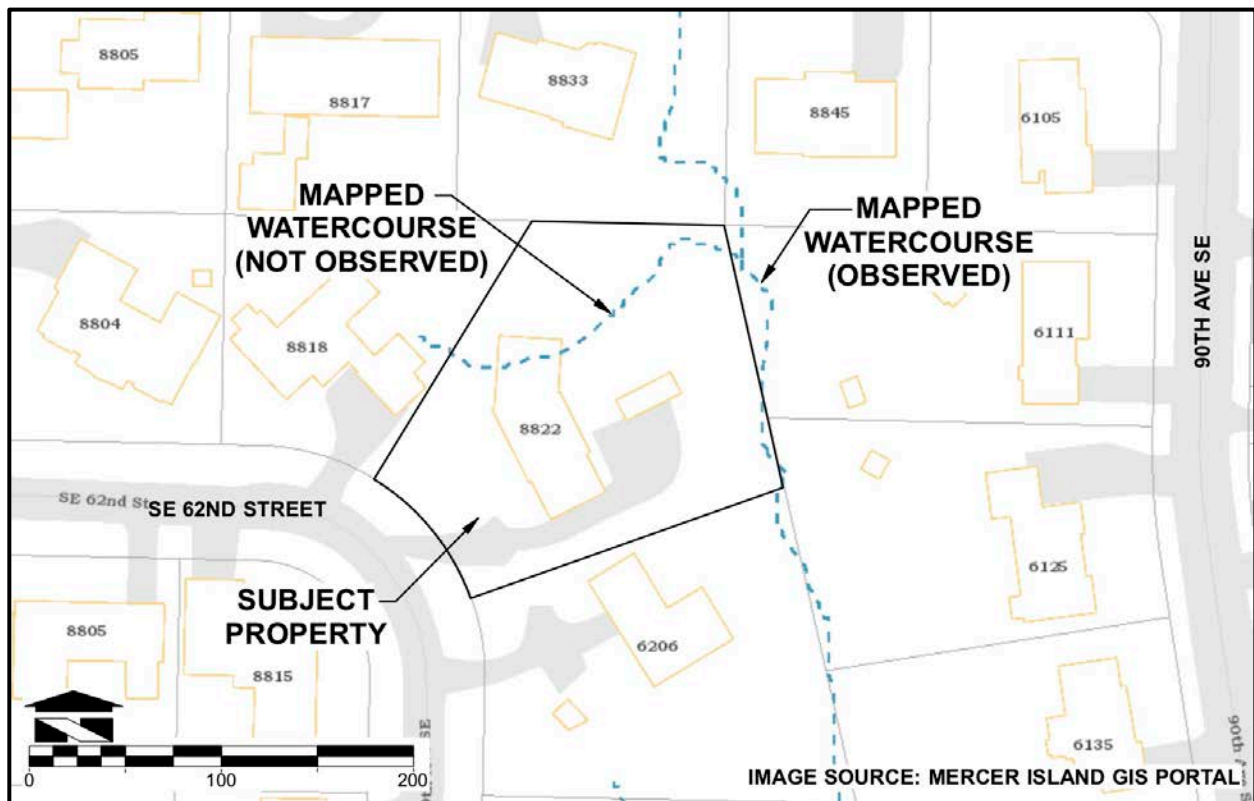
Figure 2: City-Mapped Watercourses

The City of Mercer Island Development Services Group relies on data compiled in the City of Mercer Island GIS Portal to approximate critical areas presence and locate stormwater features (among many other things). This resource was used by WRI staff prior to the site investigation, to determine potential critical areas on and in the vicinity of the subject property. This resource depicts two Type 3 watercourses within the boundaries of the subject property; Stream A, which flows through the aforementioned ravine along the east property line, and a tributary to Stream A,

which is shown passing through maintained lawn, the primary residence, and impervious surfaces in the northern portion of the site. Based on the developed condition of the site, the existence of the mapped Type 3 watercourse (flowing through the primary residence) was thought to be unlikely. Special care was taken during the site inspection to confirm or deny the presence of the mapped tributary. See Figure 2 below, which shows the location of City-mapped watercourses in the vicinity of the subject property.

The mapped location of the tributary to Stream A was physically inspected on March 1, 2019. Best available science suggests that directly observed hydrology or evidence of recent surface flow support a stream presence determination. Evidence of flow includes defined bed and banks, scour marks, fine and coarse sediments deposited on existing vegetation, flattened vegetation in the direction of flow, and the presence of wet-tolerant vegetation.

Perennial streams in Puget Sound typically contain hydrology in early March. Given the absence of hydrology or indicators of surface flow along the entire path of the City-mapped watercourse during the March visit, WRI staff has determined that the mapped watercourse does not exist.

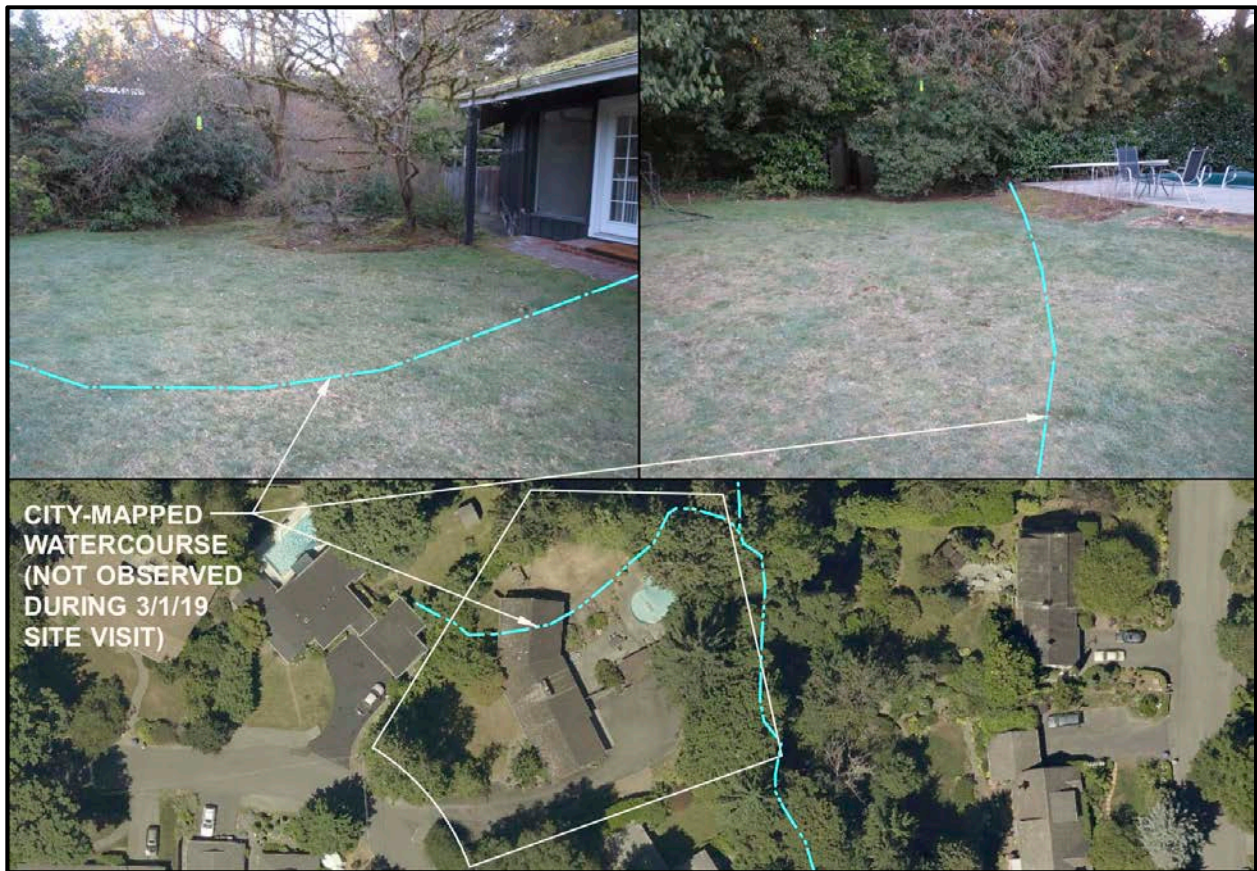
Figure 3: Site Photos of City-Mapped Watercourse

The City's map error should be corrected by removing the mapped tributary to Stream A. Figure 3 below shows site photos from the March visit, and provides visual evidence that the mapped stream does not exist. No additional discussion of the (non-existent) tributary to Stream A is included in this report.

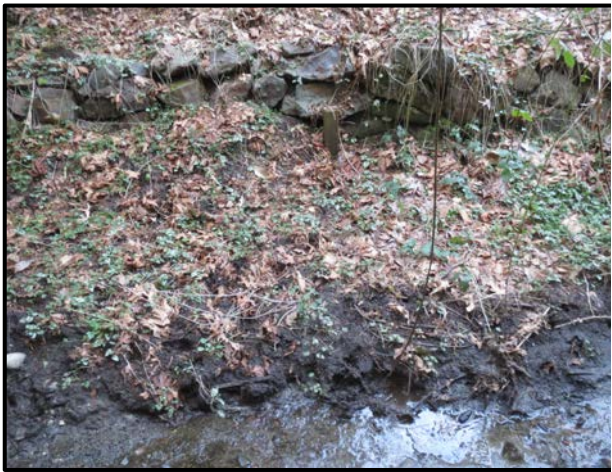
Figure 4: Facing East Towards Wetland A

Wetland A is 123 square feet in total area. The feature is located along the east property line of the subject property, on the left bank of Stream A. The feature forms from groundwater discharge at the toe of an existing retaining wall, and is also supported by the hyporheic zone associated with Stream A. Groundwater was observed in data site S-1 at the same elevation as the stream bed. Wetland A was rated as a slope wetland due to lack of evidence of overbank flooding. Vegetation was not flattened or otherwise marked, scour marks and recent or layered sediment deposits were not observed in the soil profile.

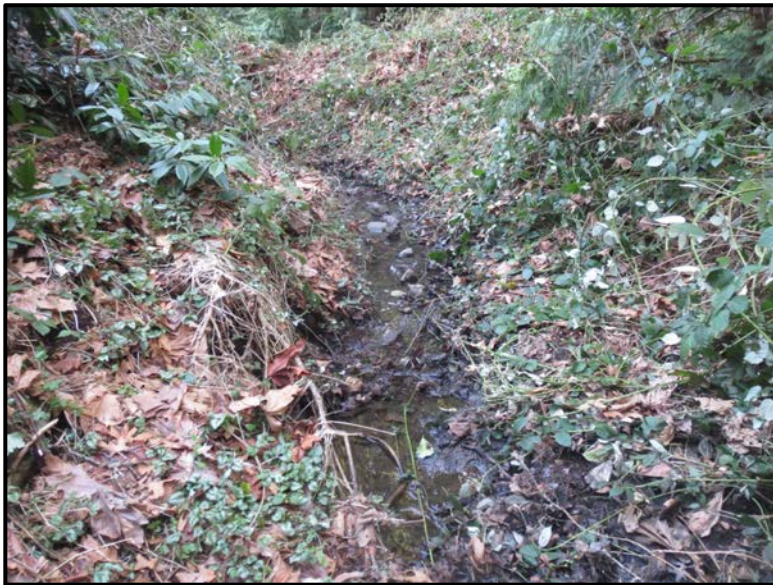
Figure 6: Facing South Along Stream A

The open channel of Stream A originates at the outlet of a large-diameter culvert located near the northeast corner of the subject property. The channel terminates where it enters another culvert located in the southeast corner of the subject property. The open channel consists of mixed cobble, bricks, and mud. The feature is an intermittent stream based on physical observation of a dry bed during the March site visit. Piped watercourses require 25-foot protective buffers, and Type 3 watercourses require 35-foot protective buffers. Based on comparison with the Mercer Island GIS Portal, it appears that Stream A outlets directly to Lake Washington on the east side of Mercer Island.

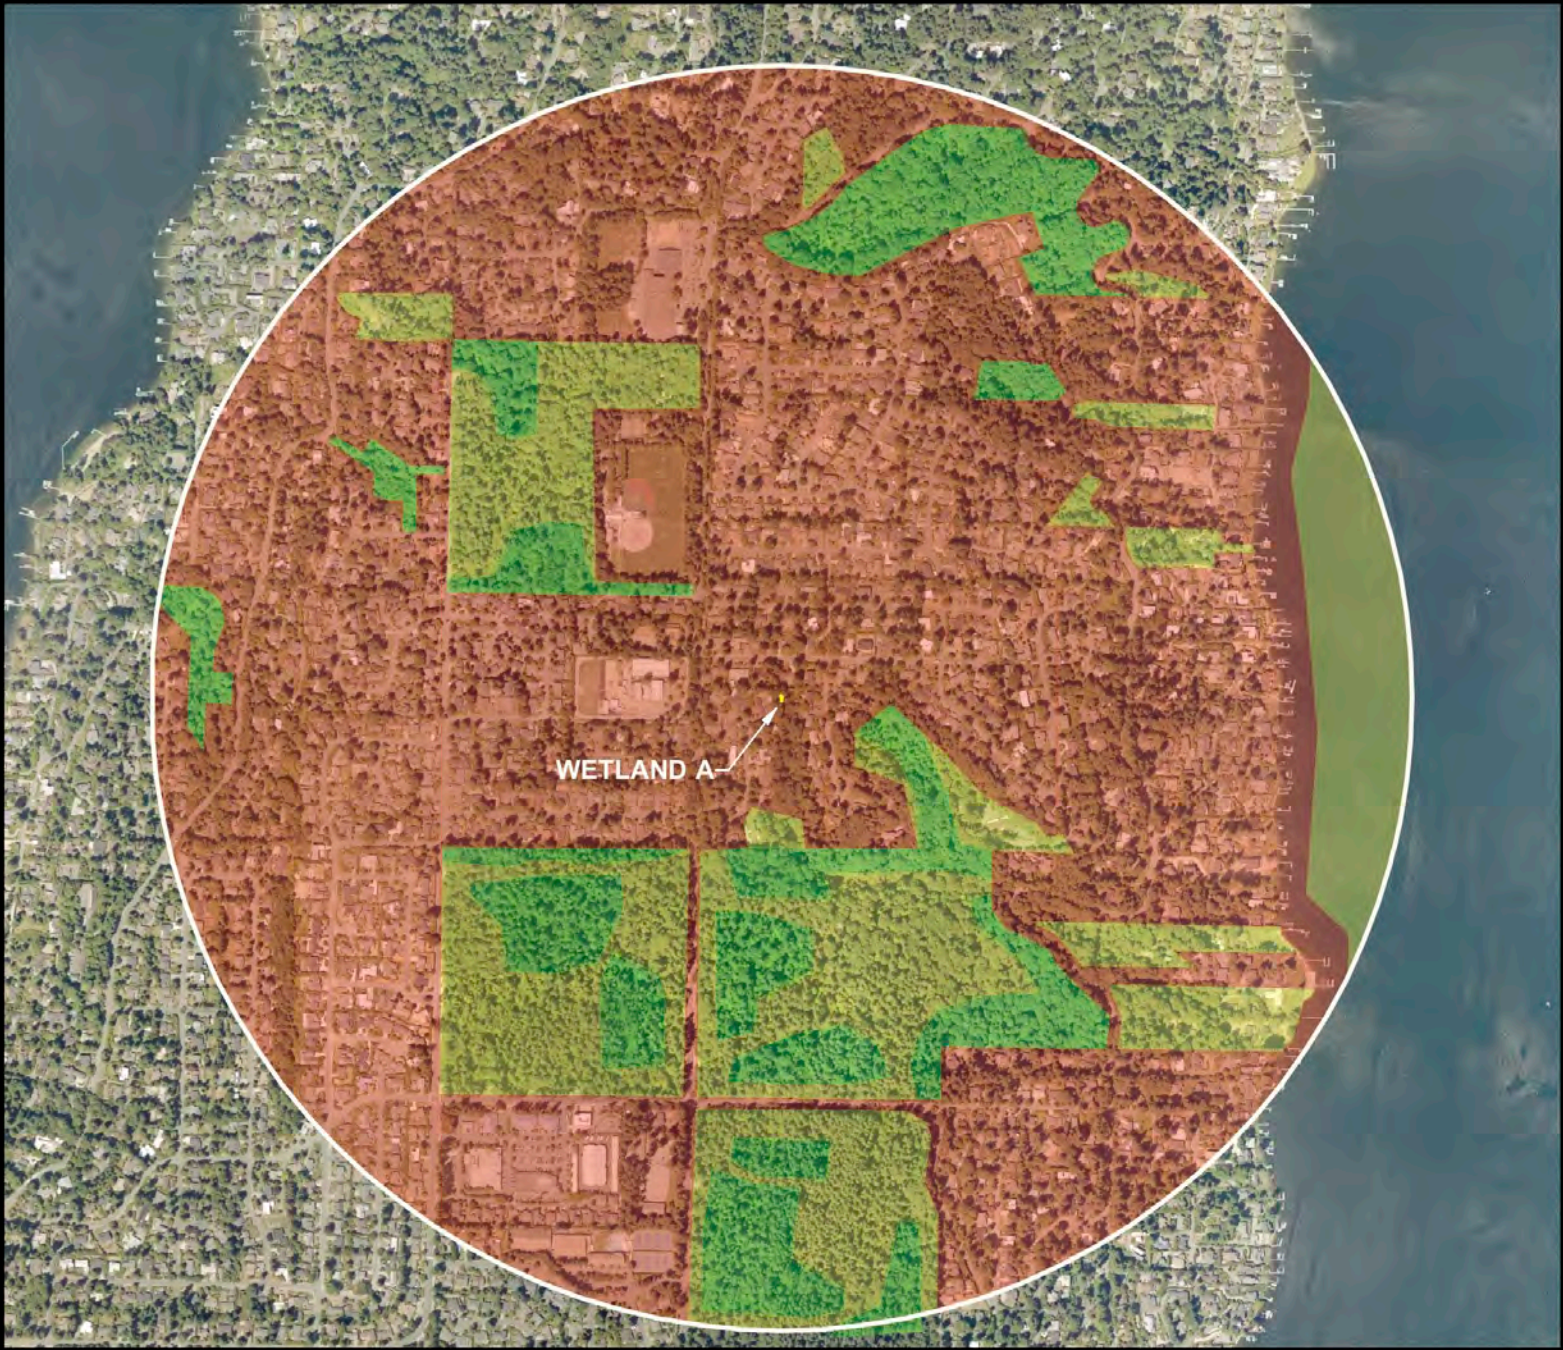
HEADRICK - 8822 SE 62ND ST REDEVELOPMENT  
 WETLAND RATING FIGURE A2 - WETLAND A

- RELATIVELY UNDISTURBED
- LOW/MOD. INTENSITY
- HIGH INTENSITY
- ACCESSIBLE HABITAT
- WETLAND
- 1 KM FROM WETLAND

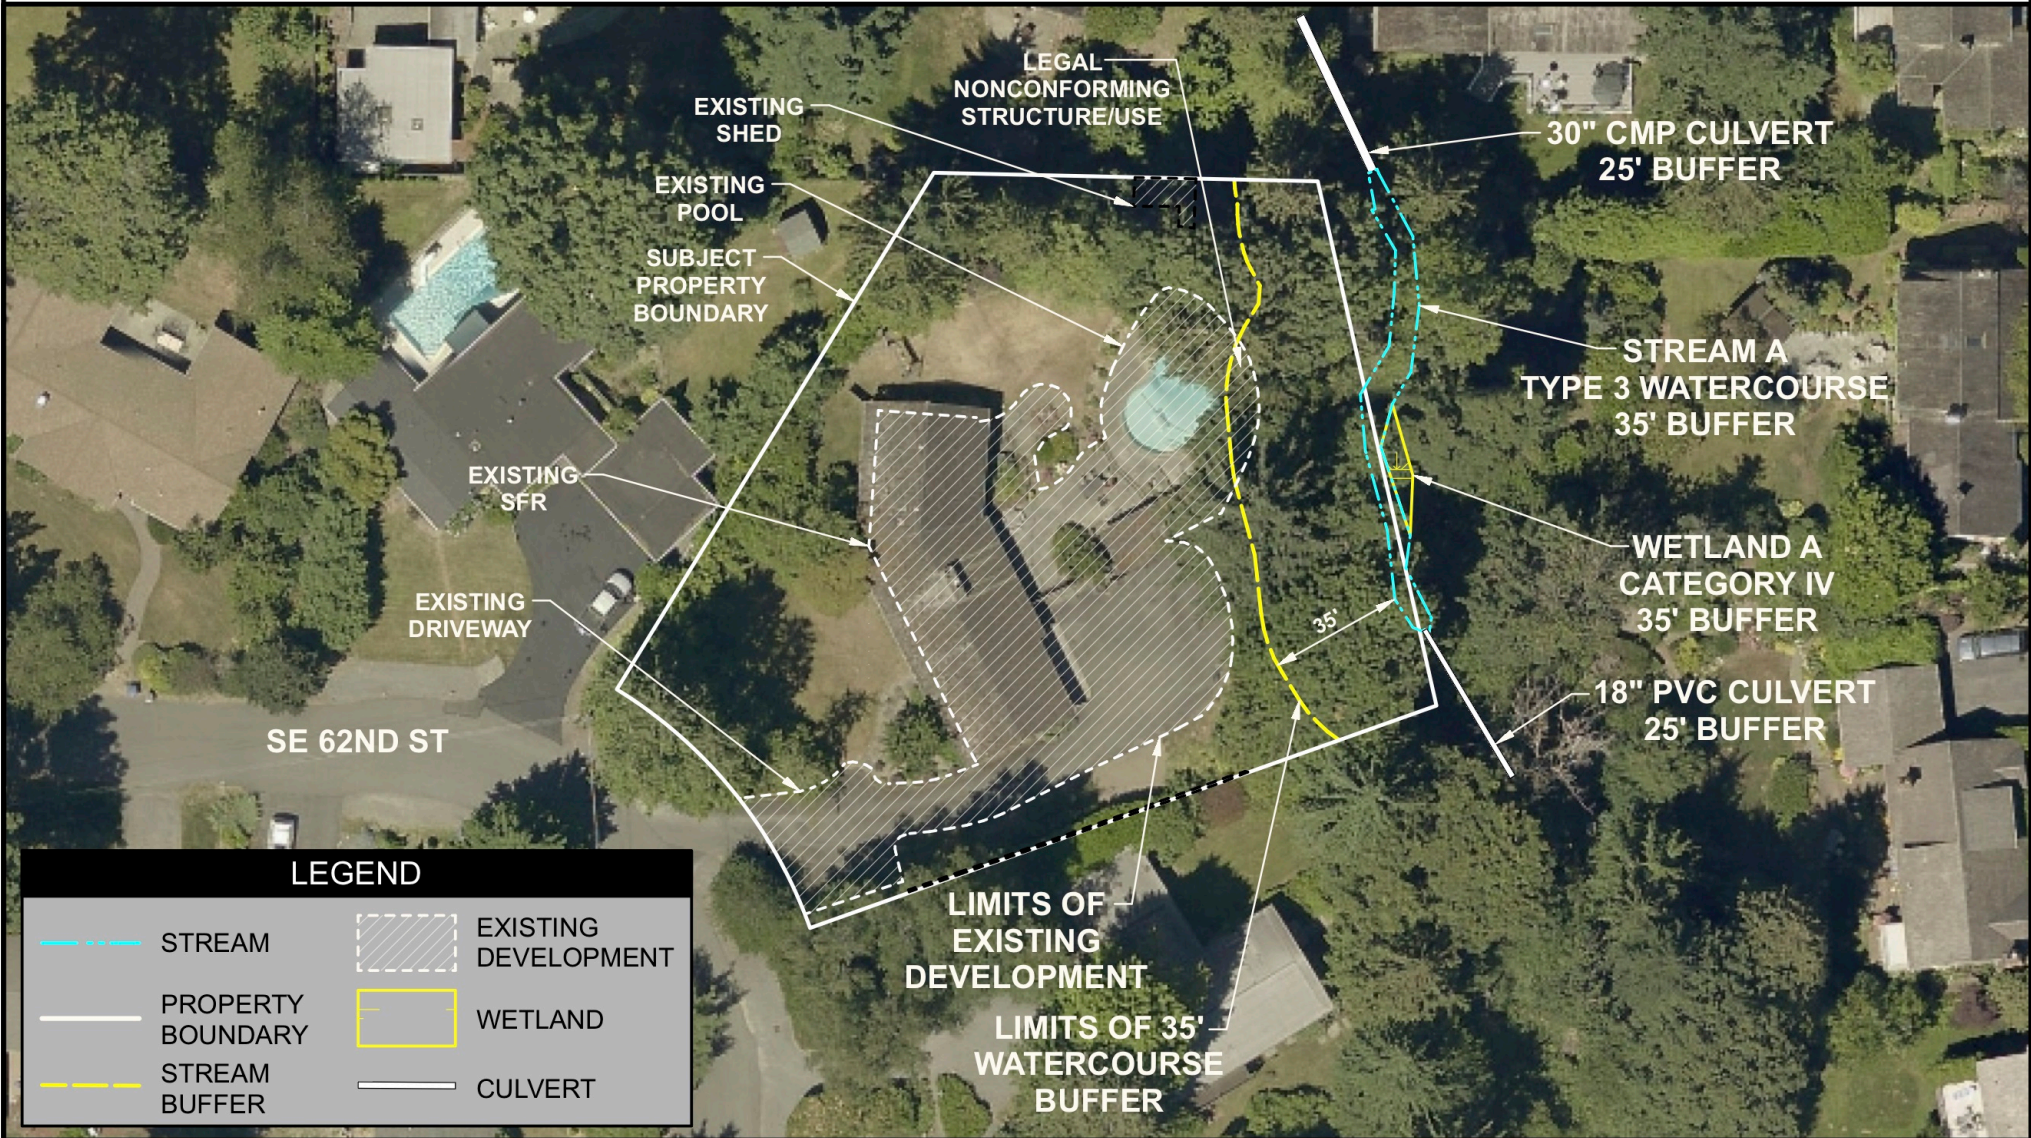
**CRITICAL AREA STUDY MAP**  
**HEADRICK GARAGE AND POOL ADDITION - 8822 SE 62ND ST**  
**EXISTING CONDITIONS**

WRI was contracted to delineate regulated features within and in the vicinity of the subject property. One wetland (Wetland A) was observed in the study area. One watercourse (Stream A) was observed. These features are depicted in the attached critical area study maps (See Appendix C). Wetland A is a small Category IV wetland that requires a 35-foot protective buffer. Stream A originates from a culvert and drains to a culvert, both of which are classified as piped watercourses. Piped watercourses require 25-foot protective buffers. The open channel is a Type 3 watercourse that requires a 35-foot protective buffer.

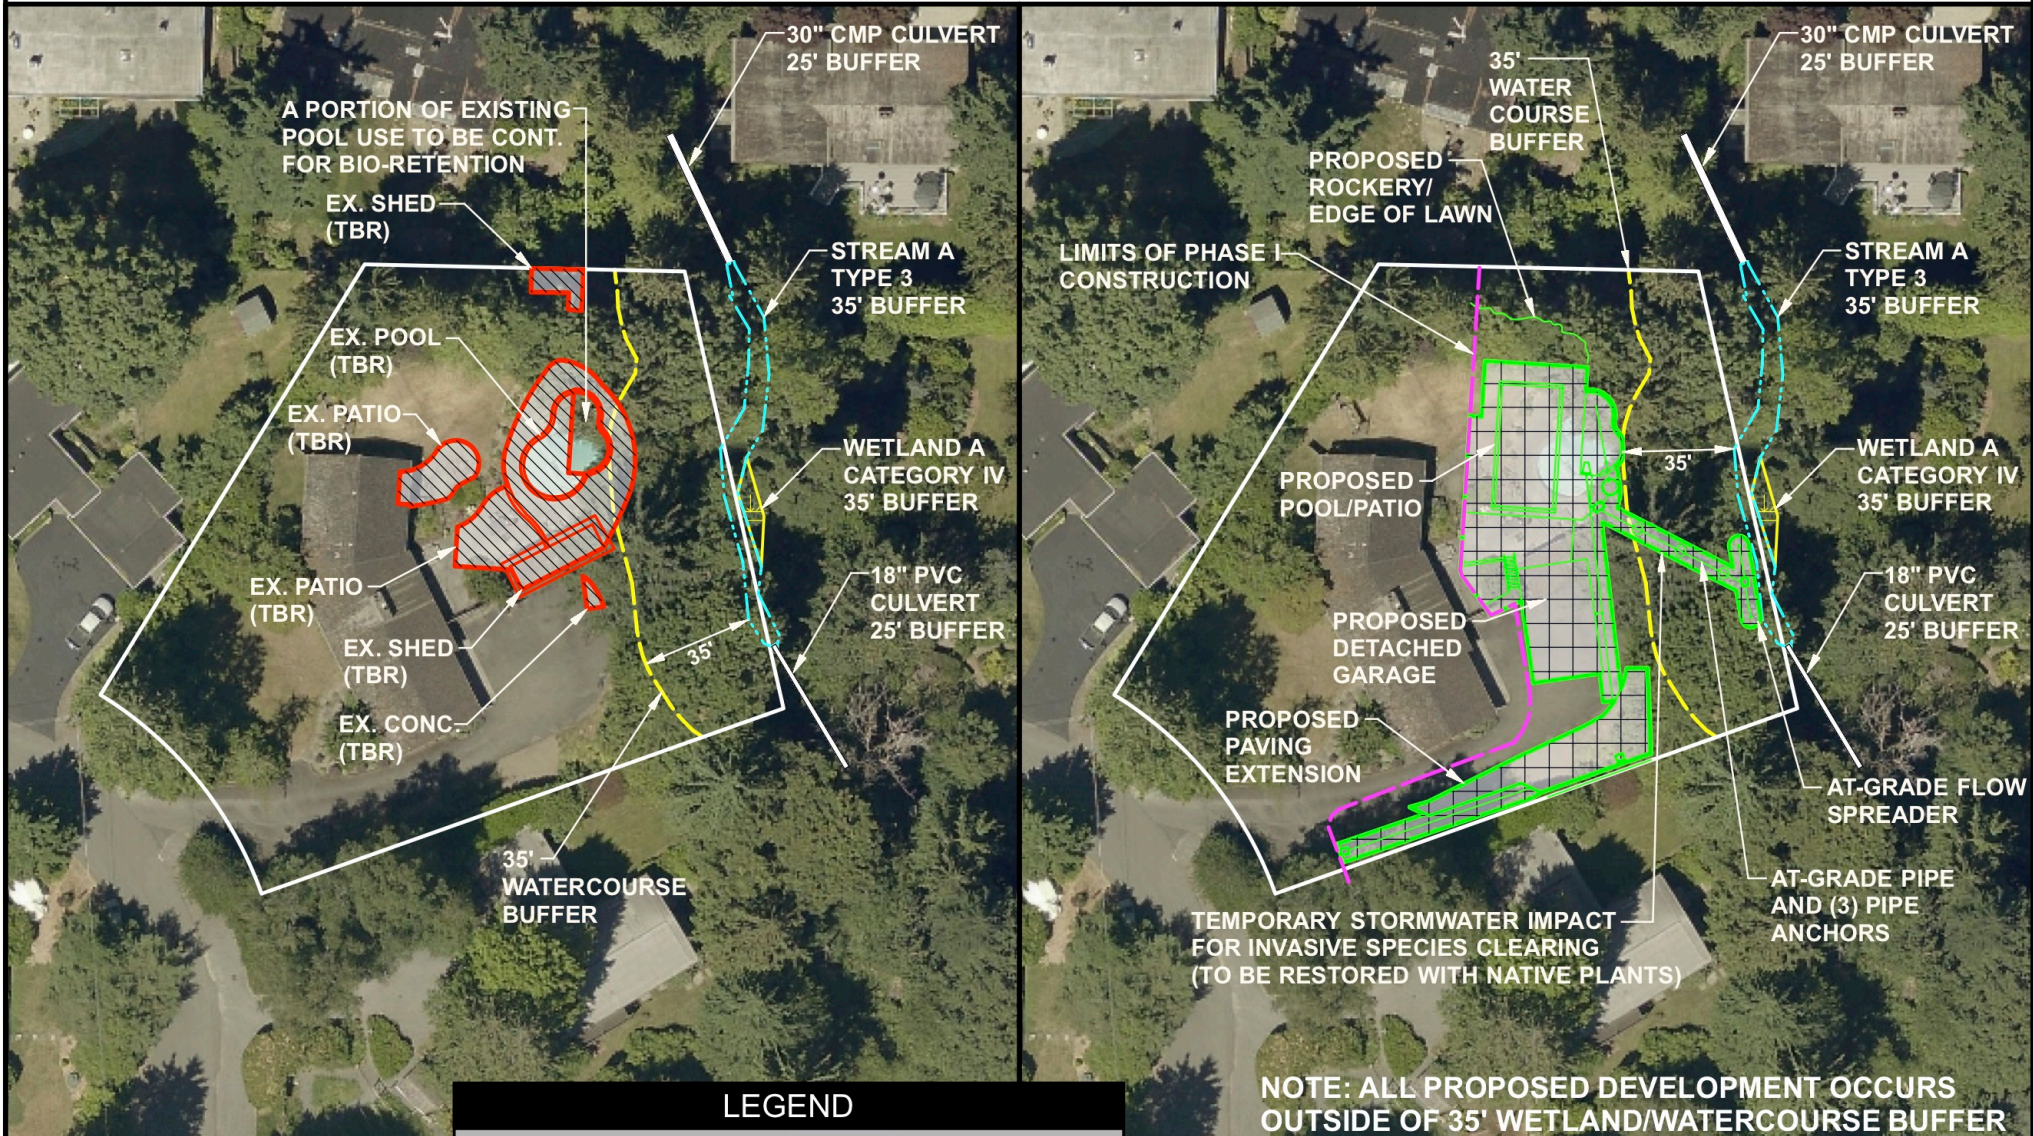
### PROPOSED DEVELOPMENT

Most new development will occur outside of critical area buffers. Impacts to critical area buffers are limited to the removal of the nonconforming patio (209 square feet), and installation of a stormwater conveyance system (378 square feet). Permanent impacts to the buffer include an above-ground pipe anchored with pin piles, and a level spreader. Clearing is necessary to install the stormwater system. Vegetation within the temporary impact area is composed of exclusively undesirable species. The following were observed during the October 24, 2019 site visit: ornamental laurel, English holly, English ivy, Himalayan blackberry, common morning glory, and yellow archangel.

The proposed redevelopment will mostly occur outside of regulated critical areas and associated buffers. This project will create 27 square feet of new permanent buffer impact, and will remove 209 square feet of an existing non-conforming use (patio). Temporary buffer impacts will occur in an area consisting exclusively of undesirable non-native vegetation. In exchange for allowing project impacts, the applicant proposes to restore 209 square feet of nonconforming pool/patio, and to remove 378 square feet of invasive species and provide replacement with native trees and shrubs. Total mitigation includes 587 square feet of buffer enhancement.

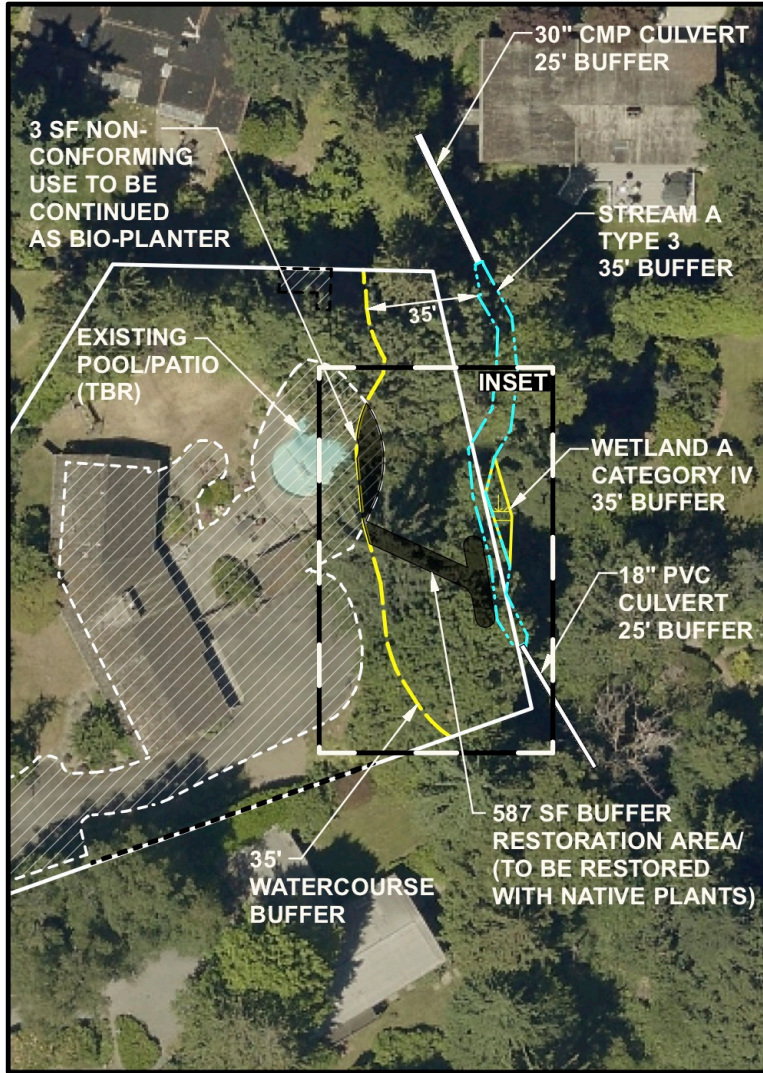
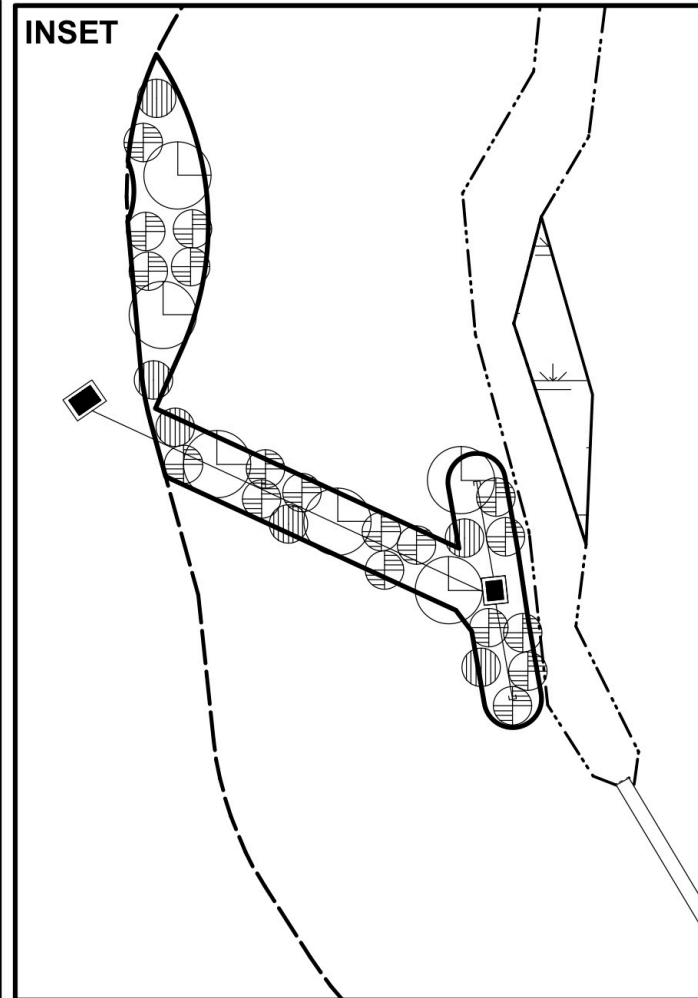
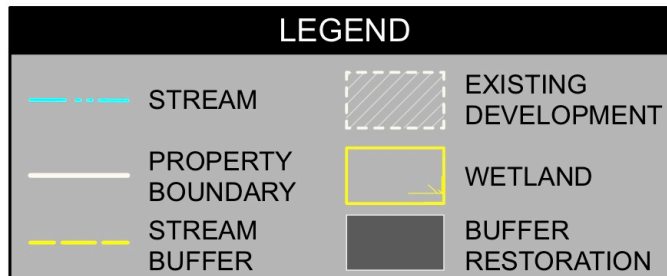
### BUFFER RESTORATION PLAN

Common Name	Latin Name	Size	Spacing	Qty.
Western red cedar	<i>Thuja plicata</i>	1 gallon	10'	6
Salmonberry	<i>Rubus spectabilis</i>	1 gallon	5'	18
Vine maple	<i>Acer circinatum</i>	1 gallon	5'	6

This project improves on-site ecological function because an existing assemblage of undesirable vegetation in the impact area will be removed and replaced with native species, and an additional 209 square feet of impervious surface will be removed and restored with native plants. Overall, this project creates a net reduction in impervious surface area in the buffer, and improves vegetative structure over the existing condition.
