CRITICAL AREA STUDY

8452 NORTH MERCER WAY ***MERCER ISLAND, WA***

Wetland Resources, Inc. Project #19201

July 25, 2019

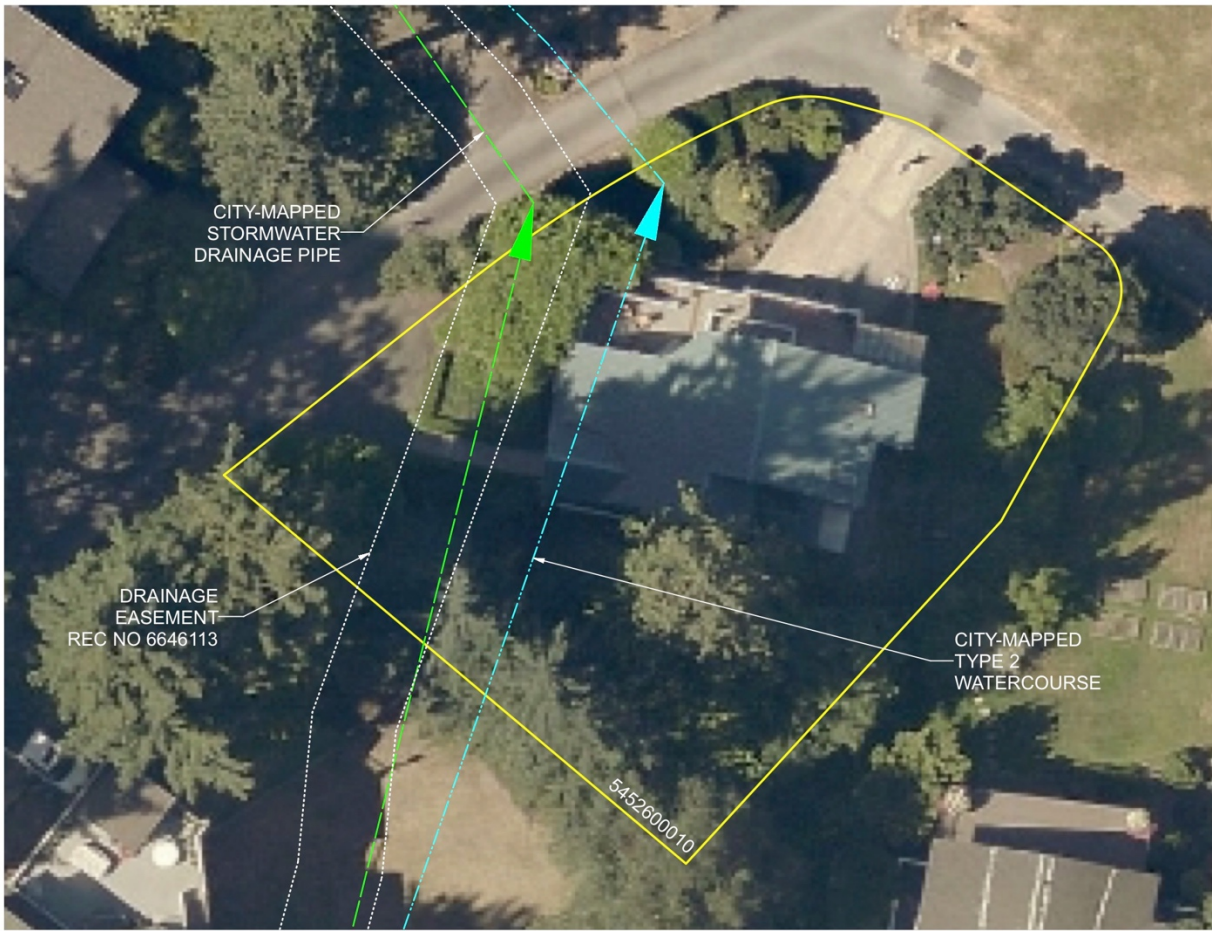
Figure 3 - Aerial photo of subject property with Mercer Island GIS Portal mapped Type 2 watercourse and stormwater drainage pipe, and recorded drainage easement.

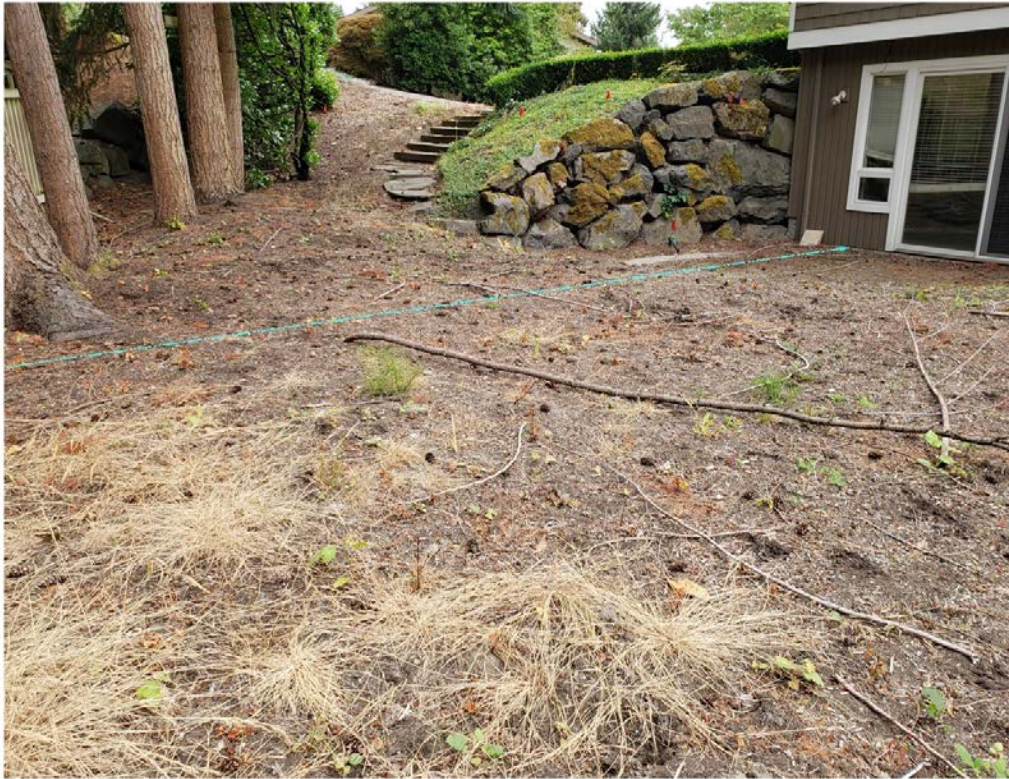
Figure 4 - Location of Mercer Island GIS Portal mapped Type 2 watercourse on the south side of the home.

Given the absence of any evidence of a stream channel or of previous surface water flow on the site, WRI has determined that no surface watercourse exists on the subject property. Based on the on-site conditions observed, the mapped stormwater drainage pipe, and the existing drainage easement, WRI has determined that a piped watercourse occurs on the subject property.

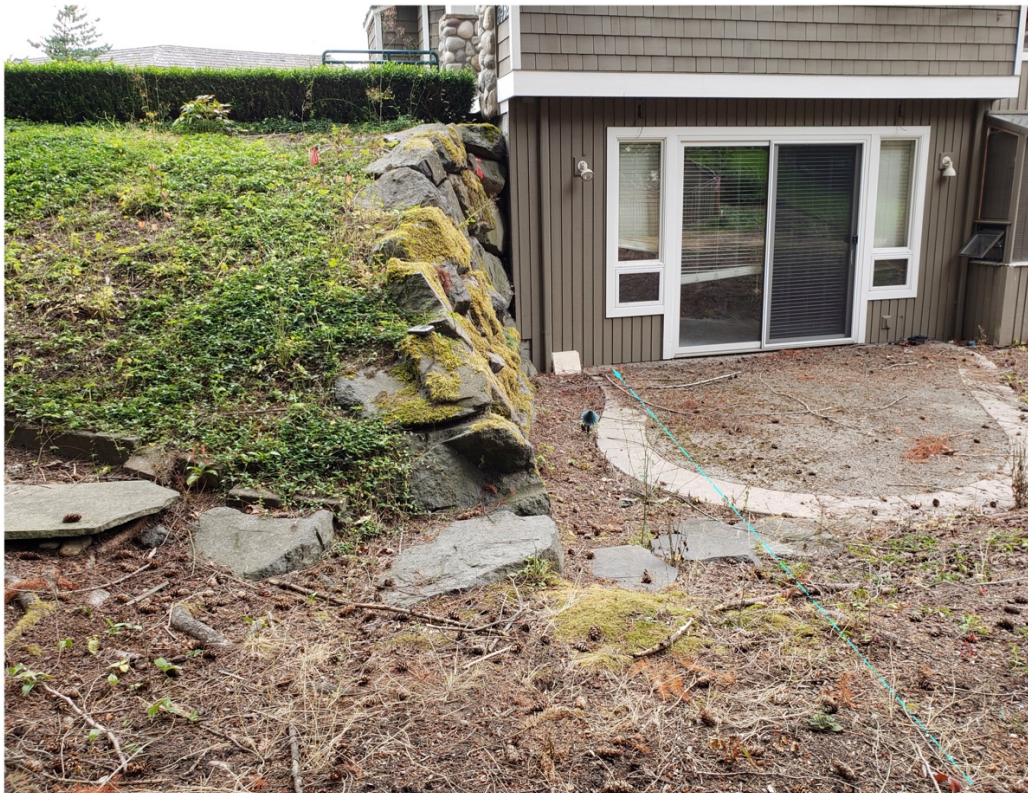
Figure 5 - Location of Mercer Island GIS Portal mapped Type 2 watercourse on the south side of the home.

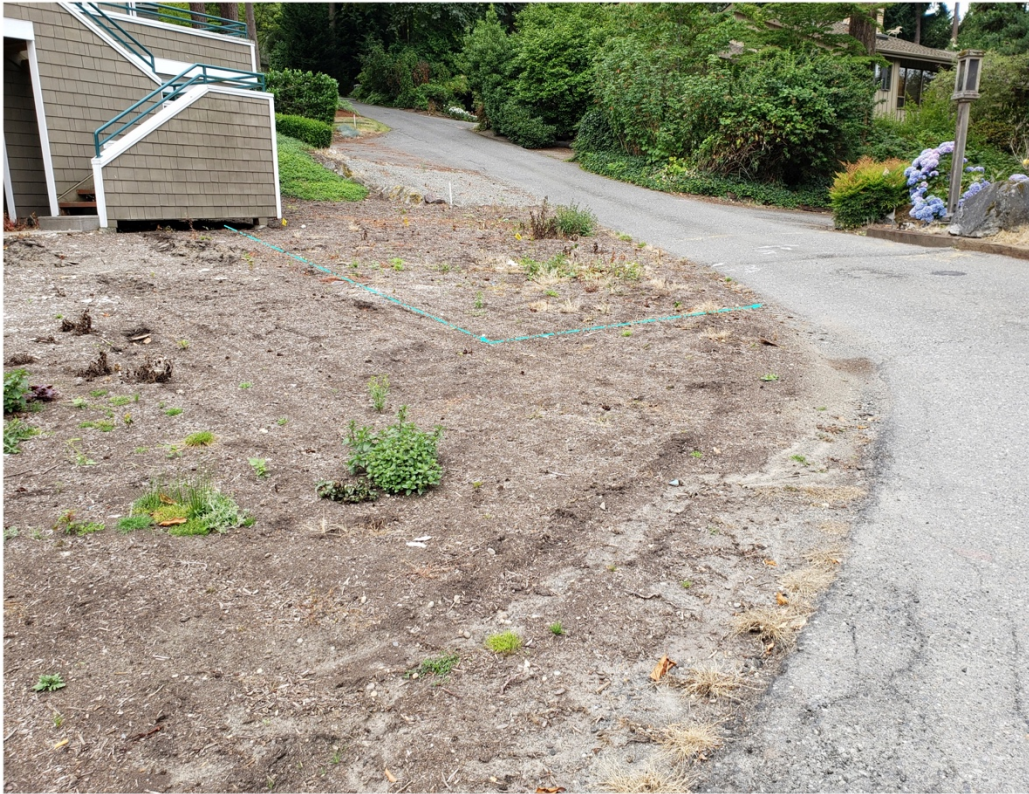
Figure 6 - Location of Mercer Island GIS Portal mapped Type 2 watercourse on the north side of the home.

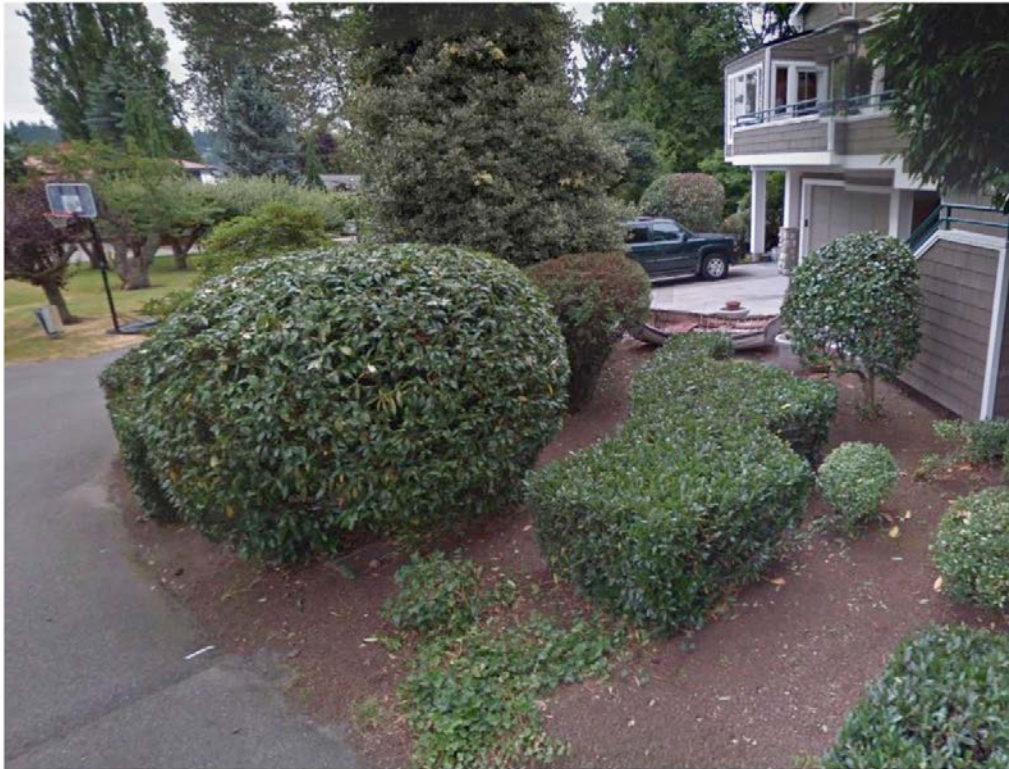
Figure 7 - Landscape plants within the piped watercourse buffer that have been removed. (Image source: Google maps)

The landscape plants that have been removed from a portion of the piped watercourse buffer (approximately 1,397 square feet) included ornamental rhododendron, cherry laurel, and other manicured ornamental landscape shrubs. Figures 7 and 8 are photographs from the Google maps “Street View” feature showing buffer conditions prior to the removal of landscaping. Gravel has been placed temporarily (approximately 145 square feet) within the on-site buffer adjacent to the parking pad on the western side of the home (see Figure 9). The gravel will be removed and this area, along with the remaining portions of the buffer where landscaping has been removed, will be planted with native species.

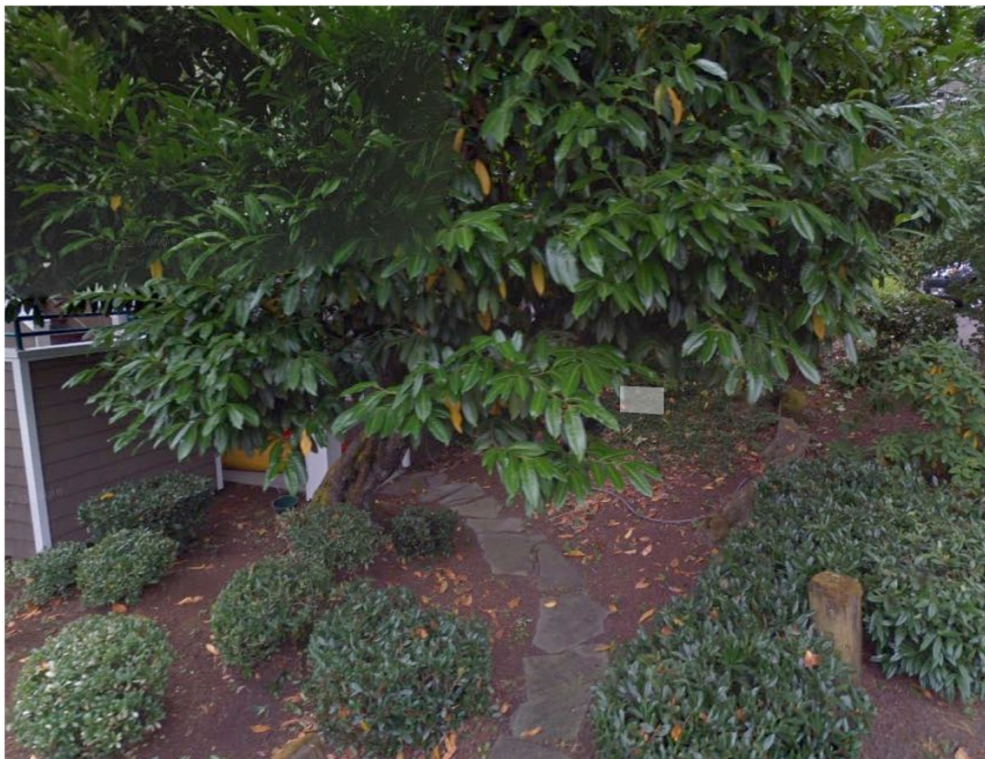
Figure 8 - Landscape plants within the piped watercourse buffer that have been removed. (Image source: Google maps)

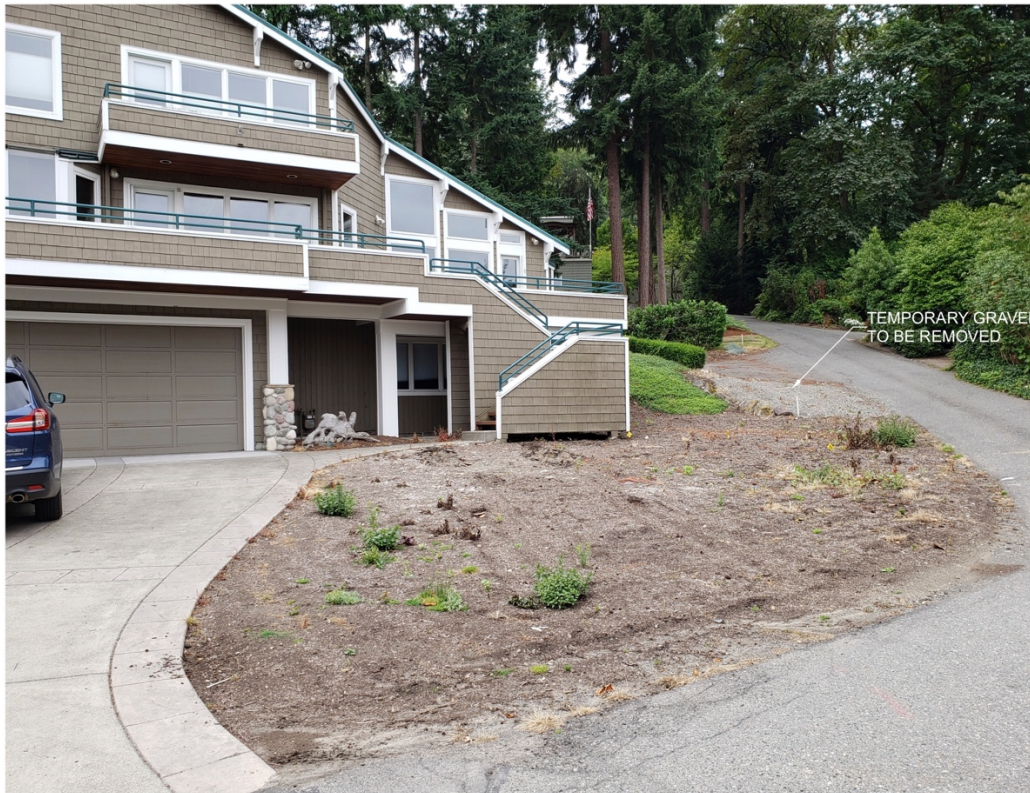
Figure 9 - Temporary gravel has been placed within the piped watercourse buffer. The gravel will be removed and the currently unvegetated portions of the on-site buffer will be planted with native species.

All gravel will be removed from the on-site buffer and the soil will be decompacted, if necessary, prior to planting to ensure successful establishment of installed native plants. The applicant proposes to restore the disturbed portions of the on-site buffer with the following native plants.
