Re: Wetland and Stream Reconnaissance – Parcel #2655500253

The Watershed Company Reference Number: 190725

Wetland and Stream Reconnaissance Sketch

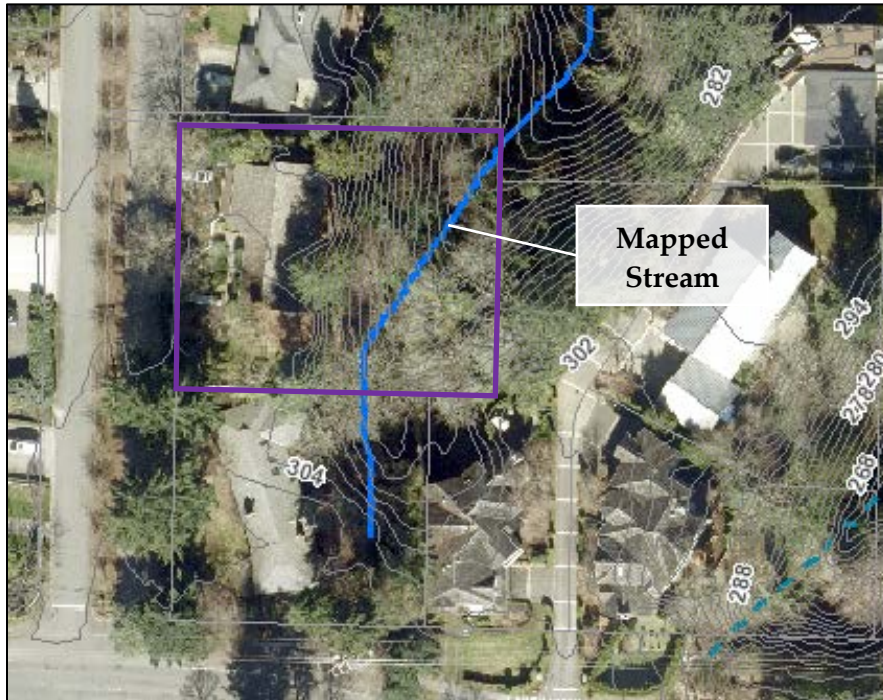
Figure 1. Screenshot of Mercer Island GIS Portal watercourse layer. Subject parcel outlined in purple.

The City of Mercer Island maps an unnamed perennial watercourse (Watercourse A) originating on the neighboring property to the south and traversing through the center of the ravine to the northeast toward Lake Washington (Figure 1). However, our investigation found no defined channels, bed and bank characteristics, scour, sorted sediments, drainage patterns or other OHWM indicators that would indicate the presence of a jurisdictional stream/watercourse. The area is characterized by a dense layer of English ivy and other herbaceous vegetation with an established duff layer. Under stream forming conditions in headwater areas, ephemeral or seasonal flows would scour and remove duff layers and form drainage patterns or small channels and rills.

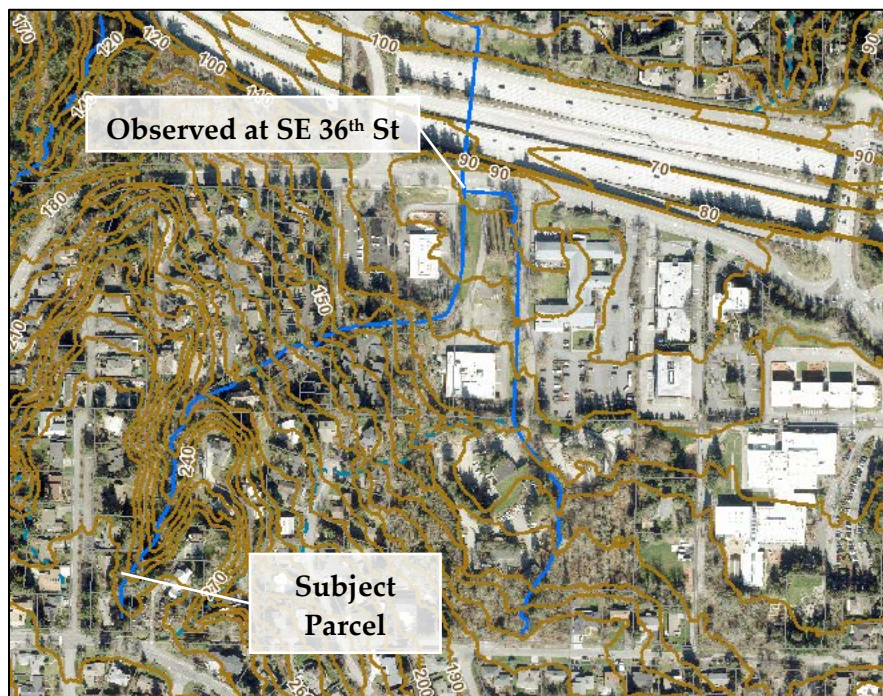
Figure 2. Screenshot of Mercer Island GIS Portal watercourse layer south of I-90.

Although there is no stream on the subject parcel, the presence of Stream A downgradient was confirmed. Downslope areas are primarily located on private property, therefore, our study of downgradient areas was limited to public road crossings. At the Southeast 36th Street crossing, Stream A is mapped flowing through a ditch on the Bright Horizons property. No streamflow was observed in this location during the site visit, however, it is unclear if the observed ditch is a continuation of Stream A or a stormwater feature of the development. Further downgradient, Stream A was observed at Southeast 33rd Street. At this location we observed stream channel steady stream flow, likely a perennial watercourse.

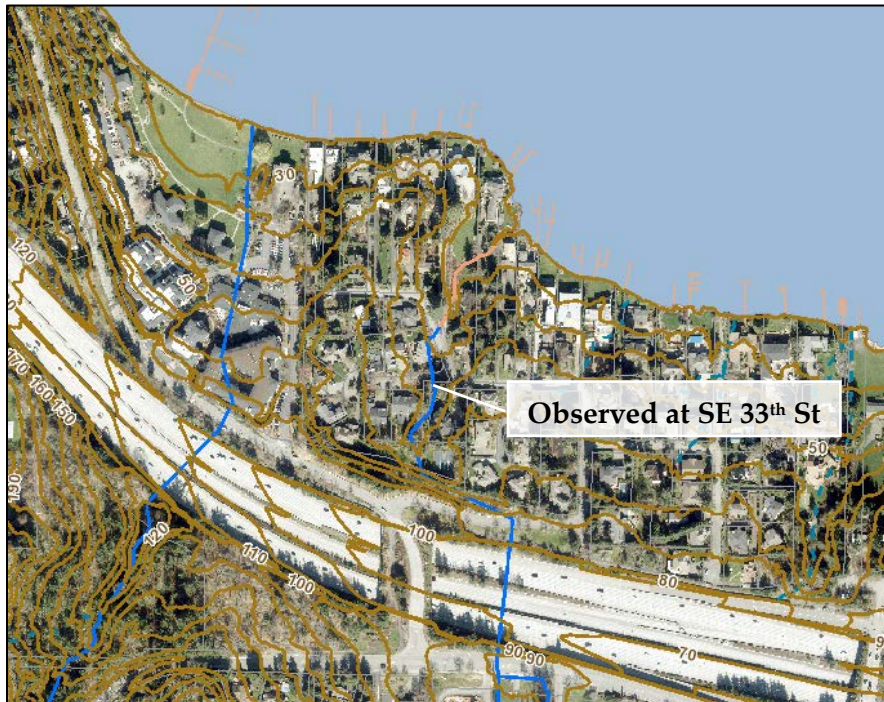
Figure 3. Screenshot of Mercer Island GIS Portal watercourse layer north of I-90.

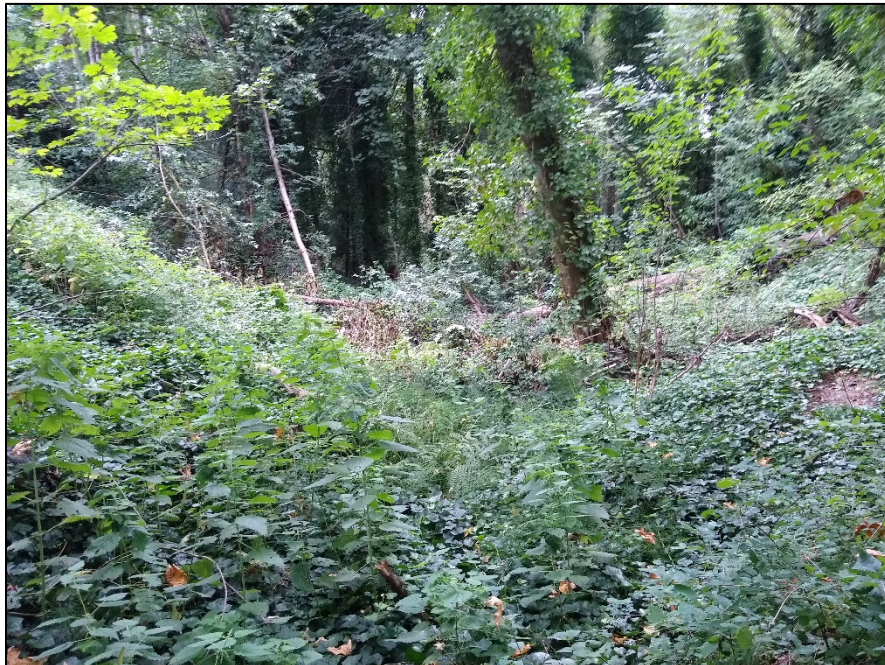
Figure 4. Photograph of ravine on the site, looking downhill.

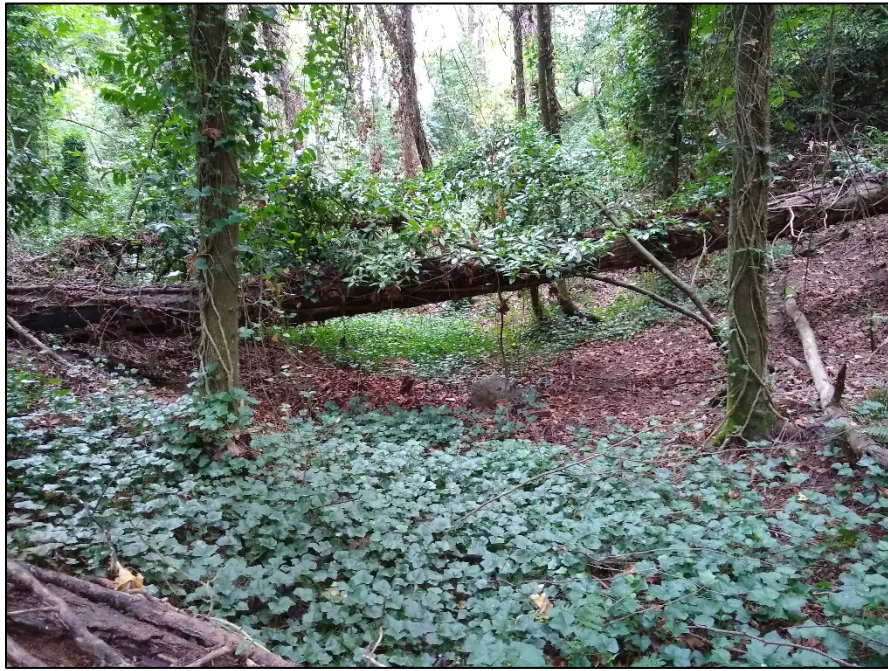
Figure 5. Photograph of ravine on the site, looking downhill.

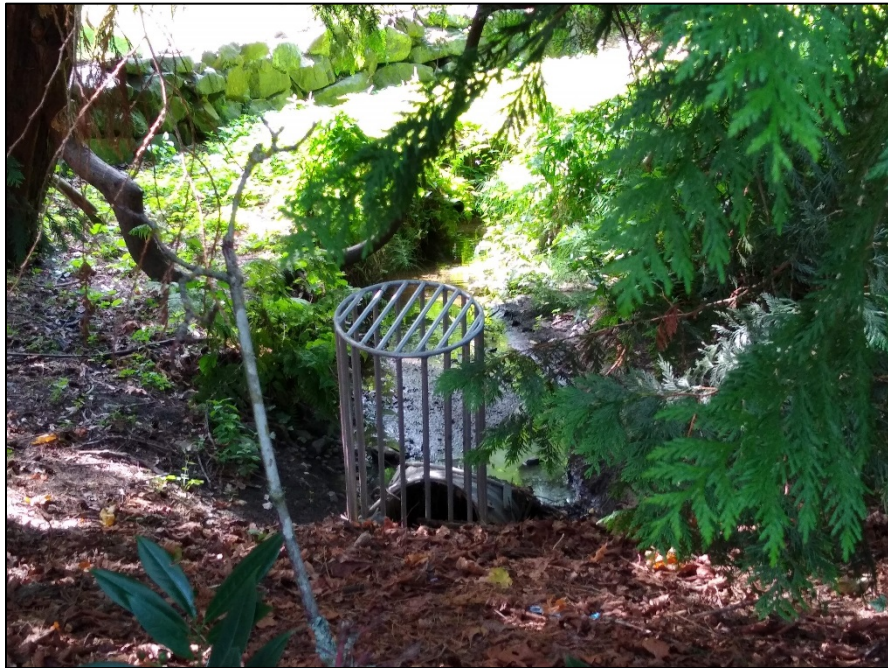
Figure 6. Photograph of Stream A taken from SE 33rd Street.

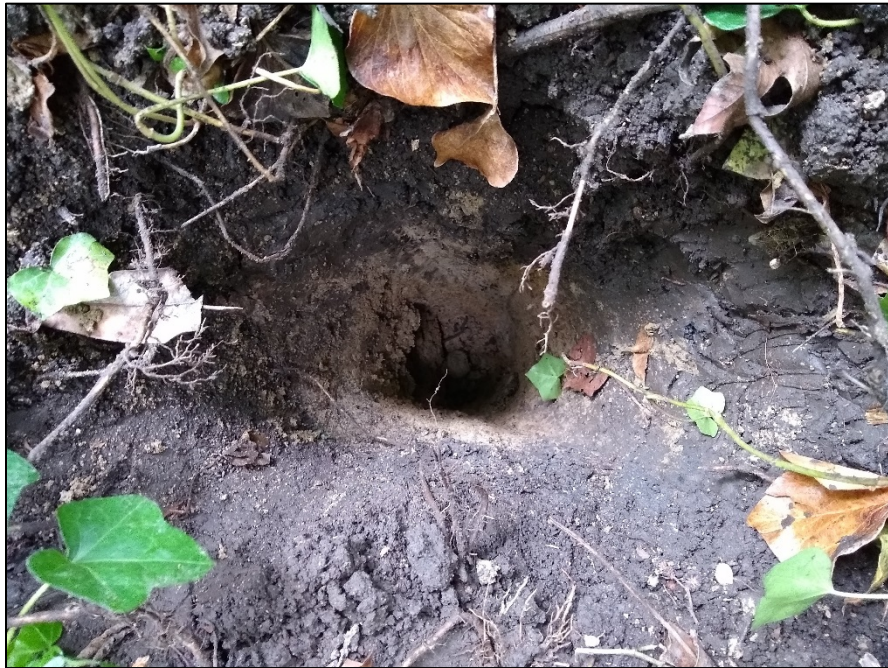
Figure 8. Photograph of DP-1 soil pit.

Water Table Present?	Yes <input type="checkbox"/> No <input checked="" type="checkbox"/>	Depth (in): _____	
Saturation Present? (includes capillary fringe)	Yes <input type="checkbox"/> No <input checked="" type="checkbox"/>	Depth (in): _____	
Describe Recorded Data (stream gauge, monitoring well, aerial photos, previous inspections), if available:			
Remarks: Soils very moist but not saturated during the month of August in a dry summer climate. Geomorphic position selected due to location in ravine at stream headwaters. Hydrology observed during a dry period when hydrology indicators are not evident. Hydrology determination based on presence of hydric soils and high soil moisture content during a dry period when non-wetland areas are typically very dry.

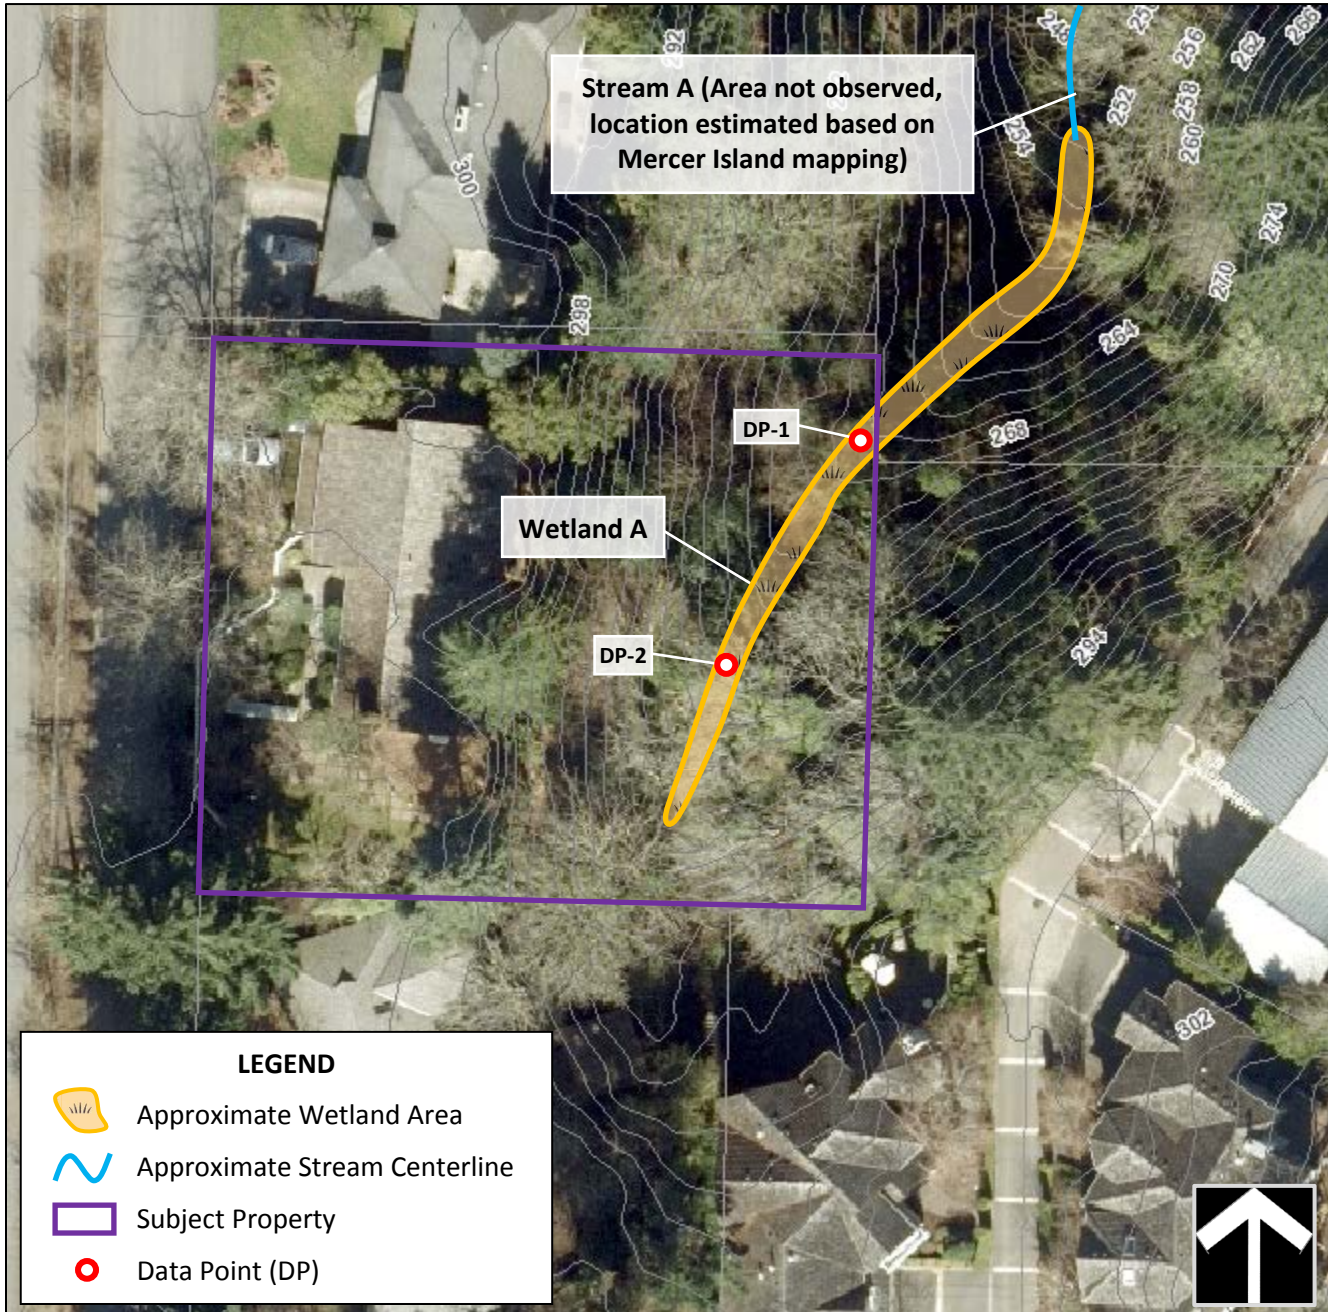
Note: Field sketch only. Features depicted are approximate and not to scale. Data points are marked with yellow- and black-striped flags.

Two wetland data points were collected confirming the presence of a small slope wetland in the center of the ravine (*see enclosed Wetland Determination Data Forms*). The feature determined to be wetland is a very narrow strip in the center of the ravine landform that contains a high groundwater table and soil saturation within the 12 inches of the soil surface was observed during the site visit. Wetland conditions are marginal, but evident within the narrow area described above. Vegetation is primarily composed of invasive English ivy (*Hedera helix*), although, lady fern (*Athyrium filix-femina*) and giant horsetail (*Equisetum telmateia*) also compose significant portions of the plant community in small localized sections. Other patches of vegetation include snowberry (*Symphoricarpos albus*), a non-wetland plant in patches of the ravine center. Soil pit data confirms saturated soils in Data Point (DP) 2 during site investigations occurring the seasonal dry period. Saturation was observed in isolated pockets of DP-2 throughout the soil profile. Soils were very moist but not saturated other sampled soil pits. Soils also showed strongly with hydric indicators, including a depleted matrix starting at around 8 inches below ground surface. Due to the variable and patchy nature of the plant communities, the wetland may be smaller than depicted in the reconnaissance sketch or split in to multiple units.
