RE: Critical Areas Determination Report for King County parcel 2581900210, located at 7216 93rd Ave SE, in the city of Mercer Island

Introduction

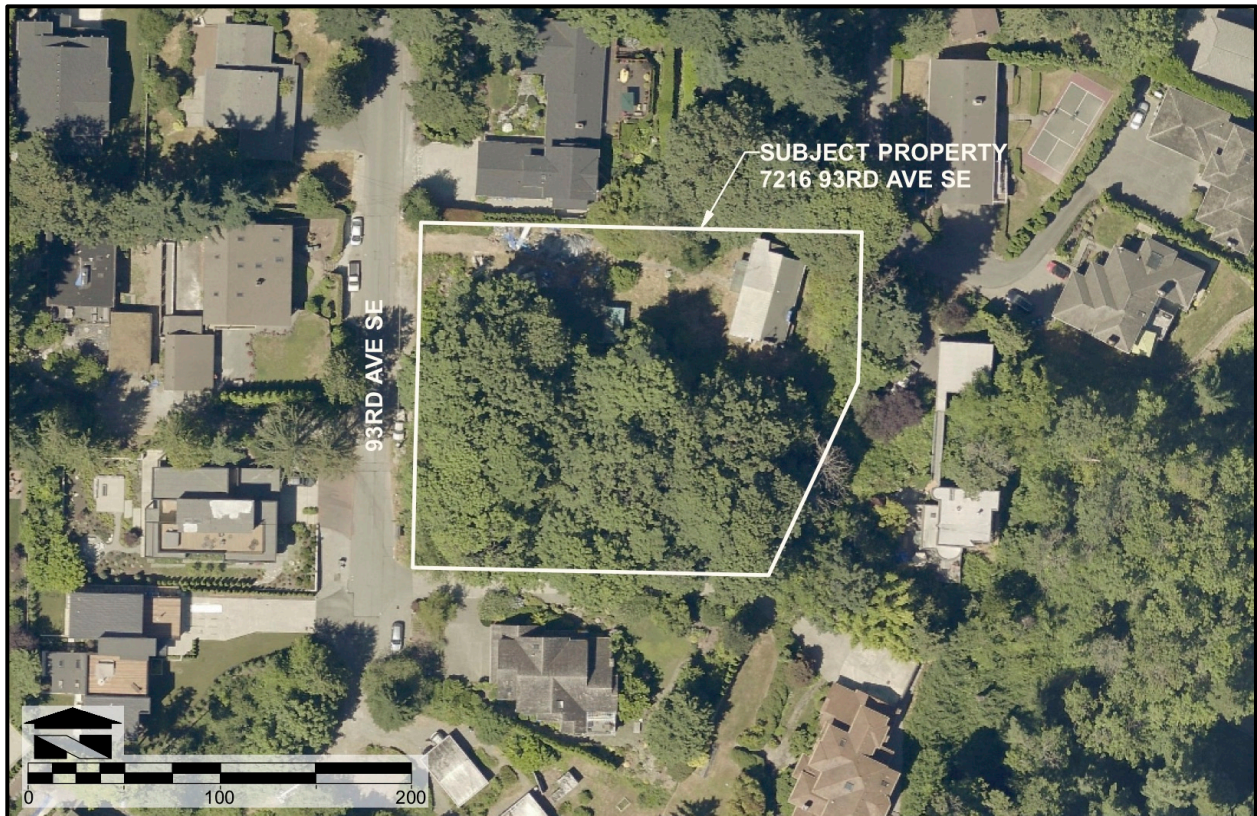
Figure 1: Aerial Overview of Subject Property

The subject property slopes east gently from 93rd Ave SE towards the existing single-family residence, which is located in the eastern portion of the property. A natural ravine is oriented east to west, and encumbers the southern two-thirds of the parcel. Residential development within the property is limited to an access driveway to the primary residence, and a garage located approximately 50 feet west of the residence. Ornamental landscaping and lawn areas are present in the northern one-third of the property. A mix of native trees and shrubs, and ornamental pioneer species dominates the ravine. No wetlands or watercourses were observed within the boundaries of the subject property.
