CRITICAL AREAS STUDY WESTHILL, INC. (LEAHY PROPERTY) CITY OF MERCER ISLAND TAX PARCEL #004610-0152

Report Revision Date: May 25, 2021

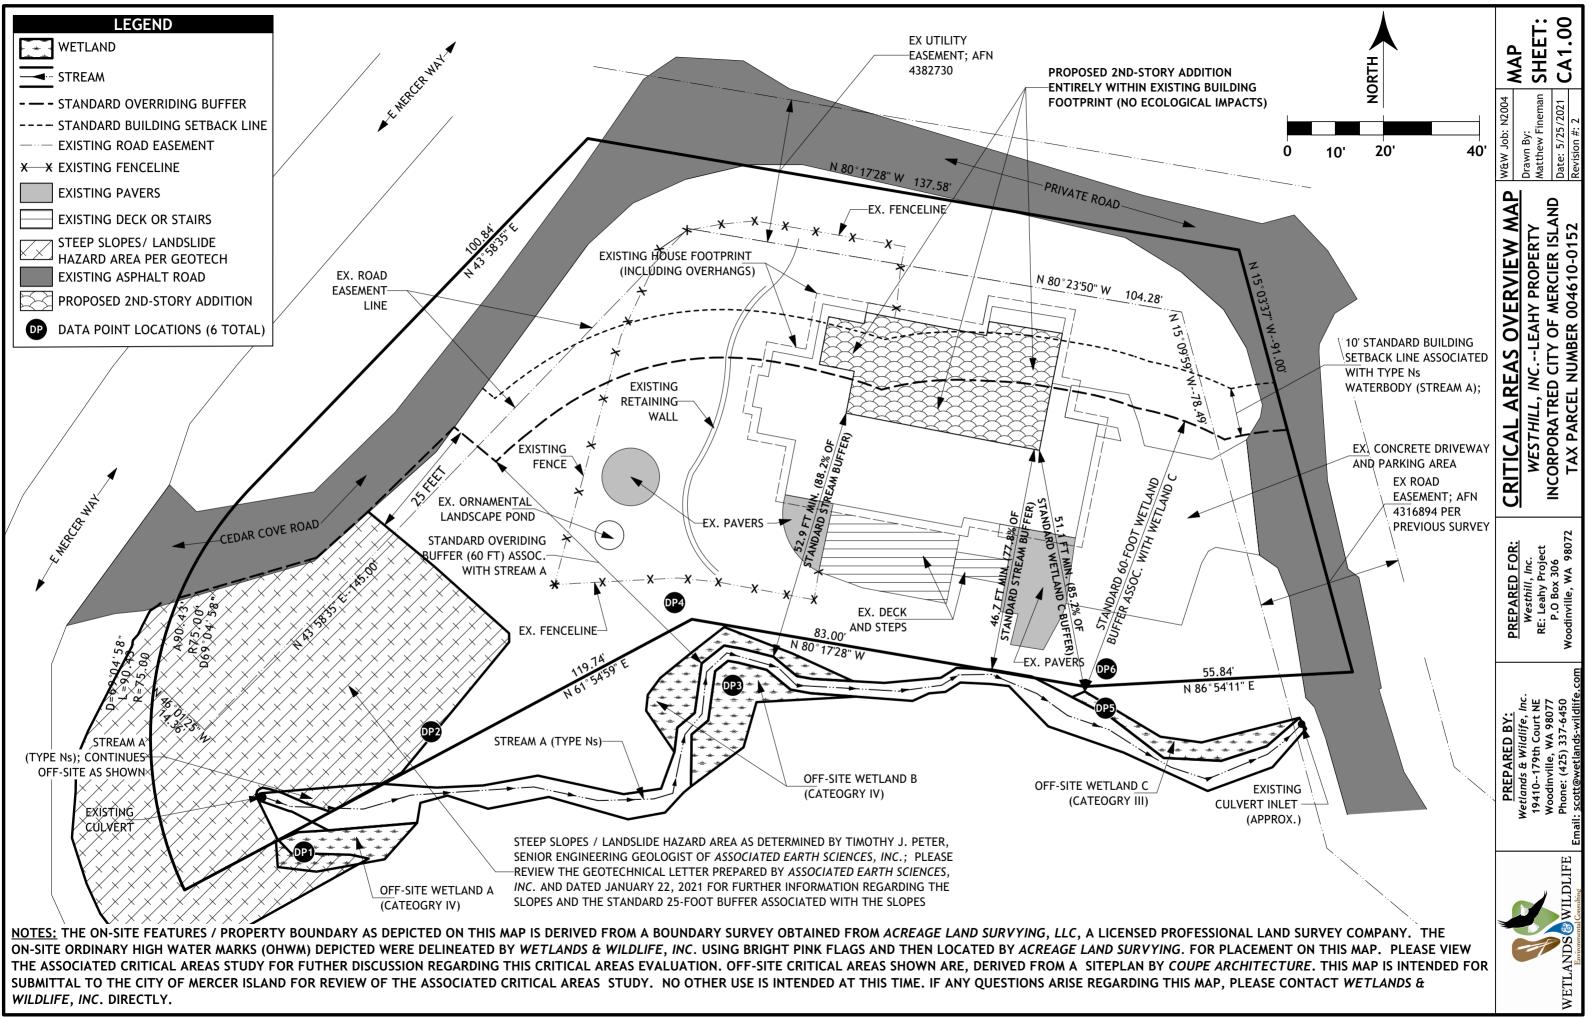
Please see the attached Map Sheet CA1.00 for a general depiction of the proposed 2nd-story addition in relation to the existing site features. Per information obtained from Cindy Larsen, Architect from *Bassett Larsen Design, LLC*, the proposed 2nd-story addition would provide approximately 1,000 square feet of additional living space. The City of Mercer Island code section 19.16.010 defines the term "building footprint" as follows: "That portion of the lot that is covered by buildings." The proposed 2nd-story addition will be located entirely within the bounds of the existing roofline / overhangs associated with the existing house. Therefore, the proposed 2nd-story addition will not result in any increase to the existing "building footprint" as defined in the City's code section 19.16.010.

Stream A transports hydrology generally from west to east. This stream is located on-site among the southwestern portion of the property, and then extends off-site but is located in close proximity to the southern property line as shown on Map Sheet CA1.00. Stream A is classified on the City of Mercer Island GIS Portal as a non-fish bearing stream and appears to be a seasonal / intermittent stream. Therefore, the stream is considered a Type Ns stream. Per MICC section 19.07.180.C.1, Type Ns streams in the City of Mercer Island typically receive 60-foot protective buffers. Therefore, the standard buffer width required for this stream on this site equals 60 feet. Please see the discussion below regarding overlapping buffer widths. Please also see the attached Map Sheet CA1.00 for a depiction of Stream A.

Off-site Wetland A is located off-site to the south of the property, near the southwest property corner as depicted on the attached Map Sheet CA1.00. Per the City of Mercer Island code requirements, Wetland A was rated using the Washington State Wetland Rating System for Western Washington (Revised, Publication No. 14-06-029, October 2014). The wetland slopes from south to north toward Stream A and was therefore rated as a "Slope" wetland on the Wetland Rating Form. Using the Wetland Rating Form, the subject wetland scored a total of 14 points (6 points for Water Quality Functions, 4 points for Hydrologic Functions, and 4 points for Habitat Functions) and is therefore considered a **Category IV wetland**. The rating form is attached to this report for viewing. Per the table shown MICC 19.07.090.C.1, Category IV wetlands typically require a protective buffer width of 40 feet to be applied parallel to the wetland boundary. **Therefore, the standard buffer width required for Wetland A equals 40 feet.** Please view the discussion below regarding overlapping buffer widths and the attached Map Sheet CA1.00 for a depiction of Wetland A and its associated protective buffer.

Off-site Wetland B is located off-site to the south of the property, south of the existing residence as depicted on the attached Map Sheet CA1.00. Per the City of Mercer Island code requirements, Wetland B was rated using the Washington State Wetland Rating System for Western Washington (Revised, Publication No. 14-06-029, October 2014). The wetland slopes from toward Stream A and was therefore rated as a "Slope" wetland on the Wetland Rating Form. Using the Wetland Rating Form, the subject wetland scored a total of 13 points (6 points for Water Quality Functions, 3 points for Hydrologic Functions, and 4 points for Habitat Functions) and is therefore considered a **Category IV wetland**. The rating form is attached to this report for viewing. Per the table shown MICC 19.07.090.C.1, Category IV wetlands typically require a protective buffer width of 40 feet to be applied parallel to the wetland boundary. **Therefore, the standard buffer width required for Wetland B equals 40 feet.** Please view the discussion below regarding overlapping buffer widths and the attached Map Sheet CA1.00 for a depiction of Wetland B and its associated protective buffer.

As mentioned above, the subject properties contain multiple Critical Areas which are regulated pursuant to Chapter 19.07 of the MICC. When two or more Critical Area buffers overlap, the more restrictive buffer typically applies. On these particular properties, the resulting standard buffer line from overlapping buffer widths is shown on the attached Map Sheet CA1.00.

In addition to the protective buffer widths described above, MICC section 19.07.180.C.7 states "...buildings and other structures shall be set back a minimum of ten feet from the edges of a watercourse buffer." However, per previous detailed email correspondence between Robin Proebsting (Senior Planner at the City of Mercer Island's Community Planning and Development Department) and Cindy Larsen of *Bassett Larsen Design, LLC,* an additional 10-foot building setback line is not required to accommodate the proposed 2nd-story addition in this scenario due to the existing residence in the buffer. Further, the proposed 2nd-story addition will be located farther from the stream and wetland than the existing residence and the addition will be constructed entirely within the building footprint associated with the existing residence. The attached Map Sheet CA1.00 depicts the standard 10-foot building setback line.

Wetlands & Wildlife, Inc. was retained by *Westhill, Inc.* to conduct detailed Critical Areas evaluations of the subject property and vicinity pursuant to the requirements outlined in Chapter 19.07 (Environment) of the Mercer Island City Code (MICC). Specifically, *Wetlands & Wildlife, Inc.* was retained to determine if any wetlands, streams, or associated protective buffer areas regulated by the MICC exist on or near the property. *Wetlands & Wildlife, Inc.* conducted detailed Critical Areas multiple site visits to the subject property during 2020. Please review the RESULTS AND FINDINGS OF CRITICAL AREAS EVALUATION section of this report for further information. Please also see the attached Critical Areas Overview Map (Map Sheet CA1.00).
