## Sewall Wetland Consulting, Inc.

RE: Parcel #5454000060 – Critical Areas Report  
SWC Job#21-185

### 1.0 INTRODUCTION

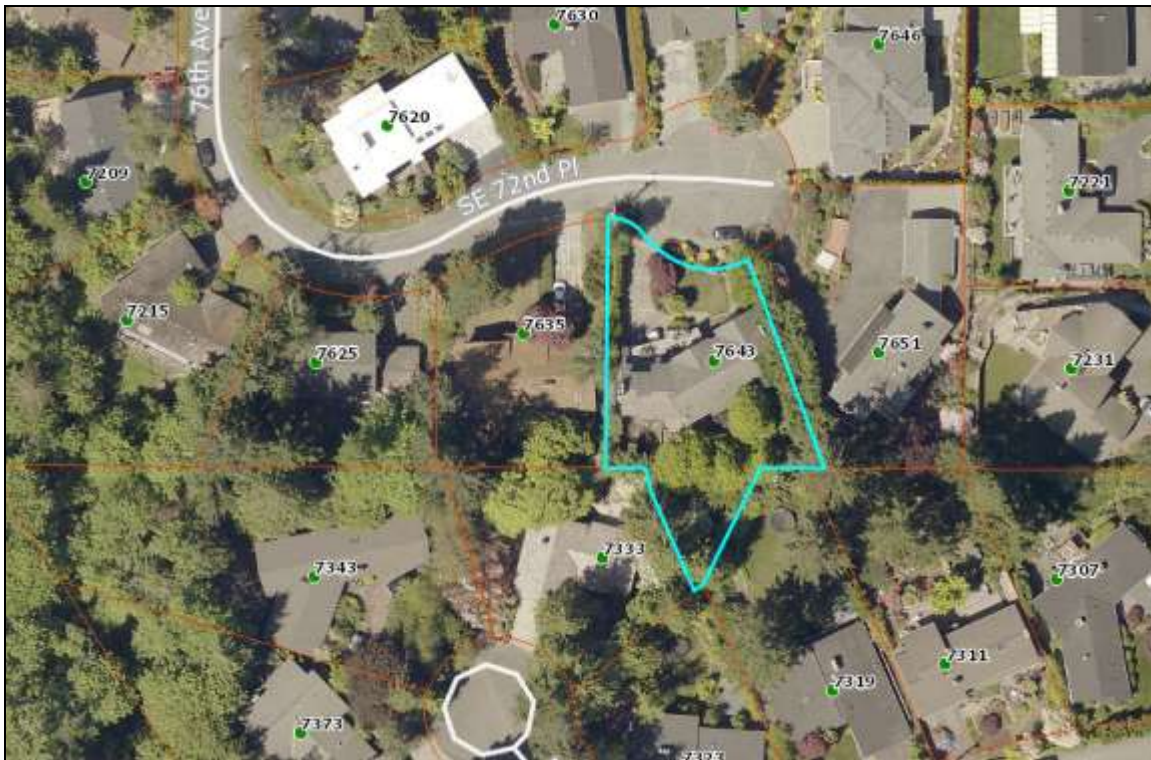
*Above: 2019 aerial photograph of the site.*

King County iMap with wetland and stream layers depicts no wetlands or streams on or near the site (see aerial image page 2 of this report).

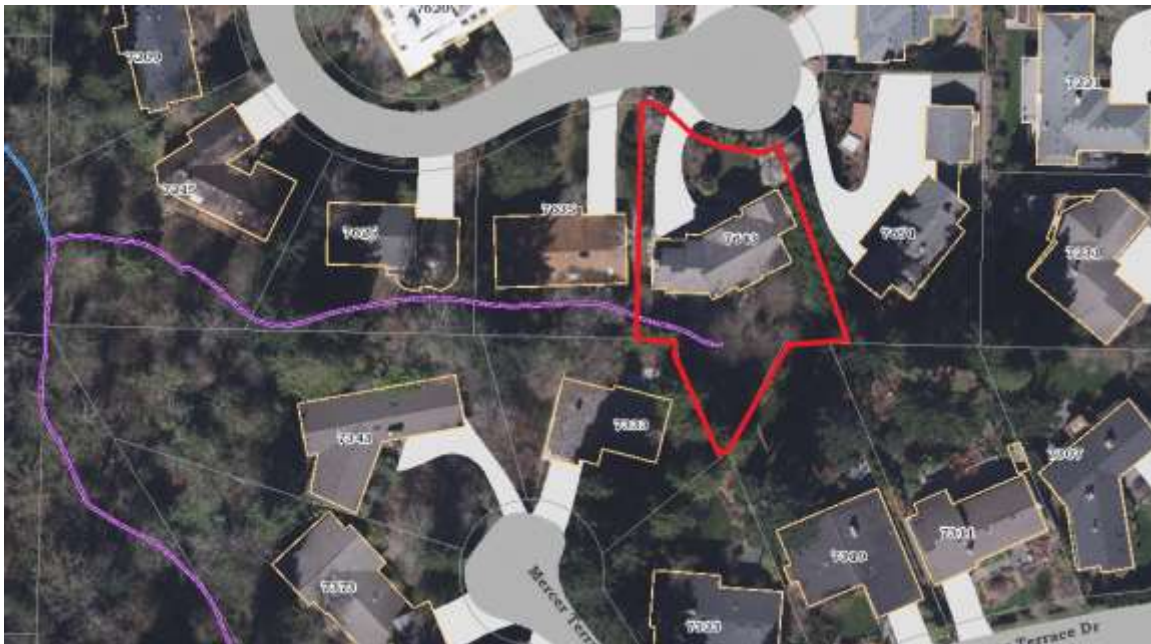
According to City of Mercer online mapping website with wetland and stream layers activated, there is a stream that starts in the center of the backyard on the site and flows to the west.

*Above: City of Mercer Island mapping of wetlands and streams on or near the site.*

No wetlands, streams or buffers of wetlands or streams are present n the site. The stream depicted on the City inventory mapping is clearly erroneous and the stream does not exist.

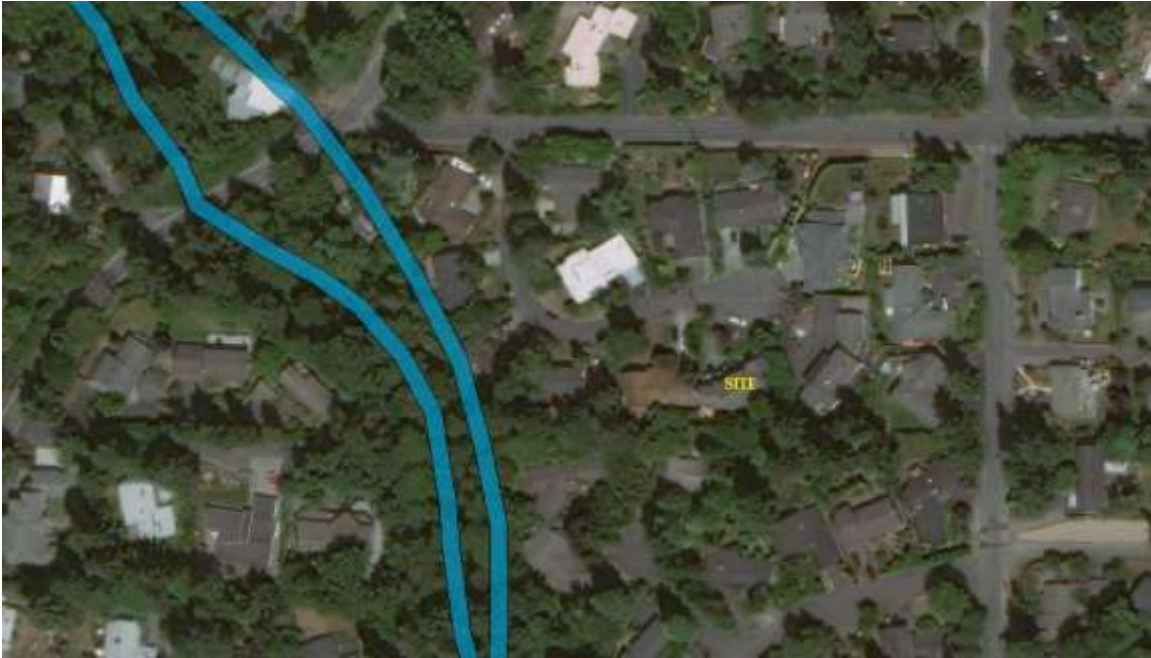
The NWI map depicts no wetlands or streams on the site. The closest stream mapped is approximately 300' west of the site.

*Above: NWI Map of the study area*

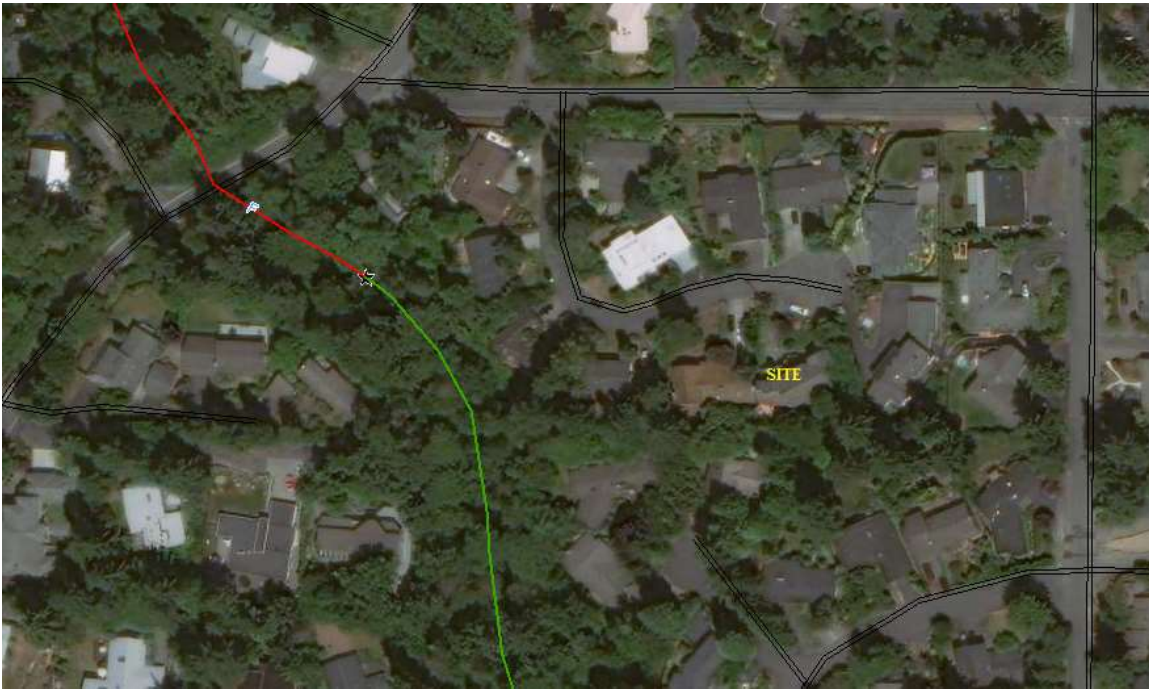
According to the WDNR Fpars website which depicts known streams, there are no streams on or near the site. The closest stream is mapped approximately 300' west of the site.

*Above: WDNR Fpars Water Type Mapping of the site*

We could observed the 2 abutting lots to the west (7625 & 7635) from which extends just over 200' west of the site and could clearly see that the area is just landscaped lawns with no wetlands or streams present. If the stream that the city maps depict on the site exists at all, it must start at least 200' west of the site, similar to that shown on the WDNR Fpars mapping shown at the top of this page.

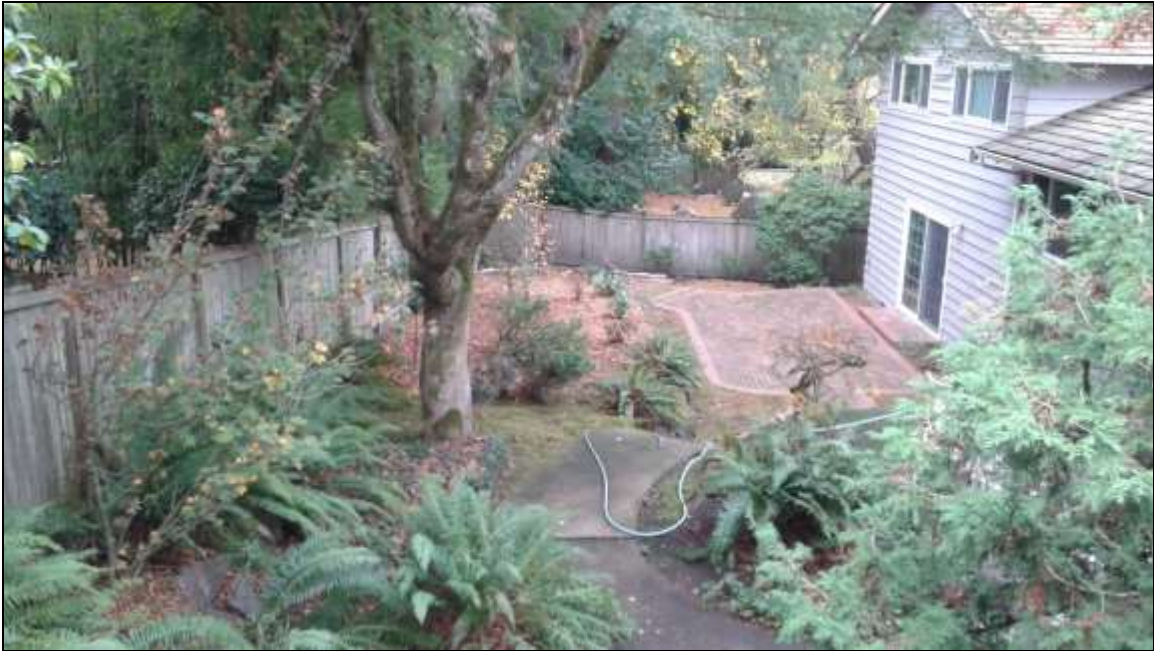
*Above: looking west from the site across parcels at 7625 & 7635 SE 72nd Place. No stream channel is present on either of these parcels nor the site itself.*

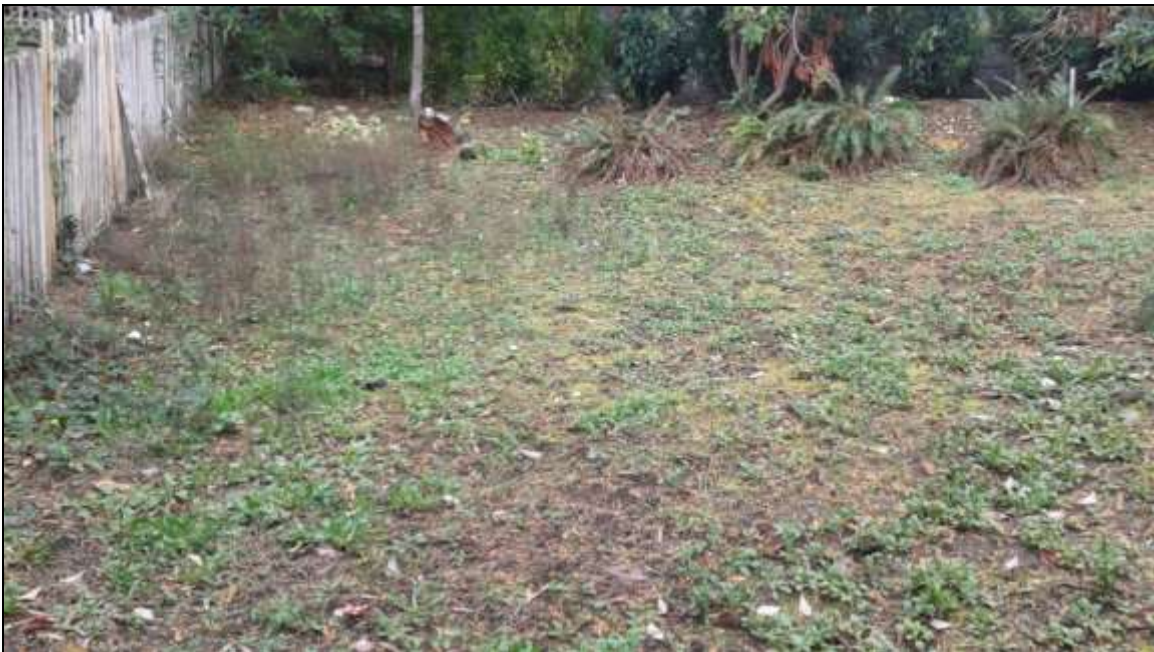
As previously described, an existing single family is located on the site with associated paved driveway and landscaped areas. The back yard south of the home is a landscaped play area and lawn. There is no wetland or stream channel present. We inspected the site to the south of the parcel which is lawn and there is also no wetland or stream in this area.

*Above: Area on the south side of the site, no stream channel is present.*
