CRITICAL AREA STUDY

Zhang Property – Tax ID 1438700145
City of Mercer Island, WA

Wetland Resources, Inc. Project #21016

First Submittal: July 19, 2021
Revision 1: February 22, 2022

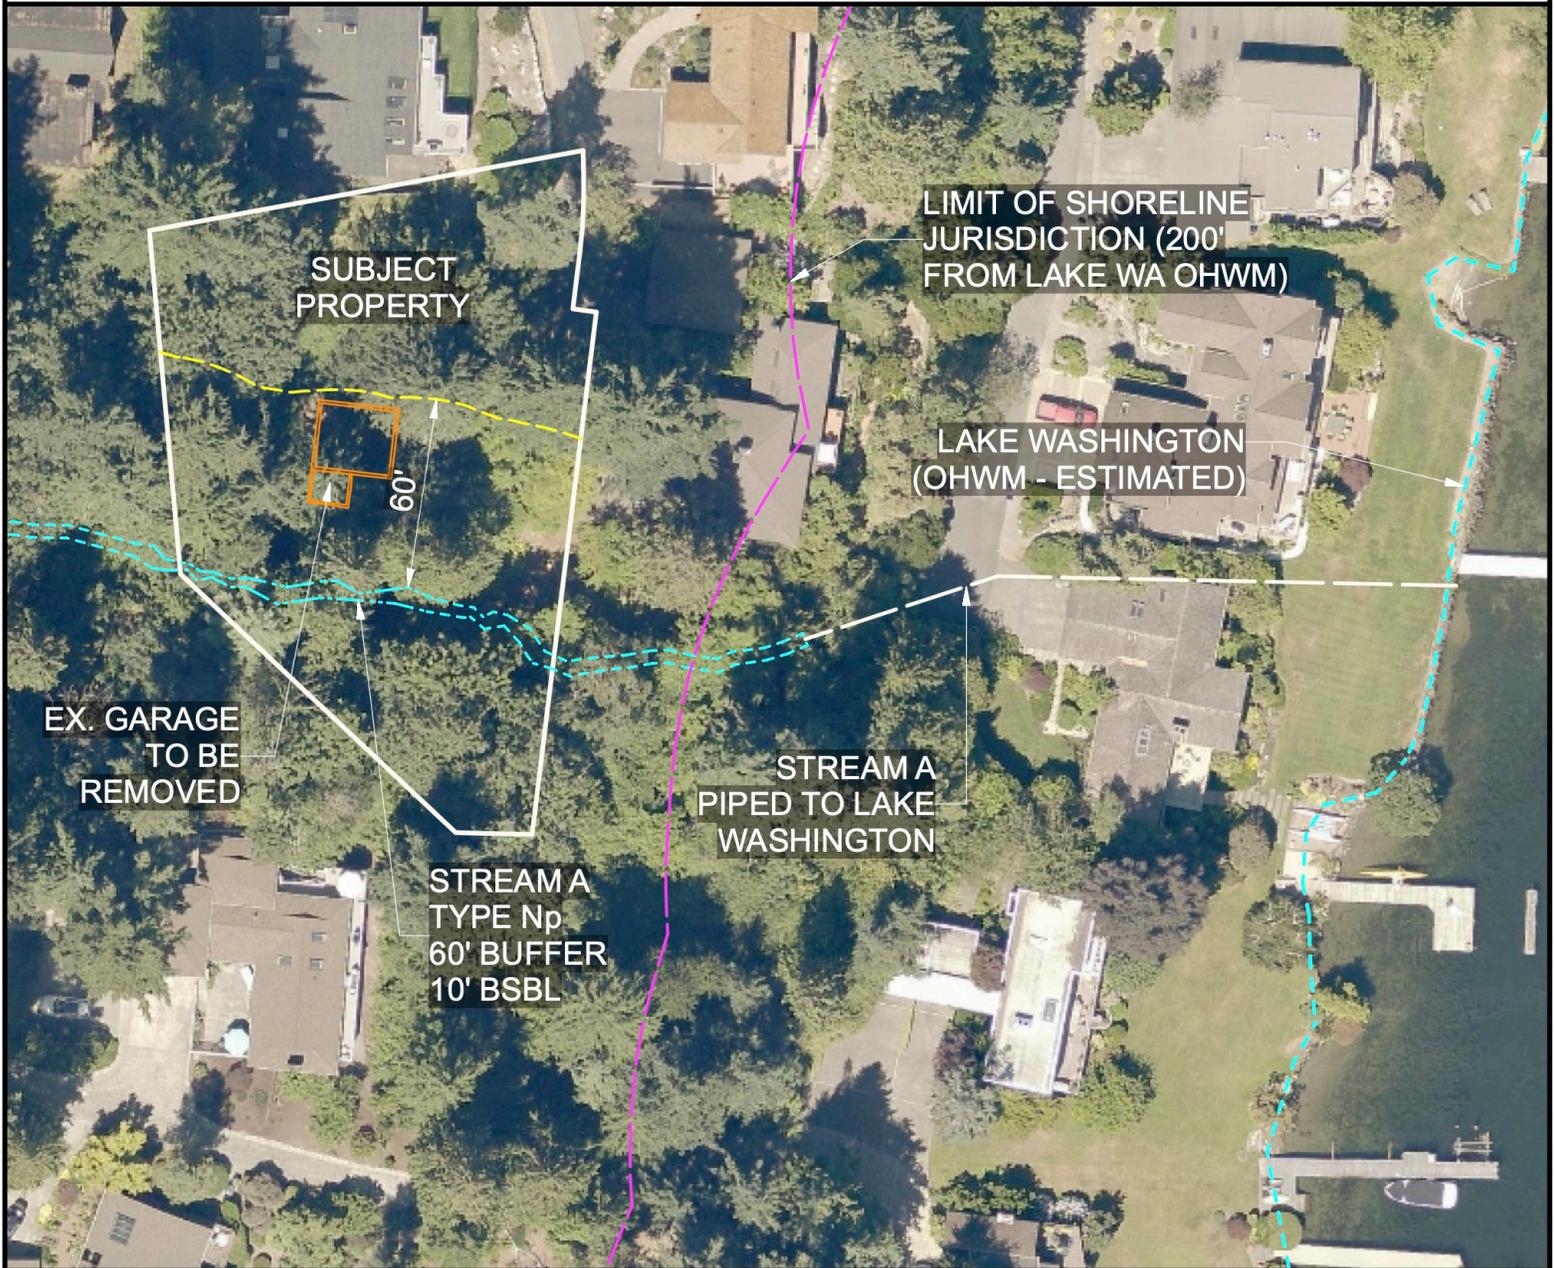
CRITICAL AREA STUDY MAP - EXISTING CONDITIONS
ZHANG PROPERTY - K.C. TAX ID 1438700145
 PORTION OF SECTION 19, TOWNSHIP 24N, RANGE 5E, W.M.

ON-SITE PORTION OF STREAM A WAS DELINEATED AND SURVEYED. OFF-SITE PORTION OF STREAM A WAS ESTIMATED USING PUBLICLY AVAILABLE RESOURCES AND BASED ON INTERPRETATION OF THE DIGITAL ELEVATION MODEL.

Stream A is a narrow, slightly down-cut stream that flows eastward through the center of the subject site. Two tributaries to Stream A originate west of East Mercer Way in the Southeast 53rd Place Open Space. At the confluence of the tributaries, Stream A is culverted beneath East Mercer Way and outflows into the Cayhill Open Space property. The stream flows along the north boundary of Cayhill Open Space until it enters the subject property from the west.

The on-site portion of Stream A forms at the base of a broad ravine that slopes east towards Lake Washington. The stream channel varies between narrow, channelized areas and shallow braided areas where the stream temporarily broadens. Stream A meanders to the east through the subject property channel along the topographic low point of the ravine before discharging onto the adjacent parcel to the east (5425 96th Ave SE).

The stream flows for approximately 85 feet off-site to the east before entering a 12-inch concrete culvert. The culvert conveys Stream A for approximately 205 feet before discharging directly to Lake Washington near the common boundary between the properties located at 5428 SE 54th Street and 5436 SE 54th Street. The culvert travels beneath improved surfaces that include the terminus of SE 54th Street and the access driveway to 5436 SE 54th Street, and just north of the foundation of the primary structure located at 5436 SE 54th St.
