# Technical Memorandum

Project Name: Mercer Island Chen

## Re: Parcel 1924059317 Wetland and Stream Reconnaissance Study

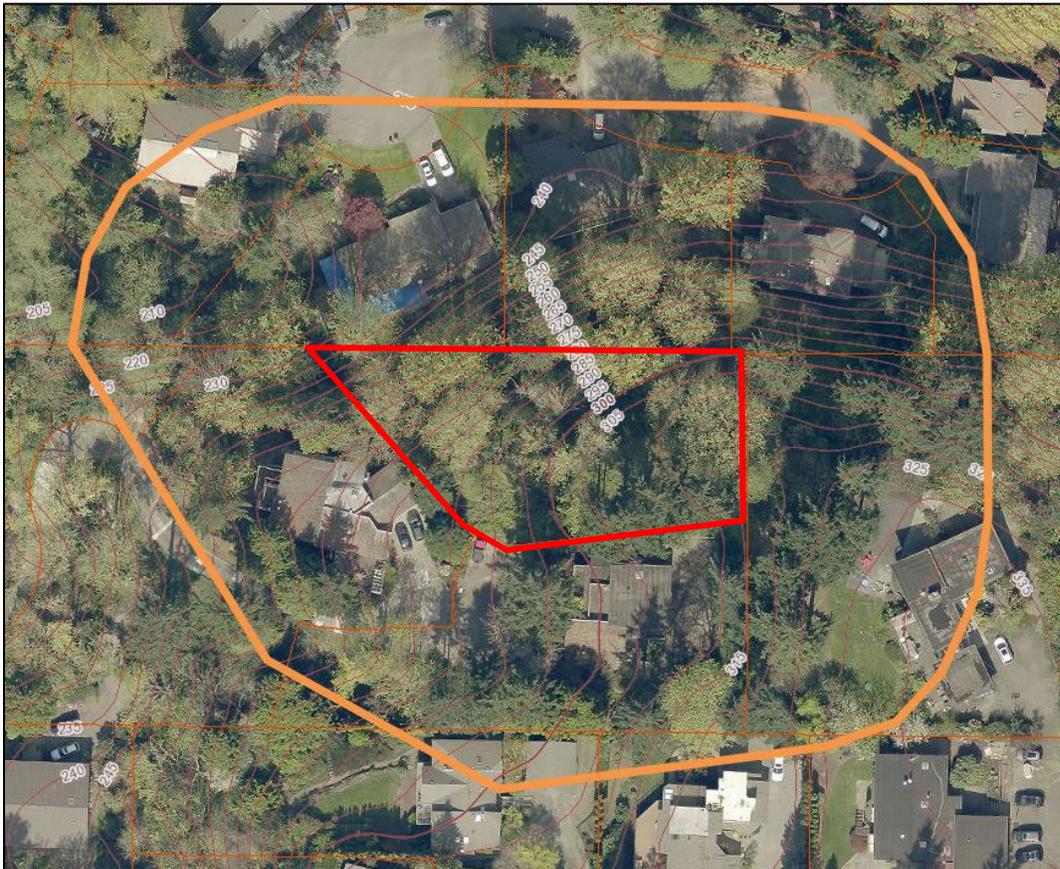
Figure 1. Study area (in orange) includes areas within 130 feet of the subject parcel (in red).

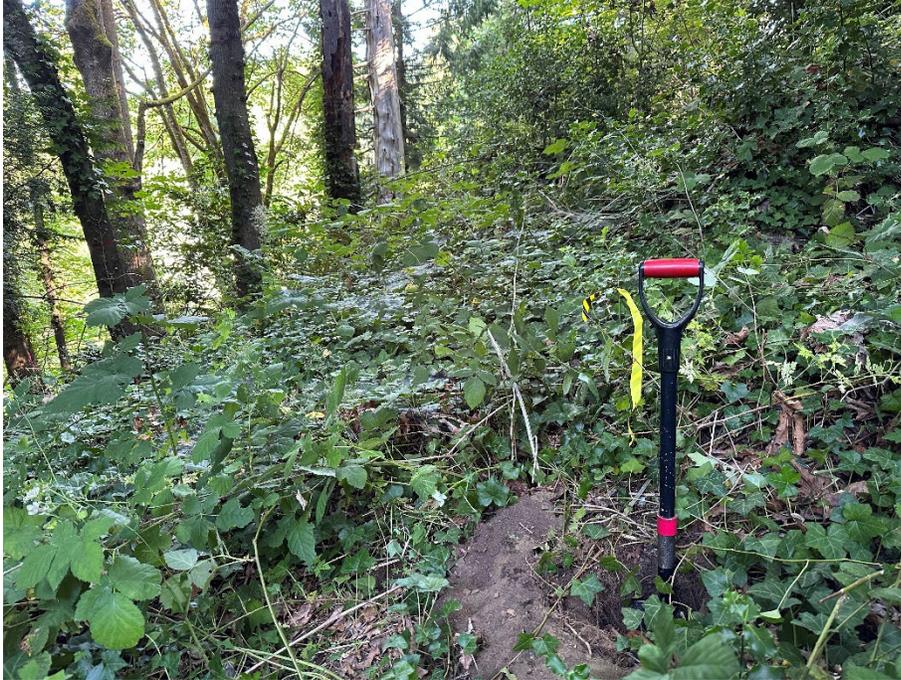
Photo 1. Data point (DP) 1, demonstrating non-wetland conditions.

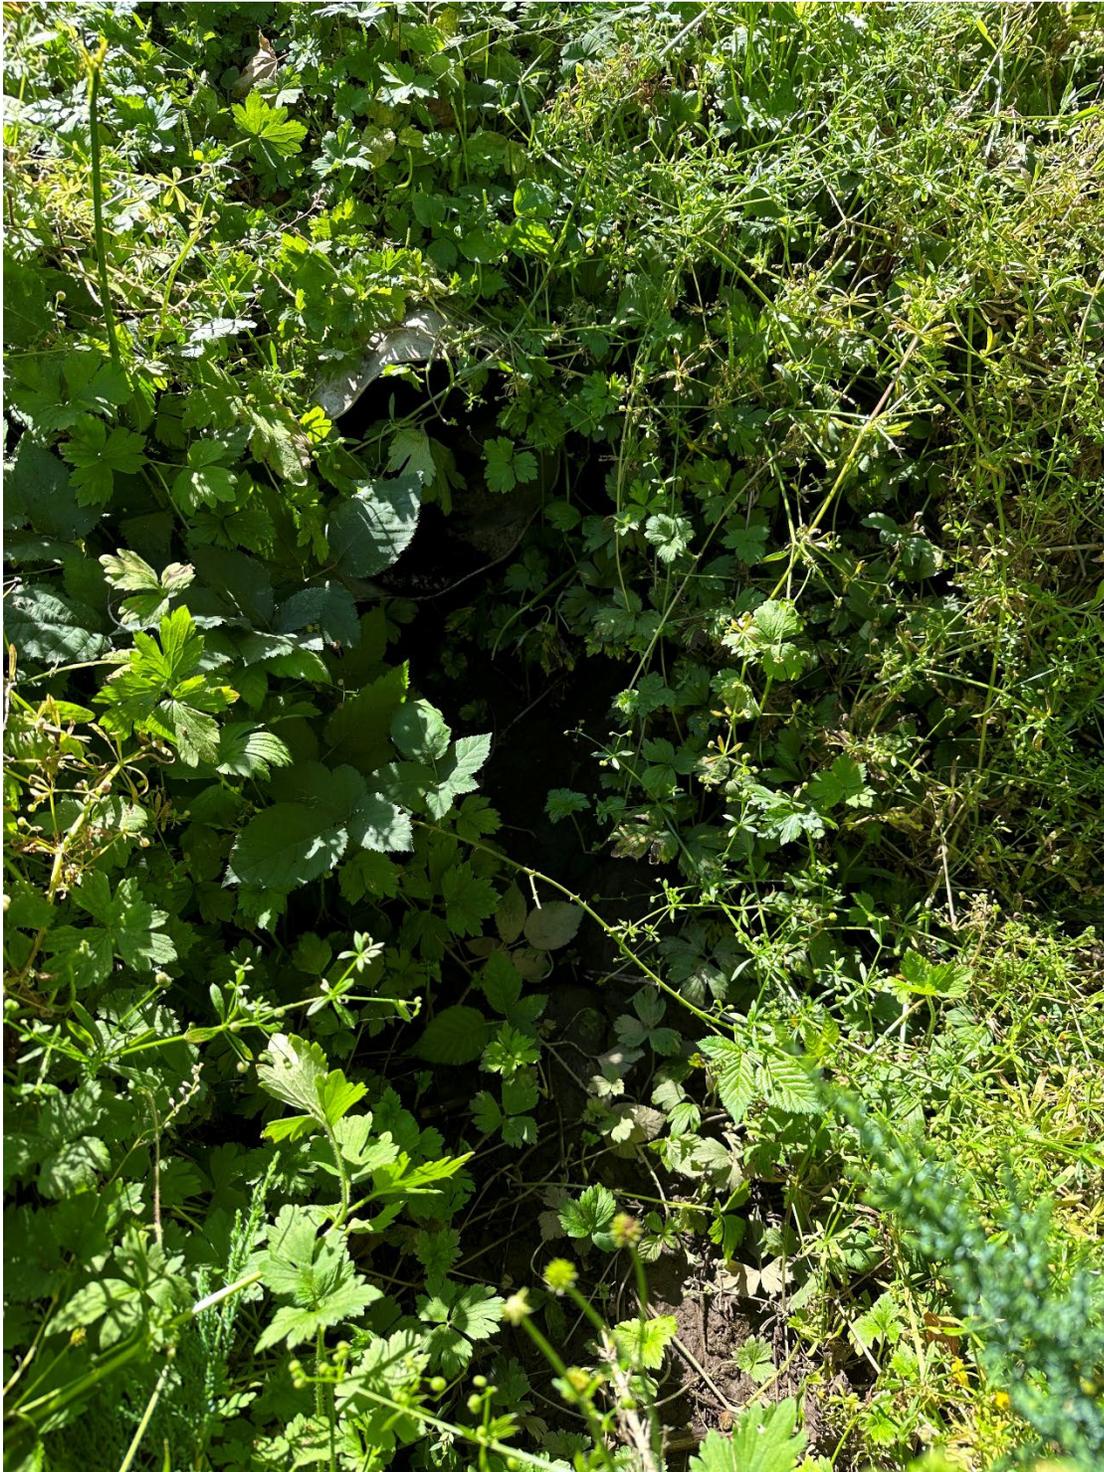
One off-site stream (Stream A) was identified approximately 115-feet north of the subject parcel. A short stream segment, approximately 20-feet in length, was observed adjacent to SE 50<sup>th</sup> Street, with a culvert on the upstream and downstream ends of the defined channel. The stream bed consists of fine sediments which appeared to be saturated at the time of the site visit; however, no stream flow was observed. Stream A's channel is approximately 1 to 2 feet in width, with a very gradual gradient. The stream channel and banks are vegetated with herbaceous plants.

Photo 3. Stream A, located off-site to the north of the subject parcel, includes a piped segment located upstream of the pictured culvert and downstream of a second culvert (not pictured).

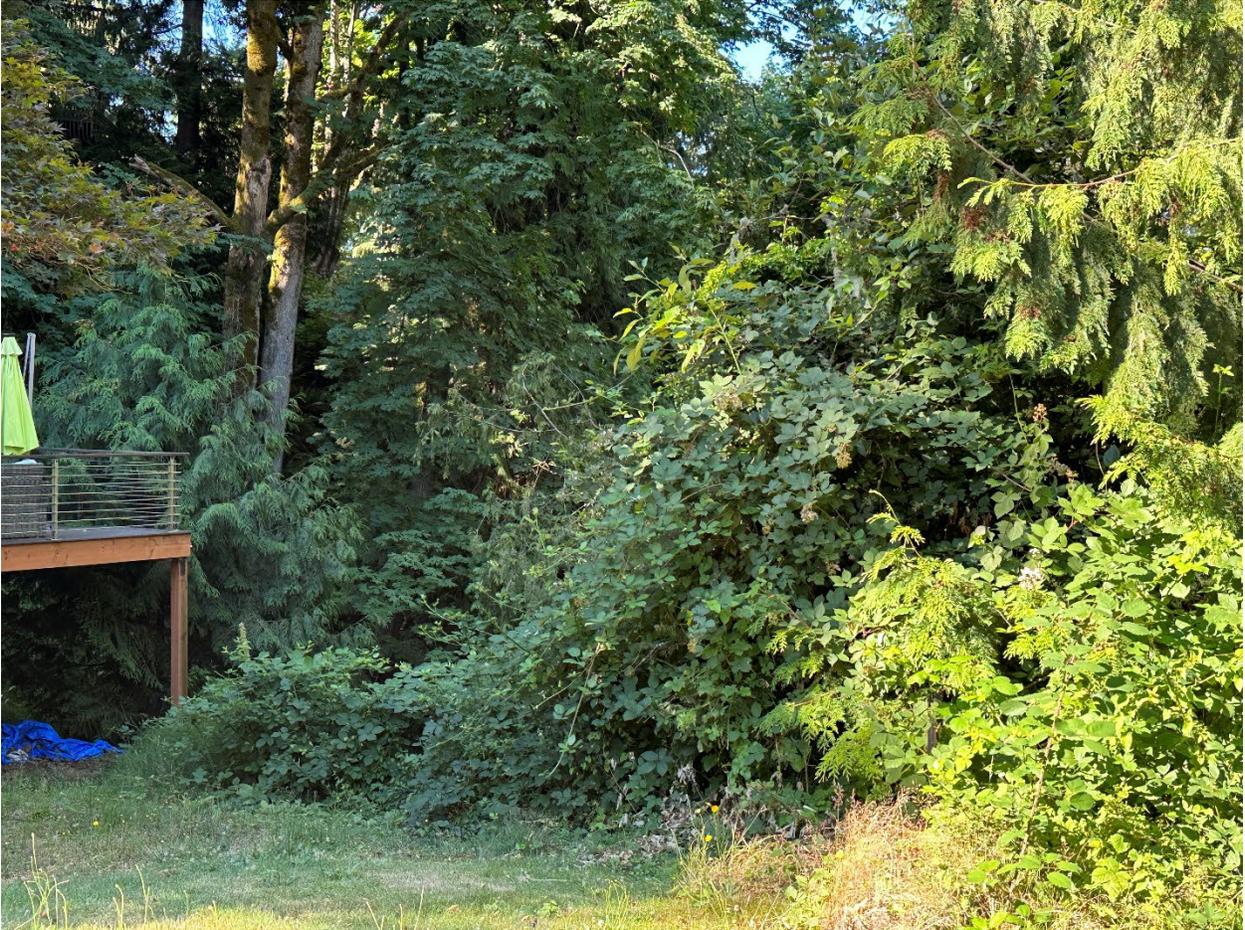
Photo 4. Presence of City of Mercer Island mapped Type Np stream segment could not be observed or confirmed from the subject parcel or right-of-way.
