March 4, 2024

AOA-7373

**SUBJECT: Wetland Reconnaissance for Asdourian Residence
5300 Butterworth Road, Parcel 866140-0020
Mercer Island, WA**

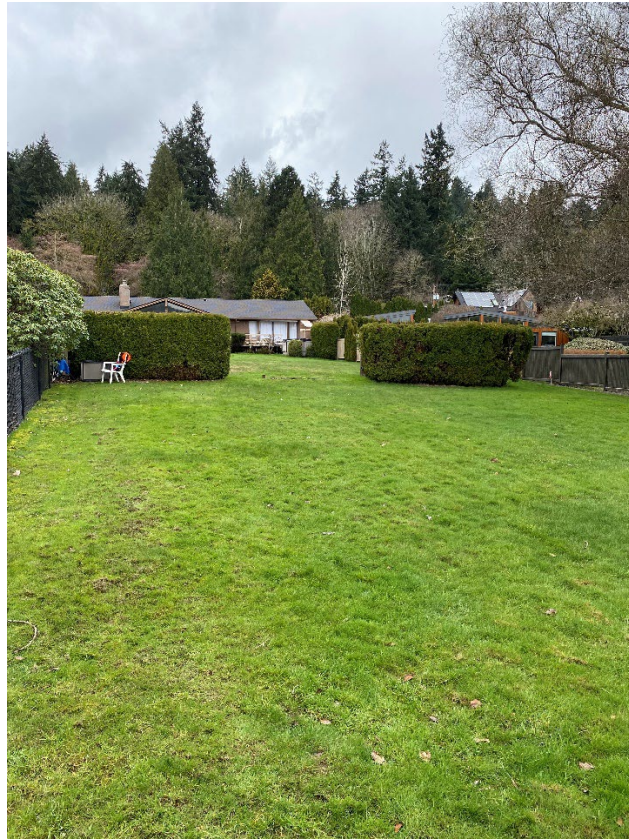
The site is currently entirely developed with a single-family residence and associated maintained yard. A mowed lawn extends to the edge of a gravel beach along the shoreline and no intact native plant communities are located on the site. Plant species on the property are generally limited to scattered ornamental tree and shrub plantings and mowed grass. No definitive hydrophytic plant communities were observed on or adjacent to the property.

View from shoreline looking towards residence.

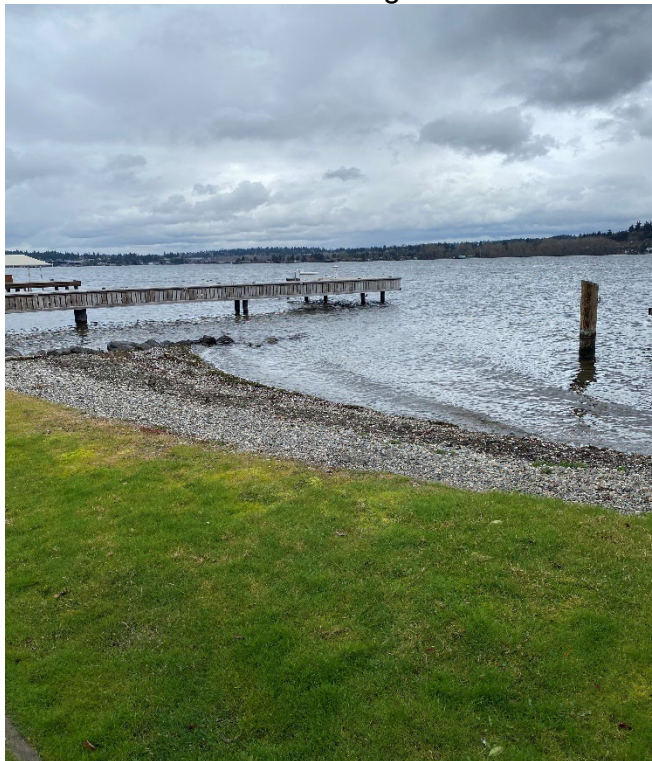
View of lawn extending to edge of shoreline.

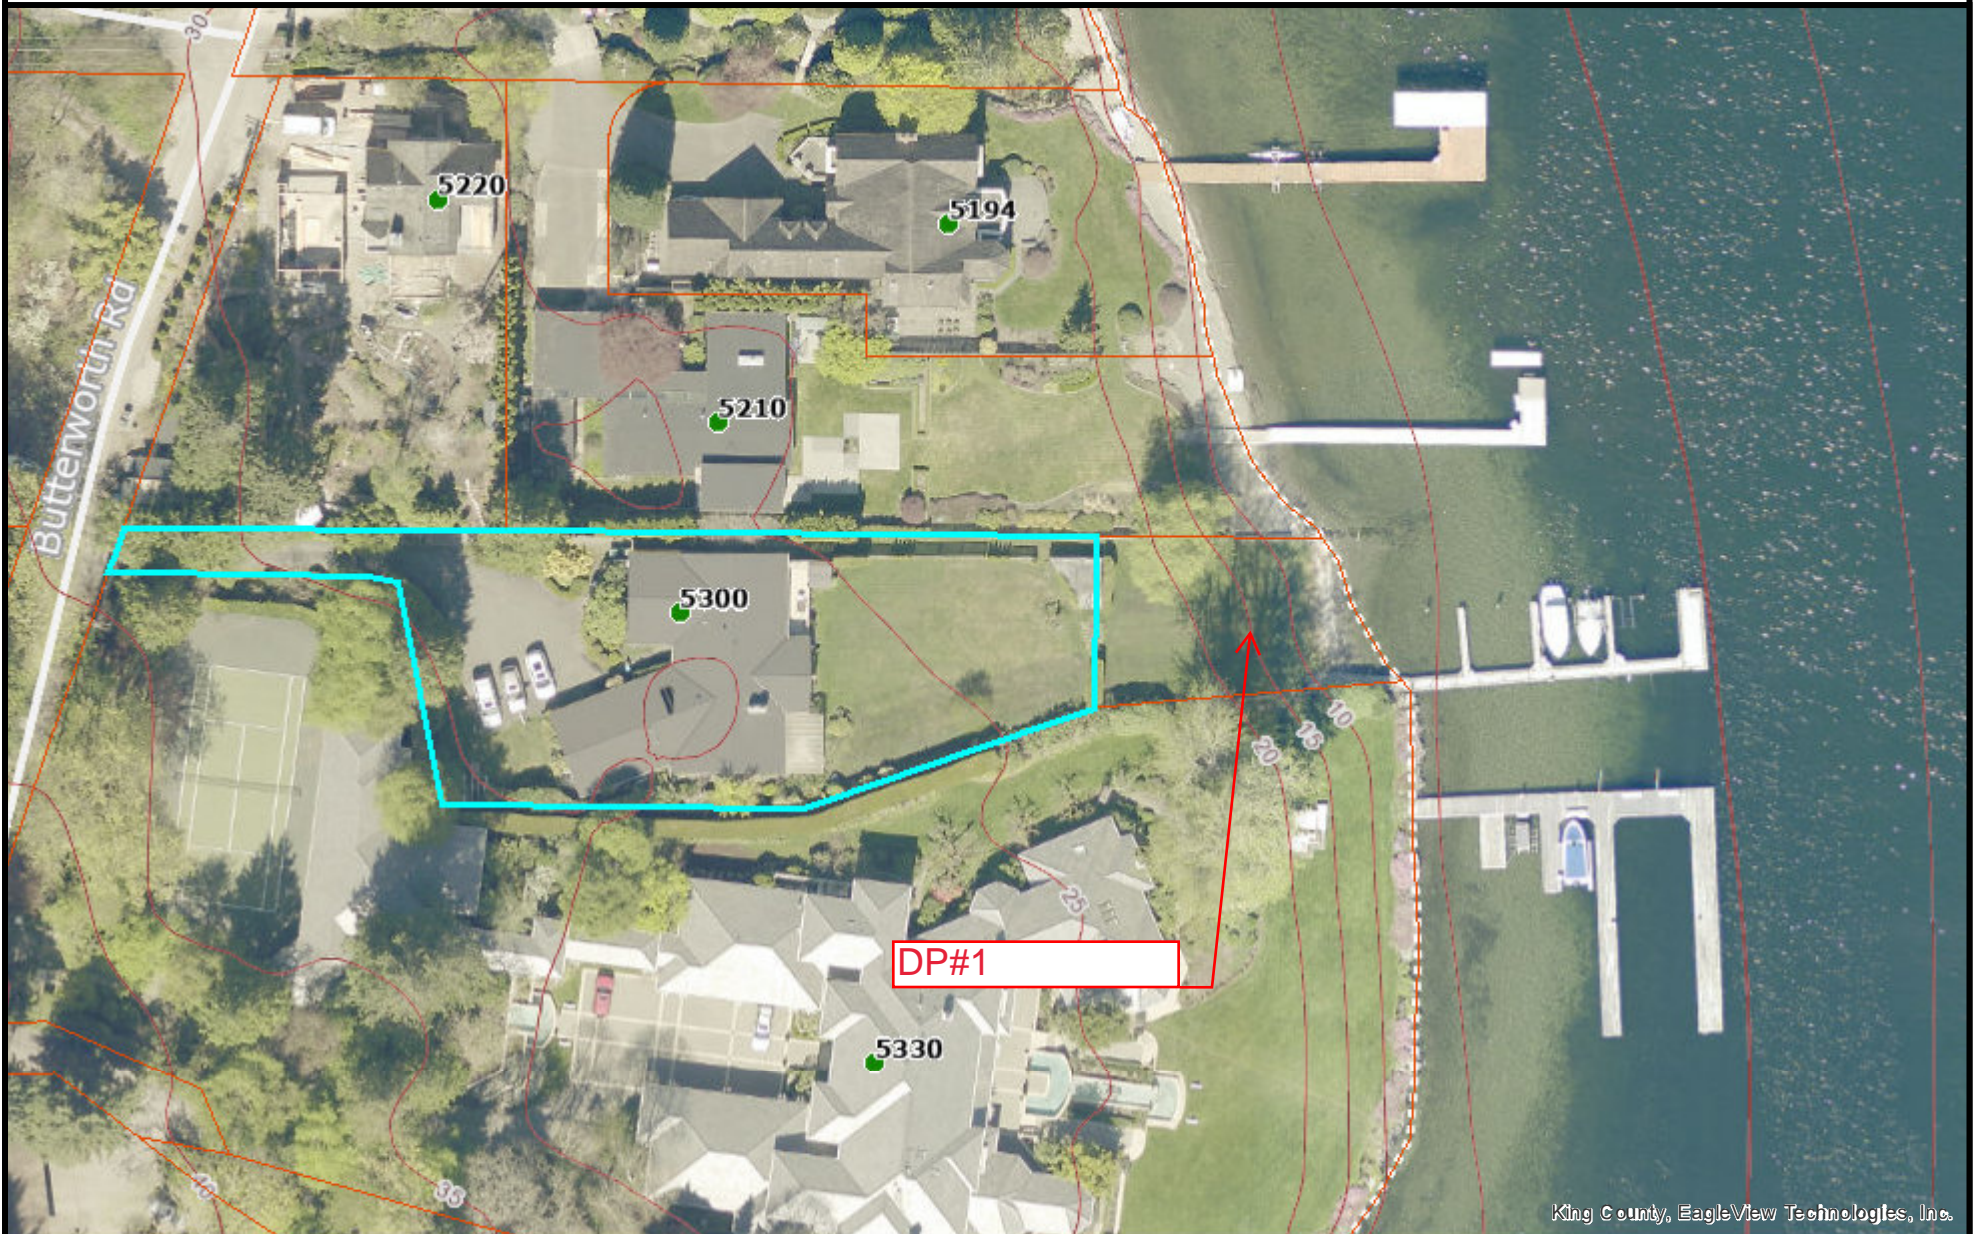
Datasheet Map

Hydrophytic Vegetation Present?	Yes <input type="checkbox"/>	No <input type="checkbox"/>	Is the Sampled Area within a Wetland?	Yes <input type="checkbox"/>	No <input checked="" type="checkbox"/>
Hydric Soil Present?	Yes <input type="checkbox"/>	No <input checked="" type="checkbox"/>		Yes <input type="checkbox"/>	No <input checked="" type="checkbox"/>
Wetland Hydrology Present?	Yes <input type="checkbox"/>	No <input checked="" type="checkbox"/>		Yes <input type="checkbox"/>	No <input checked="" type="checkbox"/>
Remarks: Upland plot, see map for location.
