# WETLAND DELINEATION REPORT

Herzl-Ner Tamid Property Mercer Island, Washington

March 26, 2024

RAEDEKE ASSOCIATES, INC.

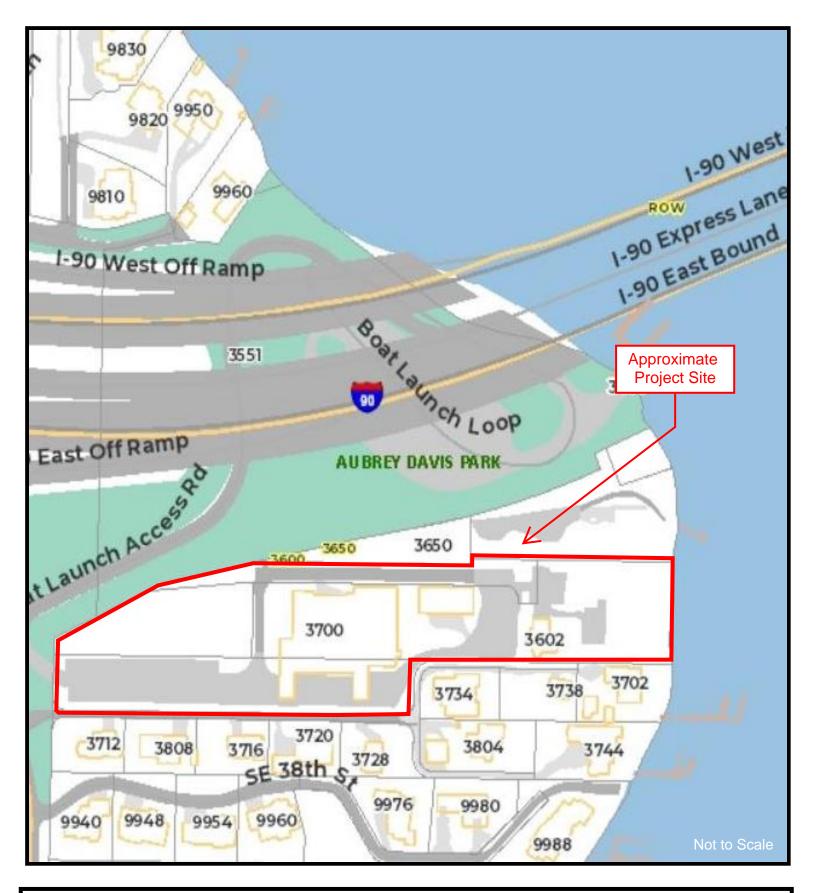
# FIGURE 4 - Mercer Island GIS Portal

The City of Mercer Island (2024b) GIS Portal (Figure 4) does not depict any watercourses within or adjacent to the project site.
