Shoreline Assessment and Critical Areas Study

BLACKBERRY BEACH

MERCER ISLAND, WA

April 2024

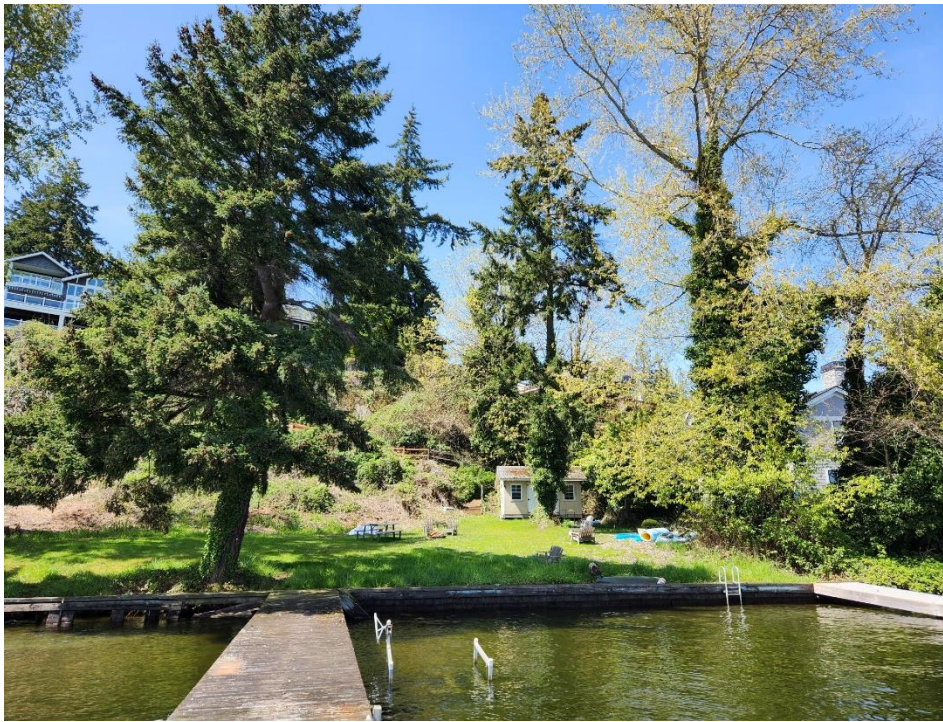
Photo 1. Existing shoreline conditions, taken from southern dock facing west.

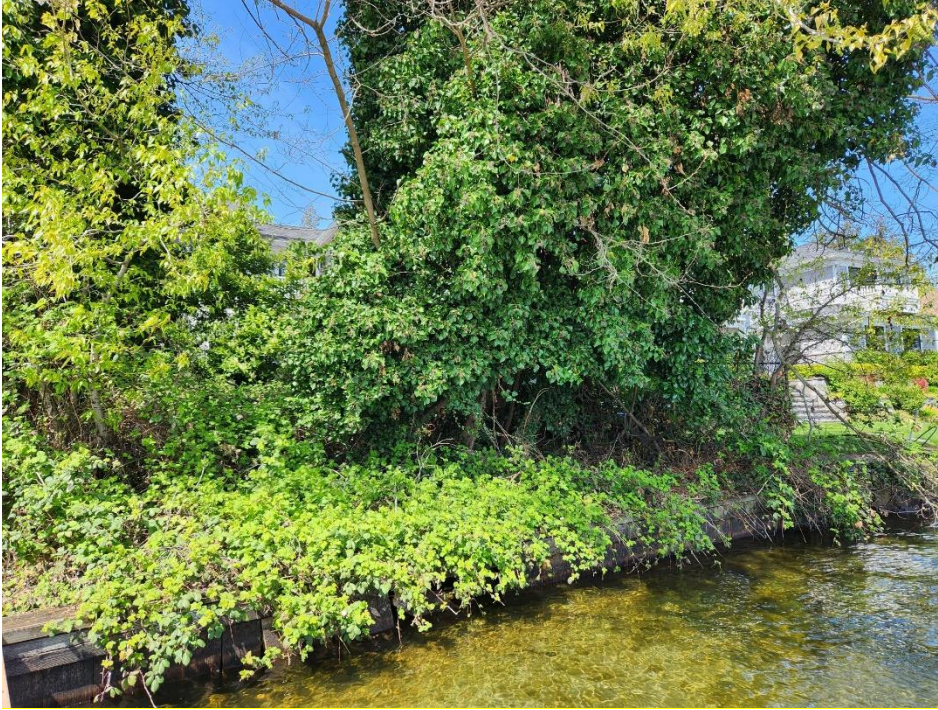
Photo 2. Himalayan blackberry and English ivy along northern portion of shoreline, facing north.

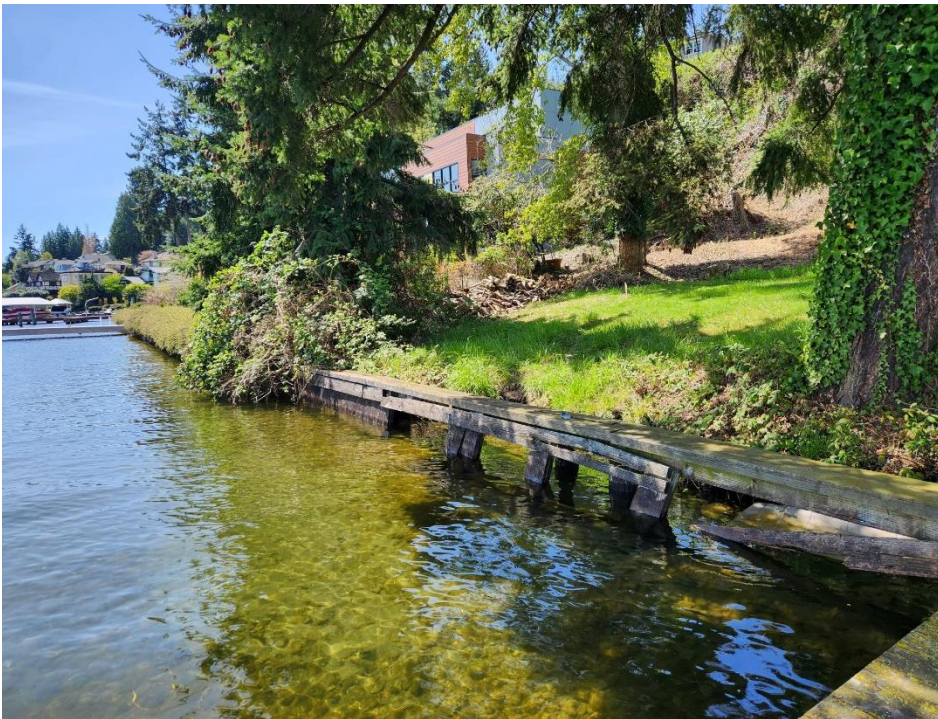
Photo 3. Damaged timber bulkhead and southern shoreline conditions, facing south.

Compliance: The existing timber bulkhead is failing in several locations and replacement is necessary to prevent further erosion of the shoreline and maintain safe access. As such, the feature can no longer adequately serve its purpose. The replacement rock and beach cove have been designed to assure no net loss of ecological functions and will not encroach waterward of the OHWM. The OHWM will be restored to pre-existing conditions in the location of the failed bulkhead, set back further landward in the vicinity of the cove, and maintained elsewhere. The project incorporates more natural shoreline stabilization measures by proposing to replace the existing timber bulkhead with rock (boulder) and a beach cove and limiting linear stabilization

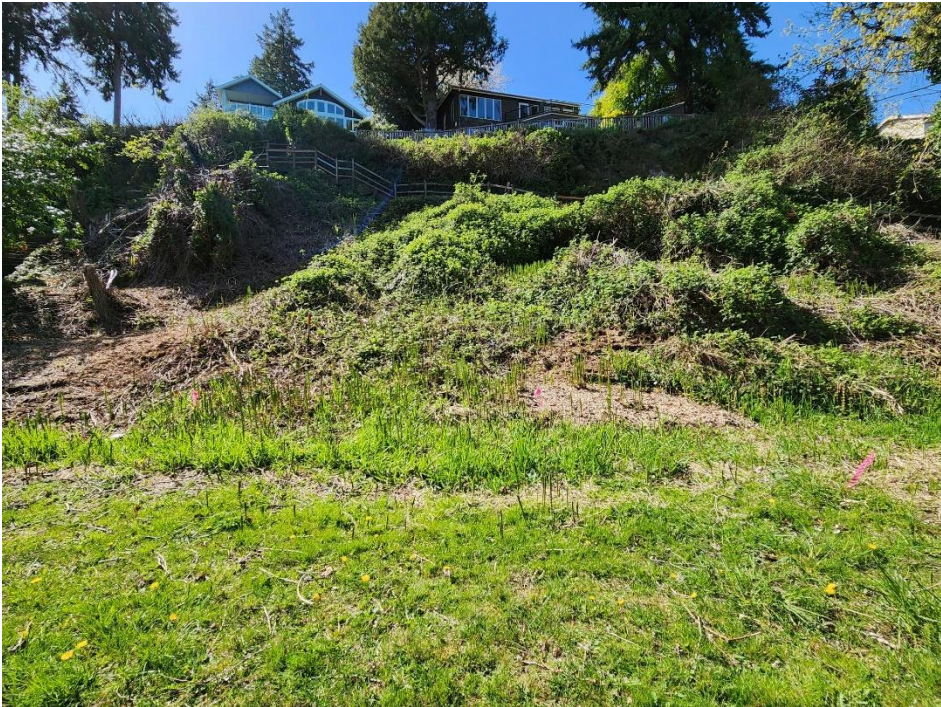
Photo 4. Wetland A and steep slope, facing west.

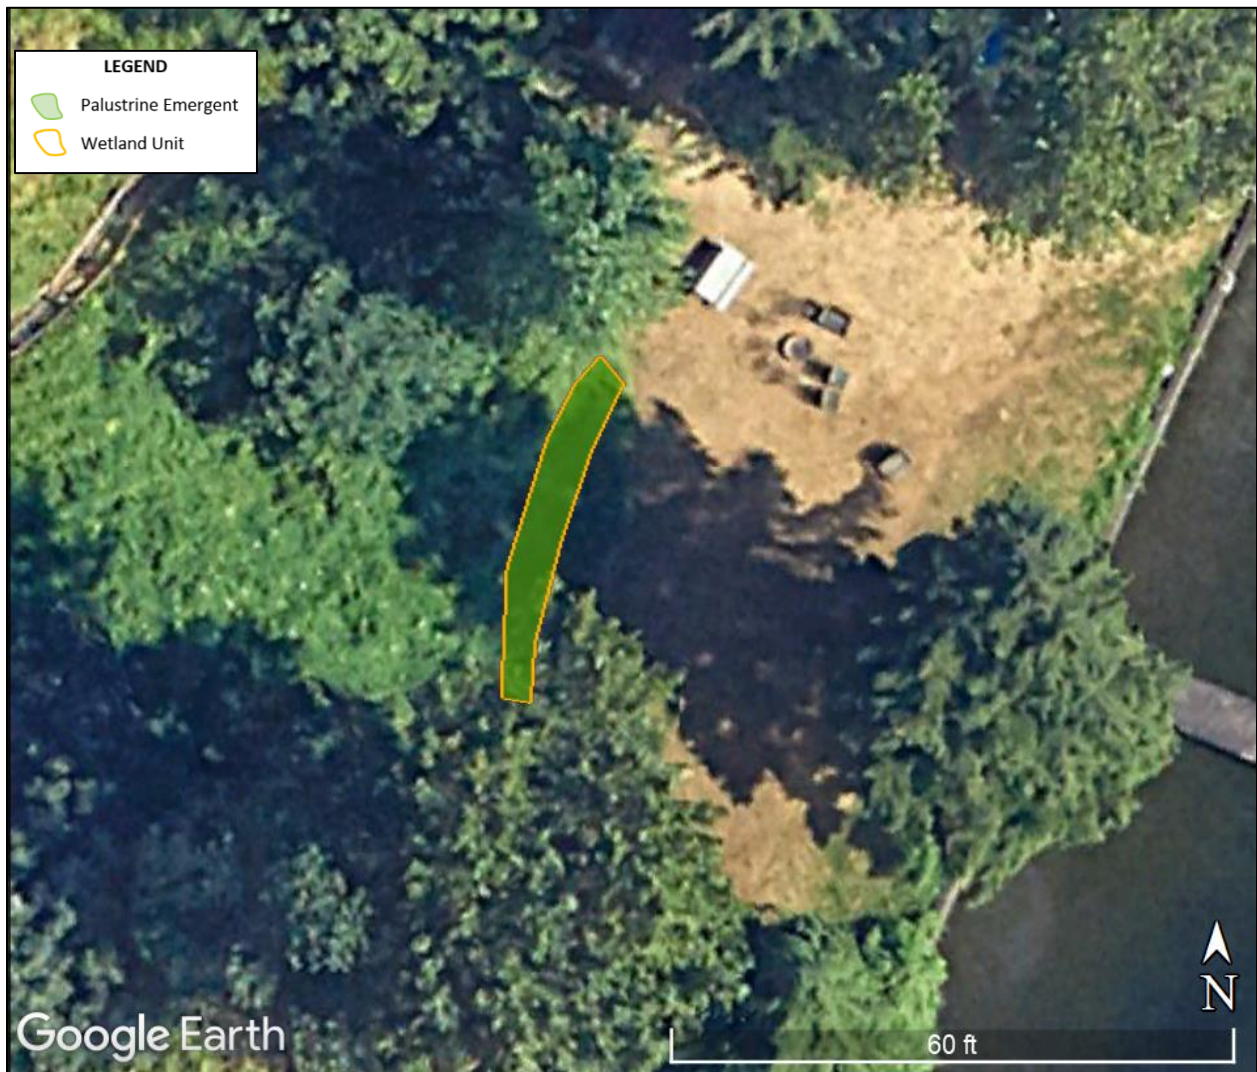
Figure 1. Cowardin plant classes – H1.1, H1.4

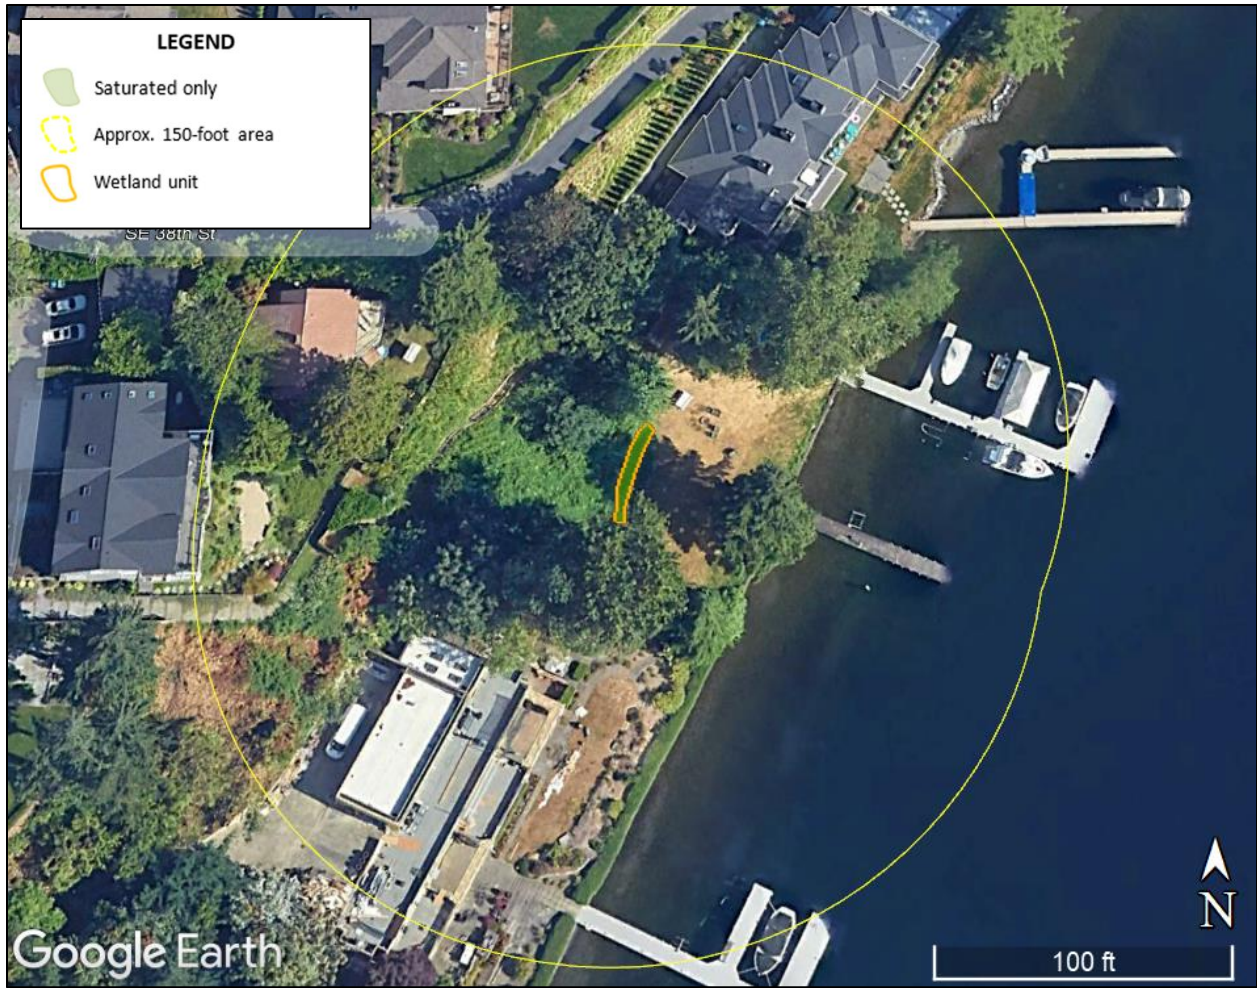
Figure 2. Hydroperiods and 150-foot area – H1.2, S2.1, S5.1

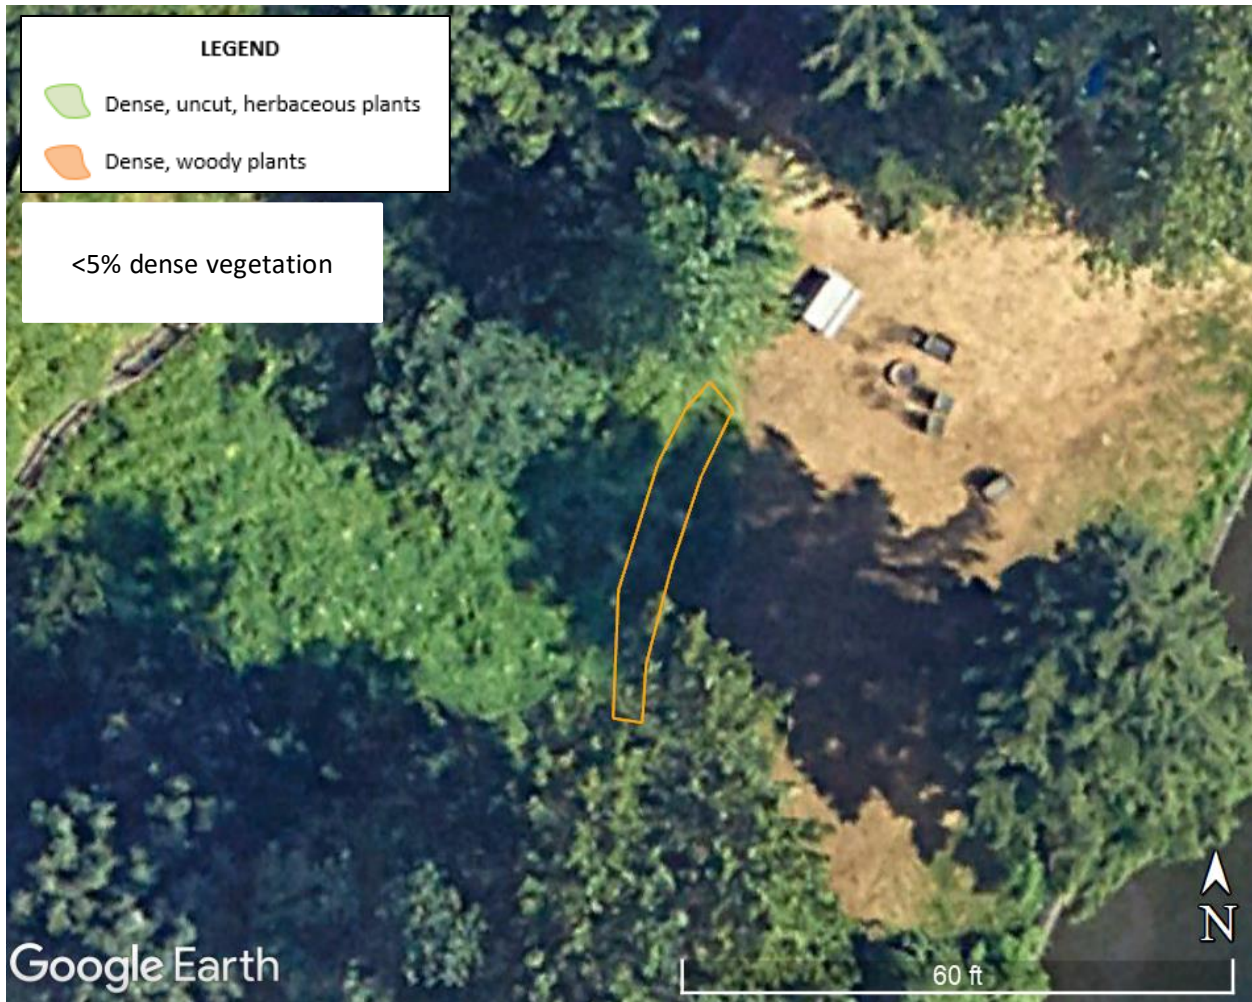
Figure 3. Plant cover of dense and rigid trees, shrubs, and herbaceous plants – S1.3, S4.1

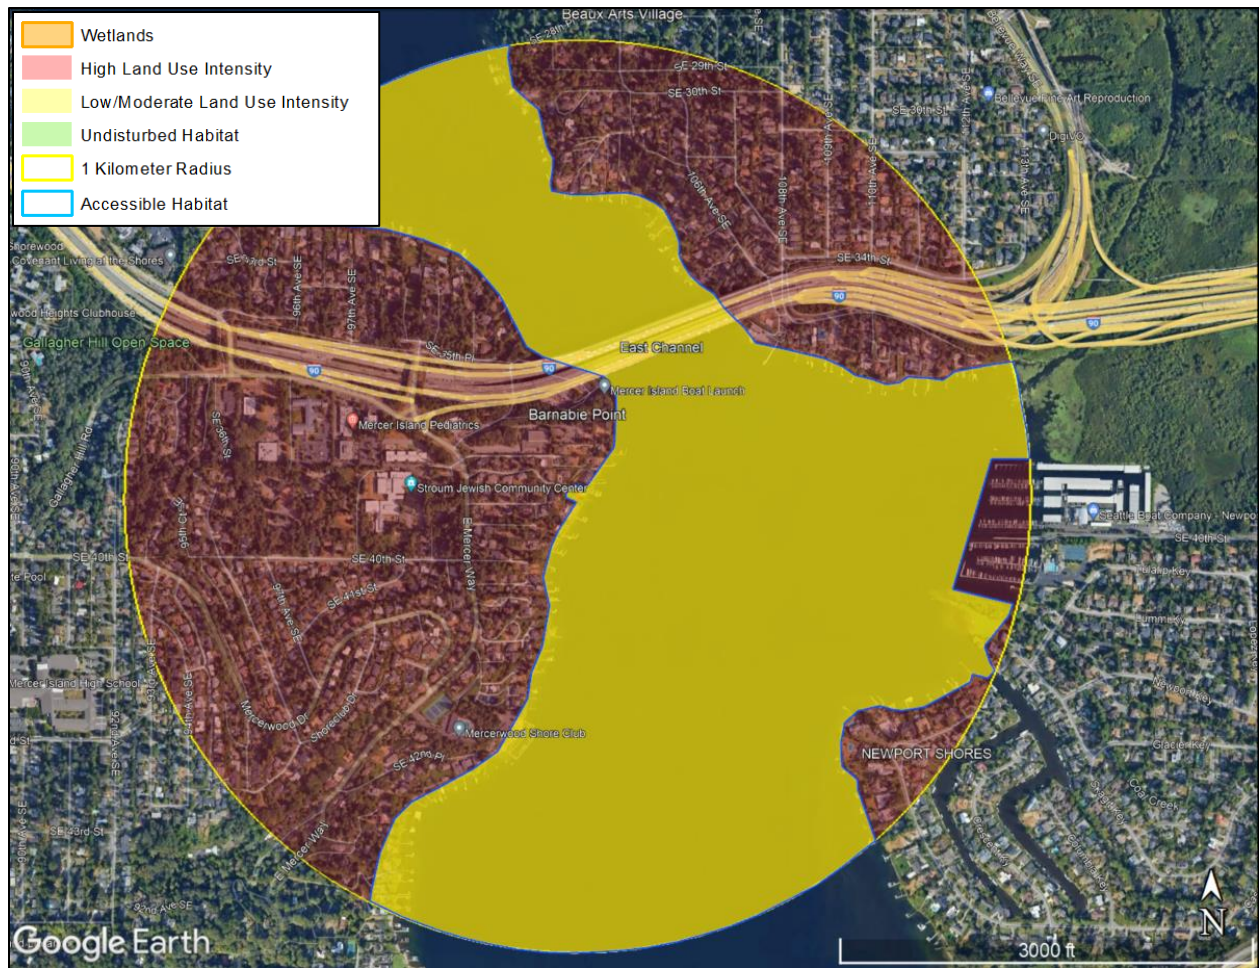
Figure 4. Undisturbed habitat and moderate-low intensity land uses within 1 km from wetland edge including polygon for accessible habitat – H2.1, H2.2, H2.3
