Subject: Geotechnical Report
Sunrise of Mercer Island
2959 76th Avenue SE
Mercer Island, Washington
File No. 26198-001-00

INTRODUCTION AND PROJECT UNDERSTANDING

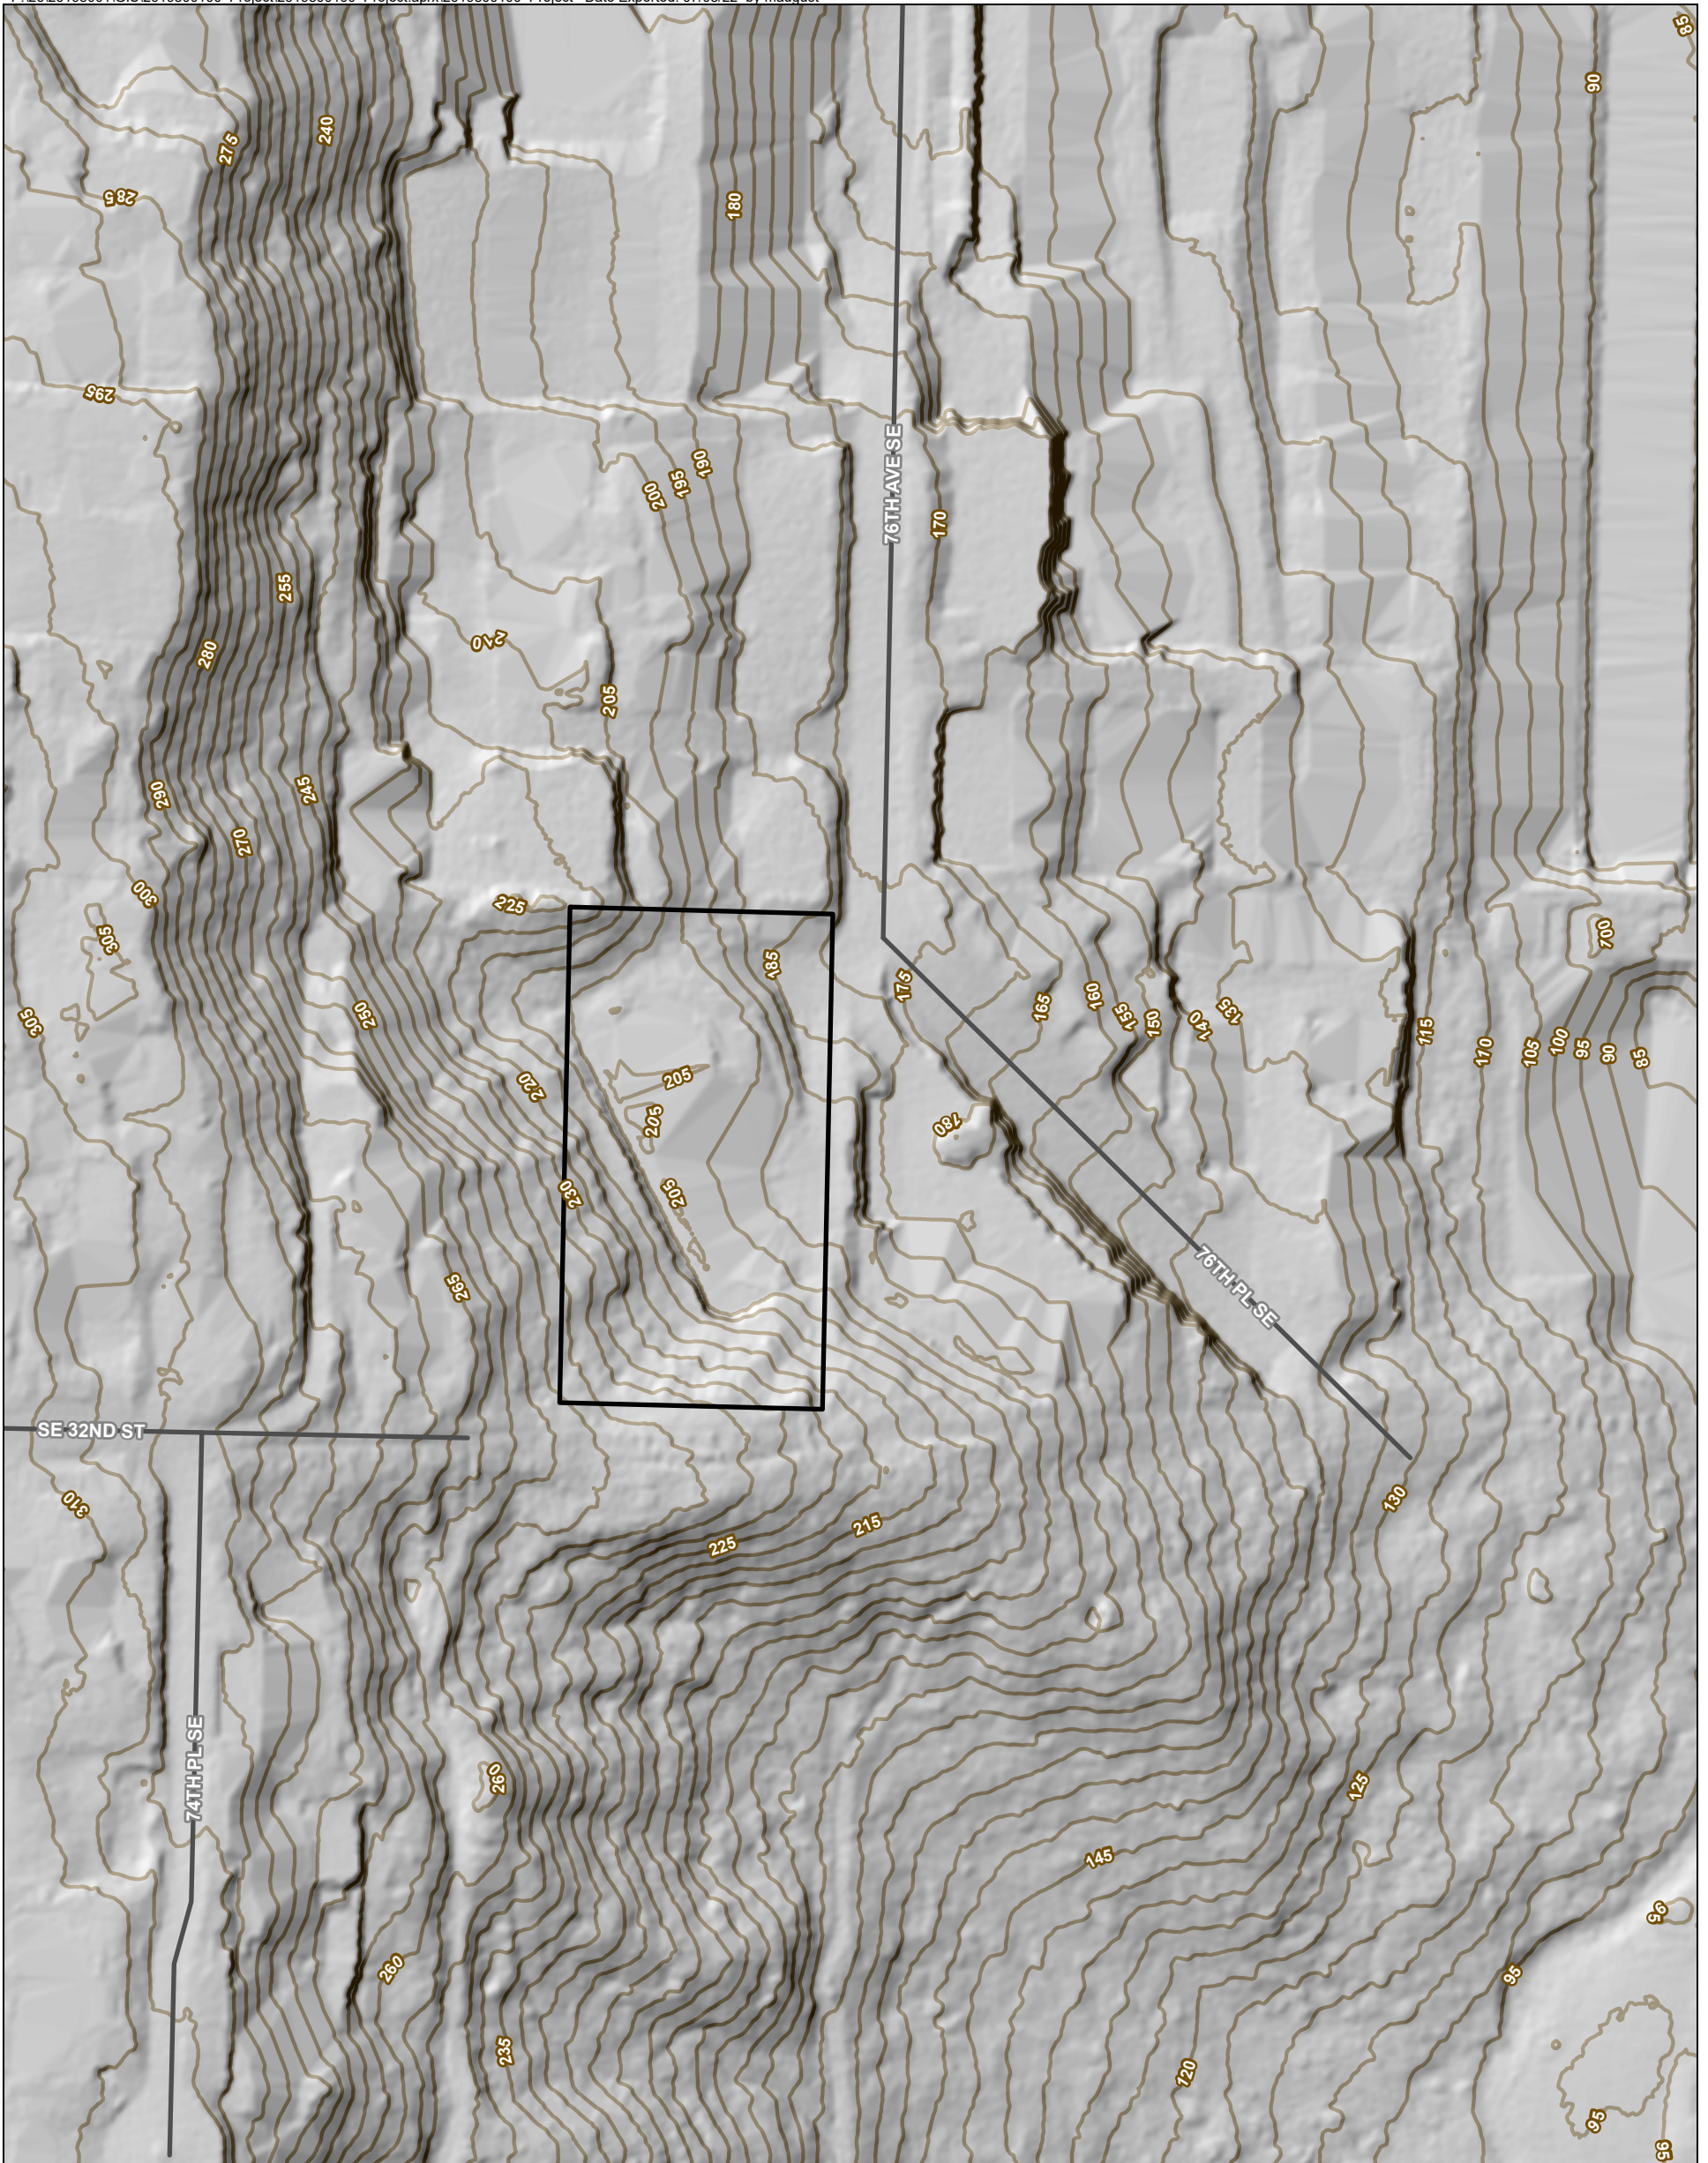
Figure 4 is a 5-foot topographic contour map overlying a LiDAR hillshade. Several areas of the steep slope on the western and northwestern property boundary indicate the presence of past slope movement. The slope features at the property boundary corners are generally arcuate in shape with no scarps visible on LiDAR.

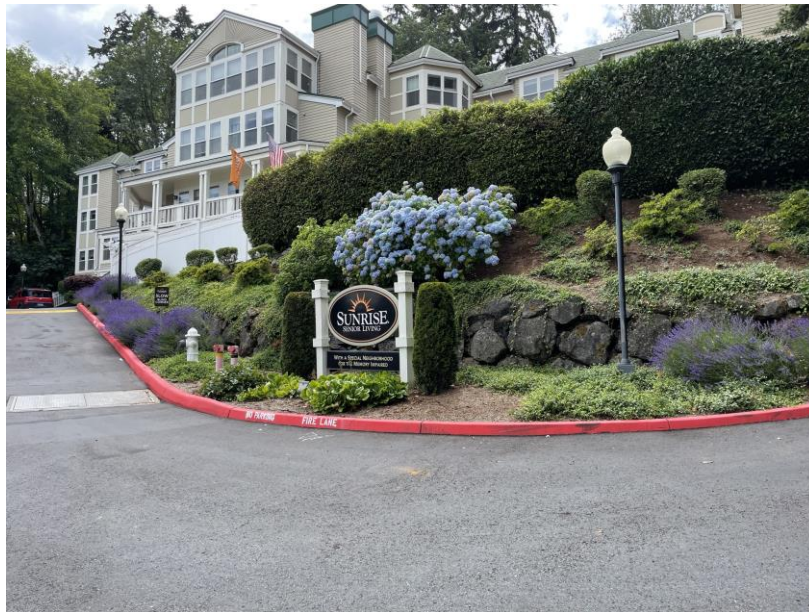
Photograph 1. View of the front portion of the Sunrise Project Site. Looking southwest

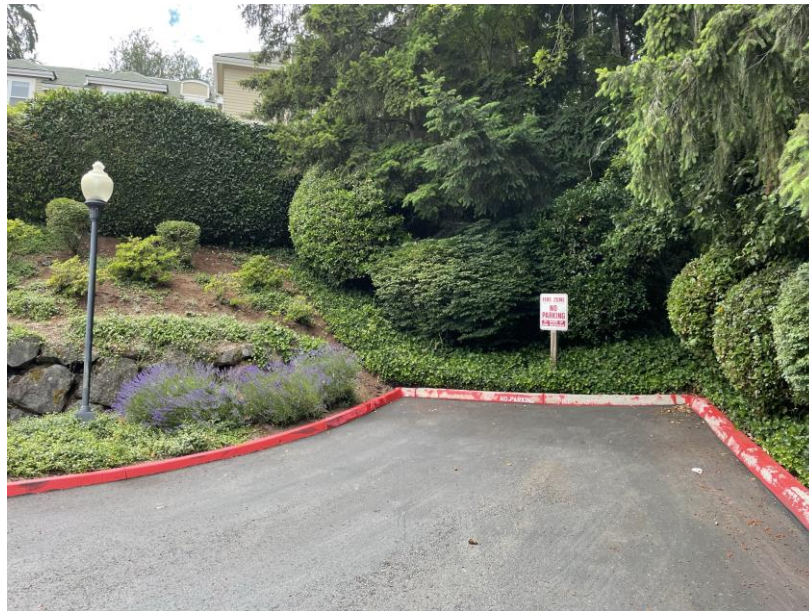
Photograph 1. View of the fire lane and the location of the proposed concrete generator pad. Looking west.

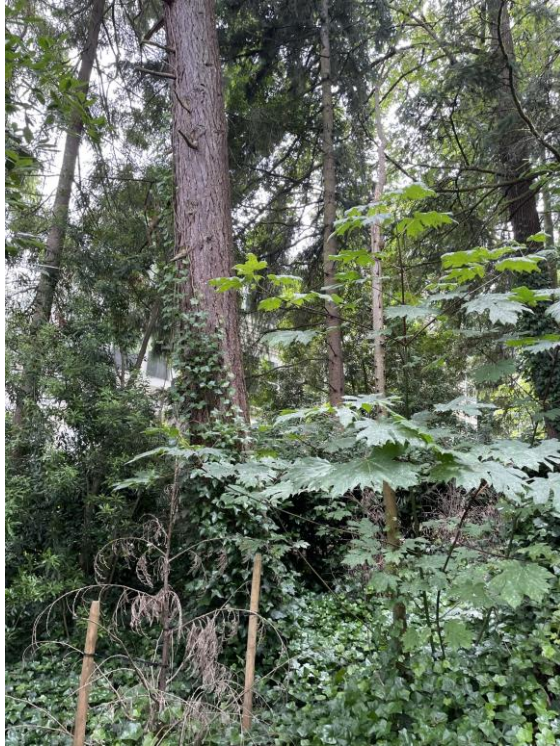
Based on our field observations, we did not observe any indication of new landside features where the proposed existing building improvements would be located. There may be some localized shallow creep along the boundary of the property on the western steep slopes. Some of the larger, more mature trees show signs of past slope movement with slightly bowed trunks. The upper portions of the trees suggest the slope movement is dormant. The smaller evergreen trees on the western slope were straight and we did not observe any surface expressions of slope movement including, tension cracks, scarps or other current erosional features.

Photograph 3. View of heavily vegetated slope on the north side of the project site. A large 24- to 30-inch evergreen with slight trunk bowing. Looking southwest.

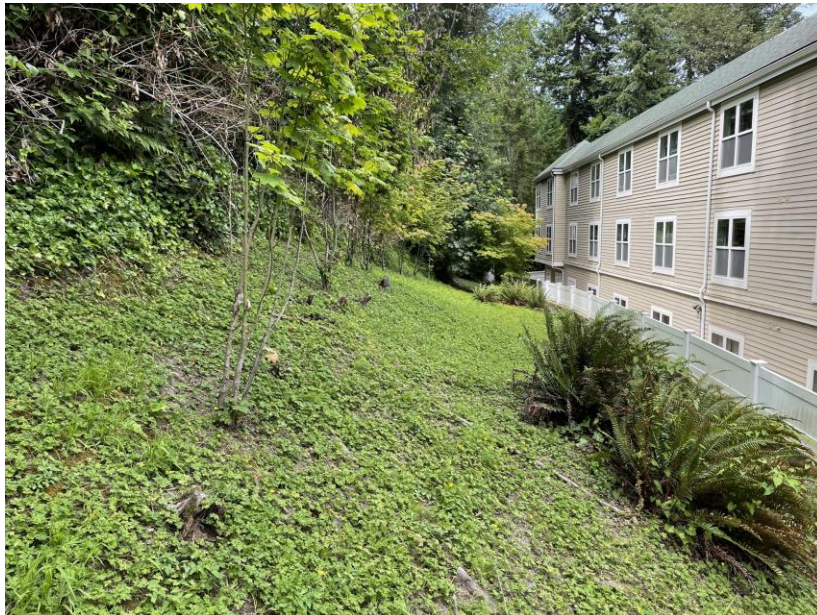
Photograph 4. View of the rear portion of the project site. The slope is cleared of trees and shrubs. Looking south.
