Re: RUE CAO 15-001 / Variance Development Application
Bill Summers

TECHNICAL MEMORANDUM

VICINITY MAP
(by King County iMap)

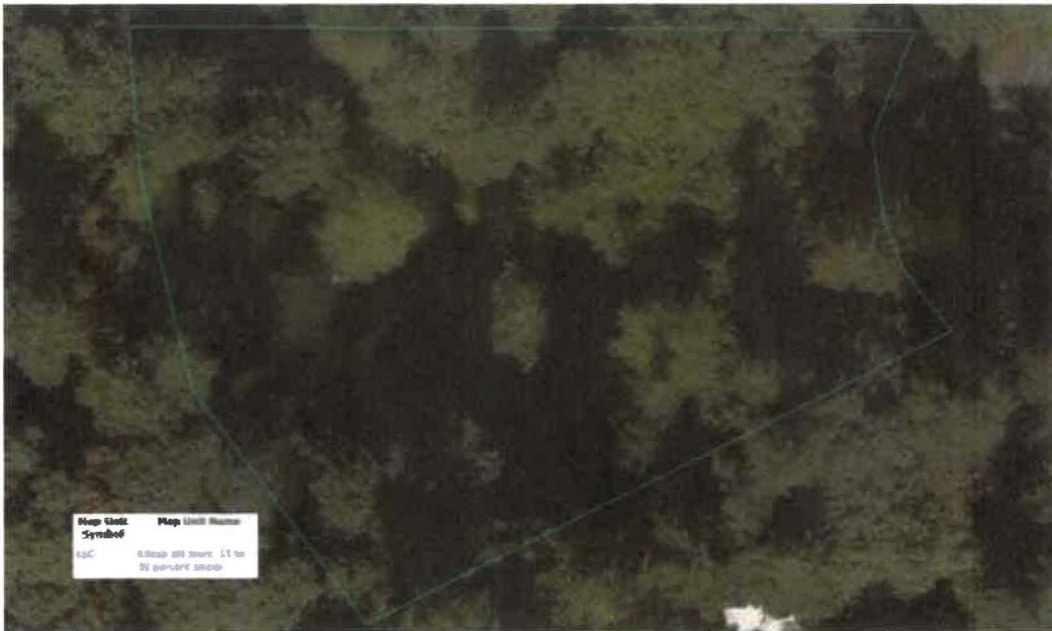
According to data on file with the NRCS Soil Survey, the site as mapped as Kitsap silt loam 15%-30% slopes. Kitsap soils are a moderately well-drained soils formed in lacustrine deposits. Kitsap soils are not considered "hydric" soils according to the publication Hydric Soils of the United States (USDA NTCHS Pub No.1491, 1991).

Above: NRCS Soil map of the study area.

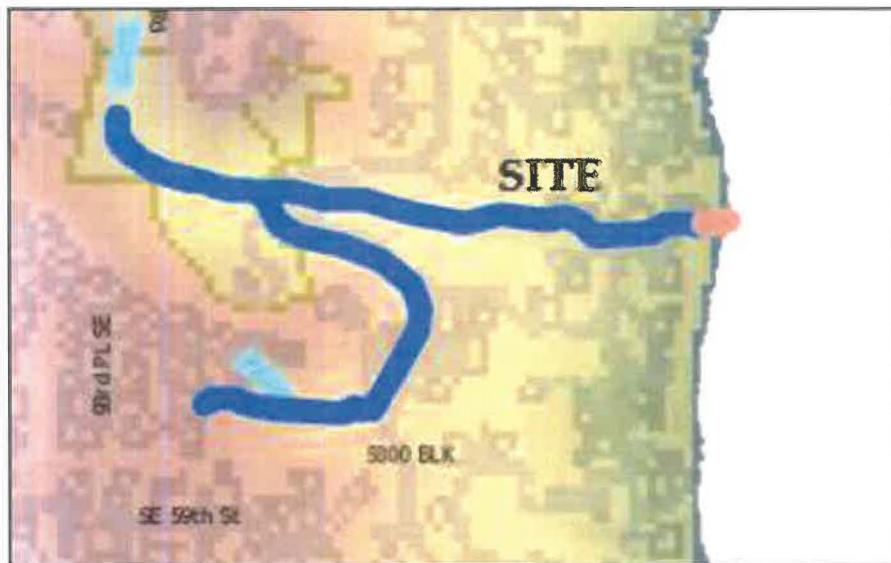
The City of Mercer Island stream inventory shows a perennial flowing non-fish bearing stream also known as a Type 2 watercourse with a 50' buffer.

Above: Mercer Island Stream Inventory of the site

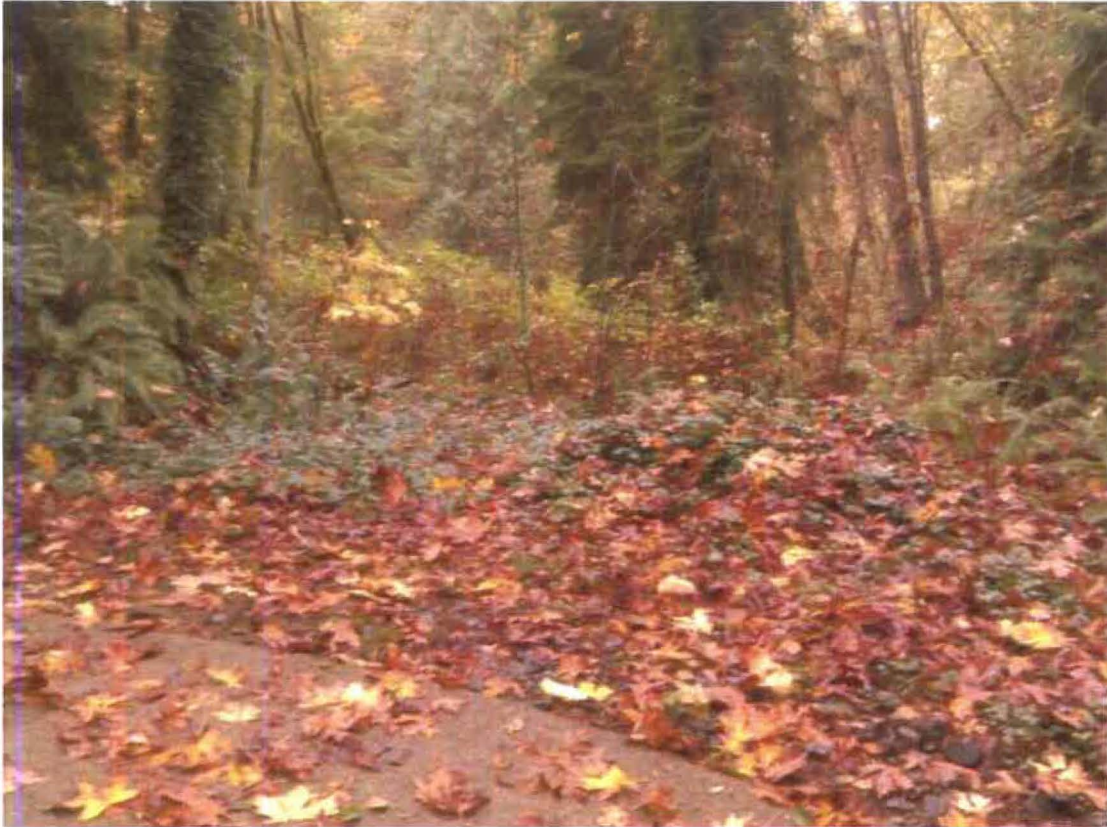
Above: Existing quarry spill access driveway which leads to proposed building site

In addition to the fill of wetland for the foundation, a minor amount of fill will occur from the proposed driveway. The driveway will be located over the current location of the quarry spall driveway that exists on the site, further reducing impacts.

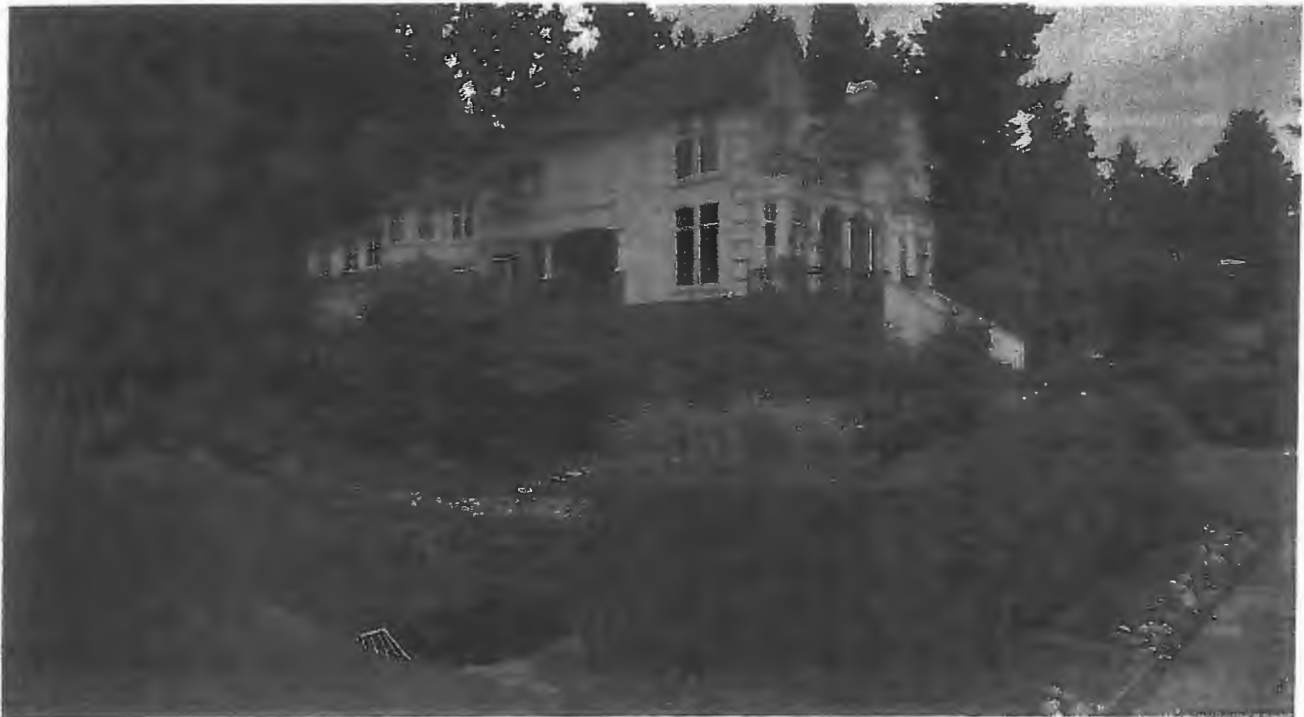
The Glenhome Sediment Pond

Five of these complaints, between October 2009 and April 2014 are reports of a catch basin being clogged. Although not explicitly stated, the catch basin is likely the outlet of the small sediment pond (the Glenhome Pond) that collects Stream A, before the stream is conveyed to the Lake. On April 22, 2014 the outlet structure to the sediment pond was modified. The previously installed 6" diameter vertical standpipe was replaced with a 12" standpipe. This modification was intended to prevent fouling of the pond outlet by debris.
