**RE: Stream Determination Report and Significant Tree Inventory for King County
Tax Parcel 8661400101**

Wetland Resources, Inc. (WRI) conducted a site investigation on November 5, 2021, on the 0.43-acre parcel reference above. The site is located between 5325 and 5335 Butterworth Road, in the City of Mercer Island, WA. It is further located as a portion of Section 19, Township 24N, Range 5E, WM. The purpose of this investigation was to classify a stream that flows through the subject property and also identify significant trees.

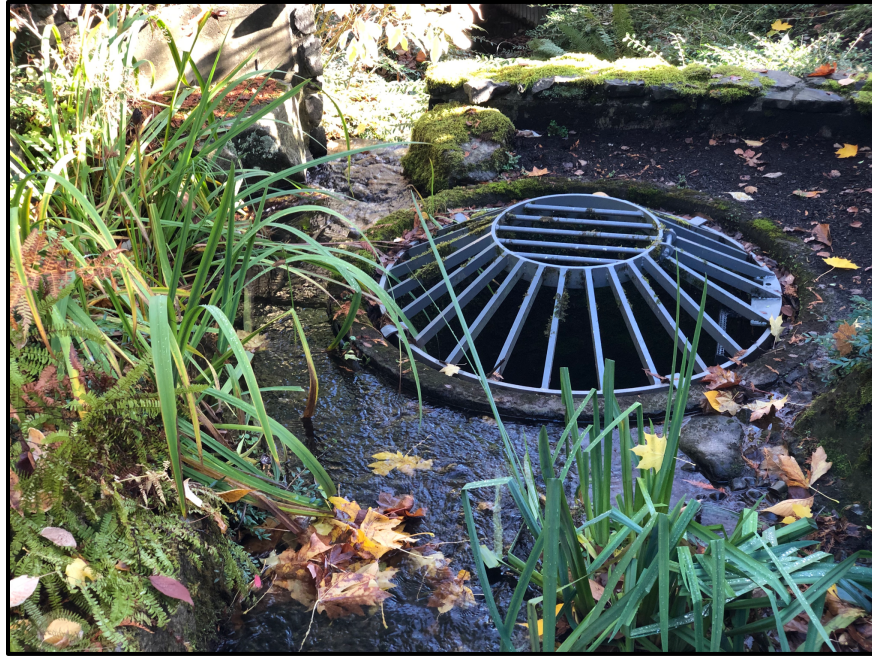
The on-site portion of the stream is generally between three to four feet wide and has an average gradient to Lake Washington of less than 12 percent. The vertical catch basin located downstream of the site provides an artificial barrier to fish passage. However, at the time of the site visit, the entirety of the streamflow was bypassing the catch basin to the north providing a direct natural water connection to Lake Washington. Provided there is no barrier to fish passage, the on-site stream meets the definition of fish habitat and therefore is classified as a Type F Watercourse. Type F Watercourses are designated 120-foot protective buffer from their flagged ordinary high water mark.

View of catch basin looking east. Note water flowing through a break in the wall around the catch basin.

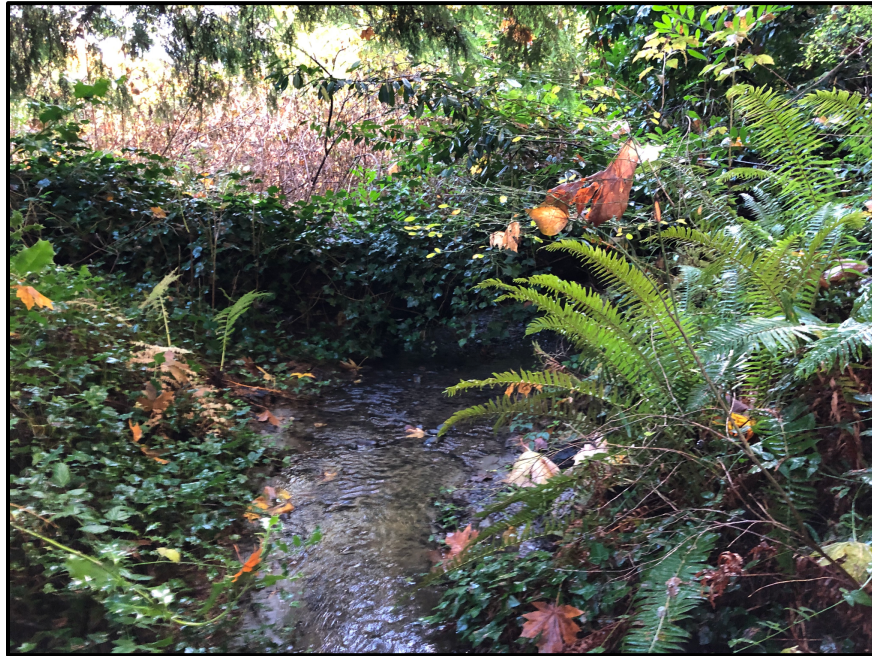
Stream condition near the eastern property boundary looking east.
