**Ecological No Net Loss Assessment Report
for
5067 84th Ave SE Mercer Island, WA**

**Richard Fallquist
5067 84th Avenue SE
Mercer Island, WA 98040**

**Northwest Environmental Consulting, LLC
3639 Palatine Avenue North
Seattle, WA 98103
206-234-2520**

April 2020

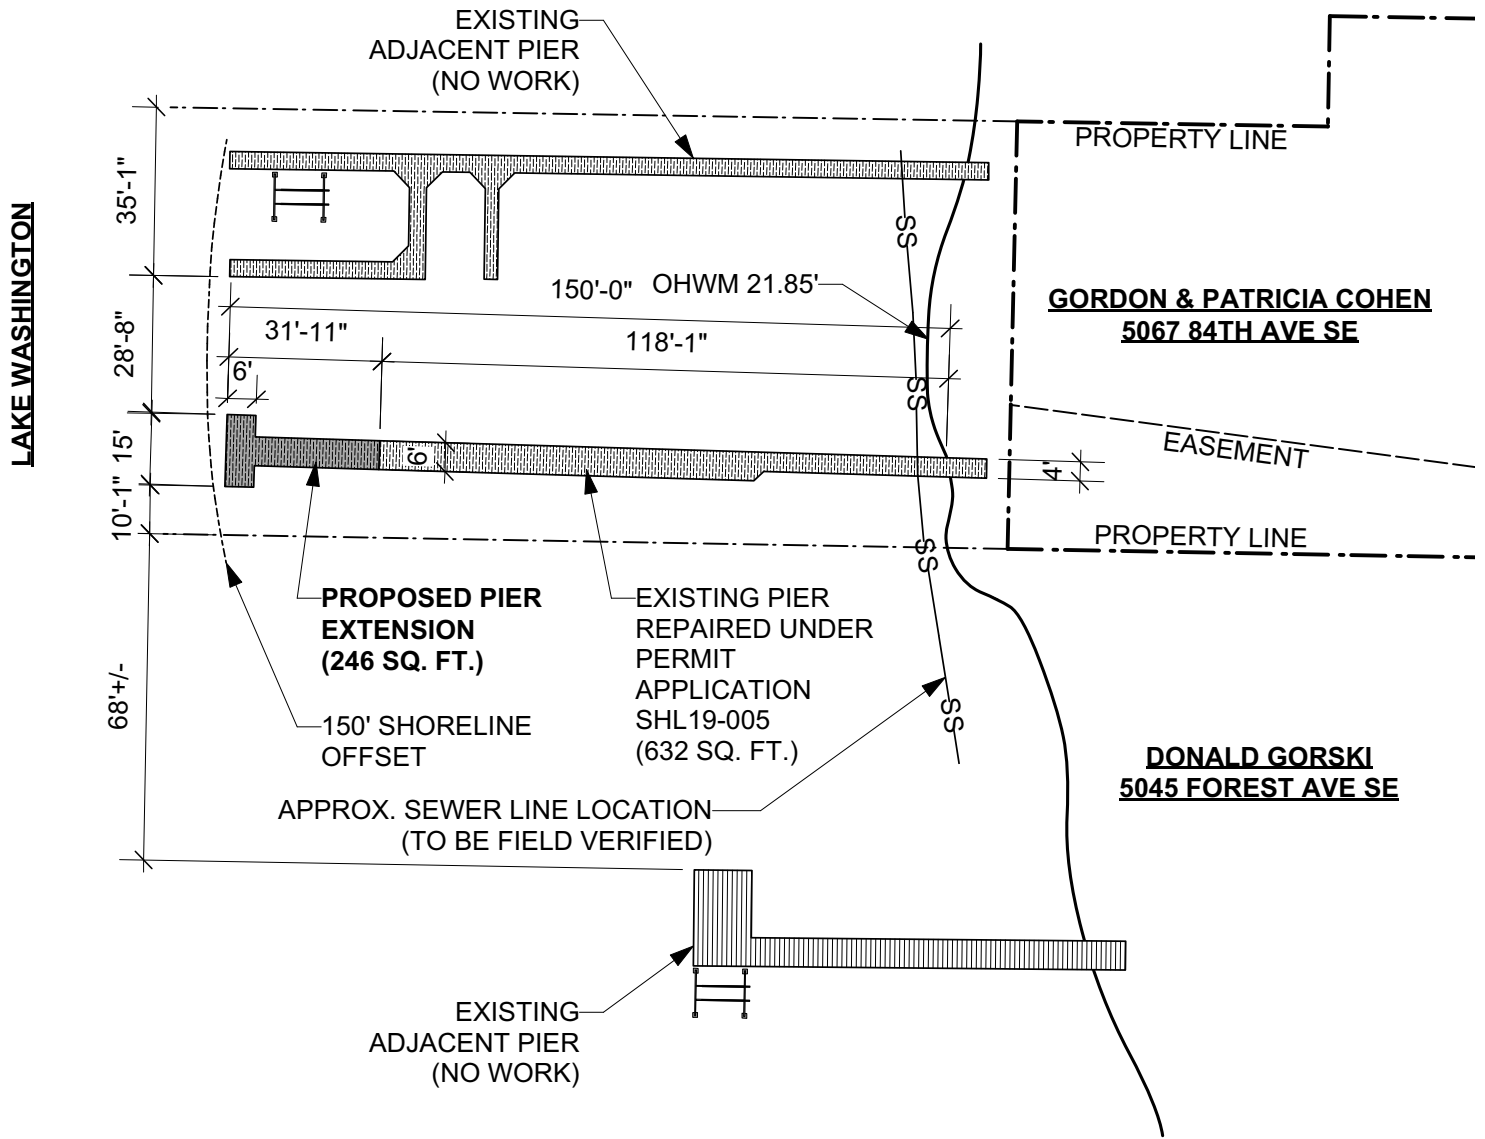
Sheet 2 of 6 **Date:** 4/9/2020

SITE PLAN
SCALE 1" = 40'-0"

The subject property is located at 5067 84th Ave SE in the City of Mercer Island, Washington (Figure 1). The parcel is on the waterfront of Lake Washington, which contains several endangered fish species listed under the Endangered Species Act and Washington State designated priority fish species. Permits are being applied for a pier extension (see Appendix A – Sheet 2 of 6).

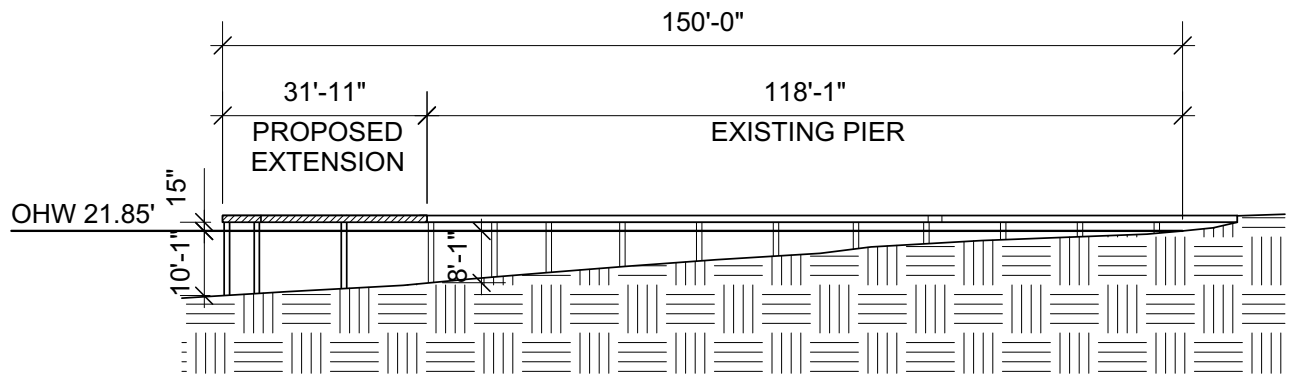
Sheet 4 of 6 Date: 4/9/2020

PIER ELEVATION

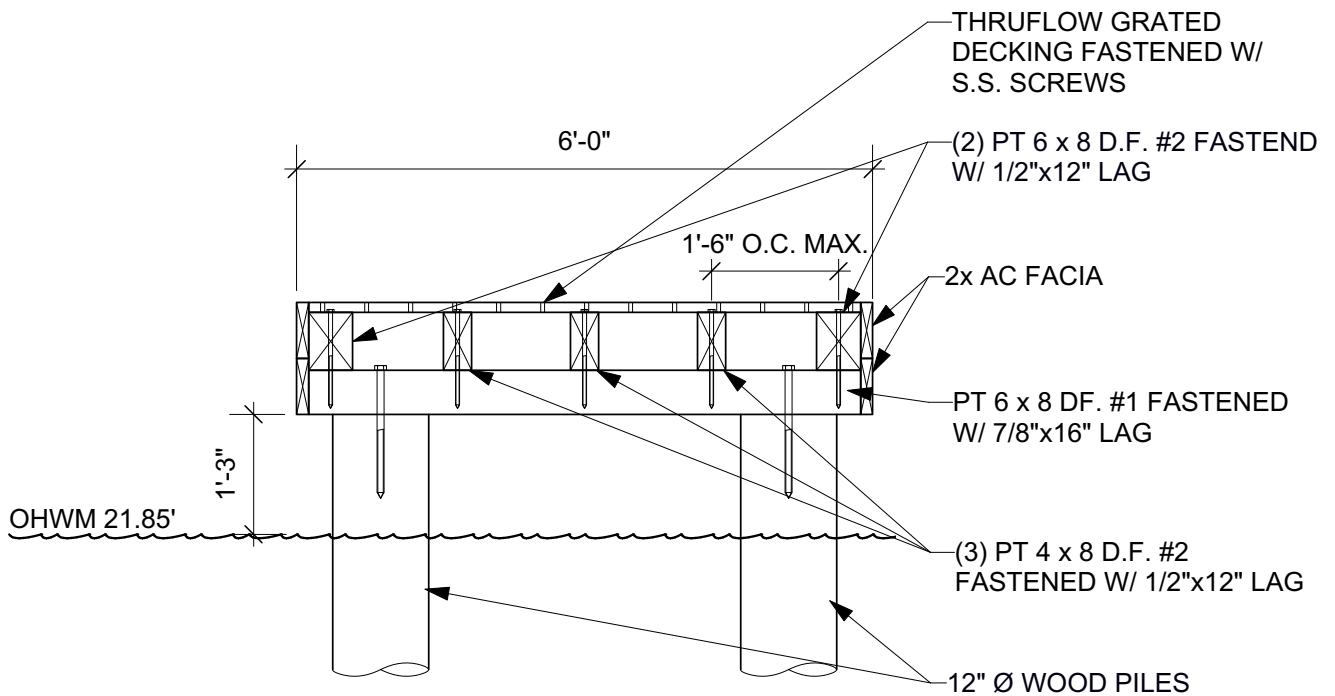
Sheet 5 of 6 **Date:** 4/9/2020

SECTION DETAIL A

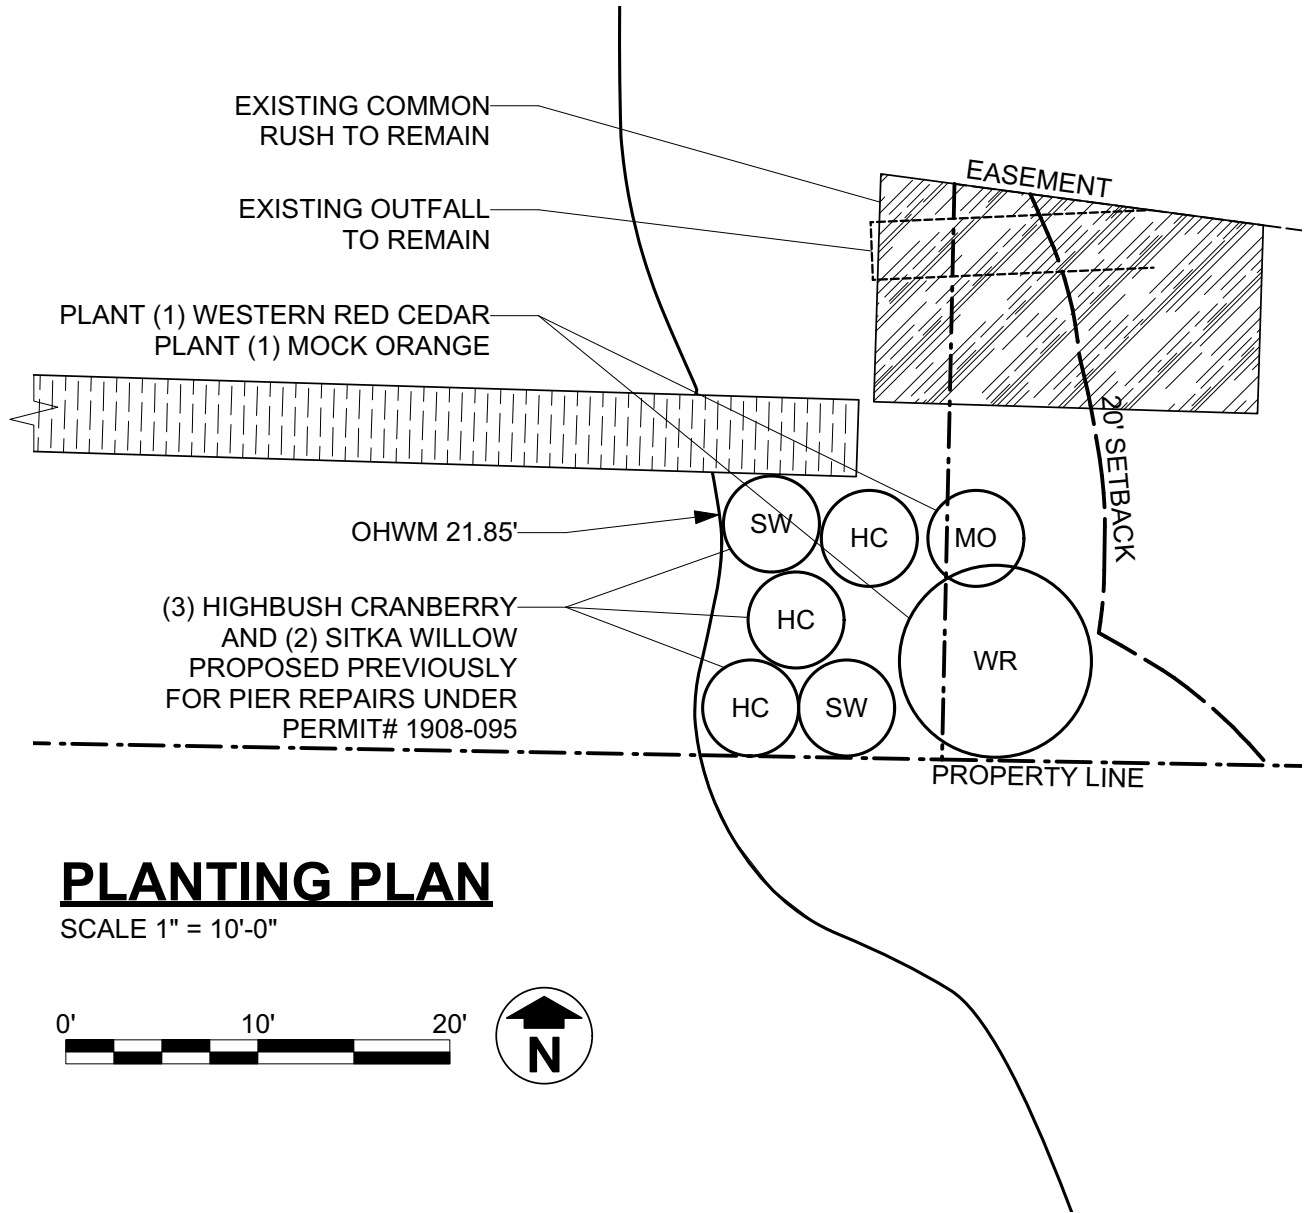
Sheet 6 of 6 **Date:** 4/9/2020

PLANTING PLAN

A shoreline planting plan will be completed using the following native species of trees and shrubs: 1 Western red cedar and 1 mock orange. In addition, 2 Sitka willows and 3 highbush cranberry shrubs will be planted to mitigate previous repairs under permit # 1908-095 (see Appendix A – Sheet 6 of 6).

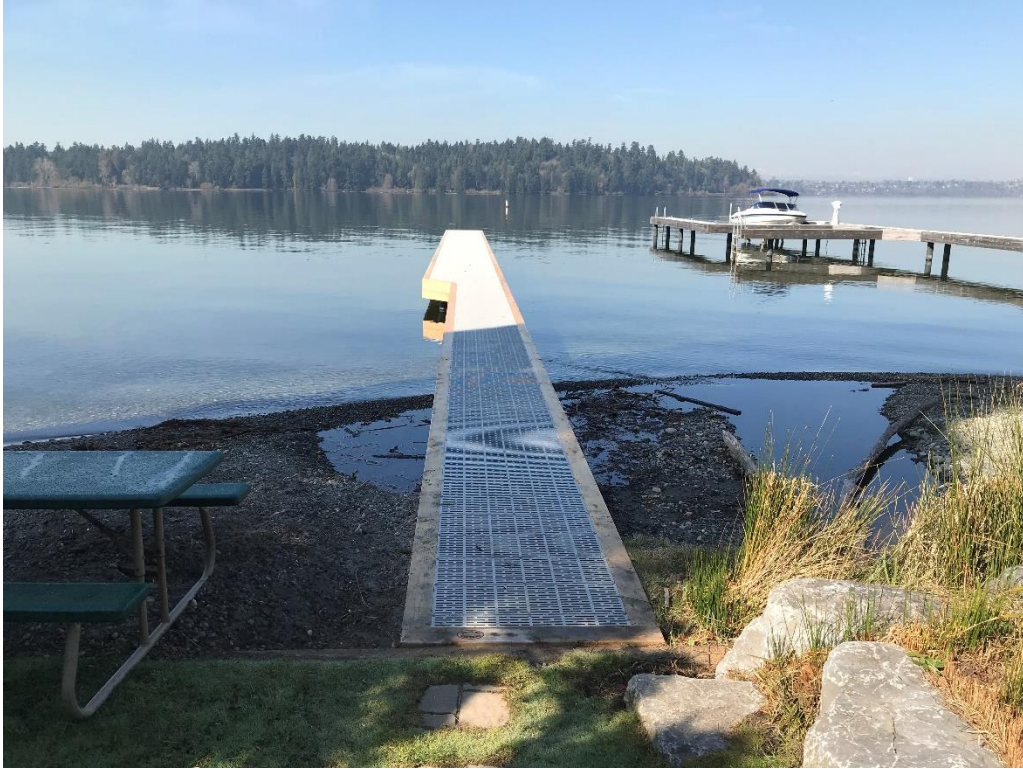
Photo 1. View of pier from shore looking west.

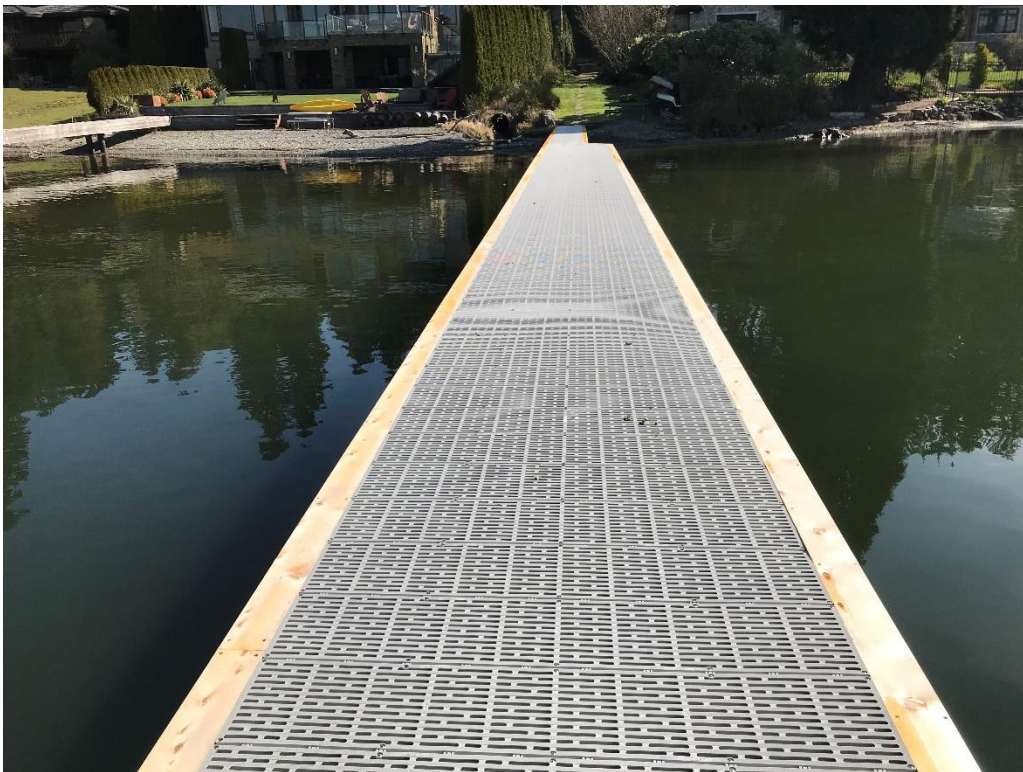
Photo 2. View of pier from end looking east.

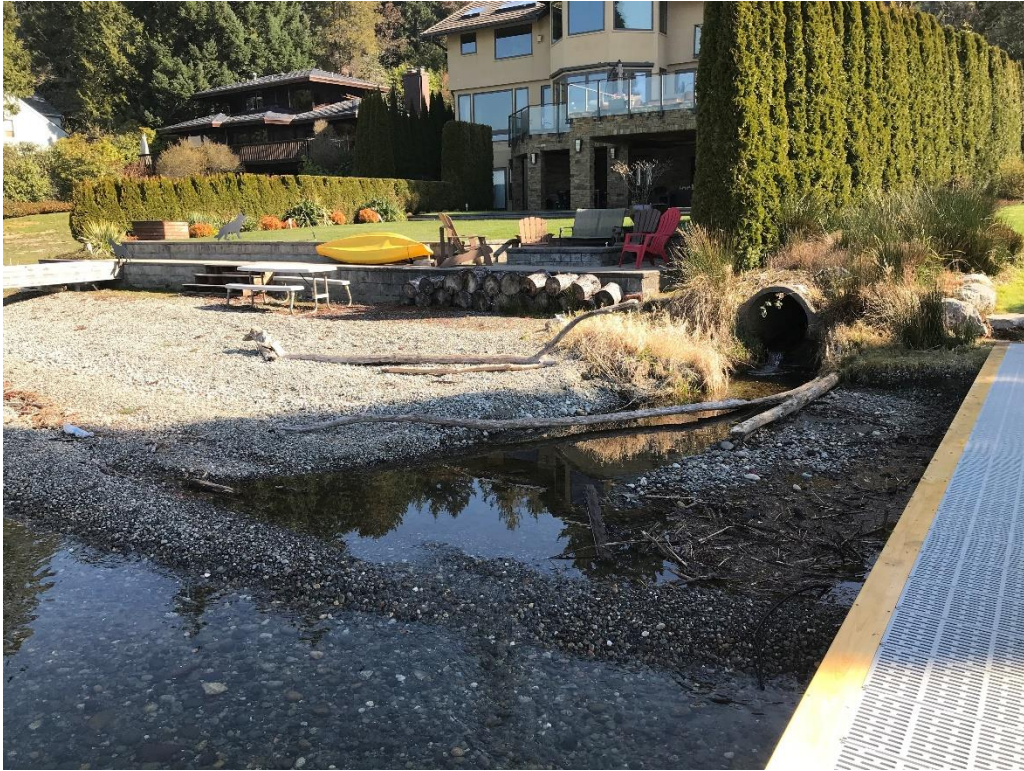
Photo 3. View of north shoreline from pier looking east.

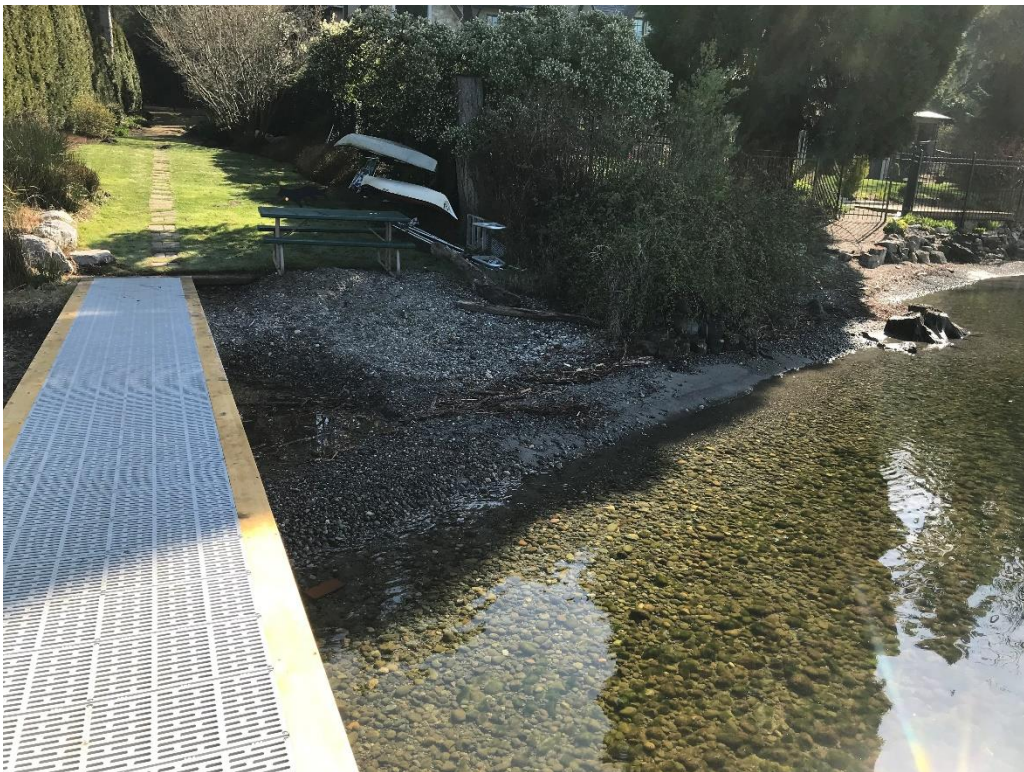
Photo 4. View of south shoreline from pier looking east.

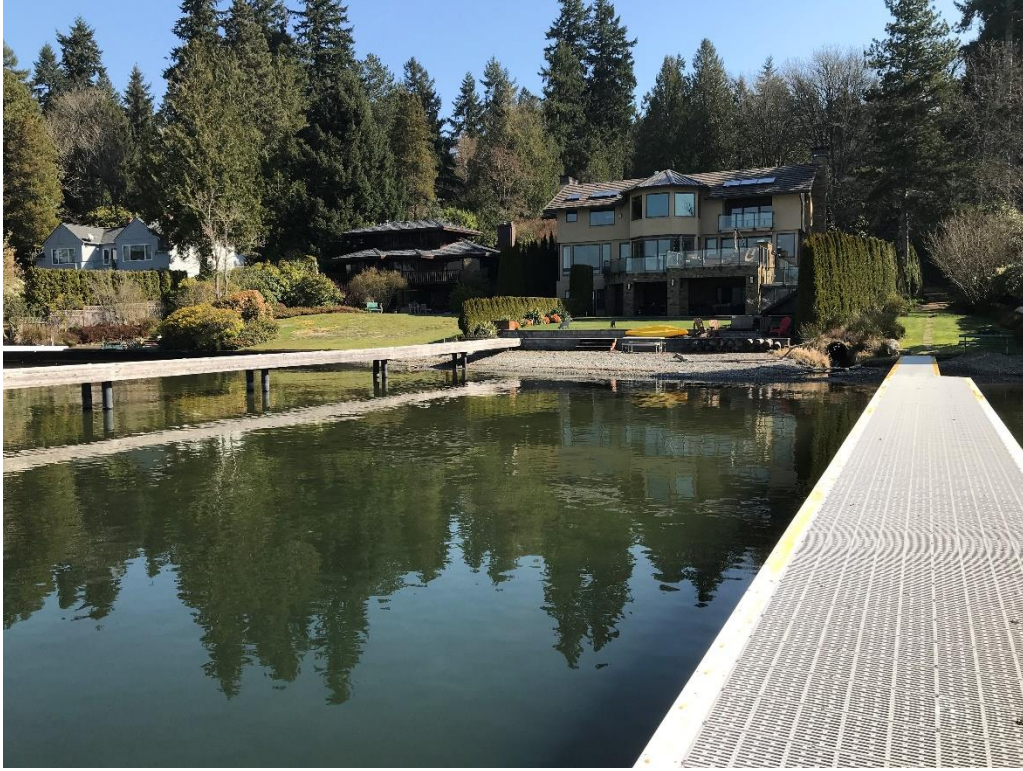
Photo 5. View of north adjacent shoreline (on subject property) from pier looking northeast.

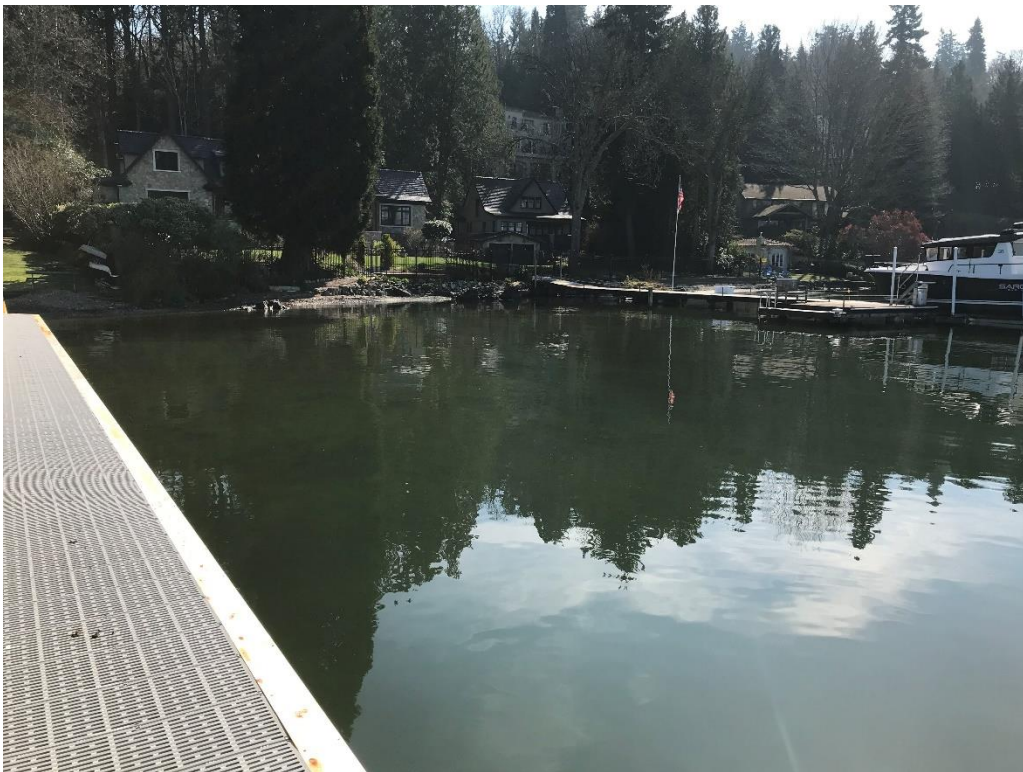
Photo 6. View of south adjacent shoreline from pier looking southeast.
