Ecological No Net Loss Assessment Report

**Owen Sun
7240 North Mercer Way
Mercer Island, WA 98040**

**Northwest Environmental Consulting, LLC
3639 Palatine Avenue North
Seattle, WA 98103
206-234-2520**

October 2020

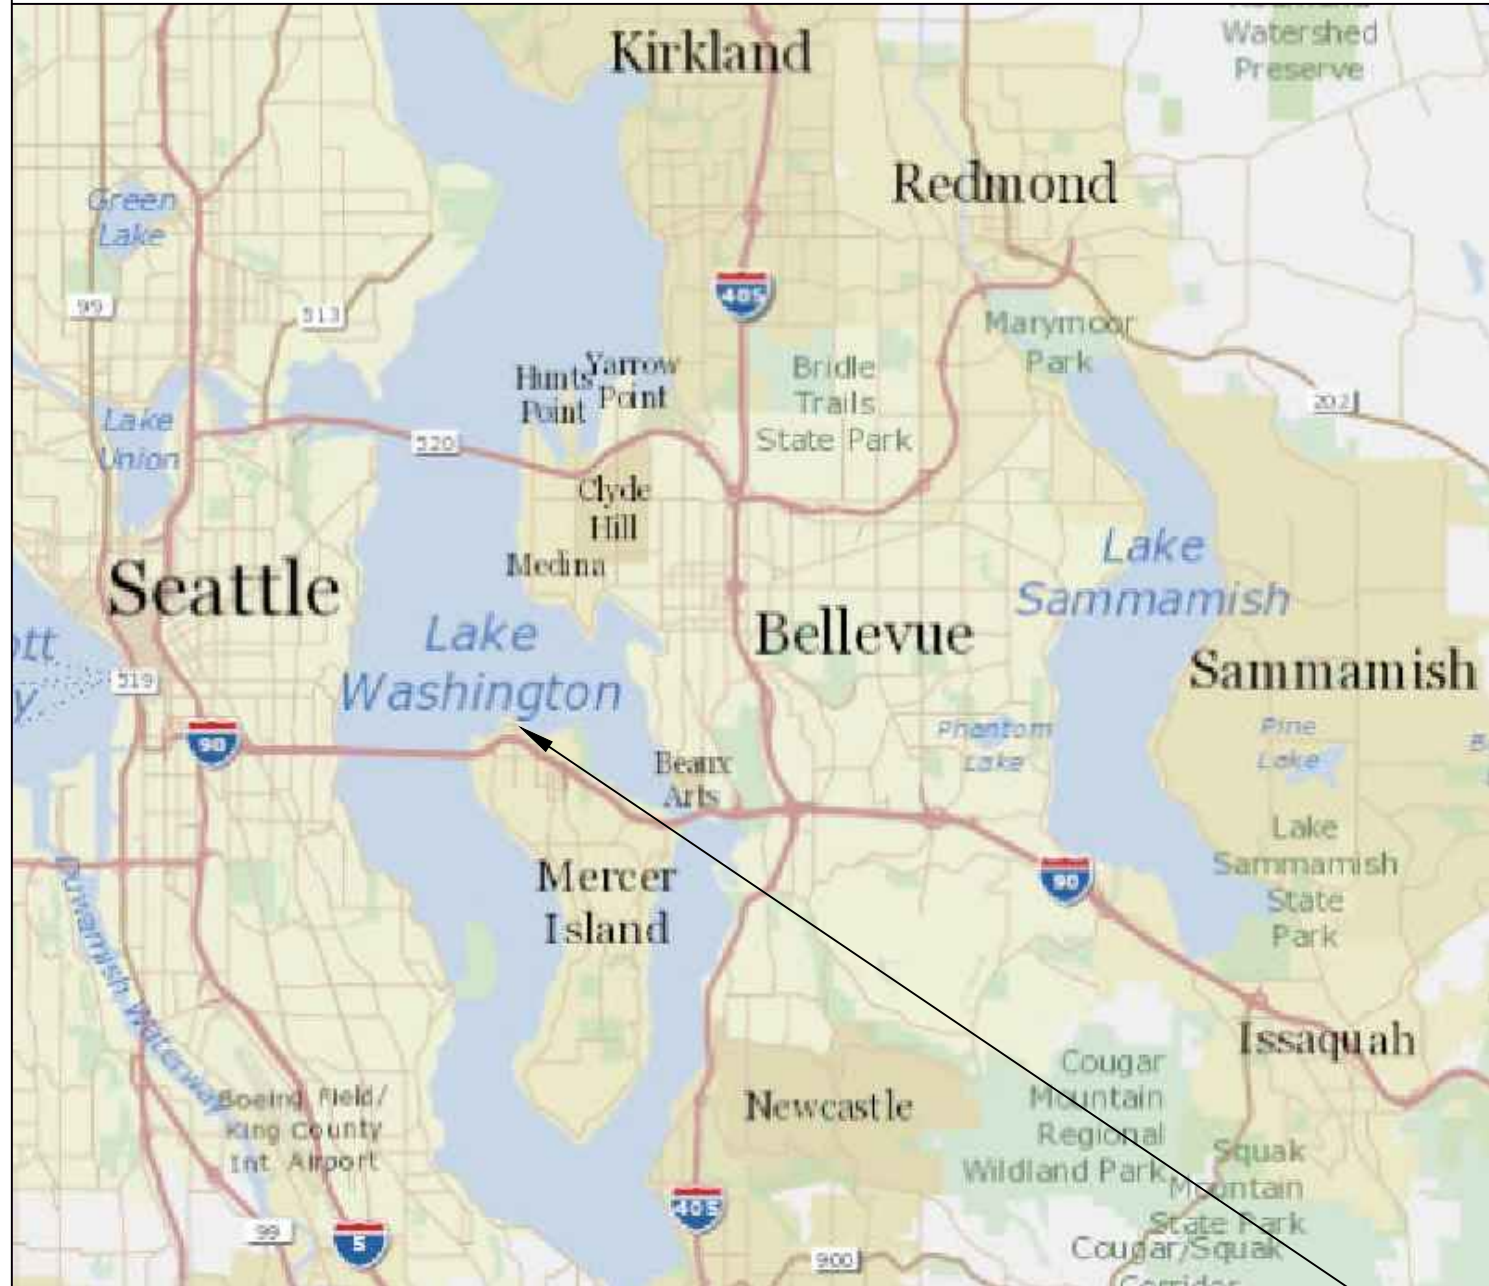
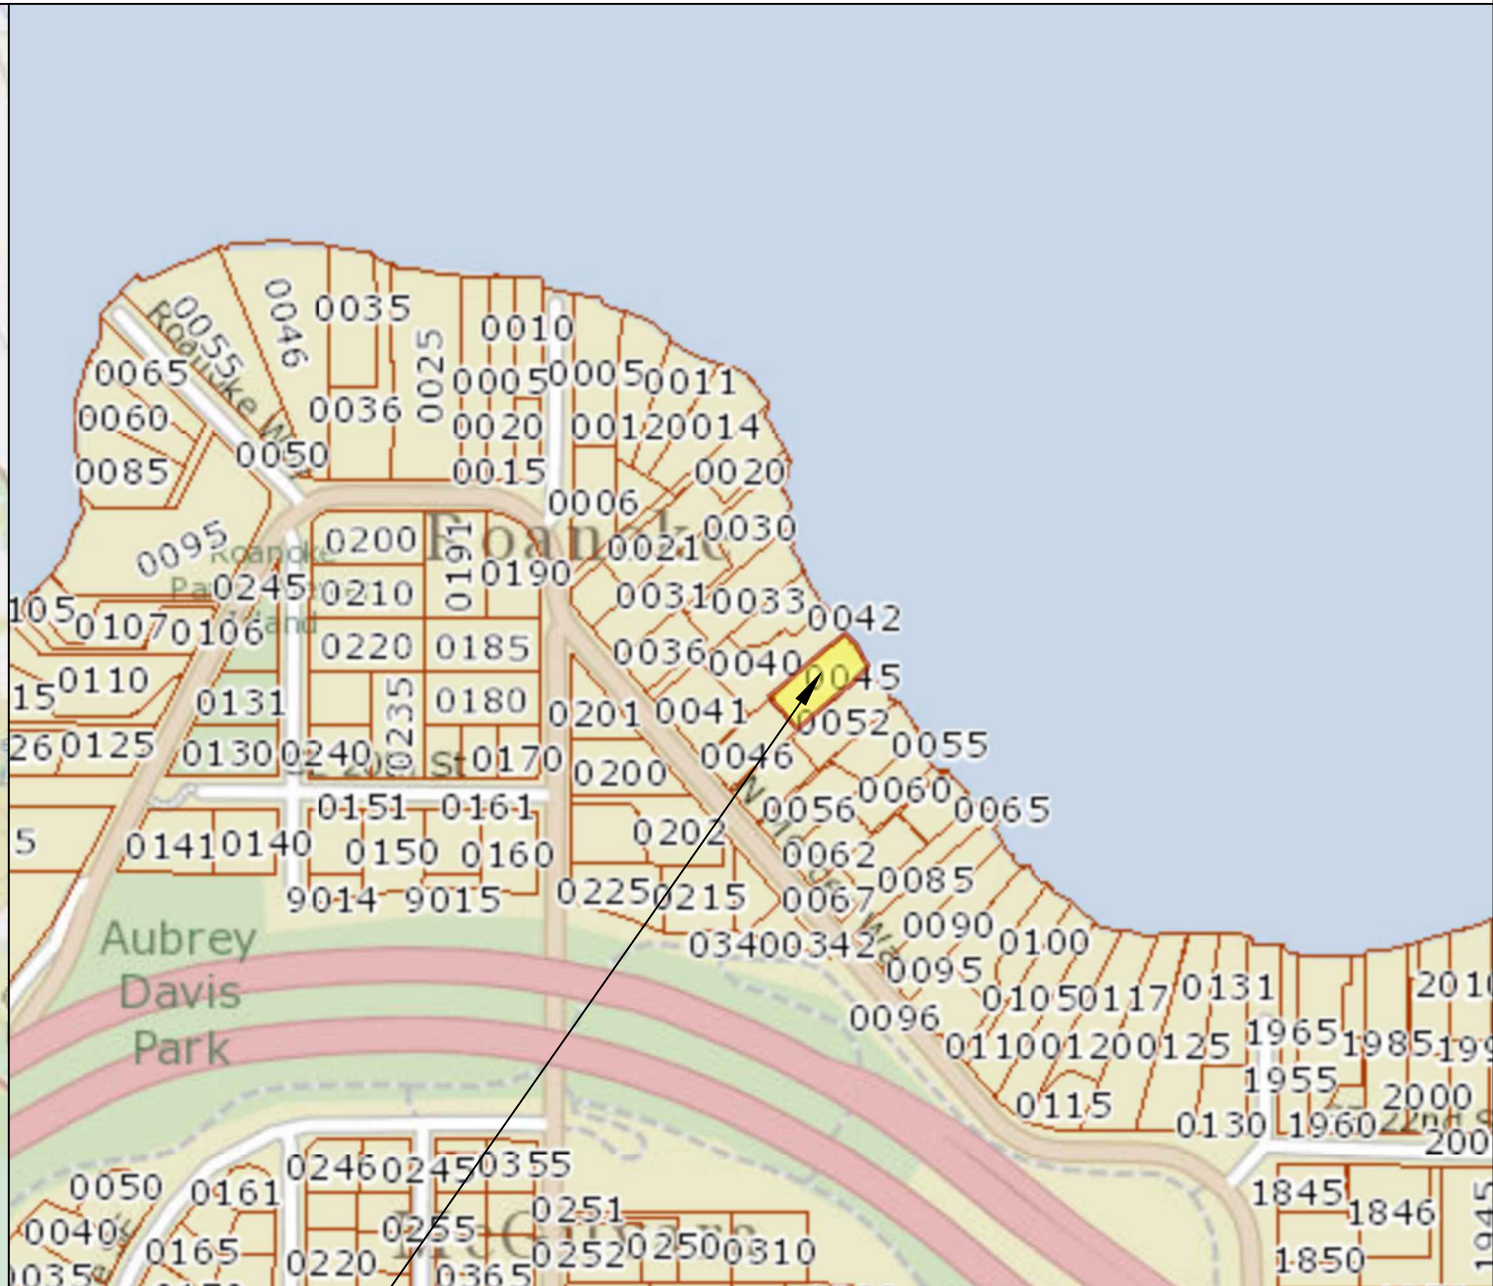
**SHEET
A1.0**

SITE PLAN

Scope of Work: We propose to repair (10) existing pile. We will also construct a beach cove, installing new thruflow decking on entire dock & installing a boat lift under the existing moorage cover.

The subject property is located at 7240 North Mercer Way (King County parcel number 5315100045) in the City of Mercer Island, Washington (see Appendix A – Sheet A1.0). The parcel is on the waterfront of Lake Washington, which contains several endangered fish species listed under the Endangered Species Act and Washington State designated priority fish species. Permits are being applied for a pier repair and the creation of a beach cove (see Appendix A – Sheets A3.0 and A4.0).

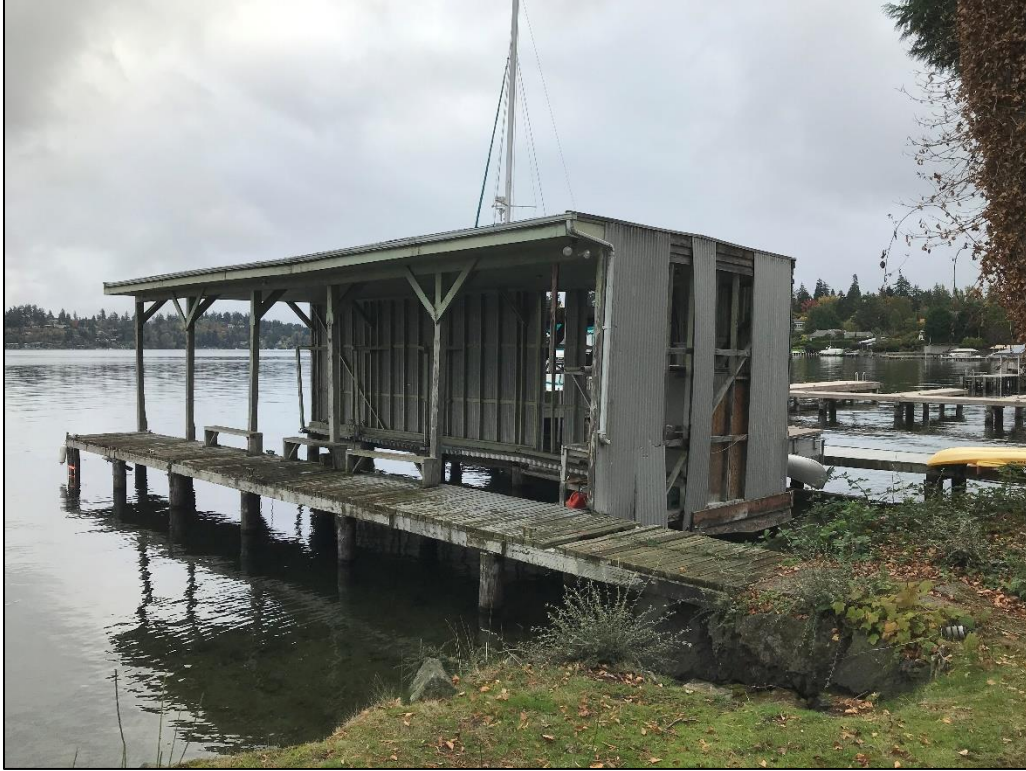
Photo 1. View of pier and moorage cover from shoreline looking east.

The only existing structures on the property are the house, the moorage cover, the existing wood pier, two mooring piles, and a rock bulkhead with rock stairs (Photos 1 through 4).

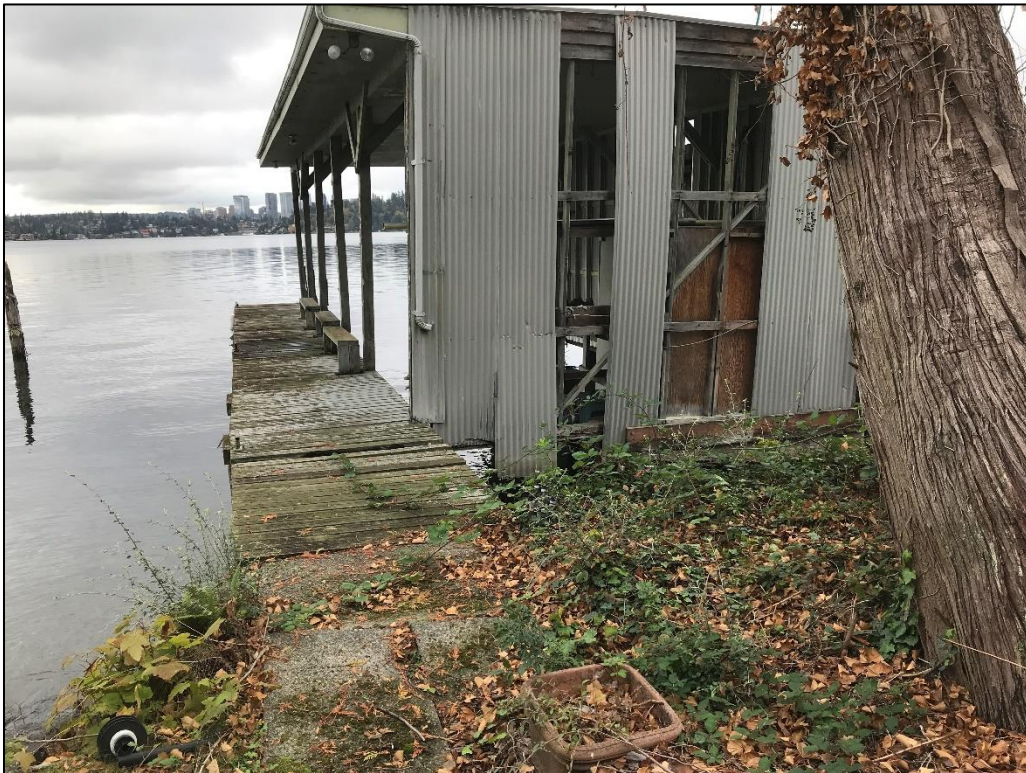
Photo 2. View of pier and moorage cover from pier entrance looking northeast.

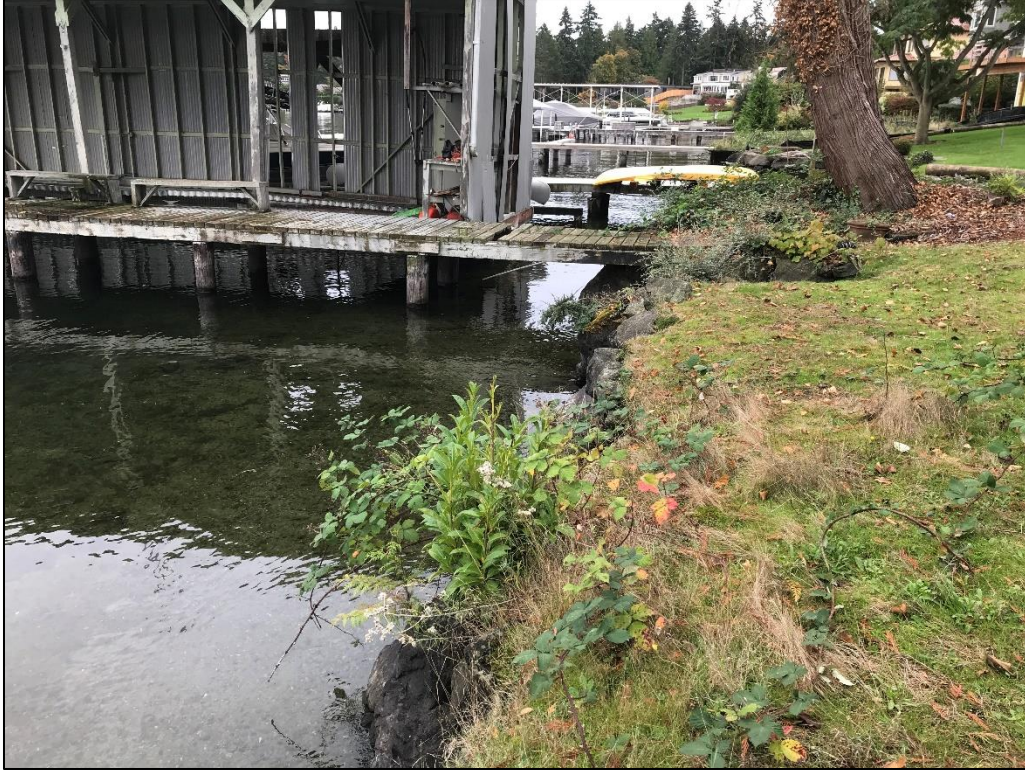
Photo 3. View of shoreline and bulkhead from northwest property line looking southeast.

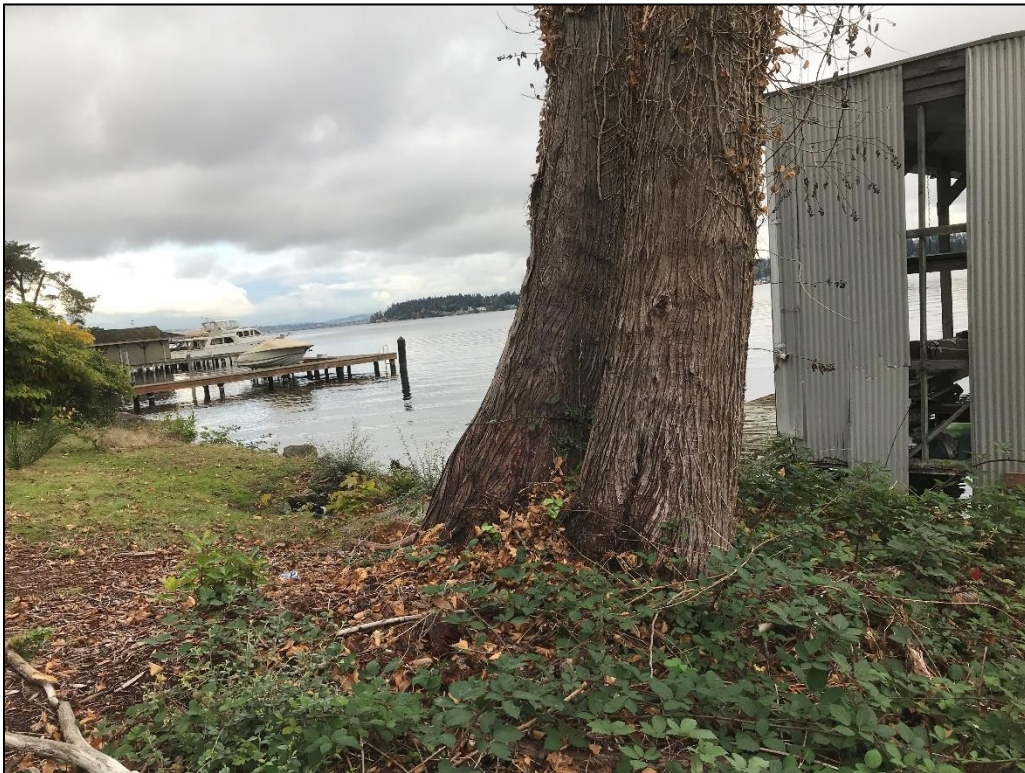
Photo 4. View of shoreline from southeast property line looking northwest.

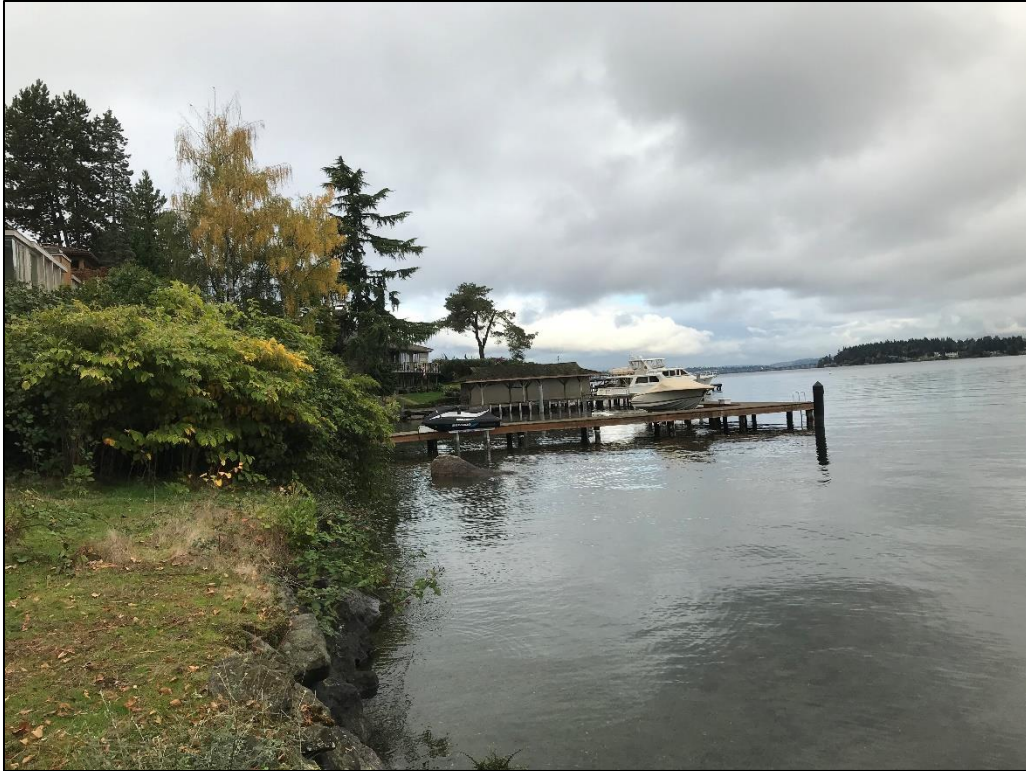
Photo 5. View of northwest adjacent shoreline and subject property shoreline from pier entrance looking northwest.

The property to the northwest has a wood pier and the shoreline was not visible from the subject property due to dense overhanging knotweed along the northwest property line (Photo 5). The property to the southeast has a rock bulkhead with a wood pier (Photo 6). The subject property yard has a lawn along the shoreline. The northwestern end of the subject property shoreline contains overhanging knotweed waterward of a Western red cedar. The middle shoreline contains a lawn with Himalayan blackberry, cotoneaster, and laurel. The northern end of the shoreline contains the rock stairs, the pier entrance, two Western red cedars, Oregon grape, cotoneaster, sword fern, and Himalayan blackberry.

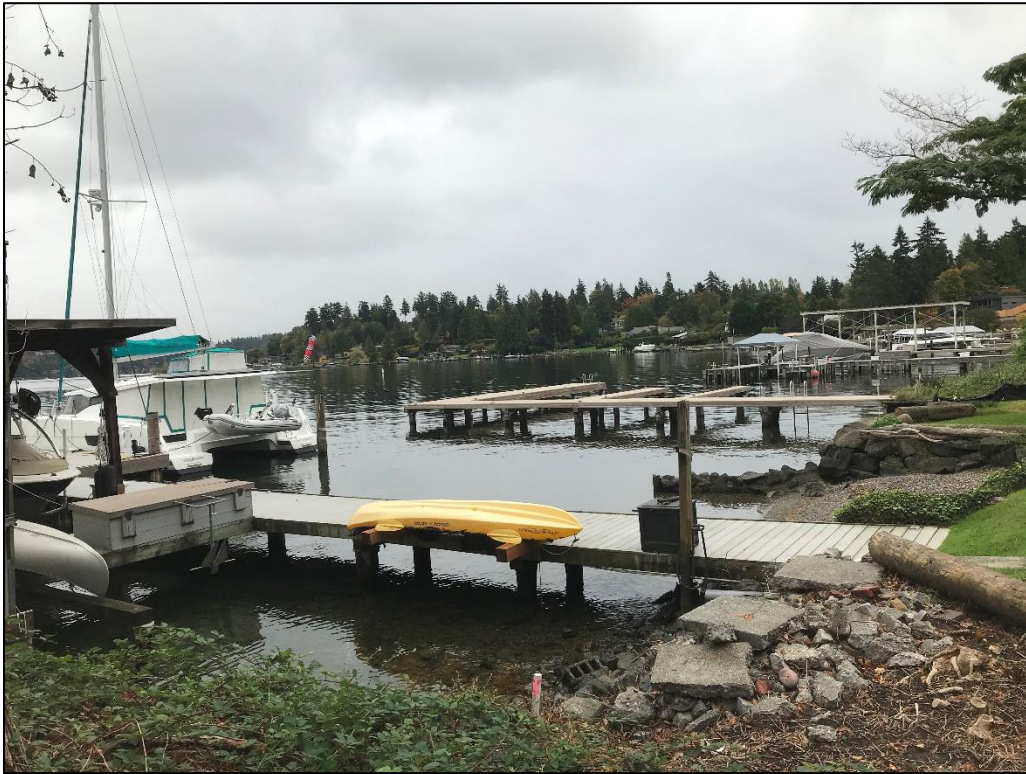
Photo 6. View of southeast adjacent property.
