Critical Areas Report

BUTTENWIESER & WILEY PROPERTY CITY OF MERCER ISLAND

November 23, 2021

Reference Number: 210441

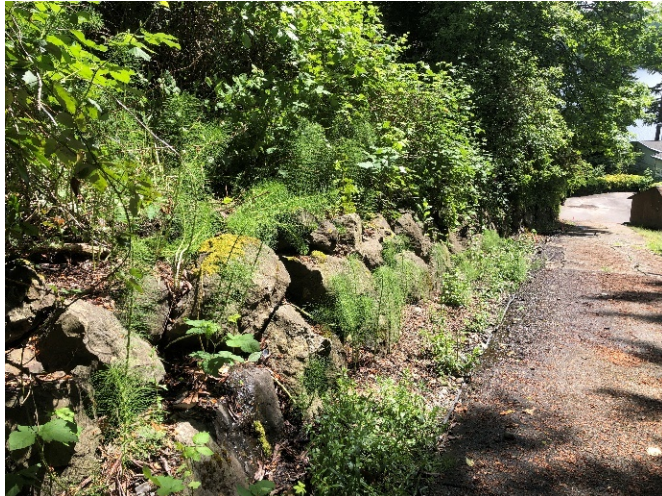
WETLAND A – Assessment Summary										
Location:	Northwestern corner of the subject parcel, along northern edge of driveway.									
WRIA / Sub-basin:	Cedar – Sammamish Watershed (WRIA 8) / Mercer Island Sub-basin

2014 Western WA Ecology Rating:	Category IV								
	Buffer Width and Buffer Setback:	40-foot buffer, 10-foot setback								
	Wetland Size:	Approx. 1,000 square feet								
	Cowardin Classification(s):	Palustrine emergent, palustrine scrub-shrub								
	HGM Classification(s):	Slope								
	Wetland Data Sheet(s):	DP-3								
	Upland Data Sheet (s):	DP-4								
	Flag Color:	Pink- and black-striped								
	Flag Numbers:	A-1 to A-9								
Vegetation	Tree stratum: N/A Shrub stratum: Himalayan blackberry (<i>Rubus armeniacus</i>) Herb stratum: Fringed willow herb (<i>Epilobium ciliatum</i>), American speedwell (<i>Veronica americanus</i>), giant horsetail (<i>Equisetum telmateia</i>)

Soils	Soil survey: Kitsap silt loam 8-30 percent slopes Field data: Loamy gleyed matrix (F2)									
Hydrology	Source: Groundwater seeps, runoff Field data: High Water Table (A2), Saturation (A3)									
Wetland Functions										
	Improving Water Quality			Hydrologic			Habitat			
Site Potential	H	M	<u>L</u>	H	M	<u>L</u>	H	M	<u>L</u>	
Landscape Potential	H	<u>M</u>	L	H	<u>M</u>	L	H	<u>M</u>	L	
Value	H	<u>M</u>	L	H	M	<u>L</u>	H	<u>M</u>	L	TOTAL
Score Based on Ratings	5			4			5			14
Description and Comments										
Wetland A is a small slope wetland that originates in the northwestern corner of the subject property and runs along the driveway. A portion of the wetland was above the rockery retaining wall that runs along the driveway. This area is supported by a native high groundwater table and seep.

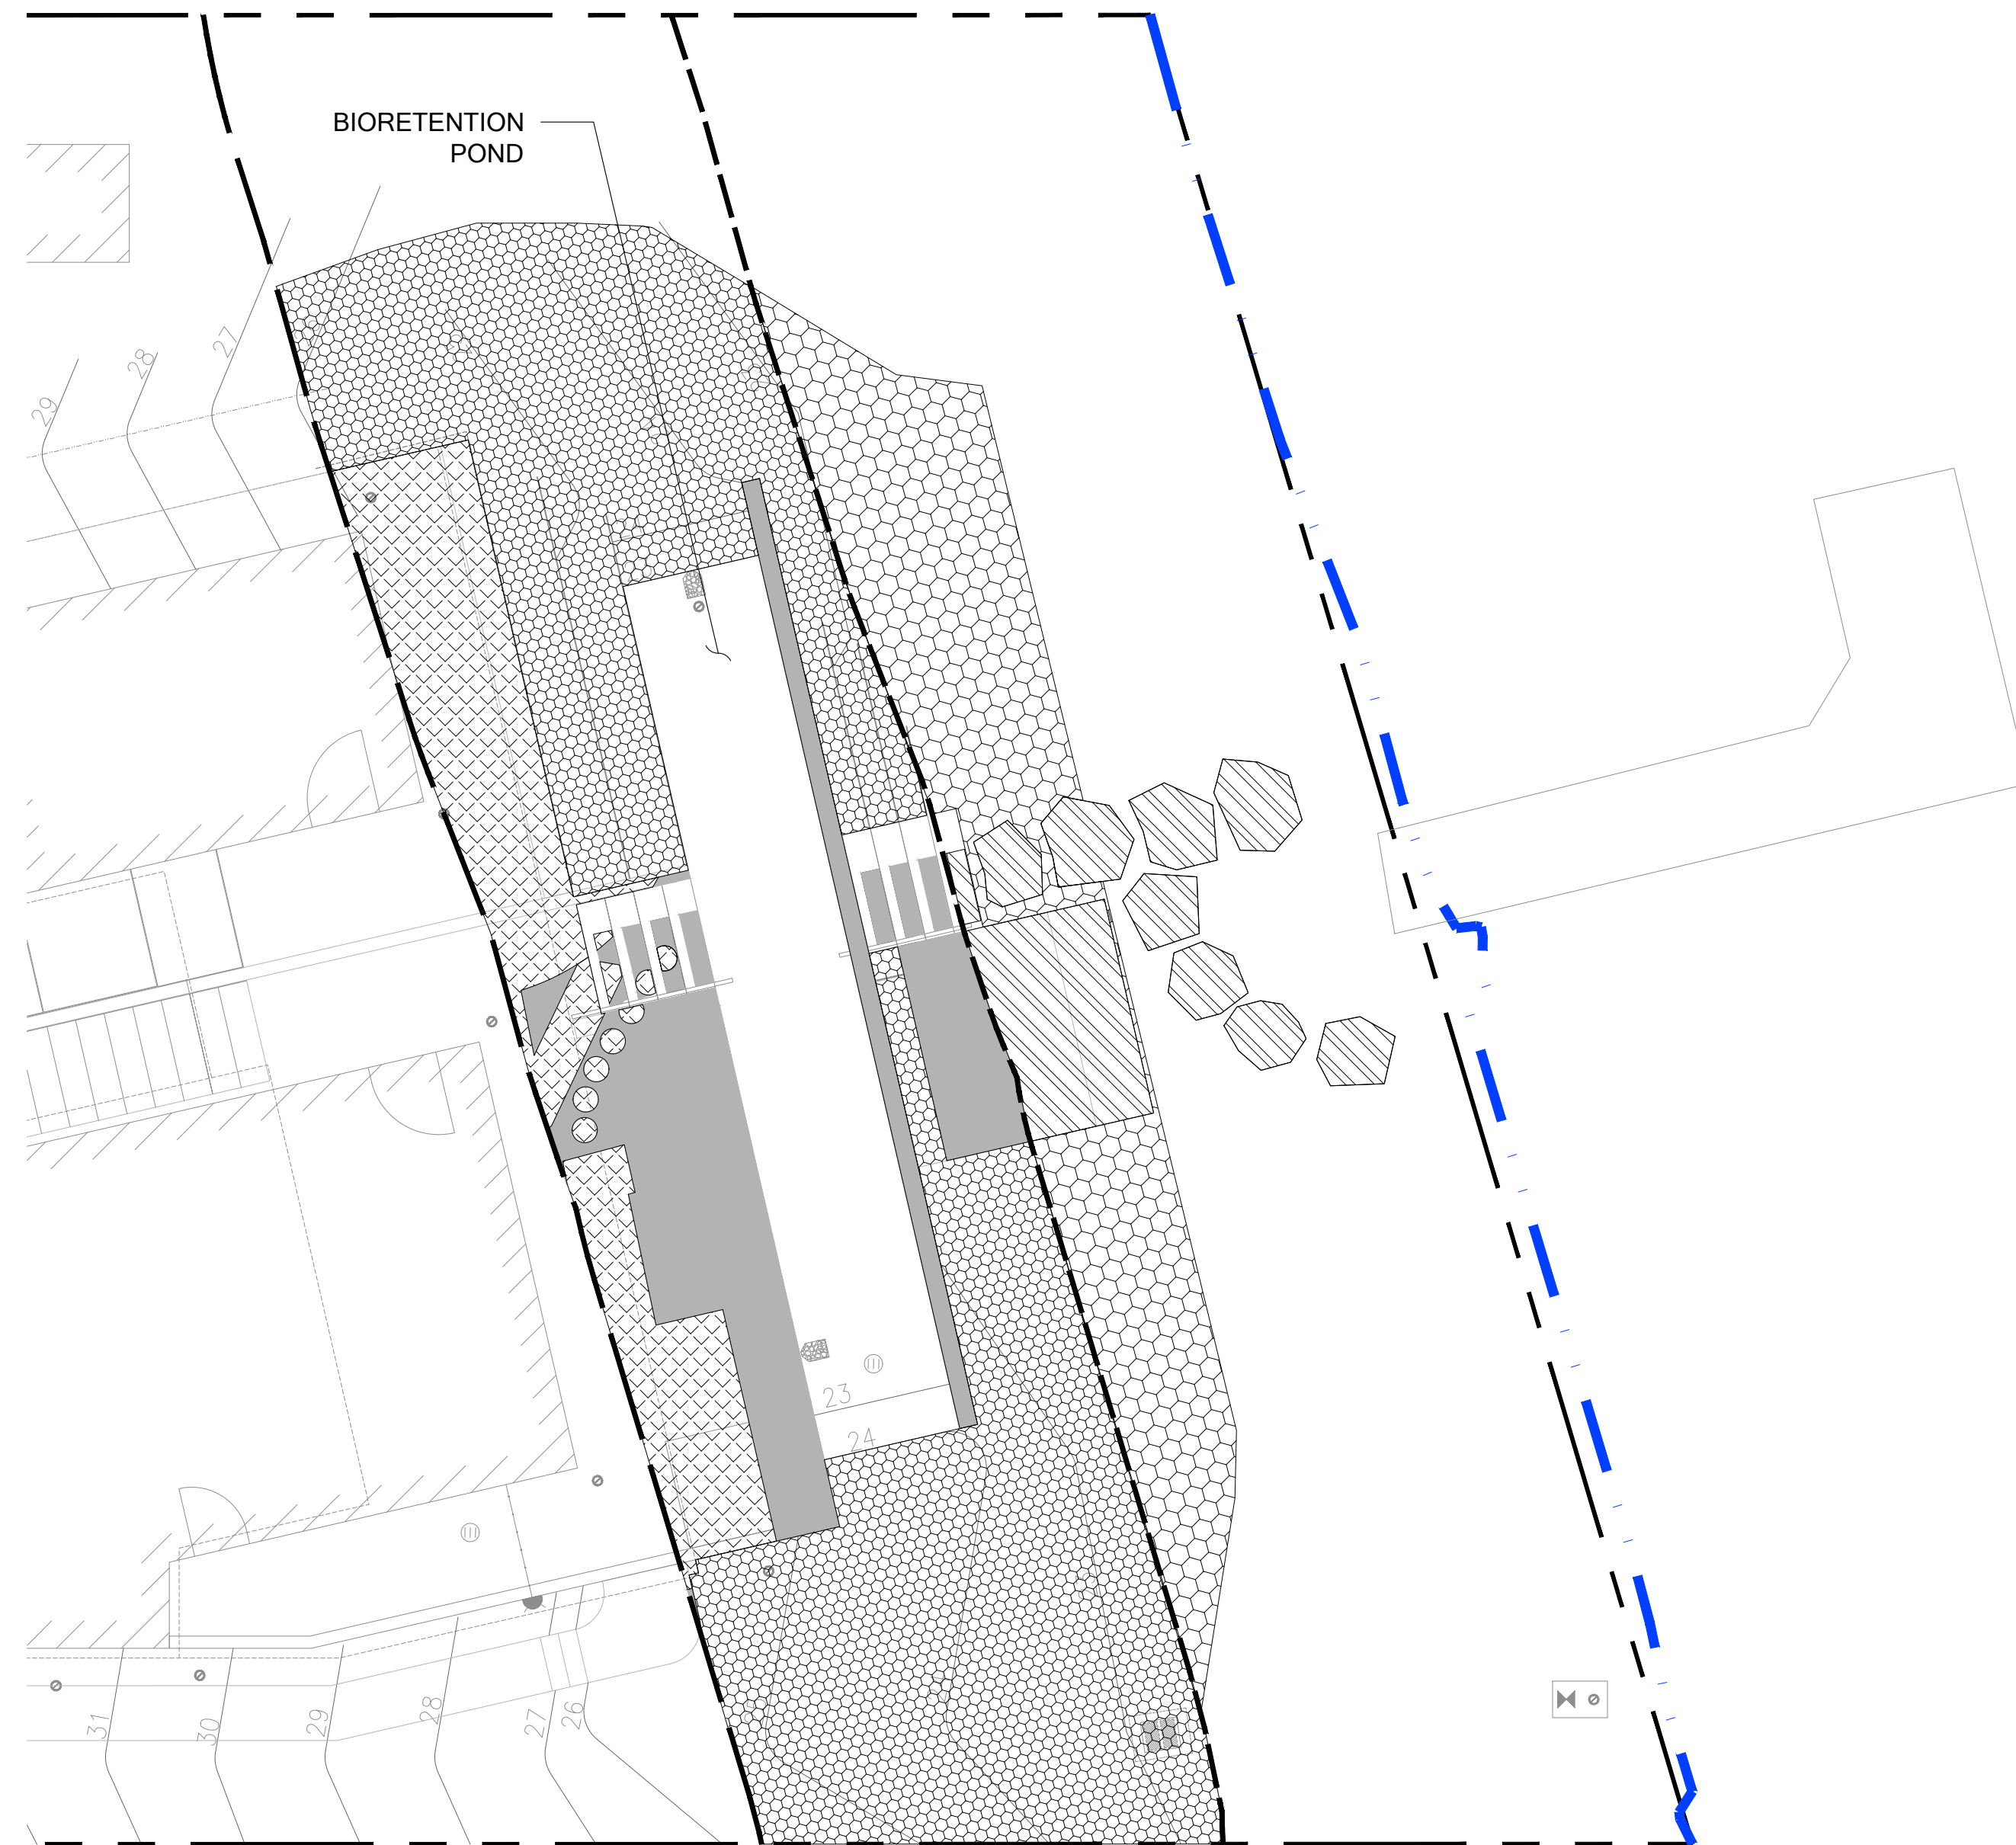
SHORELINE IMPACTS ASSESSMENT

Response: Proposed hardscape/lot coverage (i.e., impervious area) between 0 and 25 feet from the ordinary highwater mark is calculated at 4.9 percent and does not exceed 10 maximum impervious surface coverage. The proposed impervious area between 25 and 50-ft shoreline buffer zone is calculated at 29.9% and does not exceed the maximum 30 percent lot coverage. See shoreline impact calculations on mitigation plan sheet W3.

0-25' SHORELINE BUFFER IMPACTS	25-50' SHORELINE BUFFER IMPACTS
PERVIOUS TO IMPERVIOUS	206 SF	308 SF
IMPERVIOUS REMAINING IMPERVIOUS	0 SF	332 SF
TOTAL IMPERVIOUS	206 SF	640 SF
PERCENT IMPERVIOUS	7.9%	24.5%
MAXIMUM PERCENT IMPERVIOUS ALLOWED PER MICC 19.13.050(C)	10%	30%

Mitigation for the addition of impervious surfaces within shoreline jurisdiction will be accomplished by limiting impervious surfaces in the 50-foot shoreline setback to the allow maximums. Since the total change in lot coverage exceeds 1,000 square feet, the applicant is required to plant native vegetation in 75 percent of the first 20-ft of shoreline setback. Existing lawn will be replaced with a mix of native trees, shrubs, and ground cover, excluding nonnative grasses and plants on the current King County noxious weed list, in accordance with the Mercer Island Shoreline Master Program.

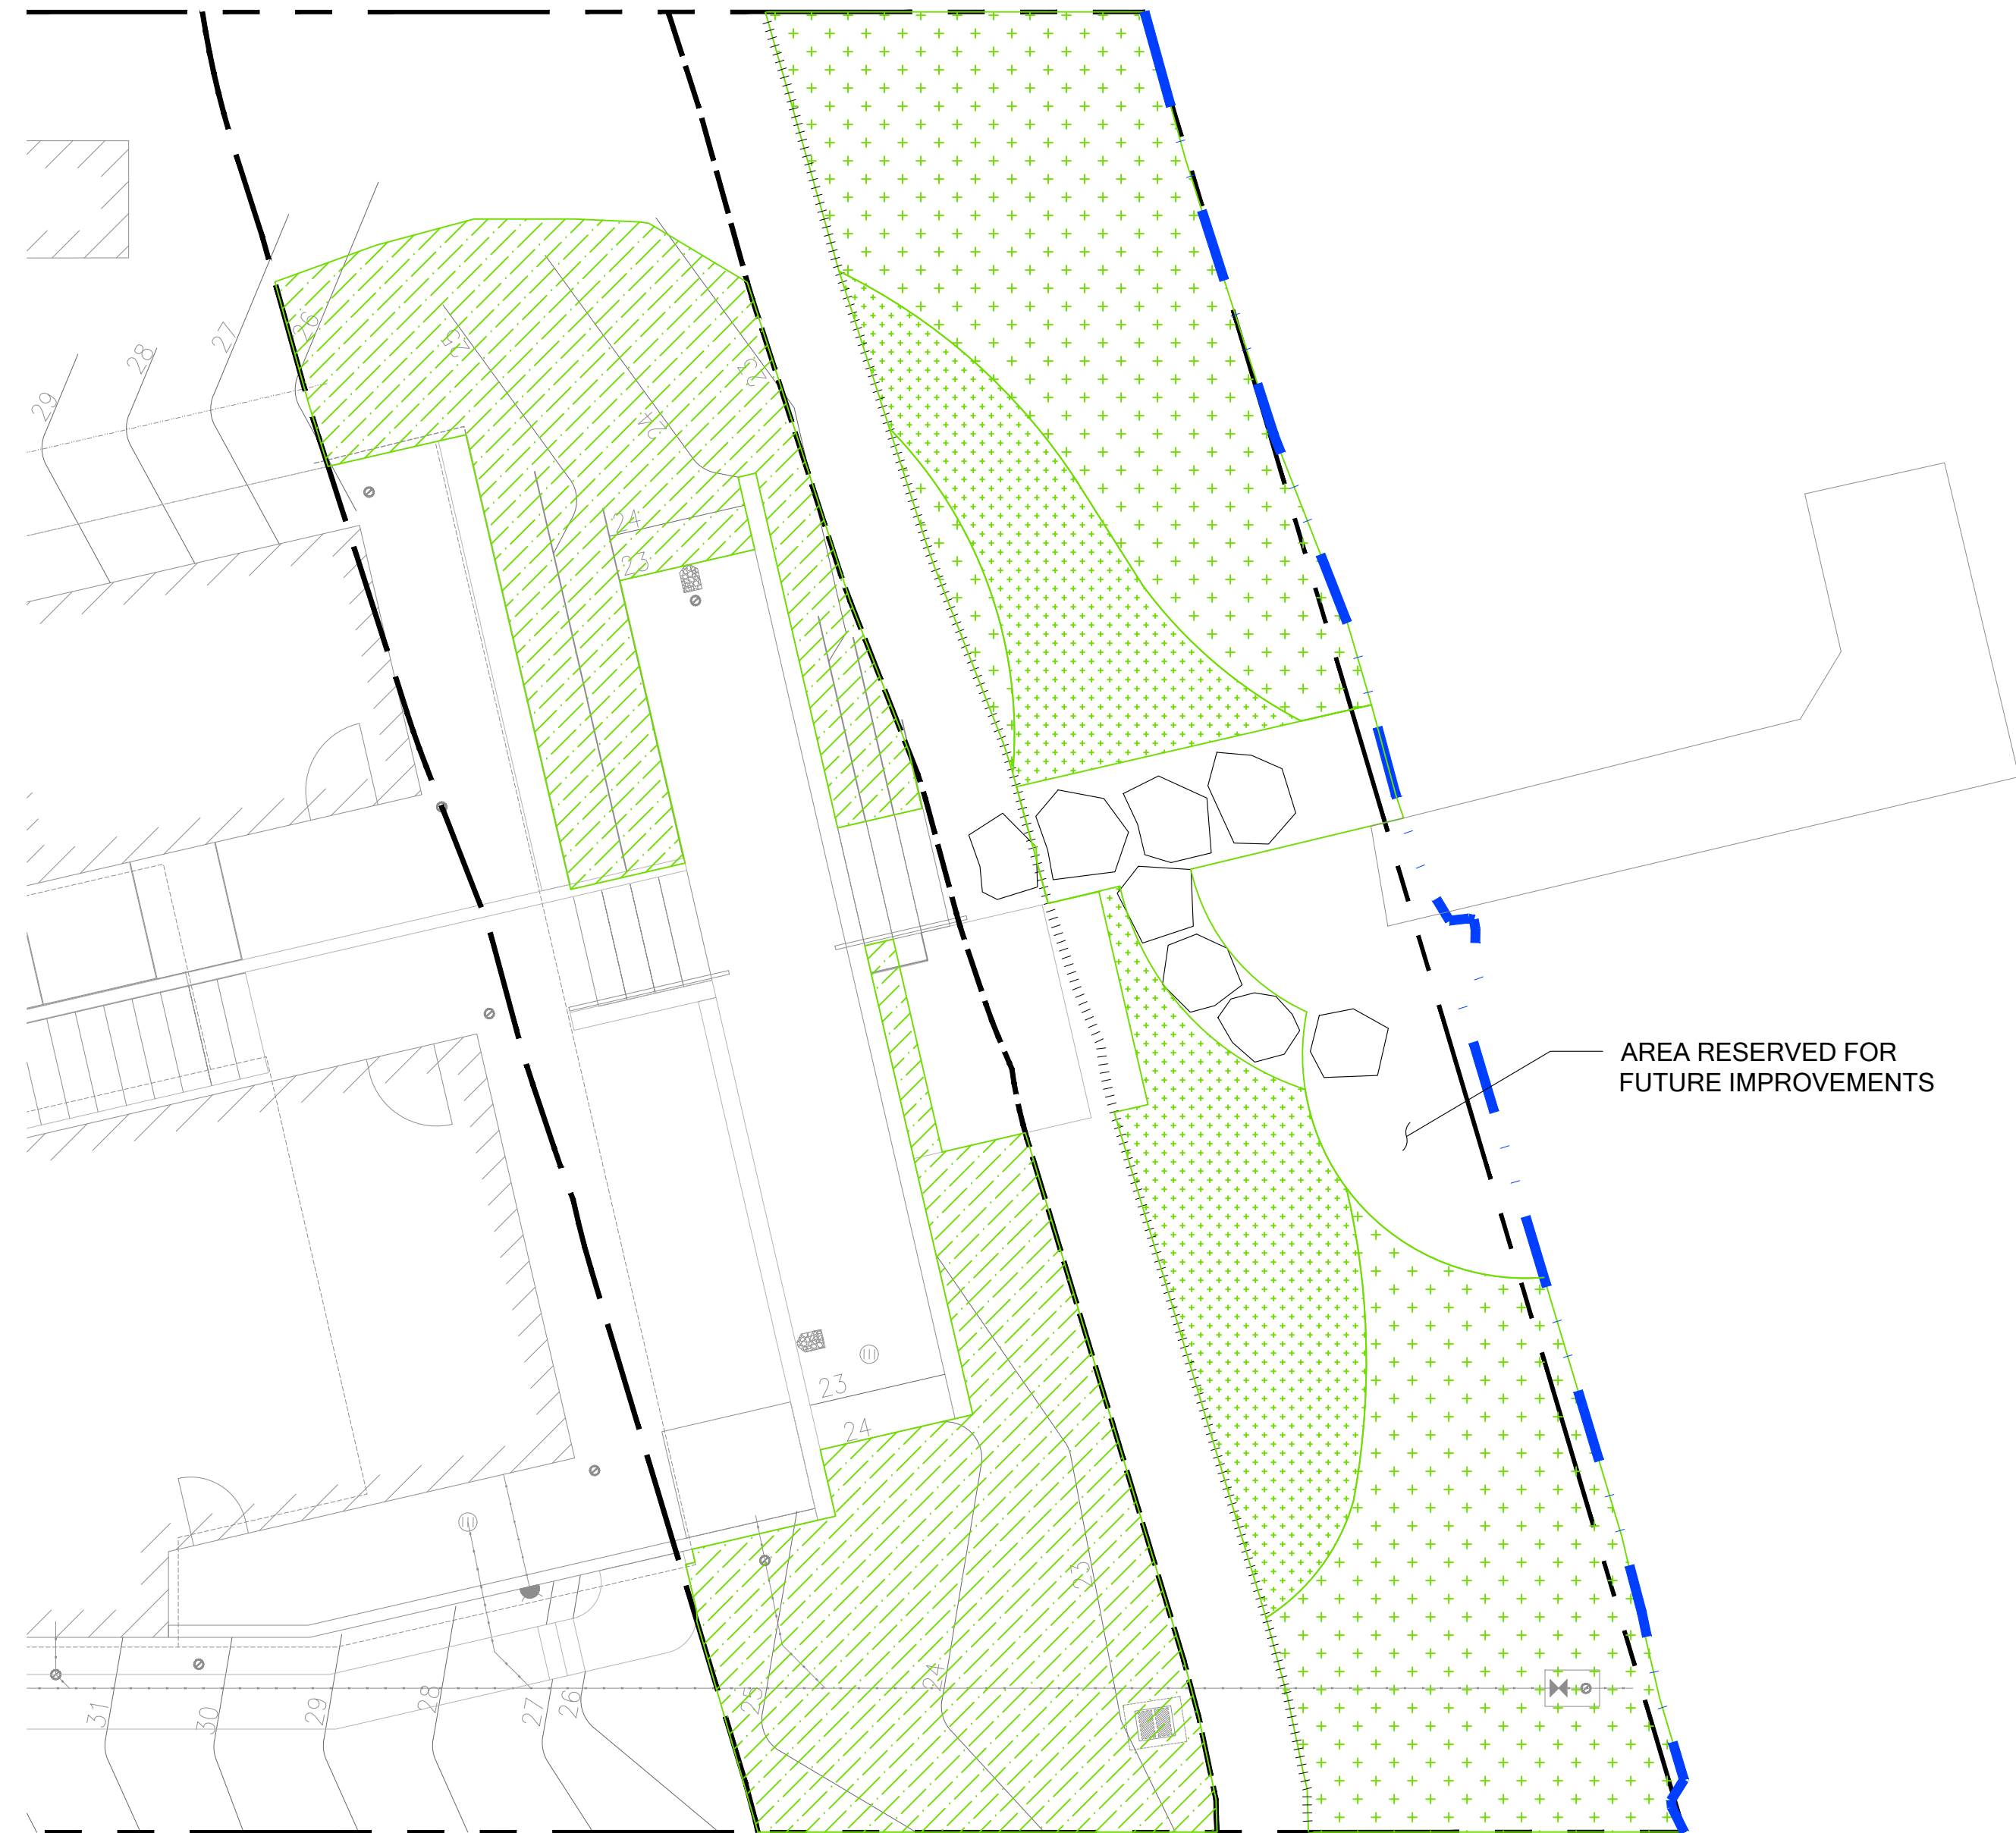
SHORELINE CONCEPTUAL MITIGATION PLAN

Response: Existing lot coverage is 7,185 SF and proposed lot coverage is 8,381 SF as calculated by Miller Hull on the Mercer Island House: Cascade Land Use Submittal, 11-5-21. This is a 1,196 SF increase in lot coverage. Therefore, per the code above, 75 percent of the 20-foot vegetation area shown in Figure C needs to be planted with native vegetation. See mitigation plan sheet W5 for the proposed planting area.

MITIGATION PLANTING AREA 1 (1,130 SF) (SEE NOTE 1)		
TREES (3)	QTY	SIZE
ACER MACROPHYLLUM / BIGLEAF MAPLE	3	5 GAL.
SHRUBS (52)		
ACER CIRCINATUM / VINE MAPLE	10	6-8' HT. MIN.
GAULTHERIA SHALLON / SALAL	10	1 GAL.
RIBES SANGUINEUM / RED FLOWERING CURRANT	11	3 GAL.
SYMPHORICARPOS ALBUS / SNOWBERRY	11	3 GAL.
VACCINIUM OVATUM / EVERYGREEN HUCKLEBERRY	10	1 GAL.
GROUNDCOVERS (64)		
ARCTOSTAPHYLOS UVA-URSI / KINNIKINNICK	9	4" POT
CAREX OBNUPTA / SLOUGH SEDGE	9	1 GAL.
DESCHAMPSIA CESPITOSA / TUFTED HAIR GRASS	9	1 GAL.
FRAGARIA CHILOENSIS / COASTAL STRAWBERRY	9	4" POT
MAHONIA REPENS / CREEPING OREGON GRAPE	9	1 GAL.
POLYSTICHUM MUNITUM / SWORDFERN	10	1 GAL.
SEDUM OREGANUM / STONECROP	9	4" POT

- MITIGATION PLANTING AREA 2 (509 SF) (SEE NOTE 1)
NO MOW NATIVE GRASS MIX
- TEMPORARY IMPACTS (1,234 SF)
NO MOW NATIVE GRASS MIX

MITIGATION FOR THE ADDITION OF IMPERVIOUS SURFACES WITHIN SHORELINE JURISDICTION WILL BE ACCOMPLISHED BY LIMITING IMPERVIOUS SURFACES IN THE 50-FOOT SHORELINE SETBACK TO THE ALLOW MAXIMUMS. SINCE THE TOTAL CHANGE IN LOT COVERAGE EXCEEDS 1,000 SQUARE FEET, THE APPLICANT IS REQUIRED TO PLANT NATIVE VEGETATION IN 75 PERCENT OF THE FIRST 20-FT OF SHORELINE SETBACK. EXISTING LAWN WILL BE REPLACED WITH A MIX OF NATIVE TREES, SHRUBS, AND GROUND COVER, EXCLUDING NONNATIVE GRASSES AND PLANTS ON THE CURRENT KING COUNTY NOXIOUS WEED LIST, IN ACCORDANCE WITH THE MERCER ISLAND SHORELINE MASTER PROGRAM.

1. MAINTAIN NO NET LOSS OF SHORELINE SETBACK FUNCTIONS.
2. RESTORE TEMPORARY DISTURBANCE AREAS TO AN EQUIVALENT OR GREATER CONDITION.
3. INCREASE NATIVE PLANT COVER AND DIVERSITY IN THE SHORELINE.
4. MAINTAIN LOW INVASIVE PLANT COVER IN THE MITIGATION AREAS.

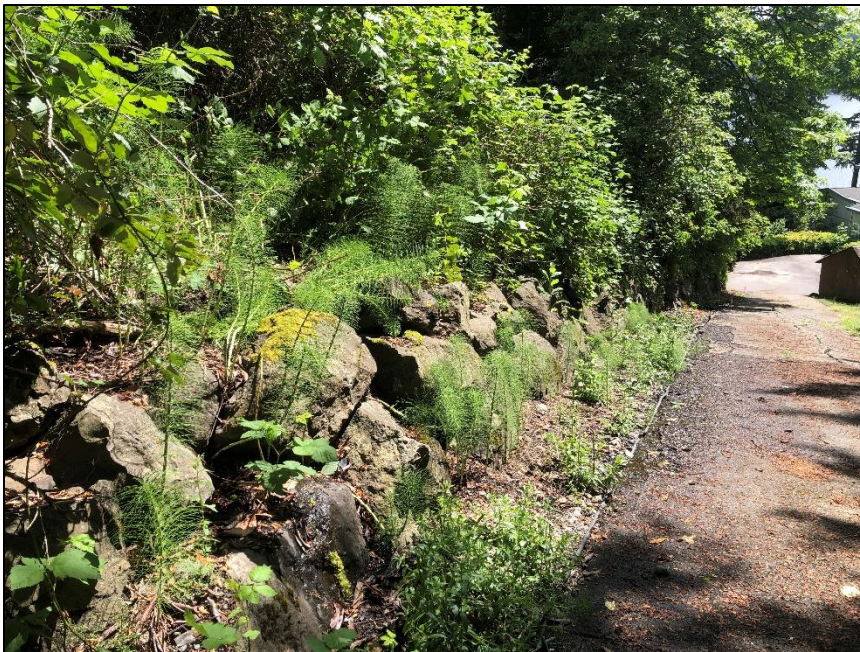
Photo 4. Wetland A looking downslope (photo taken 5/19/21).

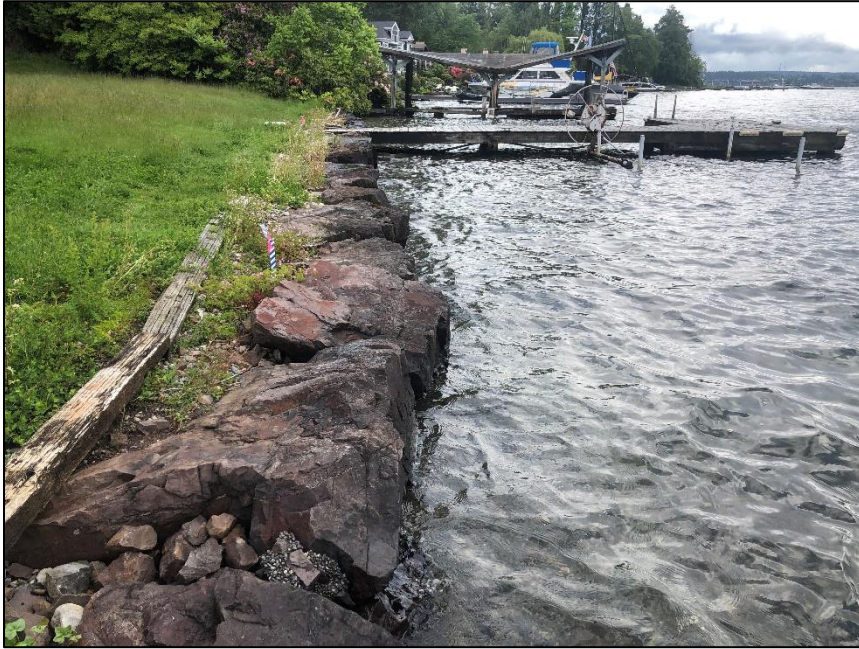
Photo 5. Lake Washington shoreline (photo taken 5/19/21).

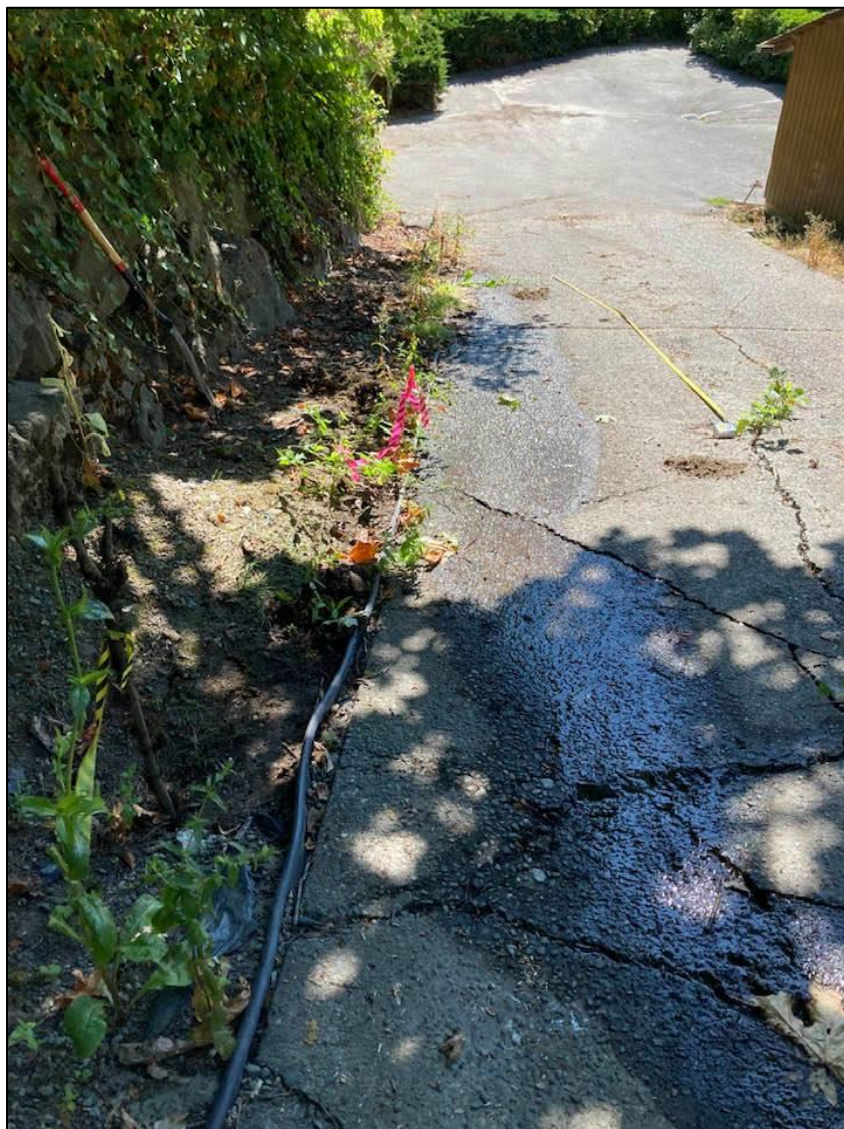
Photo 7. Seeps draining out of lower driveway adjacent to Wetland A (photo taken 7/23/21).

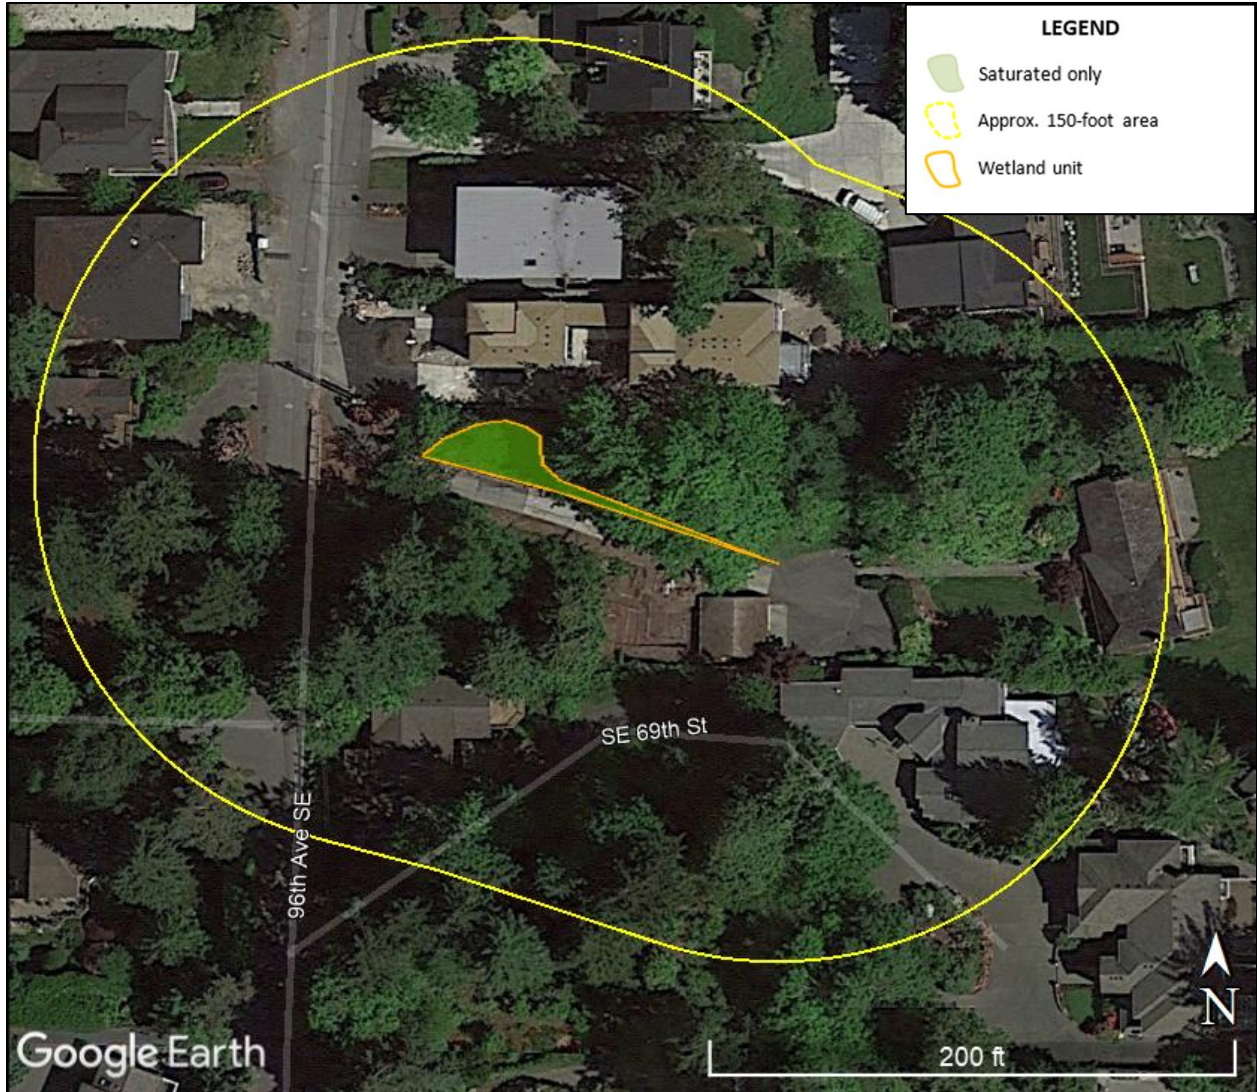
Figure 2. Hydroperiods and 150-foot area – H1.2, S2.1, S5.1

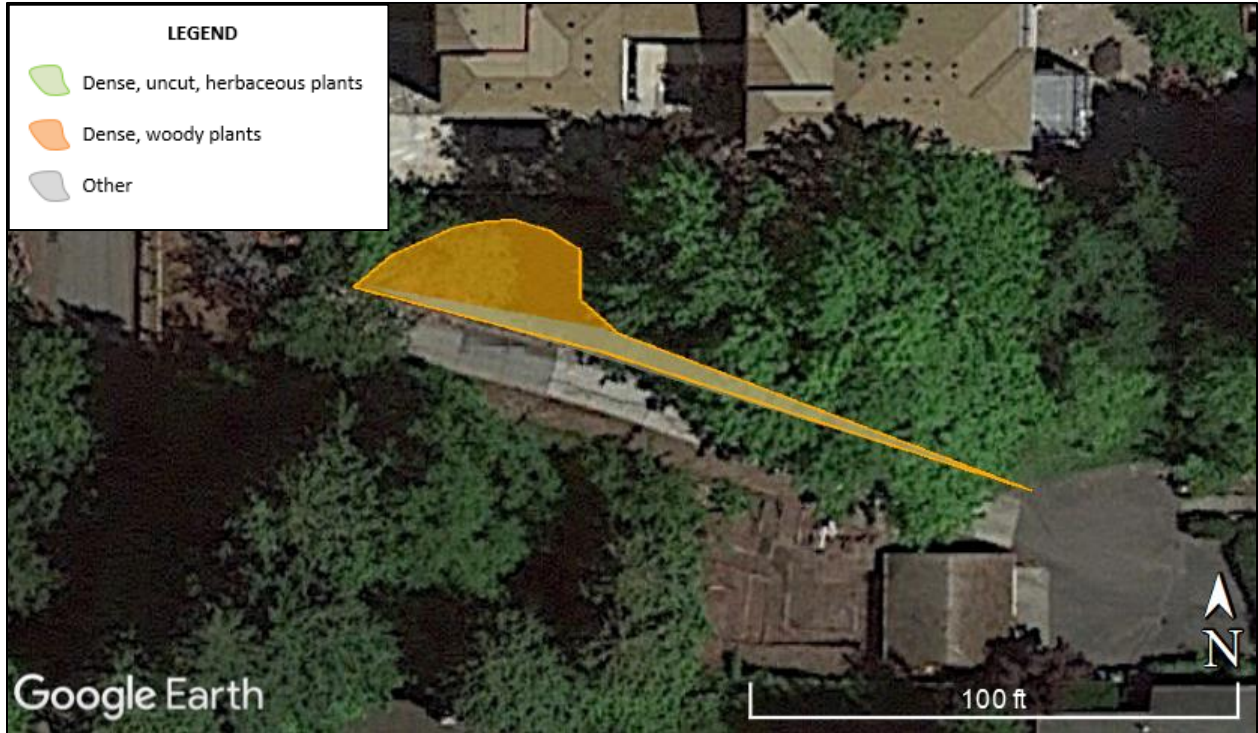
Figure 3. Plant cover of dense and rigid trees, shrubs, and herbaceous plants – S1.3, S4.1
