GEOTECHNICAL ENGINEERING REPORT

Buttenwieser/Wiley Residence
6838 96th Avenue SE
Mercer Island, Washington

Project No. 200631 • September 2, 2021 FINAL

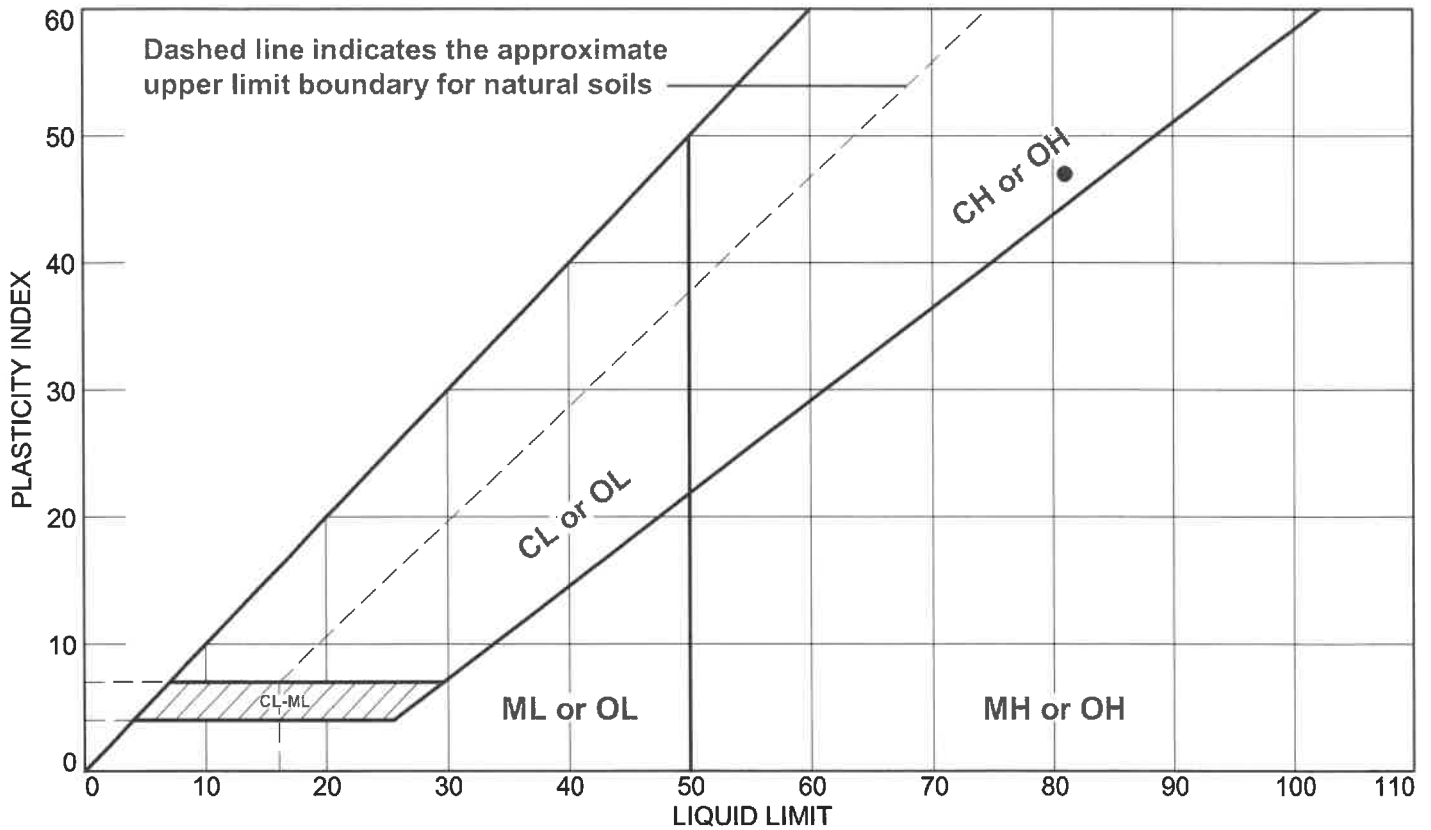
LIQUID AND PLASTIC LIMITS TEST REPORT

SOURCE	SAMPLE NO.	DEPTH	NATURAL WATER CONTENT (%)	PLASTIC LIMIT (%)	LIQUID LIMIT (%)	PLASTICITY INDEX (%)	LIQUIDITY INDEX	USCS
●	AB-06 / S-5	8385-16	15	37.4	34	81	47	0.1	CH

Liquid Limit= 81
Plastic Limit= 34
Plasticity Index= 47
Natural Moisture= 37.4
Liquidity Index= 0.1

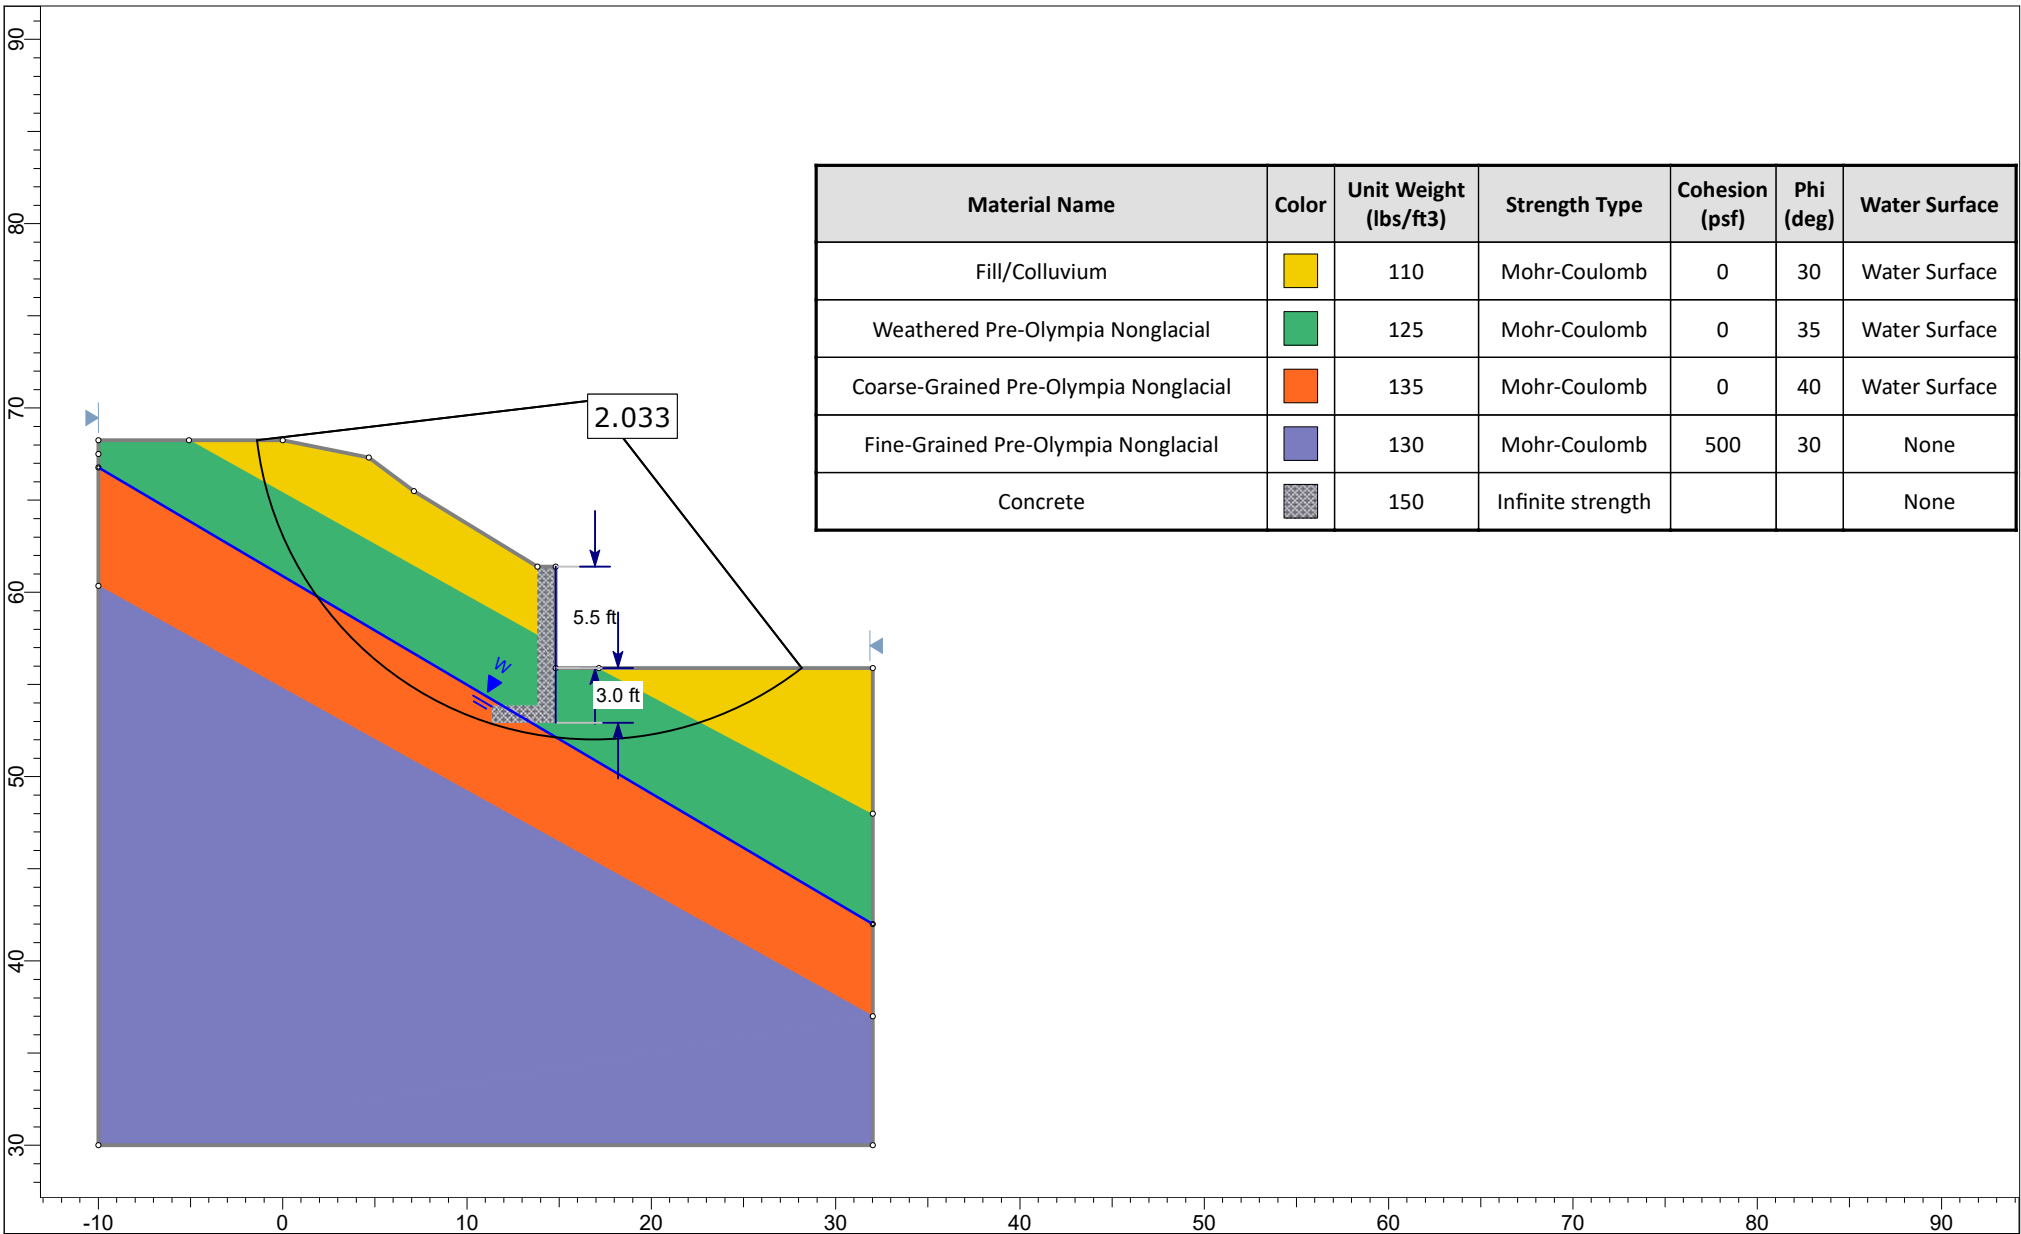
Global Stability Analysis

Material Name	Color	Unit Weight (lbs/ft ³)	Strength Type	Cohesion (psf)	Phi (deg)	Water Surface
Fill/Colluvium	Yellow	110	Mohr-Coulomb	0	30	Water Surface
Weathered Pre-Olympia Nonglacial	Green	125	Mohr-Coulomb	0	35	Water Surface
Coarse-Grained Pre-Olympia Nonglacial	Orange	135	Mohr-Coulomb	0	40	Water Surface
Fine-Grained Pre-Olympia Nonglacial	Purple	130	Mohr-Coulomb	500	30	None
Concrete	Grey with dots	150	Infinite strength			None
