Critical Areas Report

BUTTENWIESER & WILEY PROPERTY CITY OF MERCER ISLAND

November 23, 2021
(Revised April 28, 2022)

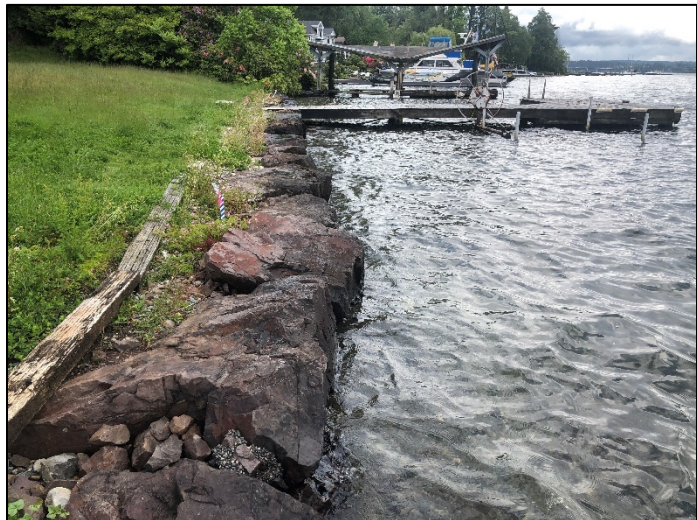
Title-page image: Waterfront of subject parcel (photo taken: 5/19/21)

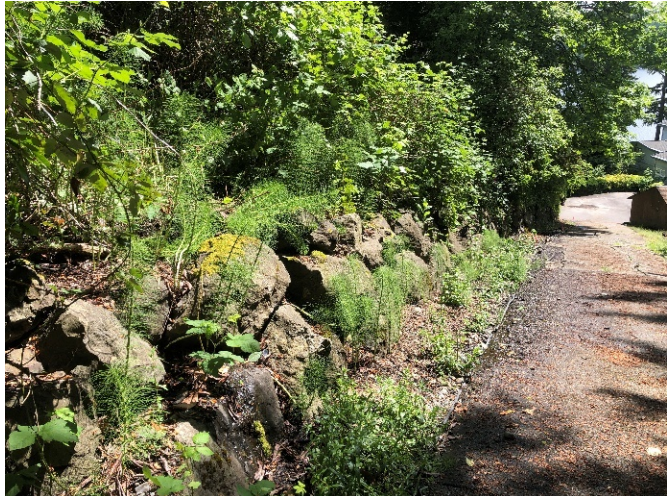
WETLAND A – Assessment Summary								
Location:	Northwestern corner of the subject parcel, along northern edge of driveway.									
WRIA / Sub-basin:	Cedar – Sammamish Watershed (WRIA 8) / Mercer Island Sub-basin

2014 Western WA Ecology Rating:	Category IV								
	Buffer Width and Buffer Setback:	40-foot buffer, 10-foot setback								
	Wetland Size:	Approx. 1,000 square feet								
	Cowardin Classification(s):	Palustrine emergent, palustrine scrub-shrub								
	HGM Classification(s):	Slope								
	Wetland Data Sheet(s):	DP-3								
	Upland Data Sheet (s):	DP-4								
	Flag Color:	Pink- and black-striped								
	Flag Numbers:	A-1 to A-9								
Vegetation	Tree stratum:	N/A								
	Shrub stratum:	Himalayan blackberry (<i>Rubus armeniacus</i>)								
	Herb stratum:	Fringed willow herb (<i>Epilobium ciliatum</i>), American speedwell (<i>Veronica americanus</i>), giant horsetail (<i>Equisetum telmateia</i>)

Soils	Soil survey:	Kitsap silt loam 8-30 percent slopes								
	Field data:	Loamy gleyed matrix (F2)								
Hydrology	Source:	Groundwater seeps, runoff								
	Field data:	High Water Table (A2), Saturation (A3)								
Wetland Functions										
	Improving Water Quality			Hydrologic			Habitat			
Site Potential	H	M	<u>L</u>	H	M	<u>L</u>	H	M	<u>L</u>	
Landscape Potential	H	<u>M</u>	L	H	<u>M</u>	L	H	<u>M</u>	L	
Value	H	<u>M</u>	L	H	M	<u>L</u>	H	<u>M</u>	L	TOTAL
Score Based on Ratings	5			4			5			14
Description and Comments										
Wetland A is a small slope wetland that originates in the northwestern corner of the subject property and runs along the driveway. A portion of the wetland was above the rockery retaining wall that runs along the driveway. This area is supported by a native high groundwater table and seep.

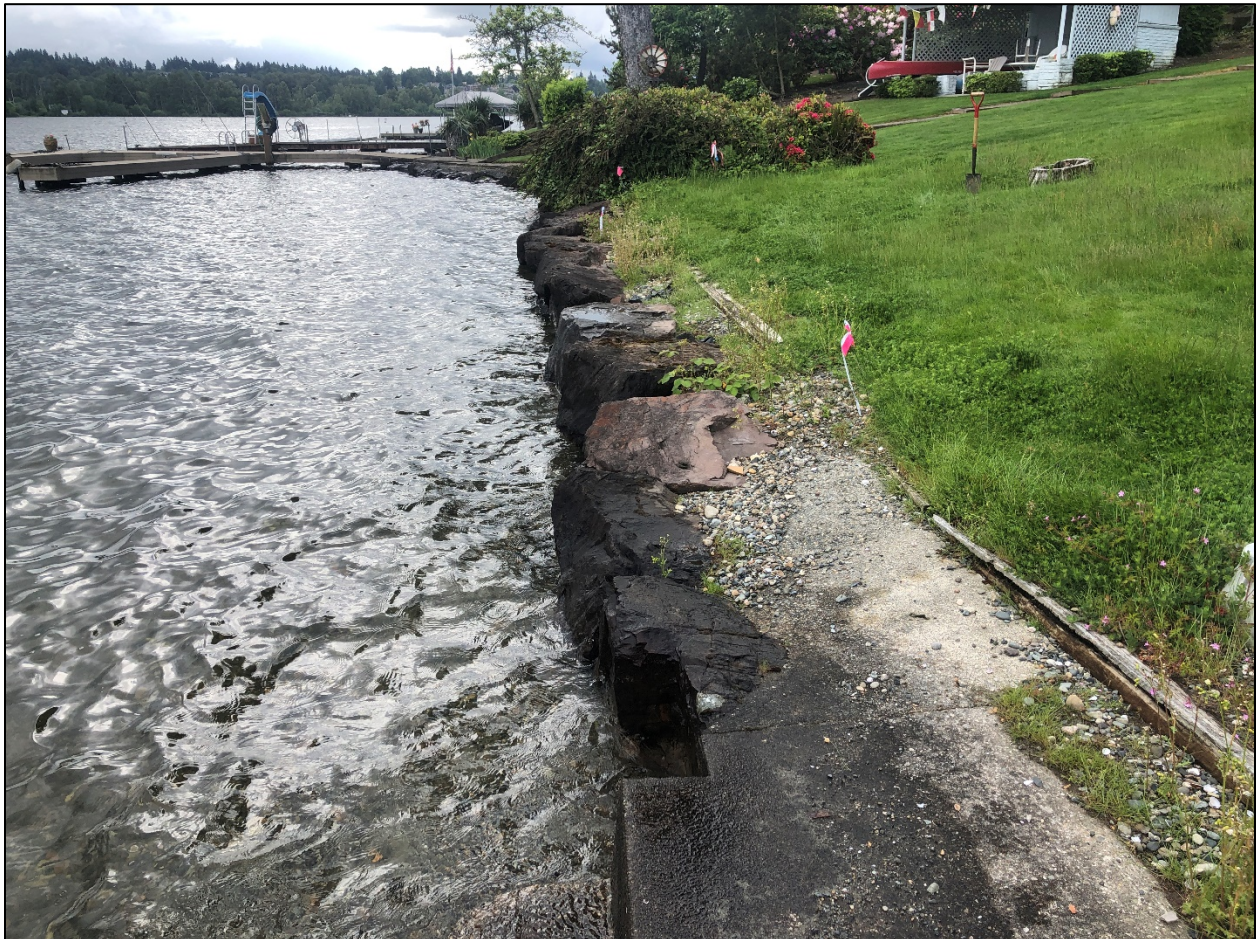
The subject property is located along the Lake Washington shoreline. The shoreline is a rock bulkhead with gravel both above and below the rockery, which is approximately three to four feet high on average. There is a small amount of riparian vegetation present on the north end of the subject parcel, which consists primarily of rhododendrons (*Rhododendron sp.*) and black locust (*Robinia pseudoacacia*).

Photo 1. Lake Washington Shoreline from subject parcel, looking south.

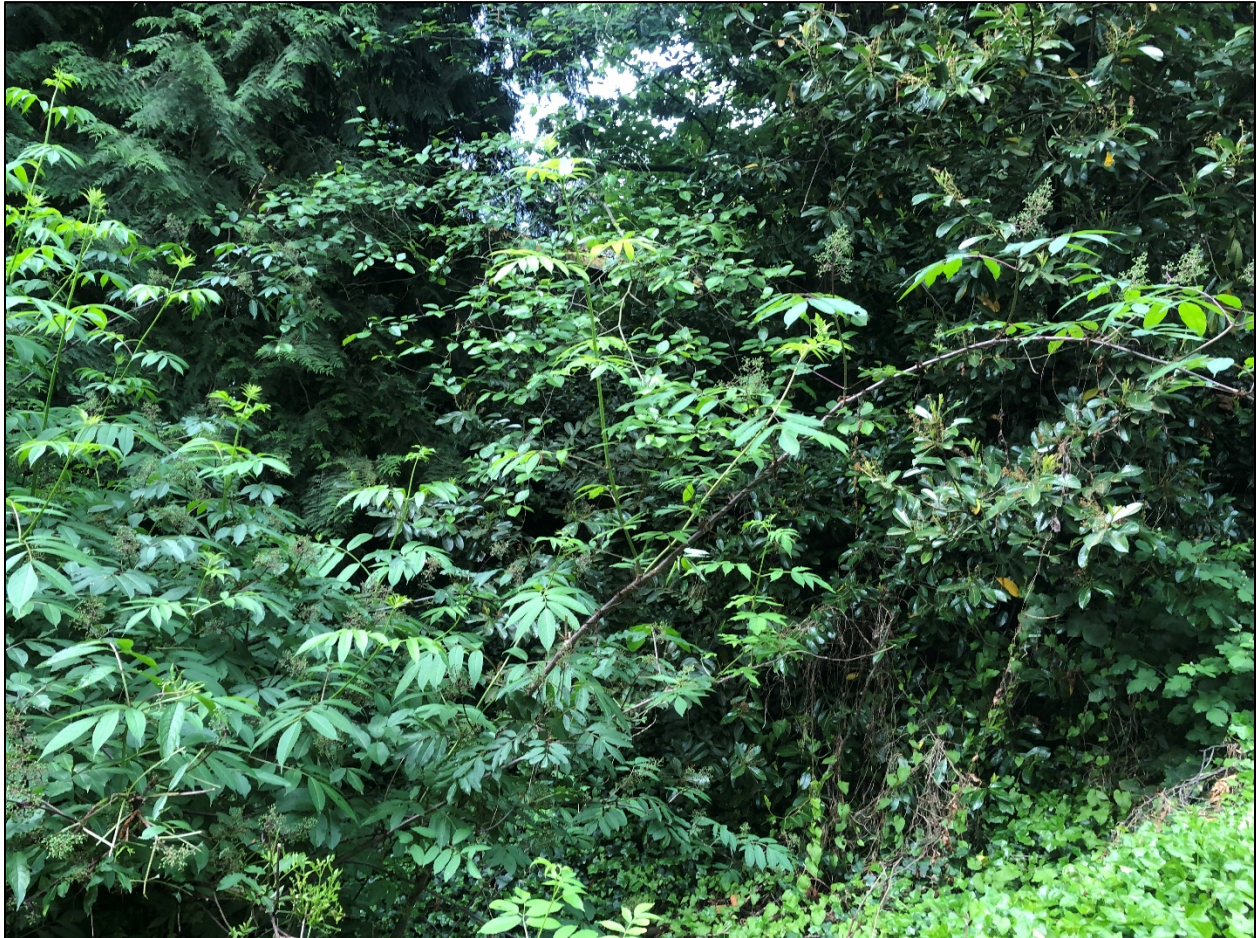
(*Hedera helix*). The southwest corner of the subject parcel is also vegetated by native vegetation, including western red cedar (*Thuja plicata*), red alder (*Alnus rubra*), Douglas-fir (*Pseudotsuga menziesii*), cherry laurel (*Prunus laurocerasus*), Oso berry (*Oemleria cerasiformis*), English ivy, and sword fern (*Polystichum munitum*). The southeastern portion of the subject parcel is occupied by the residence and its associated yard and lawn. This area is primarily dominated by lawn grasses and other ornamental plants.

Photo 2. Southwestern corner of subject parcel.

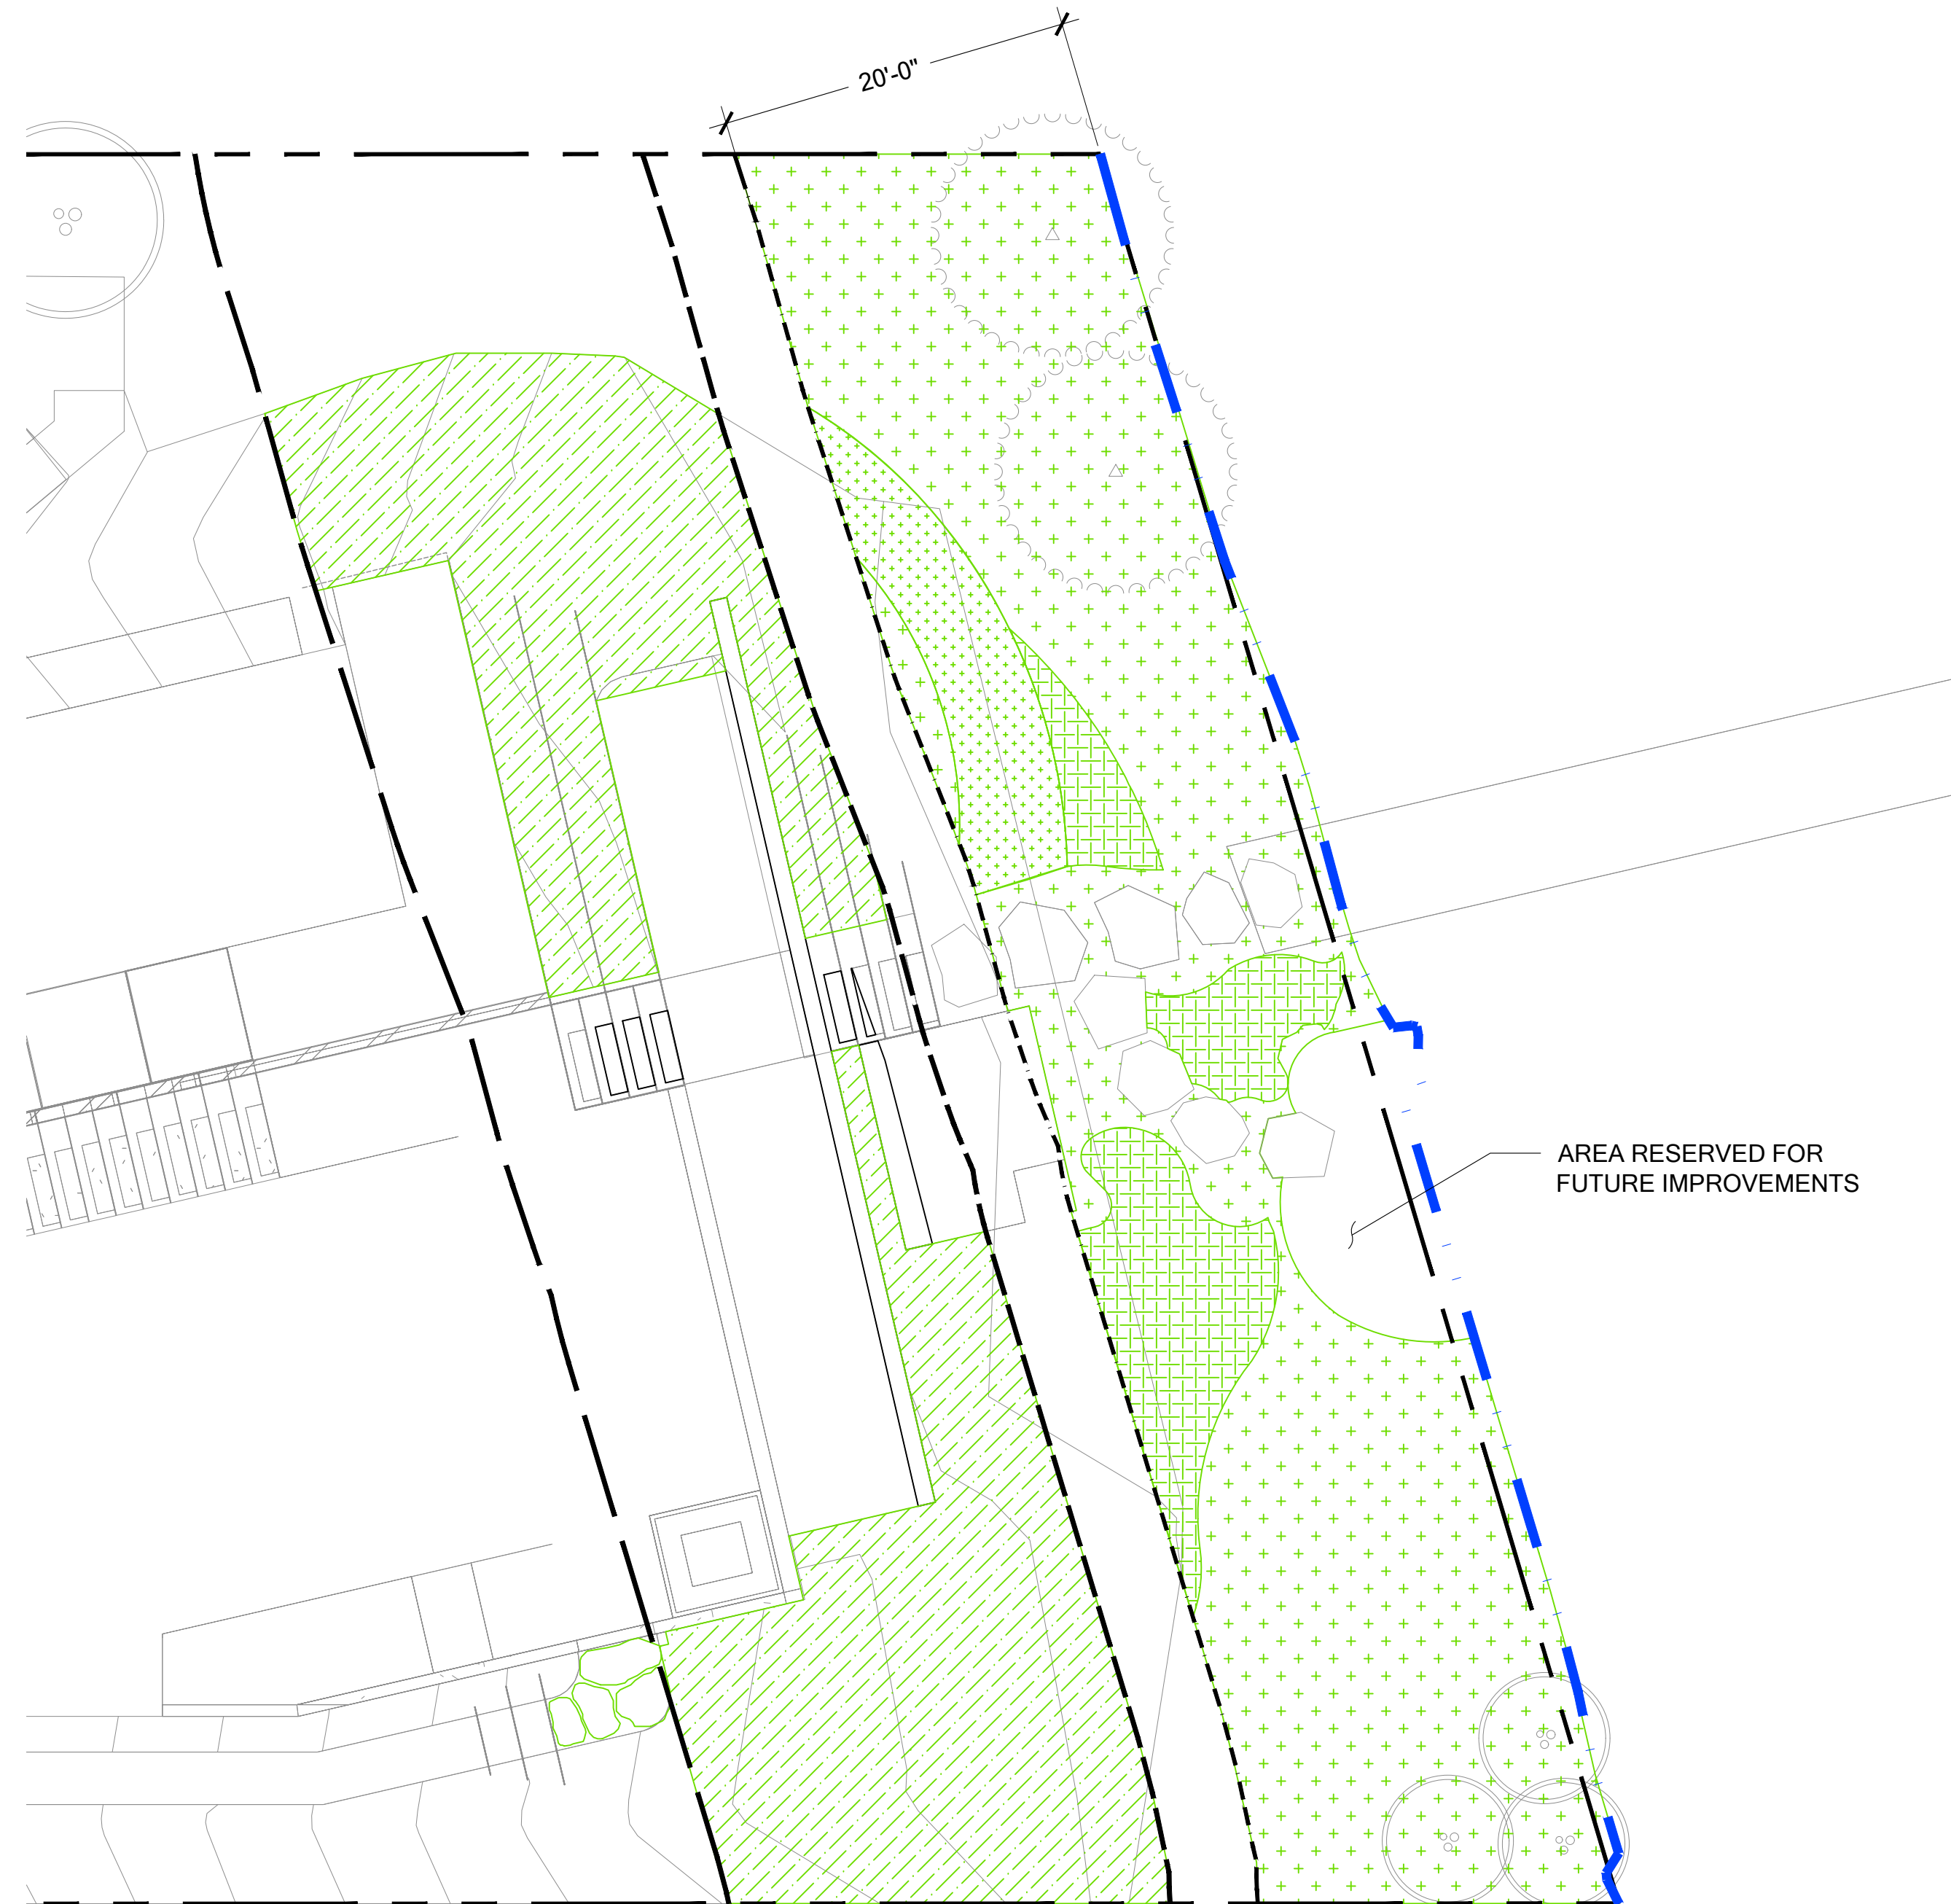
- 25-FT SHORELINE BUFFER
- 50-FT SHORELINE BUFFER
- 20-FT VEGETATION ZONE

MITIGATION FOR THE ADDITION OF IMPERVIOUS SURFACES WITHIN SHORELINE JURISDICTION WILL BE ACCOMPLISHED BY LIMITING IMPERVIOUS SURFACES IN THE 50-FOOT SHORELINE SETBACK TO THE ALLOW MAXIMUMS. SINCE THE TOTAL CHANGE IN LOT COVERAGE EXCEEDS 1,000 SQUARE FEET, THE APPLICANT IS REQUIRED TO PLANT NATIVE VEGETATION IN 75 PERCENT OF THE FIRST 20-FT OF SHORELINE SETBACK. EXISTING LAWN WILL BE REPLACED WITH A MIX OF NATIVE TREES, SHRUBS, AND GROUND COVER, EXCLUDING NONNATIVE GRASSES AND PLANTS ON THE CURRENT KING COUNTY NOxious WEED LIST, IN ACCORDANCE WITH THE MERCER ISLAND SHORELINE MASTER PROGRAM.

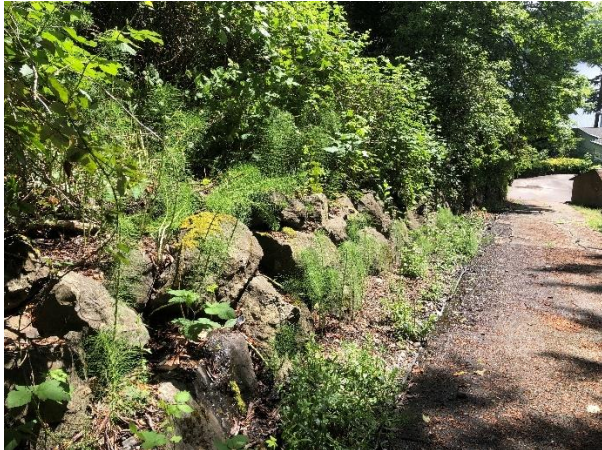
THE WATERSHED COMPANY		WETLAND A – Assessment Summary								
Location:	Northwestern corner of the subject parcel, along northern edge of driveway.									
WRIA / Sub-basin:	Cedar – Sammamish Watershed (WRIA 8) / Mercer Island Sub-basin

2014 Western WA Ecology Rating:		Category IV							
	Buffer Width and Buffer Setback:		40-foot buffer, 10-foot setback							
	Wetland Size:		Approx. 1,000 square feet							
	Cowardin Classification(s):		Palustrine emergent, palustrine scrub-shrub							
	HGM Classification(s):		Slope							
	Wetland Data Sheet(s):		DP-3							
	Upland Data Sheet (s):		DP-4							
	Flag Color:		Pink- and black-striped							
	Flag Numbers:		A-1 to A-9							
Vegetation	Tree stratum:	N/A								
	Shrub stratum:	Himalayan blackberry (<i>Rubus armeniacus</i>)								
	Herb stratum:	Fringed willow herb (<i>Epilobium ciliatum</i>), American speedwell (<i>Veronica americanus</i>), giant horsetail (<i>Equisetum telmateia</i>)

Soils	Soil survey:	Kitsap silt loam 8-30 percent slopes								
	Field data:	Loamy gleyed matrix (F2)								
Hydrology	Source:	Groundwater seeps, runoff								
	Field data:	Saturation (A3)								
Wetland Functions										
	Improving Water Quality			Hydrologic			Habitat			
Site Potential	H	M	<u>L</u>	H	M	<u>L</u>	H	M	<u>L</u>	
Landscape Potential	H	<u>M</u>	L	H	<u>M</u>	L	H	<u>M</u>	L	
Value	H	<u>M</u>	L	H	M	<u>L</u>	H	<u>M</u>	L	TOTAL
Score Based on Ratings	5			4			5			14
Description and Comments										
<p>Wetland A is a small slope wetland that originates in the northwestern corner of the subject property and runs along the driveway. A portion of the wetland was above the rockery retaining wall that runs along the driveway. This area is supported by a native high groundwater table and seep.</p>

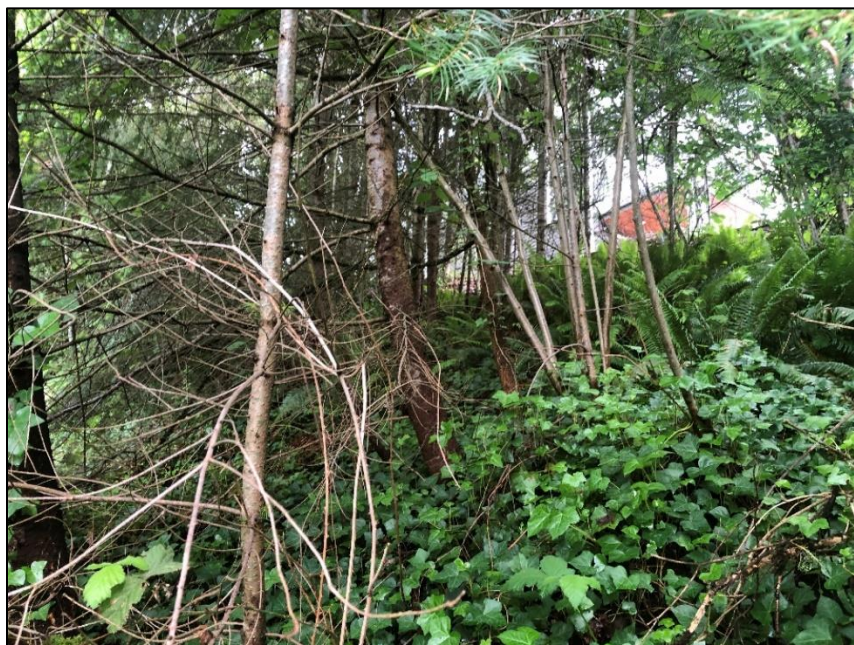
Photo 1. Non-wetland area north of driveway (photo taken 5/19/21).

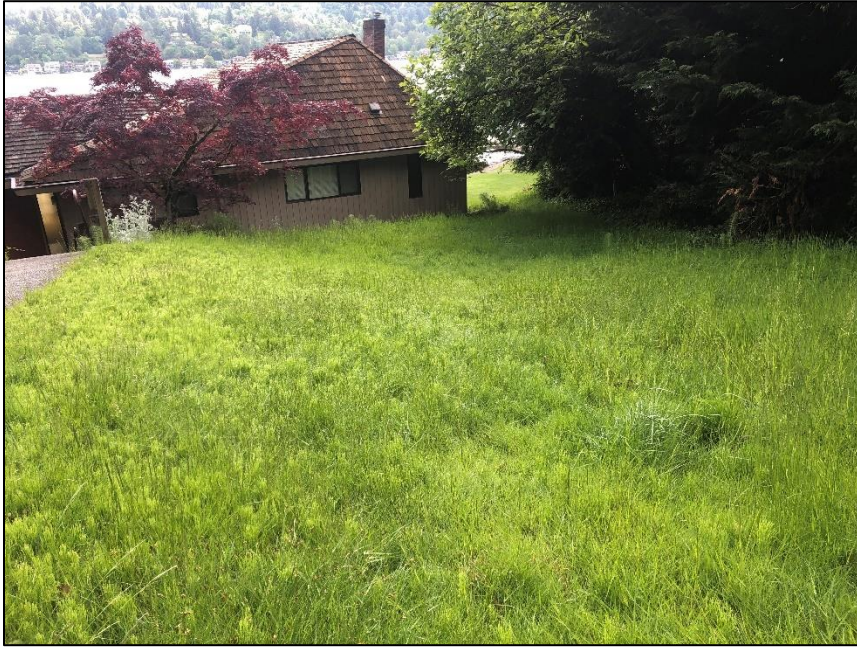
Photo 3. Developed residence and maintained lawn area upslope of the Lake (photo taken 5/19/21).

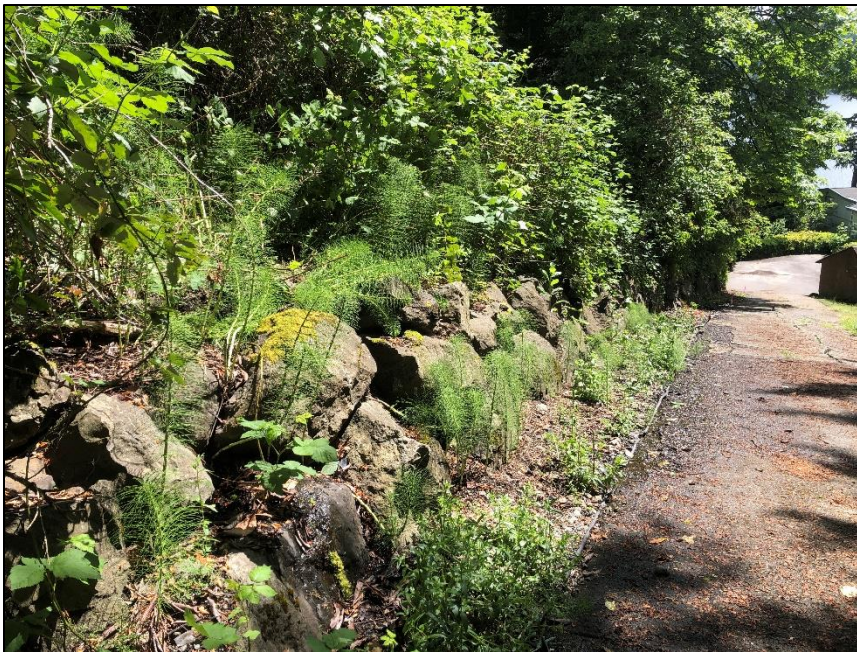
Photo 4. Wetland A looking downslope (photo taken 5/19/21).

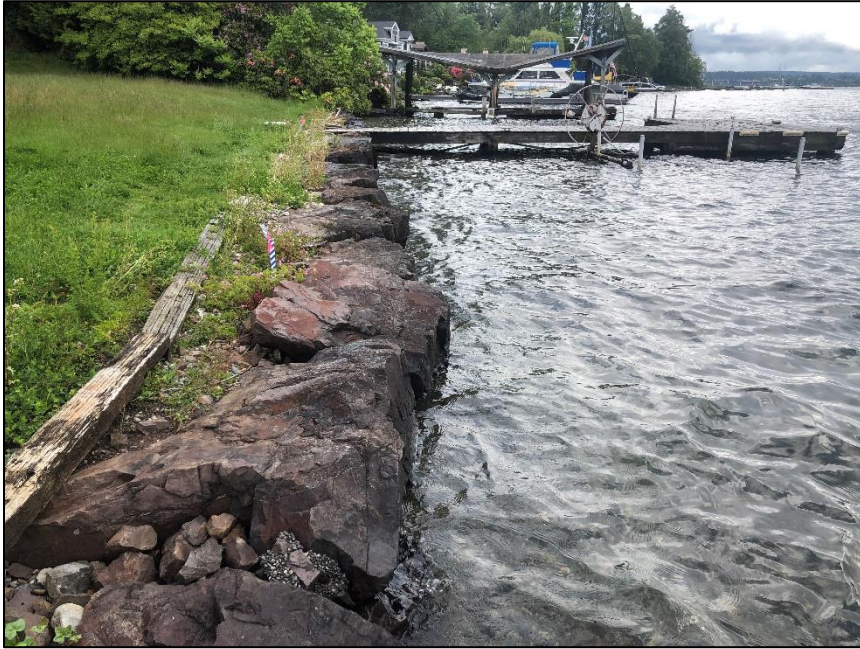
Photo 5. Lake Washington shoreline (photo taken 5/19/21).

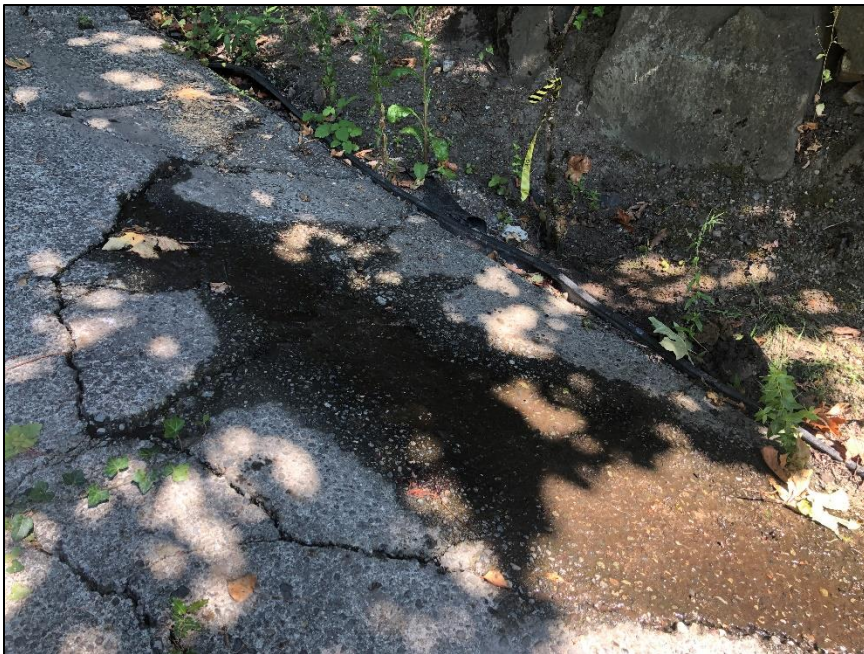
Photo 6. Surface seeps coming out of driveway adjacent to Wetland A (photo taken 7/23/21).

Assessor's page, the site was developed in 1939. The driveway steeply slopes down to the residence, where it widens out into a car pad and detached garage. A retaining wall runs along the northern edge of the driveway. The construction of the retaining wall and driveway are also accompanied by below ground utilities. Multiple drainage pipes that appear to have been installed in an effort to direct drainage along and under the driveway. Many of these pipes are now broken and do not convey water effectively. At the time of our July site visit, active seeps were observed draining onto the driveway surface and parallel to the north edge of the existing driveway. The driveway is cracked in several locations.

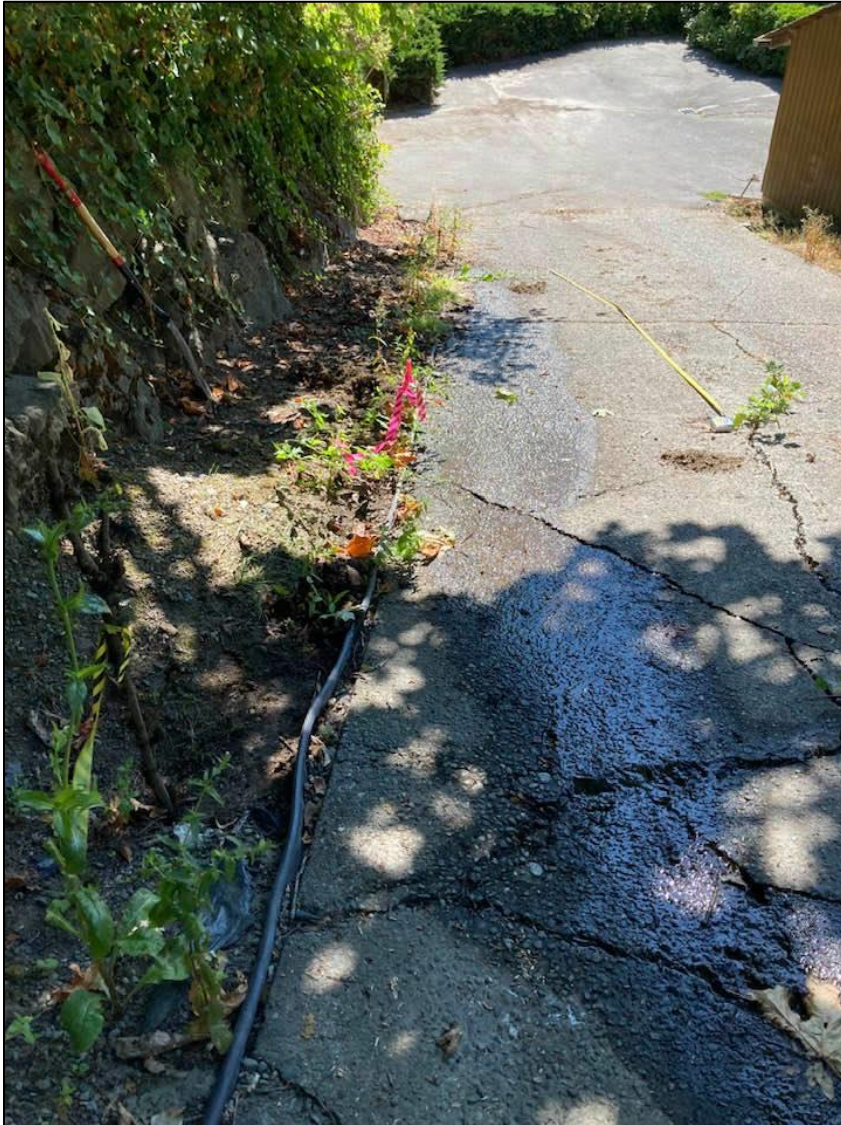
Photo 7. Seeps draining out of lower driveway adjacent to Wetland A (photo taken 7/23/21).

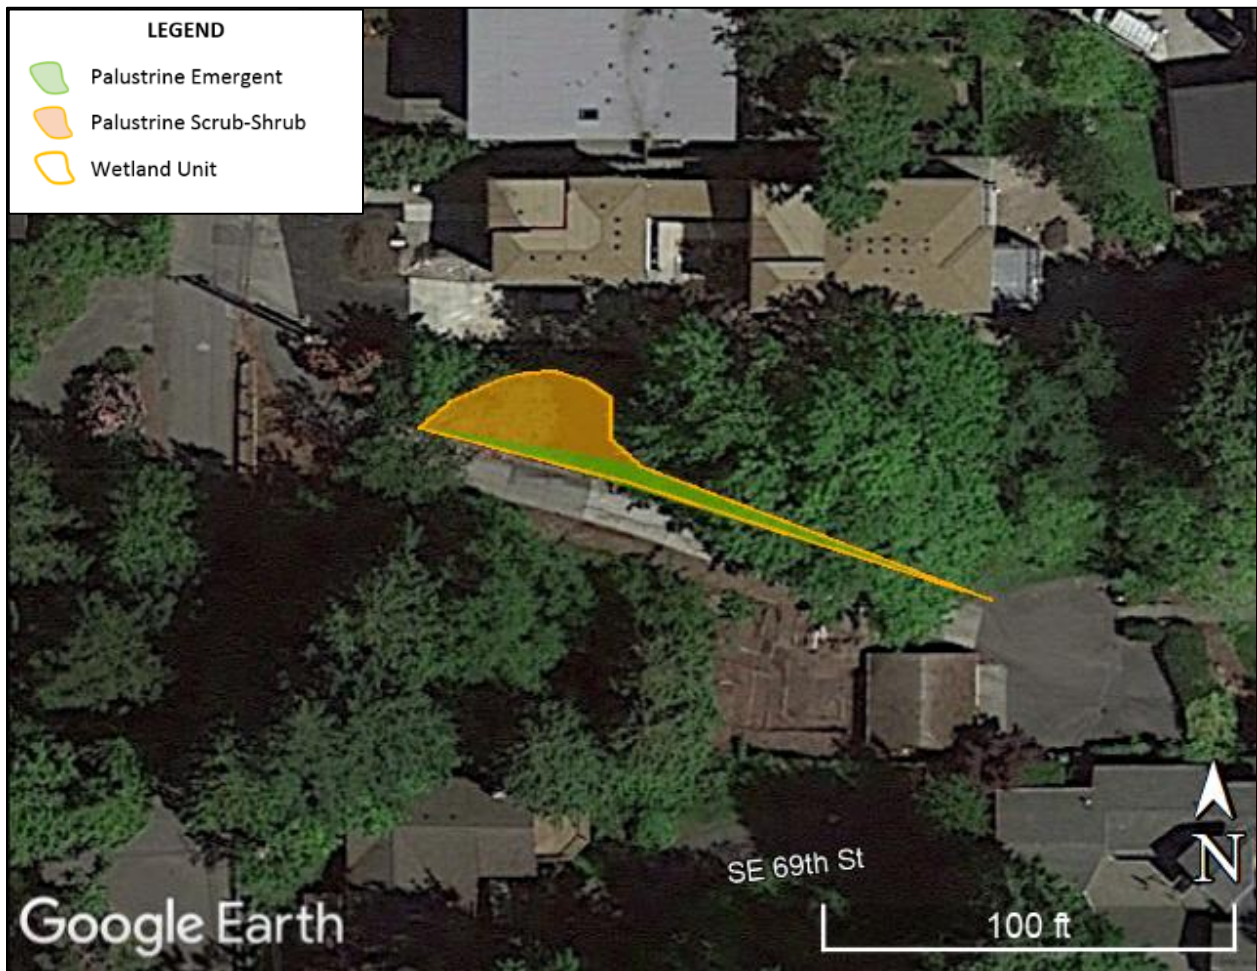
Figure 1. Cowardin plant classes – H1.1, H1.4

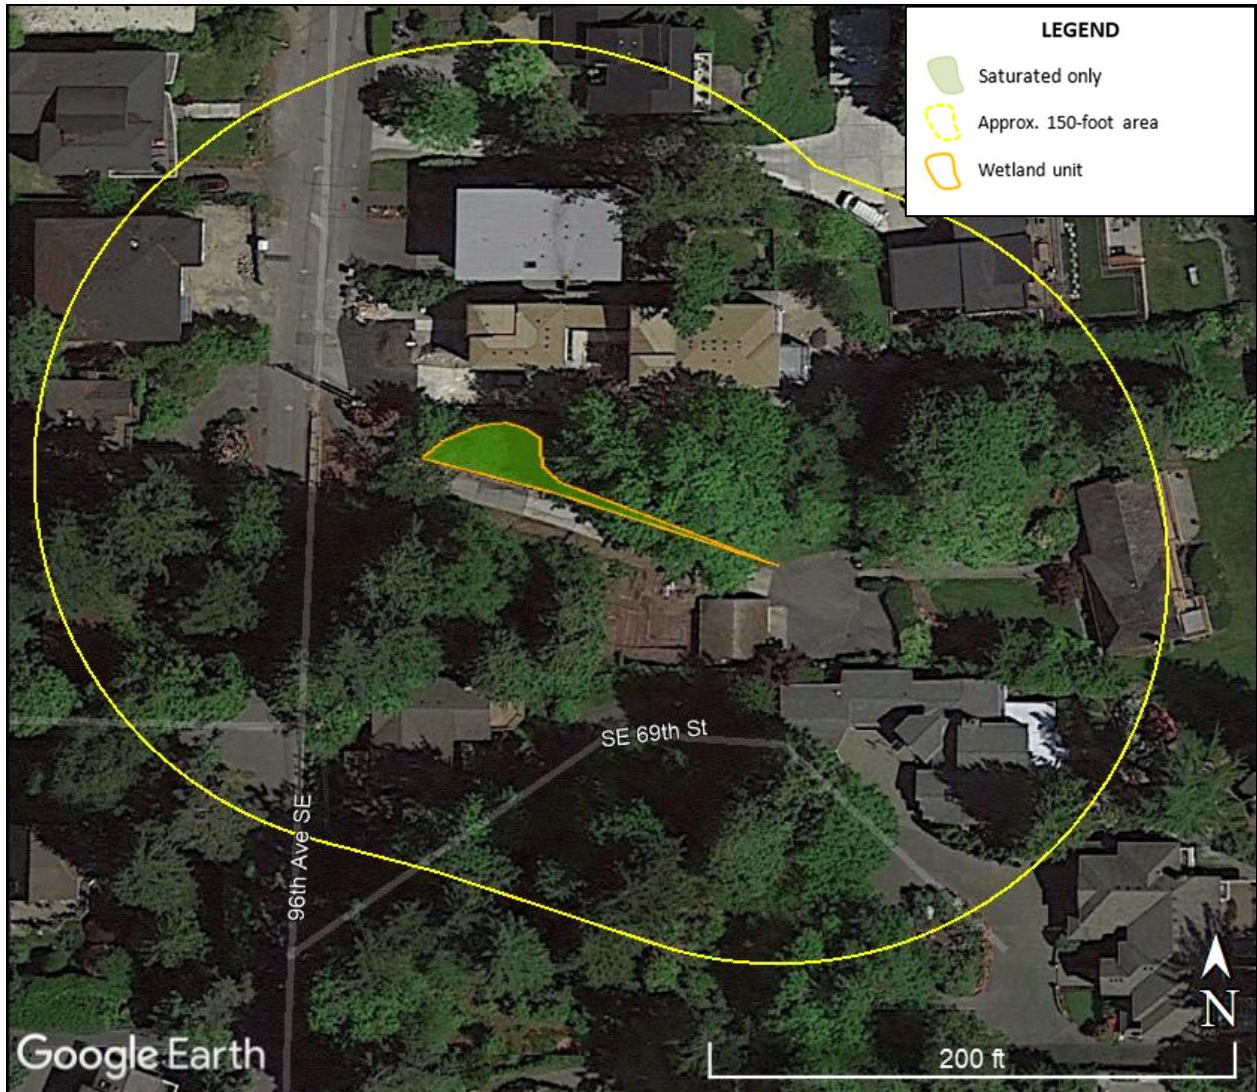
Figure 2. Hydroperiods and 150-foot area – H1.2, S2.1, S5.1

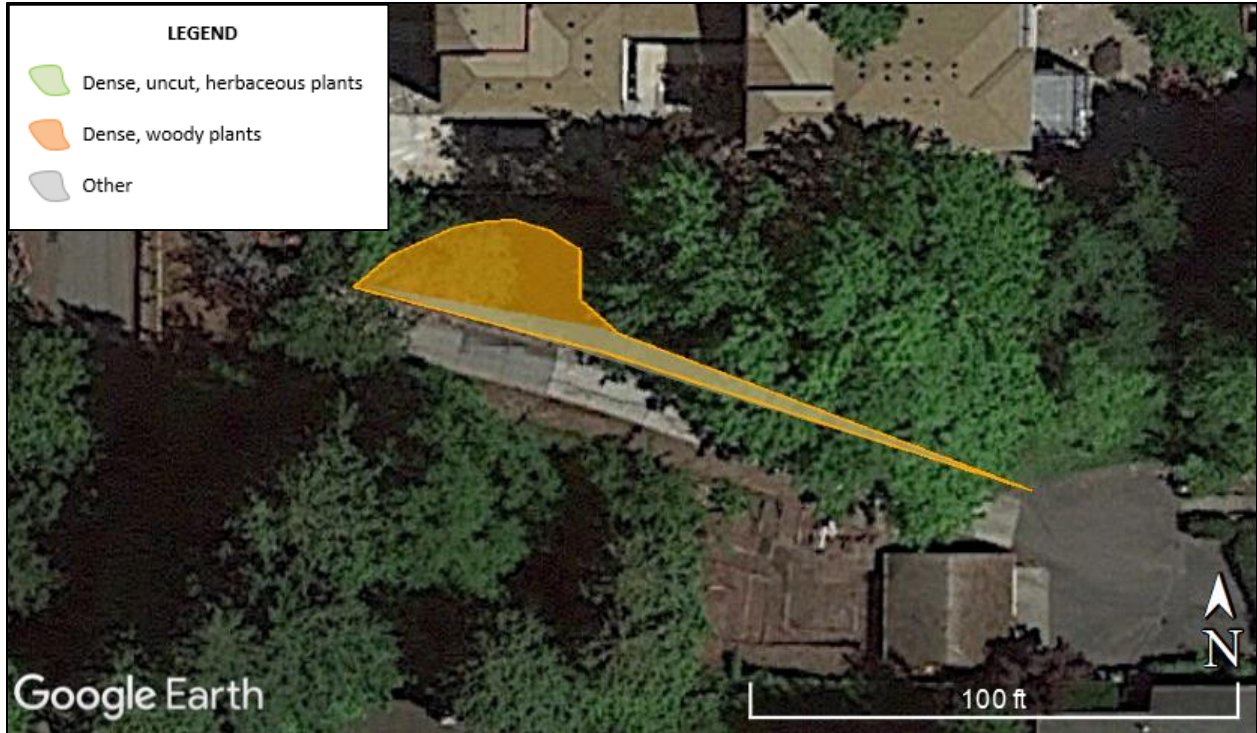
Figure 3. Plant cover of dense and rigid trees, shrubs, and herbaceous plants – S1.3, S4.1
