Ecological No Net Loss Assessment Report

Mike Rosato 5652 E Mercer Way Mercer Island, WA 98040

Permits are being applied for a dock maintenance and moorage improvements.

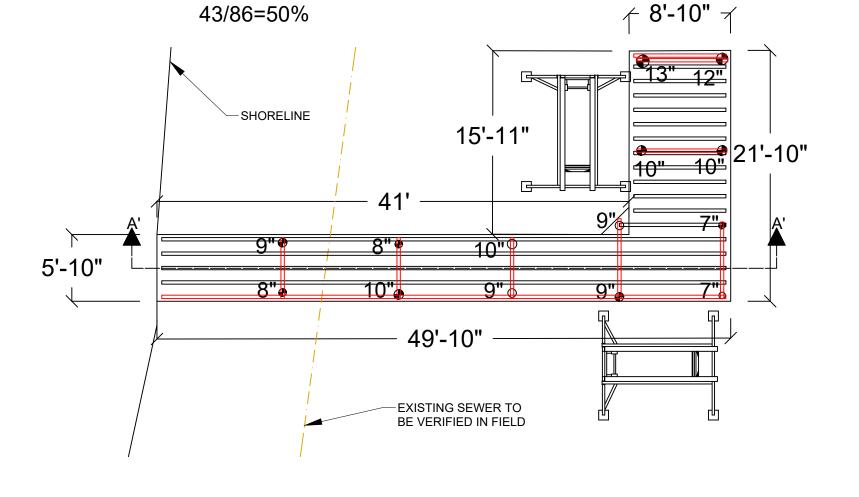
SHEET A6.0

PIER DETAILS - EXISTING/PROPOSED

Area: 432 sqft (new grated decking)

**Grated decking material is 43% light permeable

PLAN VIEW

The proposed work on the dock includes removal of 432 square feet of wood decking surface and repairing 8 existing 7 to 13-inch pilings by the sleeve and splice method. The existing boat lifts will remain, however one previously moved boat lift is being permitted as part of this project. The existing deck will be replaced with ThruFlow grated decking. Project drawings are included in Attachment A, sheets A2.0 to A7.0 with details in sheets A11.0 to A 14.0.

ThruFlow grated decking has a measured performance at 43 percent light penetration (ThruFlow, 2020). Thus, effective cover of the area is 57% of the area of a solid decked structure. Table 1 provides a summary of effective coverage:

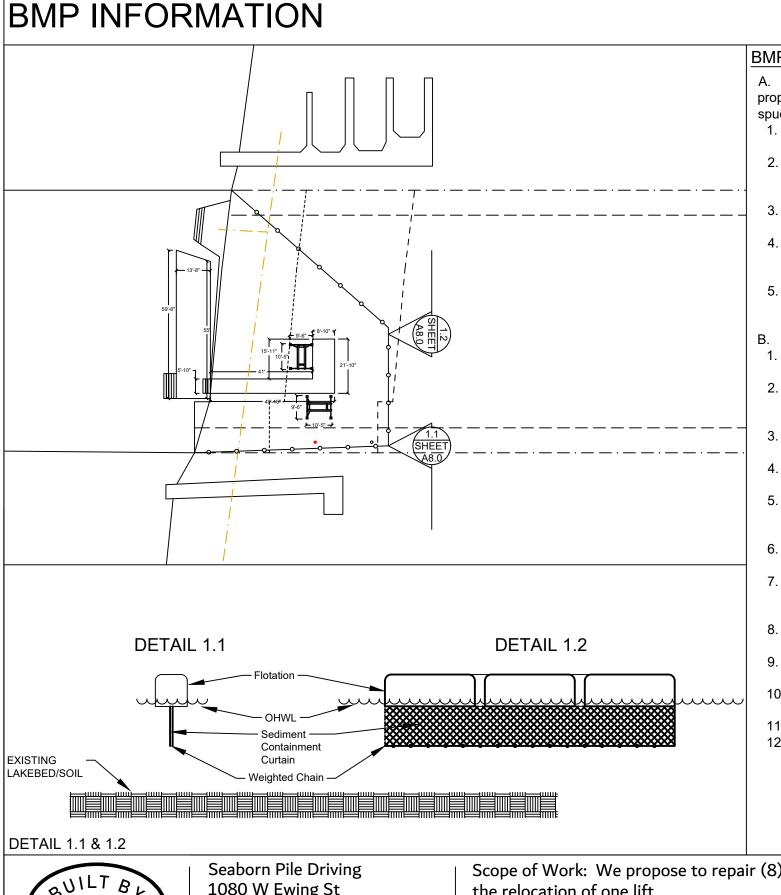
SHEET A8.0

During construction, a floating boom will surround the work barge and dock. (See Appendix A – Sheets A8.0)

Best Management Practices: Applicable BMPs will be used, such as a floating boom around the in-water work area, to contain any floating debris that may escape during construction. The barge will have a perimeter containment sock to absorb oil and grease that might inadvertently wash from the barge during construction.

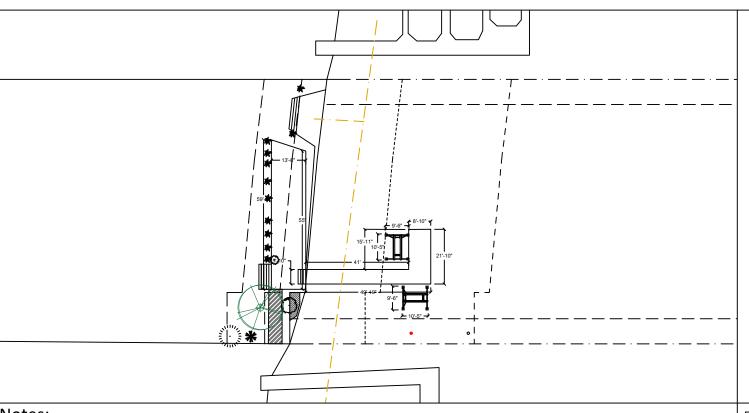
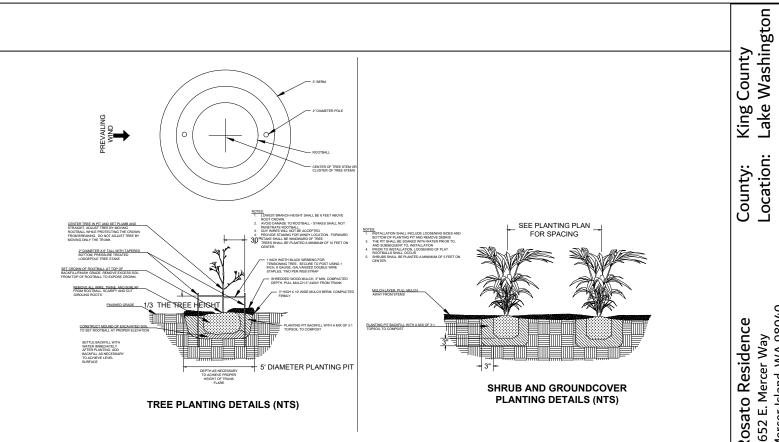
SHEET A9.0

MITIGATION PLAN

A shoreline vegetation plan is proposed, that will add 1 native western red cedar tree. The tree will provide shade and allow allochthonous material to enter the lake along the shoreline and improve shoreline conditions. Existing vegetation will be retained. See Appendix A – Sheet A9.0 to A10.0.

Shoreline: Planting additional native vegetation will increase the habitat functions of the shoreline by creating shade along the shoreline that will be an enhancement of the existing preserved vegetation at the site. The proposed Western Red Cedar will provide overhanging cover for fish, structural diversity for birds and wildlife, detritus for aquatic invertebrates and long-term recruitment of woody material and other allochthonous food sources. The proposed planting plan is included and includes retaining existing vegetation (see Appendix A - Sheet A9.0 and A10.0).

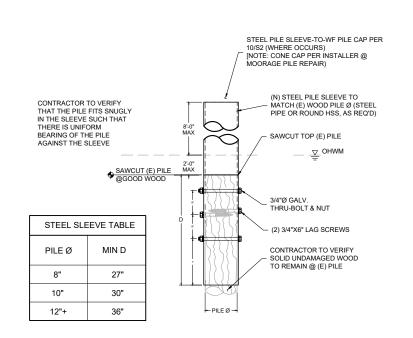
SLEEVE PILE REPAIR - TYP

STEEL SLEEVE TABLE							
PILE Ø	MAX SPLICE HEIGHT	S1	S2	S3			
9"	15"	6"	12"	3"			
12"+	28"	6"	12"	3"

- MAX PILE LOAD = 1,200 # / PILE (BOAT LOAD PARALLEL TO DOCK).
- CONTACT ENGINEERING IF BOAT SIZE EXCEEDS GENERAL NOTES MAXIMUM ALLOWABLE
- MINIMUM BOLT SPACING = 3"
- STRAP AXIS SHALL BE ORIENTED PERPENDICULAR TO LONGITUDINAL AXIS OF DOCK.

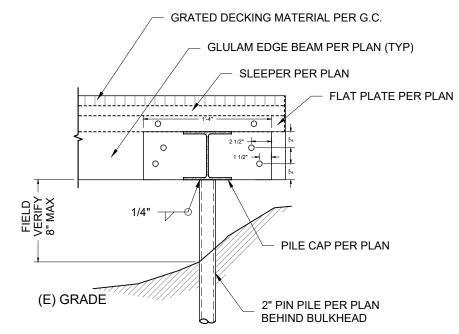
PIN PILE @SHORE MOUNT - TYP

SLEEPER PER PLAN (TYP) 1/4"Ø CARRIAGE BOLT SLEEPER TO EA ANGLE DECKING TOP OF DECKING 5/8"Ø THRU-BÖLT 2' O.C. @ PLATE **EPOXY COATED ANGLE** (2) 5/8"Ø THRU-BOLT EPOXY COATED, WF PER PLAN FLUSH WITH BEAM REF S3/SHEET12.0 3/16 V (TYP) (S5) EDGE SECTION (STEEL TRACK) - TYP

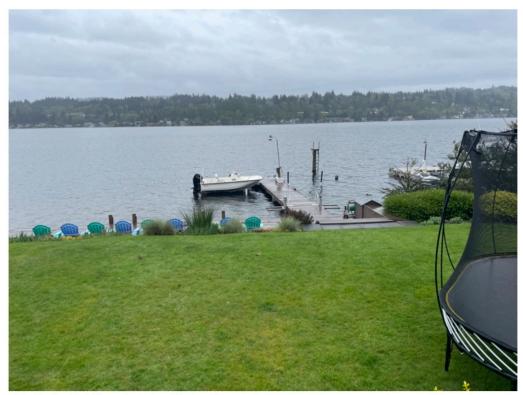
Photo 1 - Existing dock looking waterward.

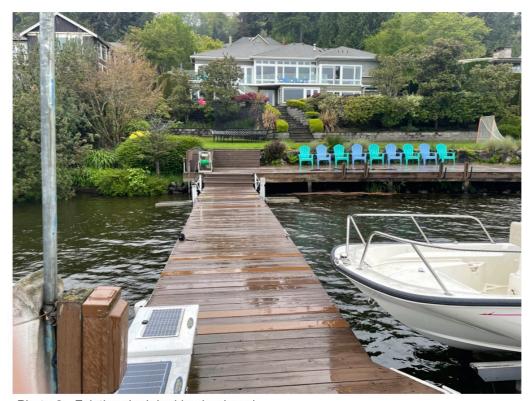
Photo 2 - Existing dock looking landward.

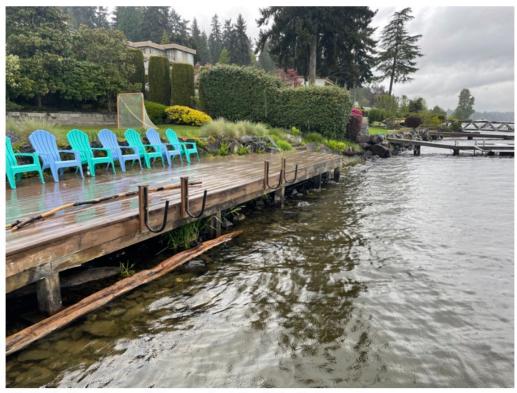
Photo 3 - Shoreline conditions north of the dock.

The shoreline is bulkhead with a rock and concrete piece bulkhead. The deck overhangs the bulkhead and covers most of the bulkhead. A small cove is present adjacent to the north side of the deck. The substrates are gravel and cobble with mixed material from the bulkhead. No submerged aquatic vegetation was observed at the time of the site visit.

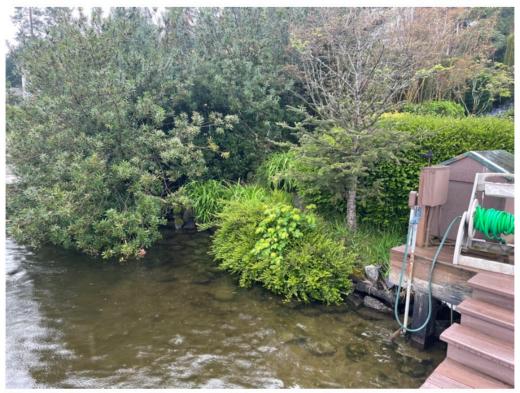
Photo 4 - Shoreline conditions south of the dock.

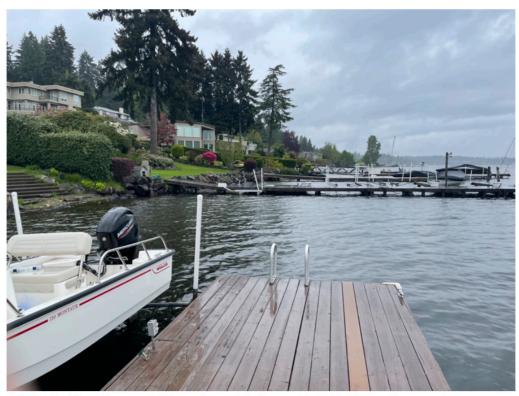
Photo 5 - Shoreline conditions adjacent to the property to the north.

The neighboring properties include armored shoreline, similar vegetation and residential docks. See attached photos in Appendix B.

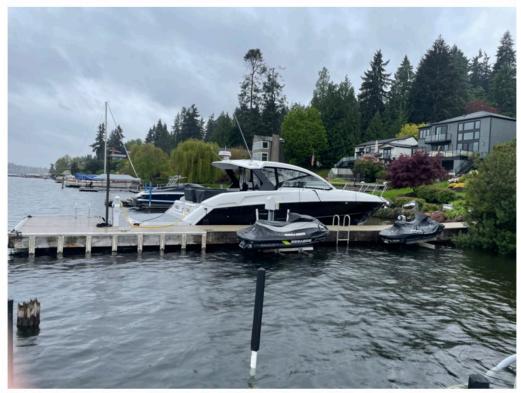
Photo 6 - Shoreline conditions adjacent to he property to the south.
