Ecological No Net Loss Assessment Report

Suzanne Skinner 7601 W. Mercer Way Mercer Island, WA 98040

Worthwest Environmental Consulting, LLC

August 2022

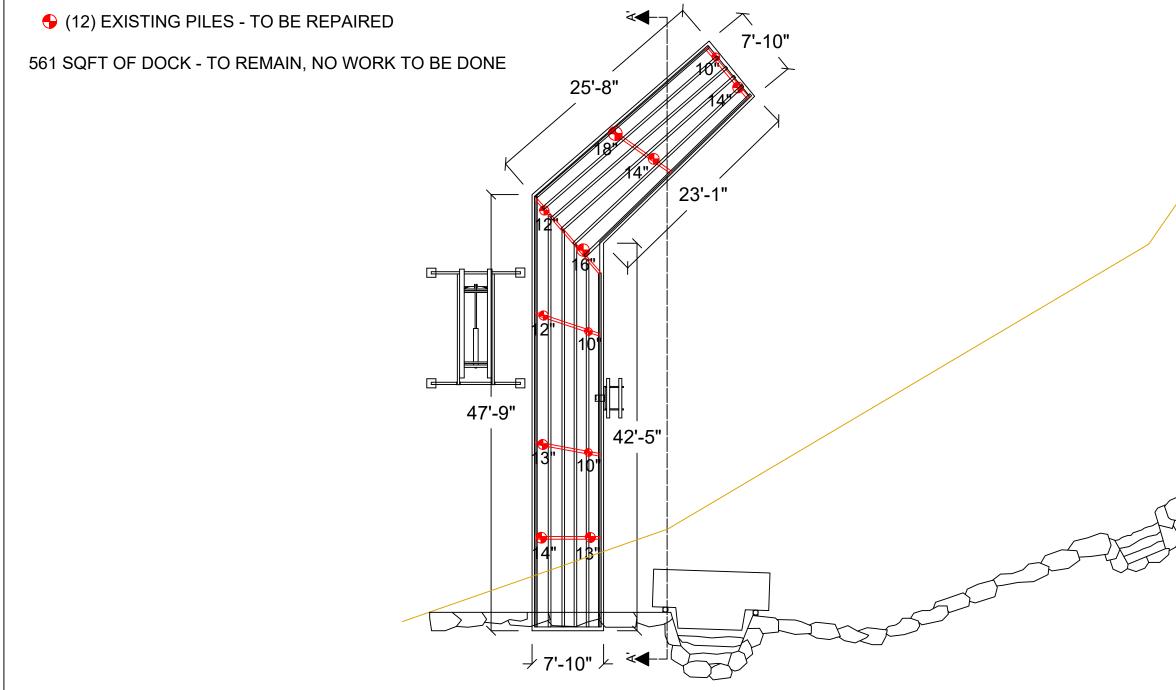
PIER DETAILS - EXISTING/PROPOSED

EXISTING DOCK TO REMAIN

PLAN VIEW

The proposed work includes repairing the existing dock by repairing 12 existing wood pilings (3, 10-inch, 2 12-inch, 2 13-inch, 3 14-inch, 1 16-inch and 1 18-inch) by pile splicing. The existing failing wood bulkhead and stairs will be removed and a new granite rock bulkhead and stairs will be constructed replacing approximately 116 linear feet of bulkhead. See sheets A2.0 to A5.0.

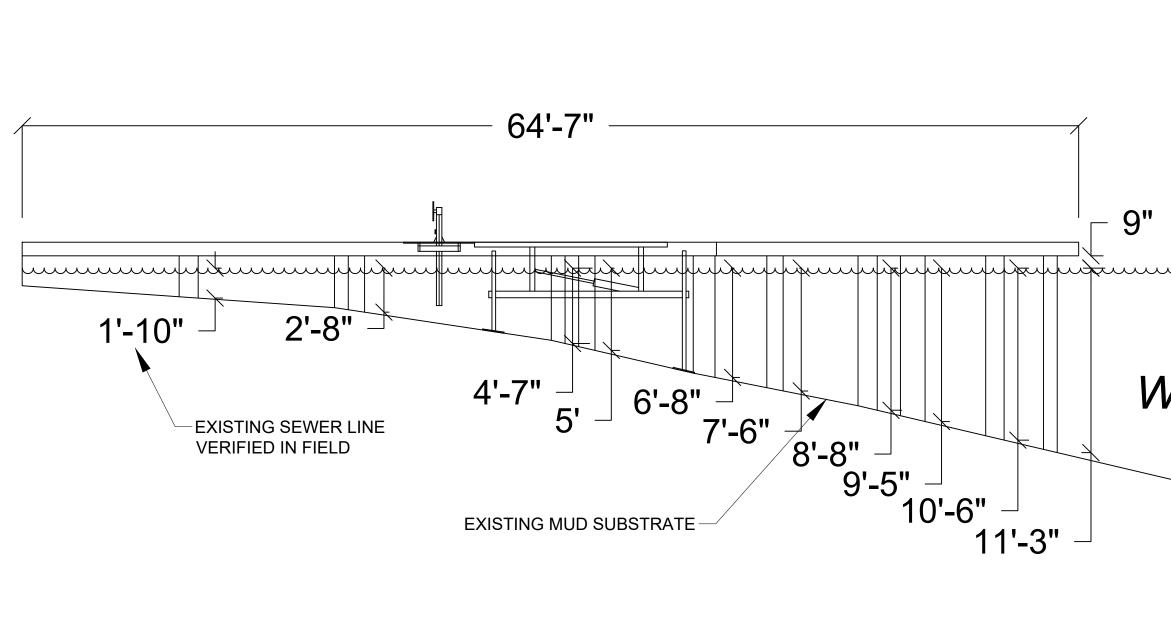
PIER DETAILS EXISTING/PROPOSED

SECTION VIEW: A'-A'

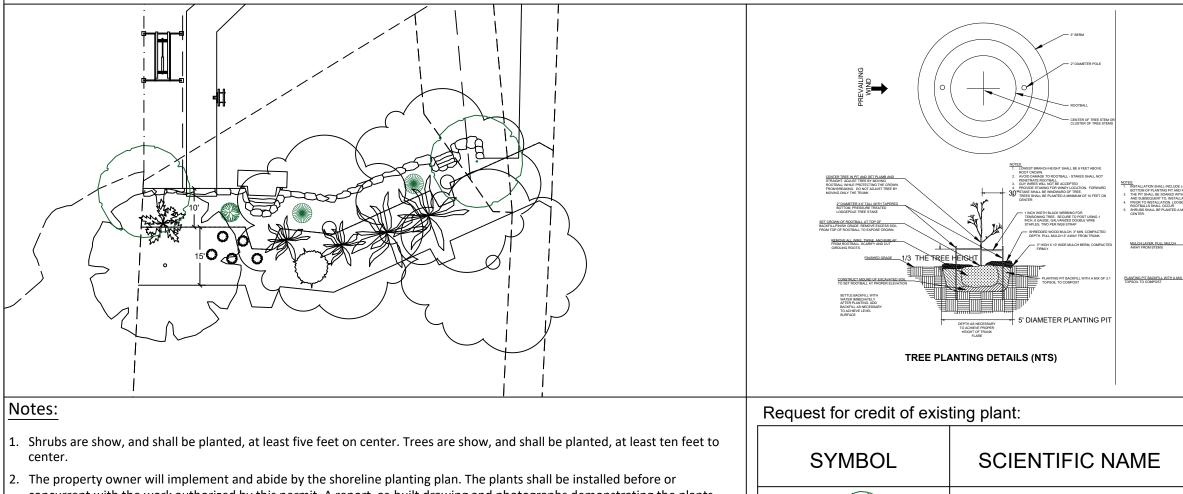
MITIGATION PLAN

- 2. The property owner will implement and ablde by the shoreline planting plan. The plants shall be installed before or concurrent with the work authorized by this permit. A report, as-built drawing and photographs demonstrating the plants have been installed or a report on the status of project construction will be submitted to the U.S. Army Corps of Engineers, Seattle District, Regulatory Branch, within 12 months from the date of permit issuance. This reporting requirement may be met by completing and submitting a U.S. Army Corps of Engineers approved Report for Mitigation Work Completion form.

- 3. The property owner will maintain and monitor the survival of installed shoreline plantings for five years after the U.S. Army Corps of Engineers accepts the as-built report. Installed plants shall achieve 100% survival during monitoring Years 1 and 2. Installed plants shall achieve at least 80% survival during monitoring Years 3, 4 and 5. Percent survival is based on the total number of plants installed in accordance with the approved riparian planting plan. Individual plants that die will be replaced with native riparian species in order to meet the survival performance standards.

·	Salix sitch	Salix sitchensis				
PROPOSE	ED PLANTING S	SPECIES				
SYMBOL	LATIN NAME	соммо				
	Rosa Nutkana	Nootk				
	Philadelphus lewisii	Mock (
$\left(\cdot \right)$	Salix Sitchensis	Sitka \

Native trees including a Pacific willow will be planted along the shoreline and the existing vegetation will be preserved. See sheets A7.0 and A8.0.

A shoreline planting plan will be implemented, mature lodgepole pines and big leaf maple are already present and functioning to improve the shoreline conditions. The owner will also add one pacific willow to the shoreline. The owner has also opted to pay into the In Lieu Fee program that will be used for conservation projects that benefit salmon in King County.

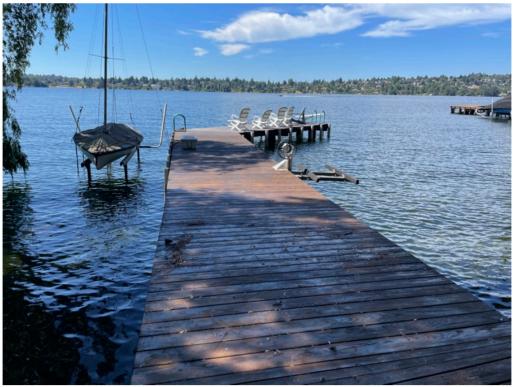
Photo 1 - Existing dock looking waterward.

The only existing structures on the property are the house and dock (Photos 1 through 6). The subject property yard is extensively vegetated with maintained with lawn, landscaped beds, trees and footpaths. Three mature big leaf maples and 2 lodgepole pines are planted overhanging the shoreline. The other vegetation includes a laurel hedge, English ivy and other ornamental vegetation.

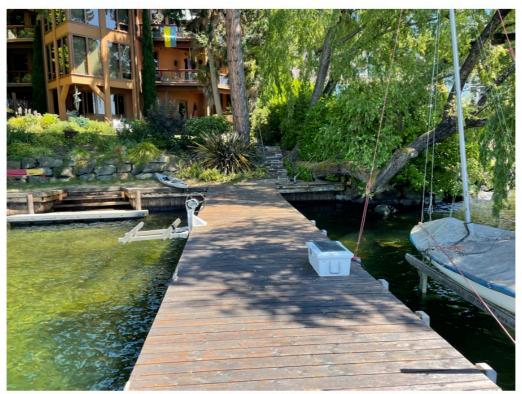
Photo 2 - Existing dock looking landward.

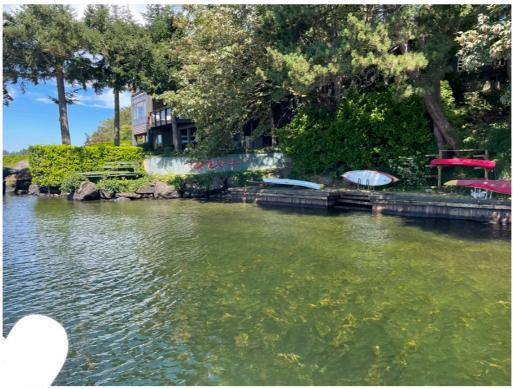
Photo 3 - Shoreline conditions looking north of the dock. Bulkhead to be replaced.

The shoreline includes a wood bulkhead along the length of the shoreline. The substrate of the lake is gravel and cobble. Eurasian milfoil has colonized the shoreline starting about 30 feet from the shore.

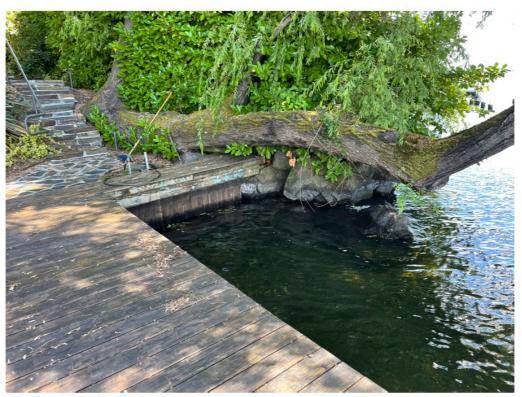
Photo 4 - Shoreline conditions looking south of the dock. Bulkhead to be replaced.
