April 2024
Luther Burbank Park Waterfront Improvements

Critical Areas Study

Prepared for City of Mercer Island

Prepared by
Anchor QEA
1201 3rd Avenue, Suite 2600
Seattle, Washington 98101

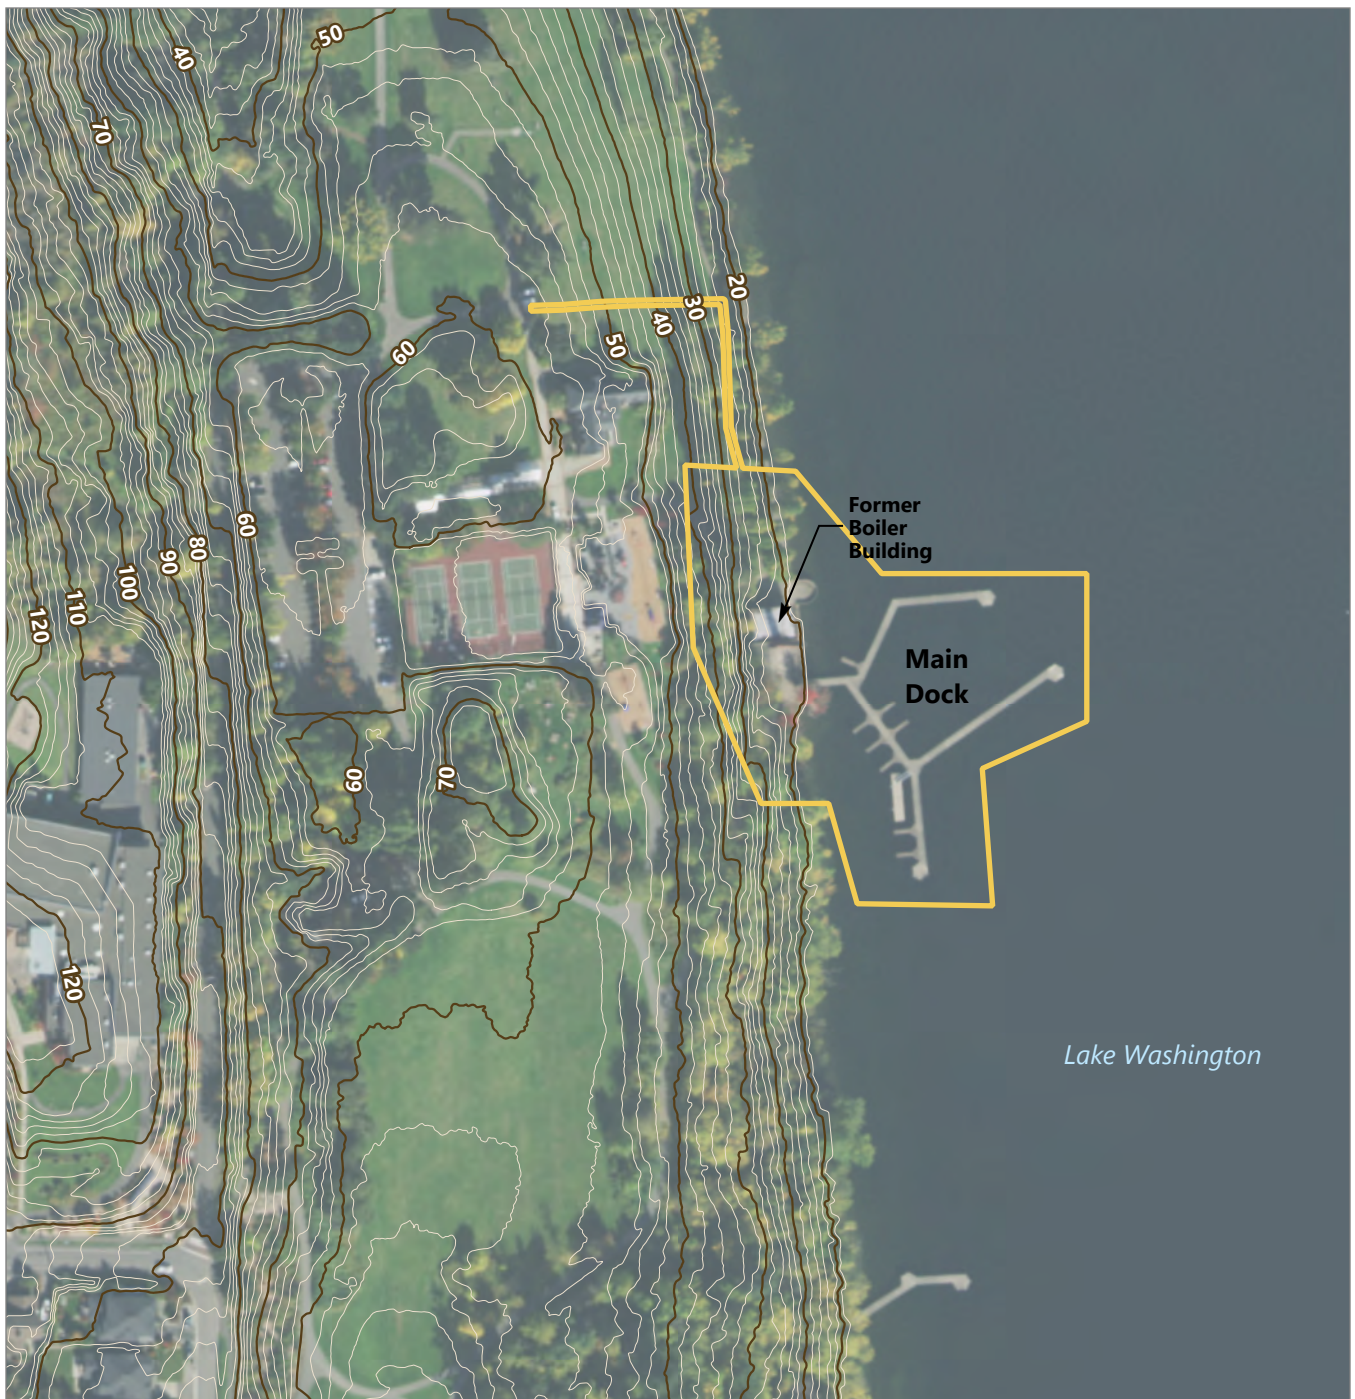
Figure 7
Project Area Boundary and Topography
 Critical Areas Study
 Luther Burbank Park Waterfront Improvements

The topography of the Park and Project area slopes down from the inland side of the Park to the Lake Washington shoreline. Topographic maps identify the highest elevation in the Project area as approximately 44 feet North American Datum of 1988 (NAVD88), sloping down toward the shoreline (Figure 7).

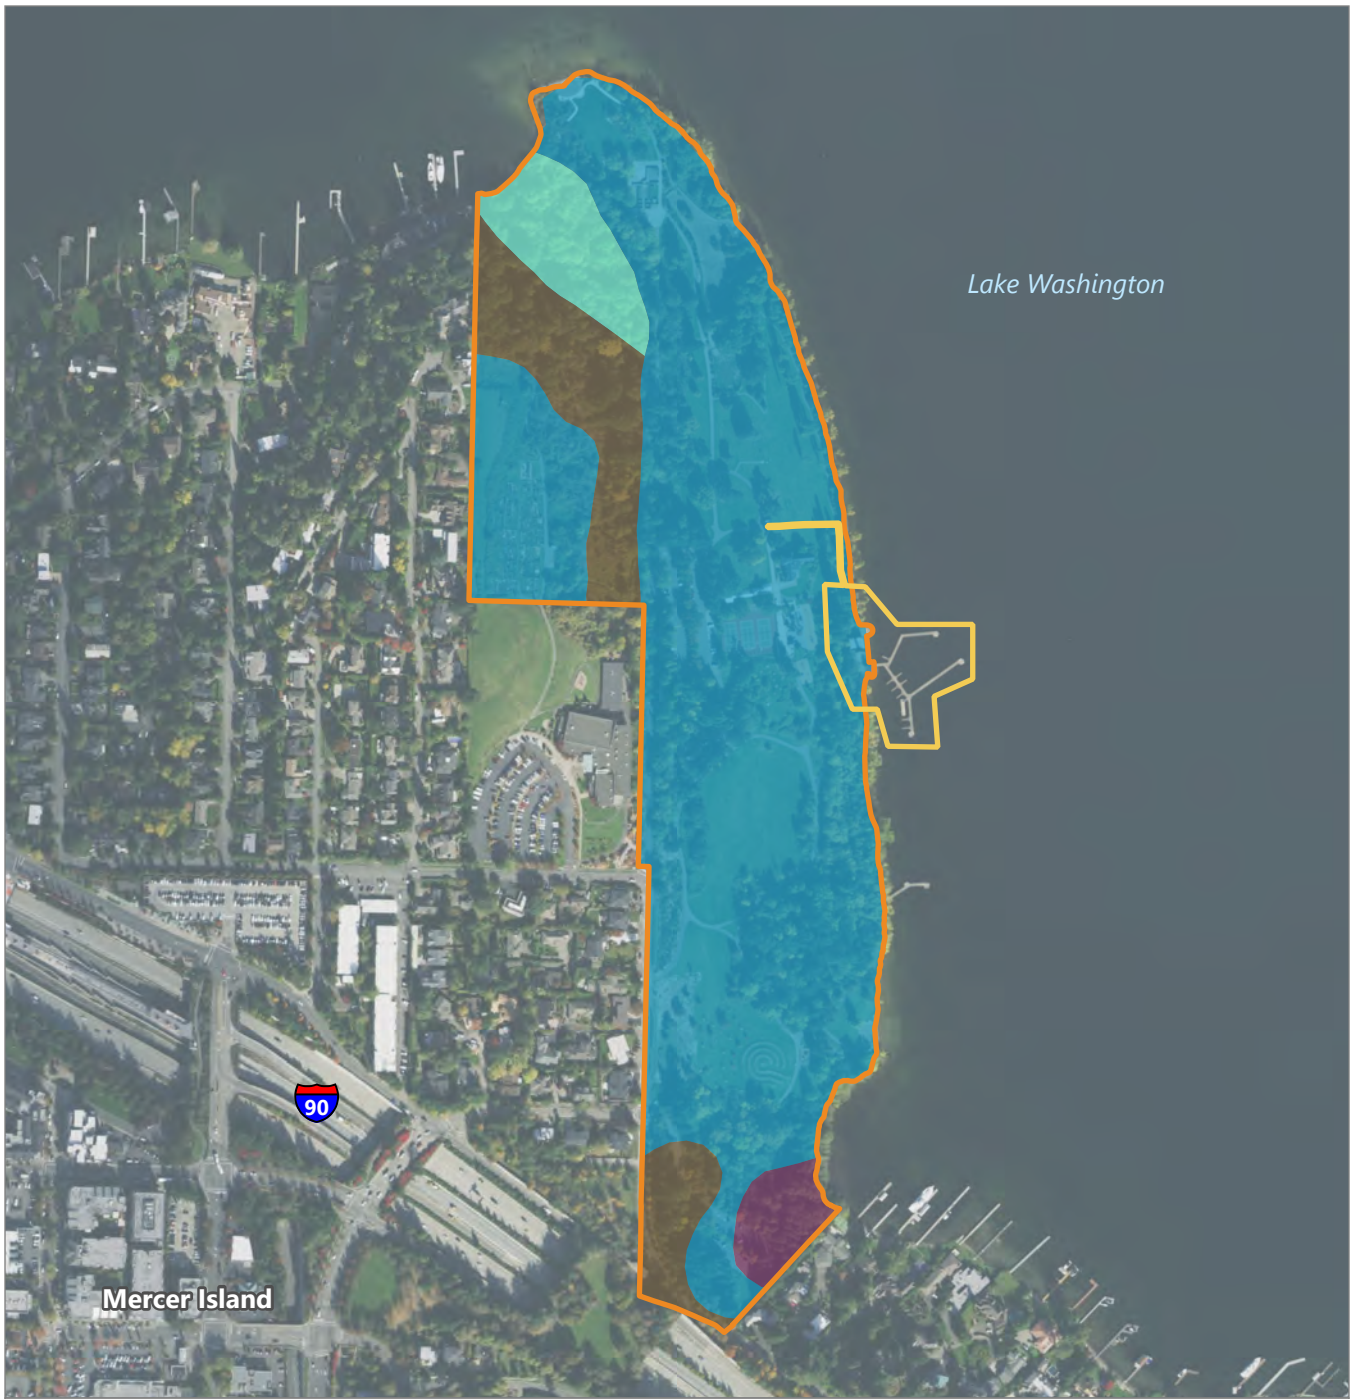
Figure 8
USDA NRCS Soils
 Critical Areas Study
 Luther Burbank Park Waterfront Improvements

The Natural Resources Conservation Service (NRCS) Web Soil Survey identifies one soil series, Kitsap silt loam, 2% to 8% slopes, within the Project area (NRCS 2020; Figure 8).

The upland portion of the Project area is located within a mapped erosion hazard area (Figure 10). Mapped soils in the Project area consist of Kitsap silt loam, 2% to 8% slopes (Figure 8). This soil type has a slight to moderate erosion hazard (SCS 1973).

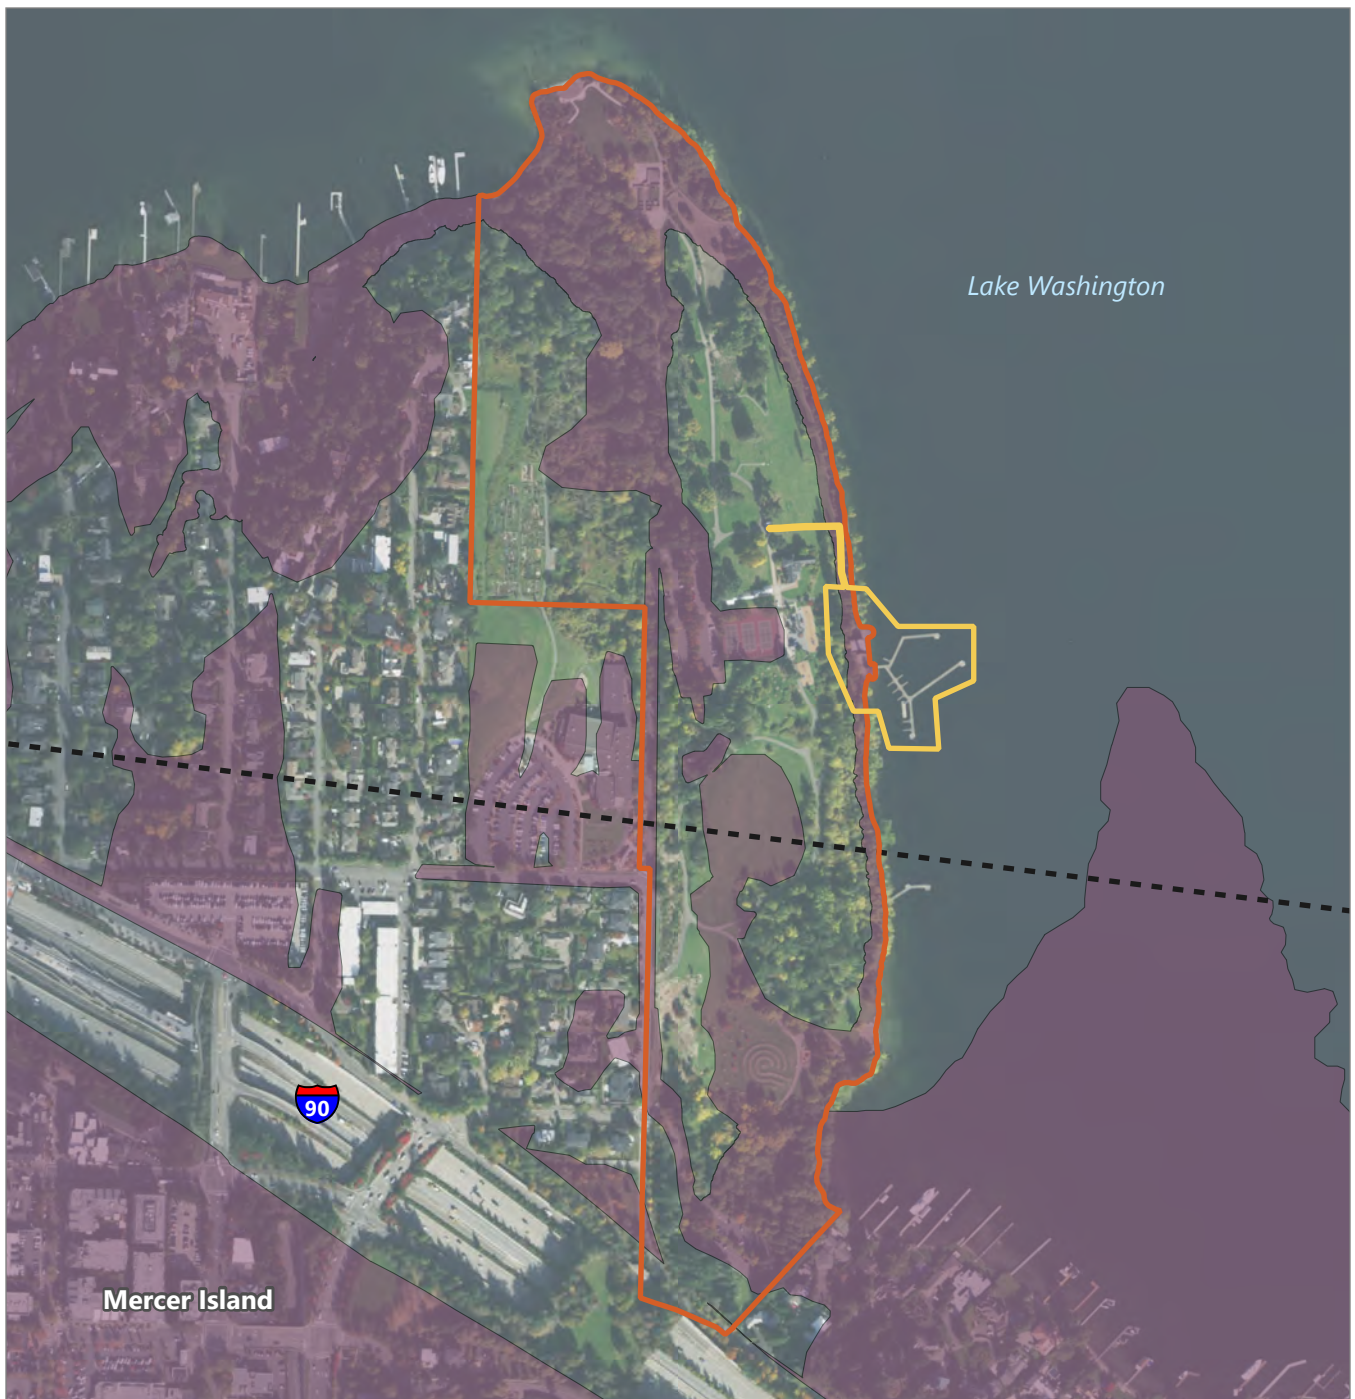
Figure 11
Landslide Hazard Areas
 Critical Areas Study
 Luther Burbank Park Waterfront Improvements

The upland portion of the Project area is located within a mapped landslide hazard area (Figure 11). The Project area contains slopes greater than 15% and 40%, meeting the above code definitions.

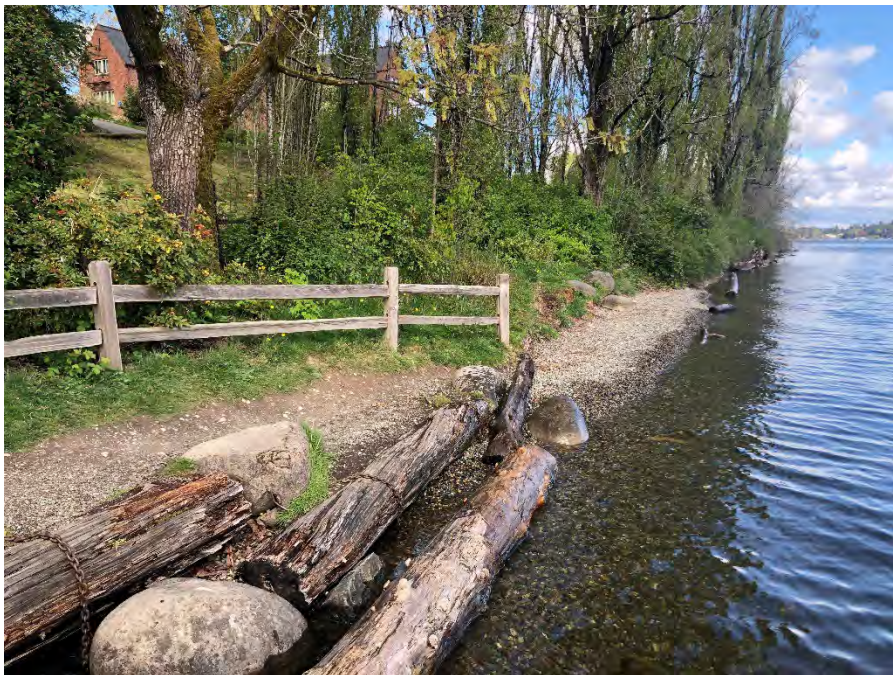
Photograph 2. Looking northwest over existing north beach (April 2021).

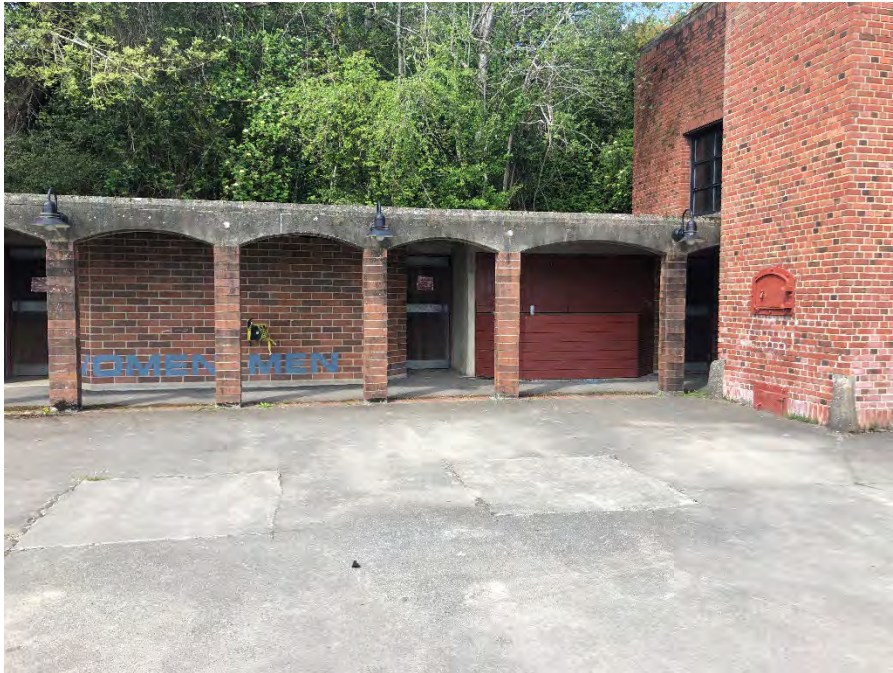
Photograph 6. Existing restroom annex building (April 2021).

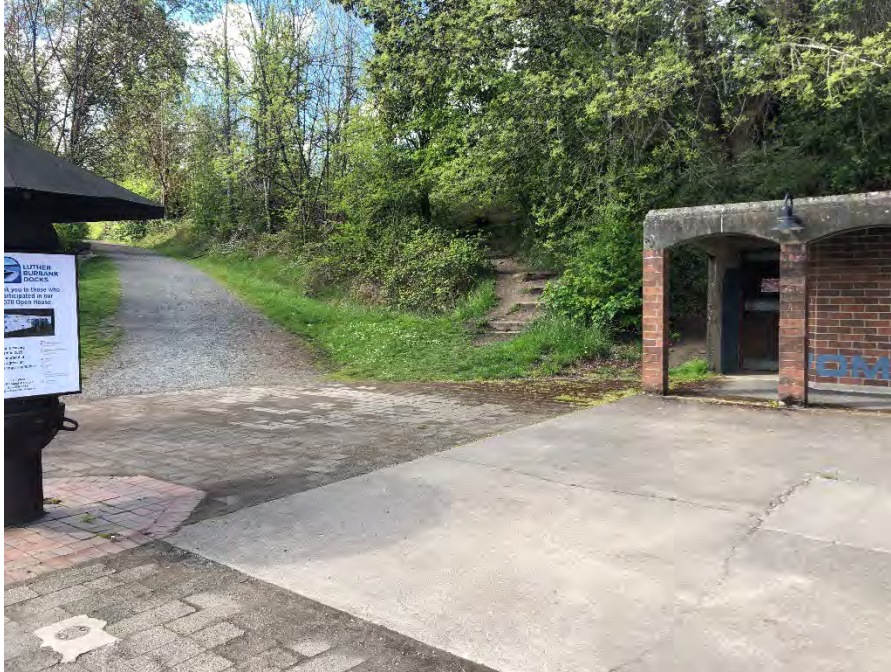
Photograph 7. Existing gravel access driveway and footpath with wooden stairs at south end of plaza (April 2021).

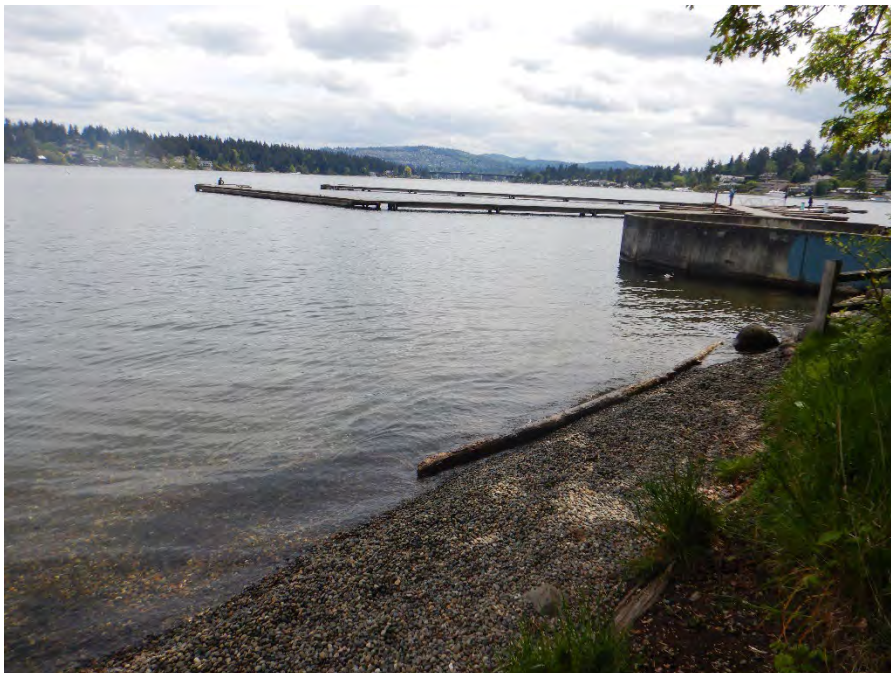
Photograph 8. Looking southeast from north beach over existing docks (May 2022).

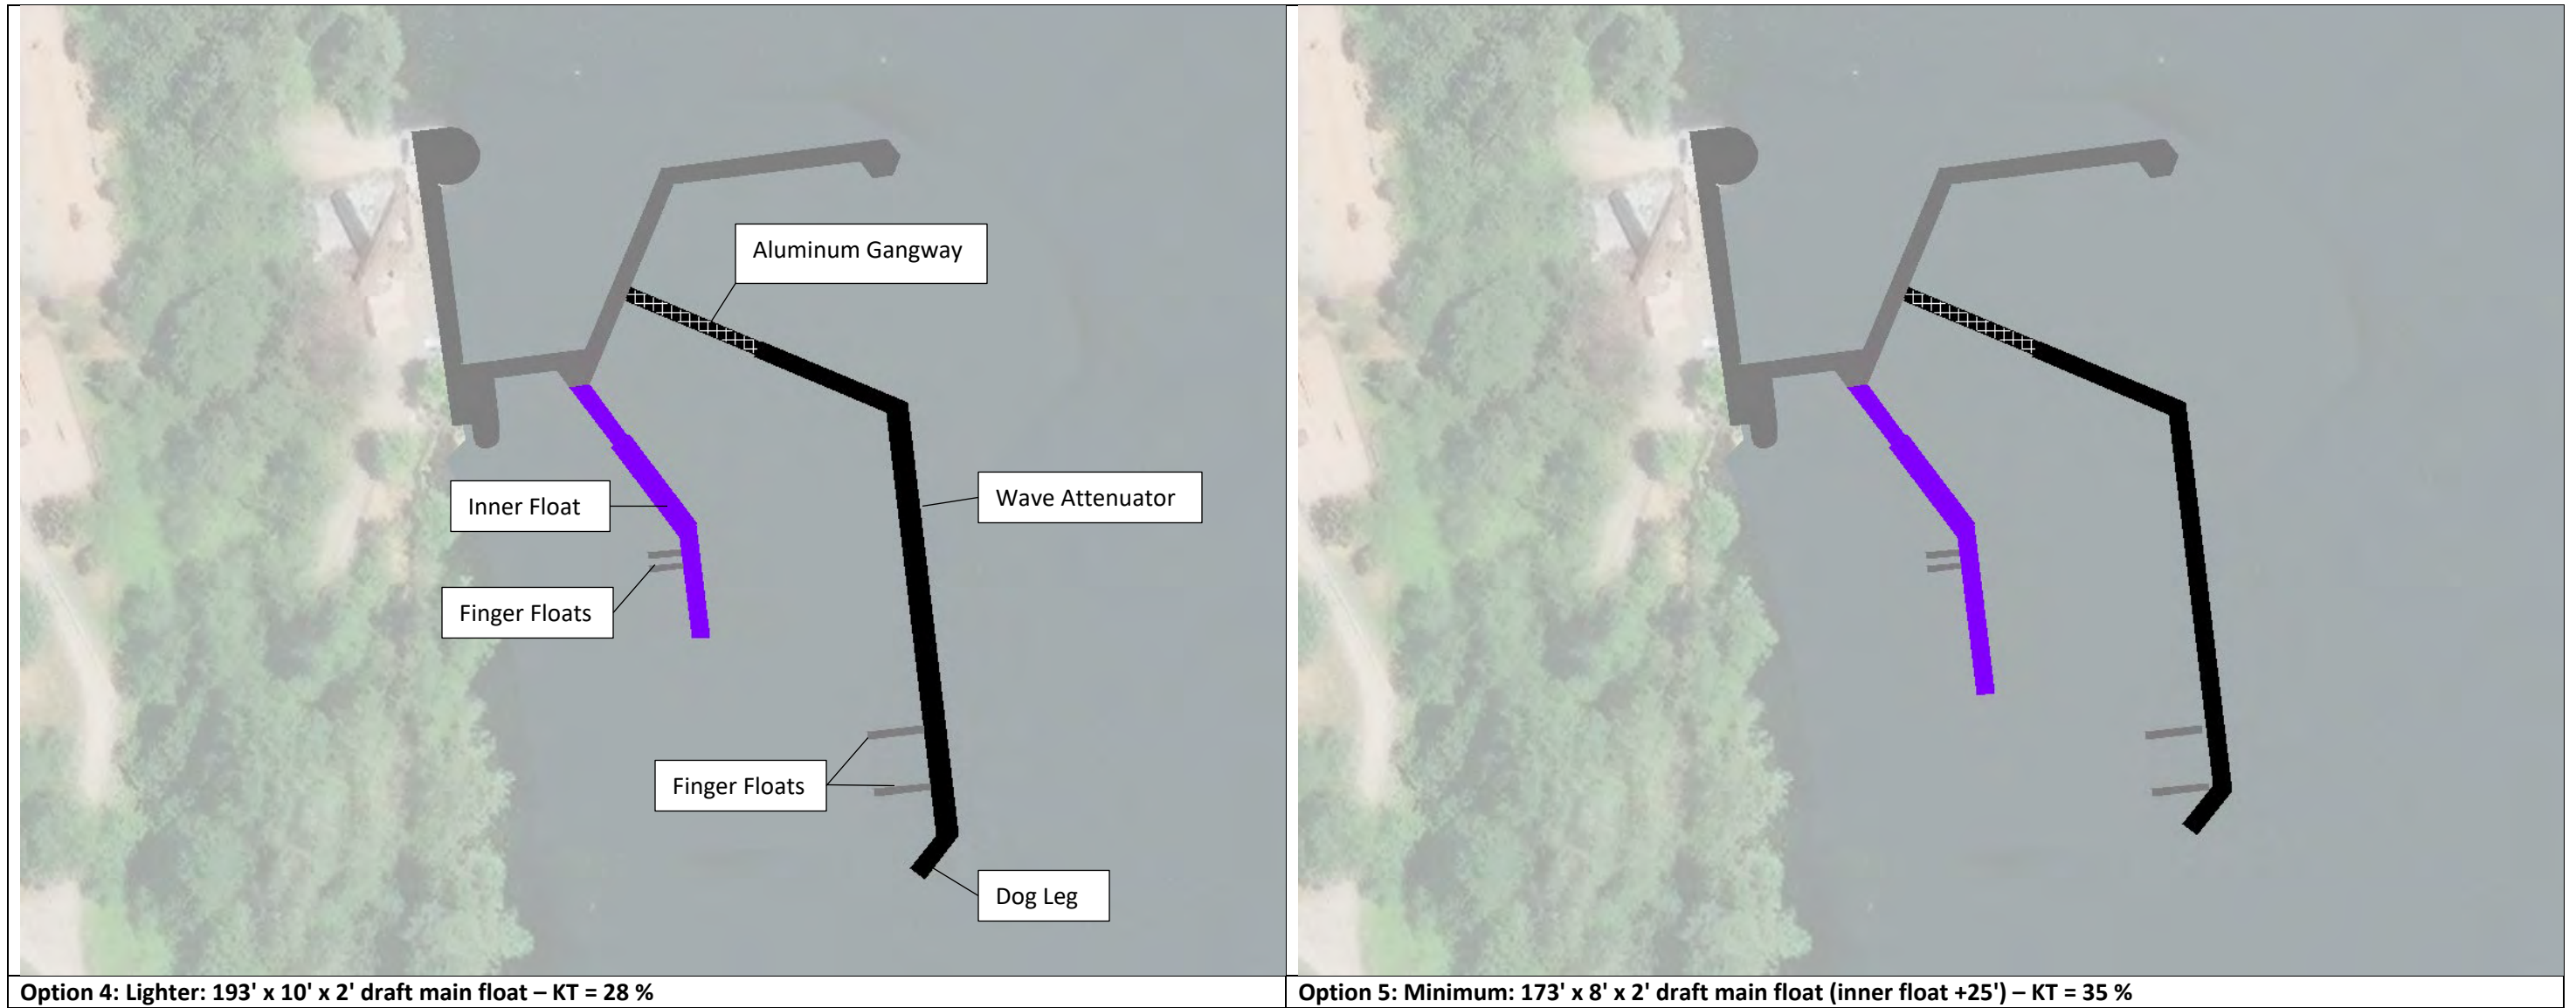
Option 4: Lighter: 193' x 10' x 2' draft main float – KT = 28 %

Option 5: Minimum: 173' x 8' x 2' draft main float (inner float +25') – KT = 35 %

Figure 5: Dock Configurations used in the Wave and Boat Wake Numerical Modeling Evaluation.

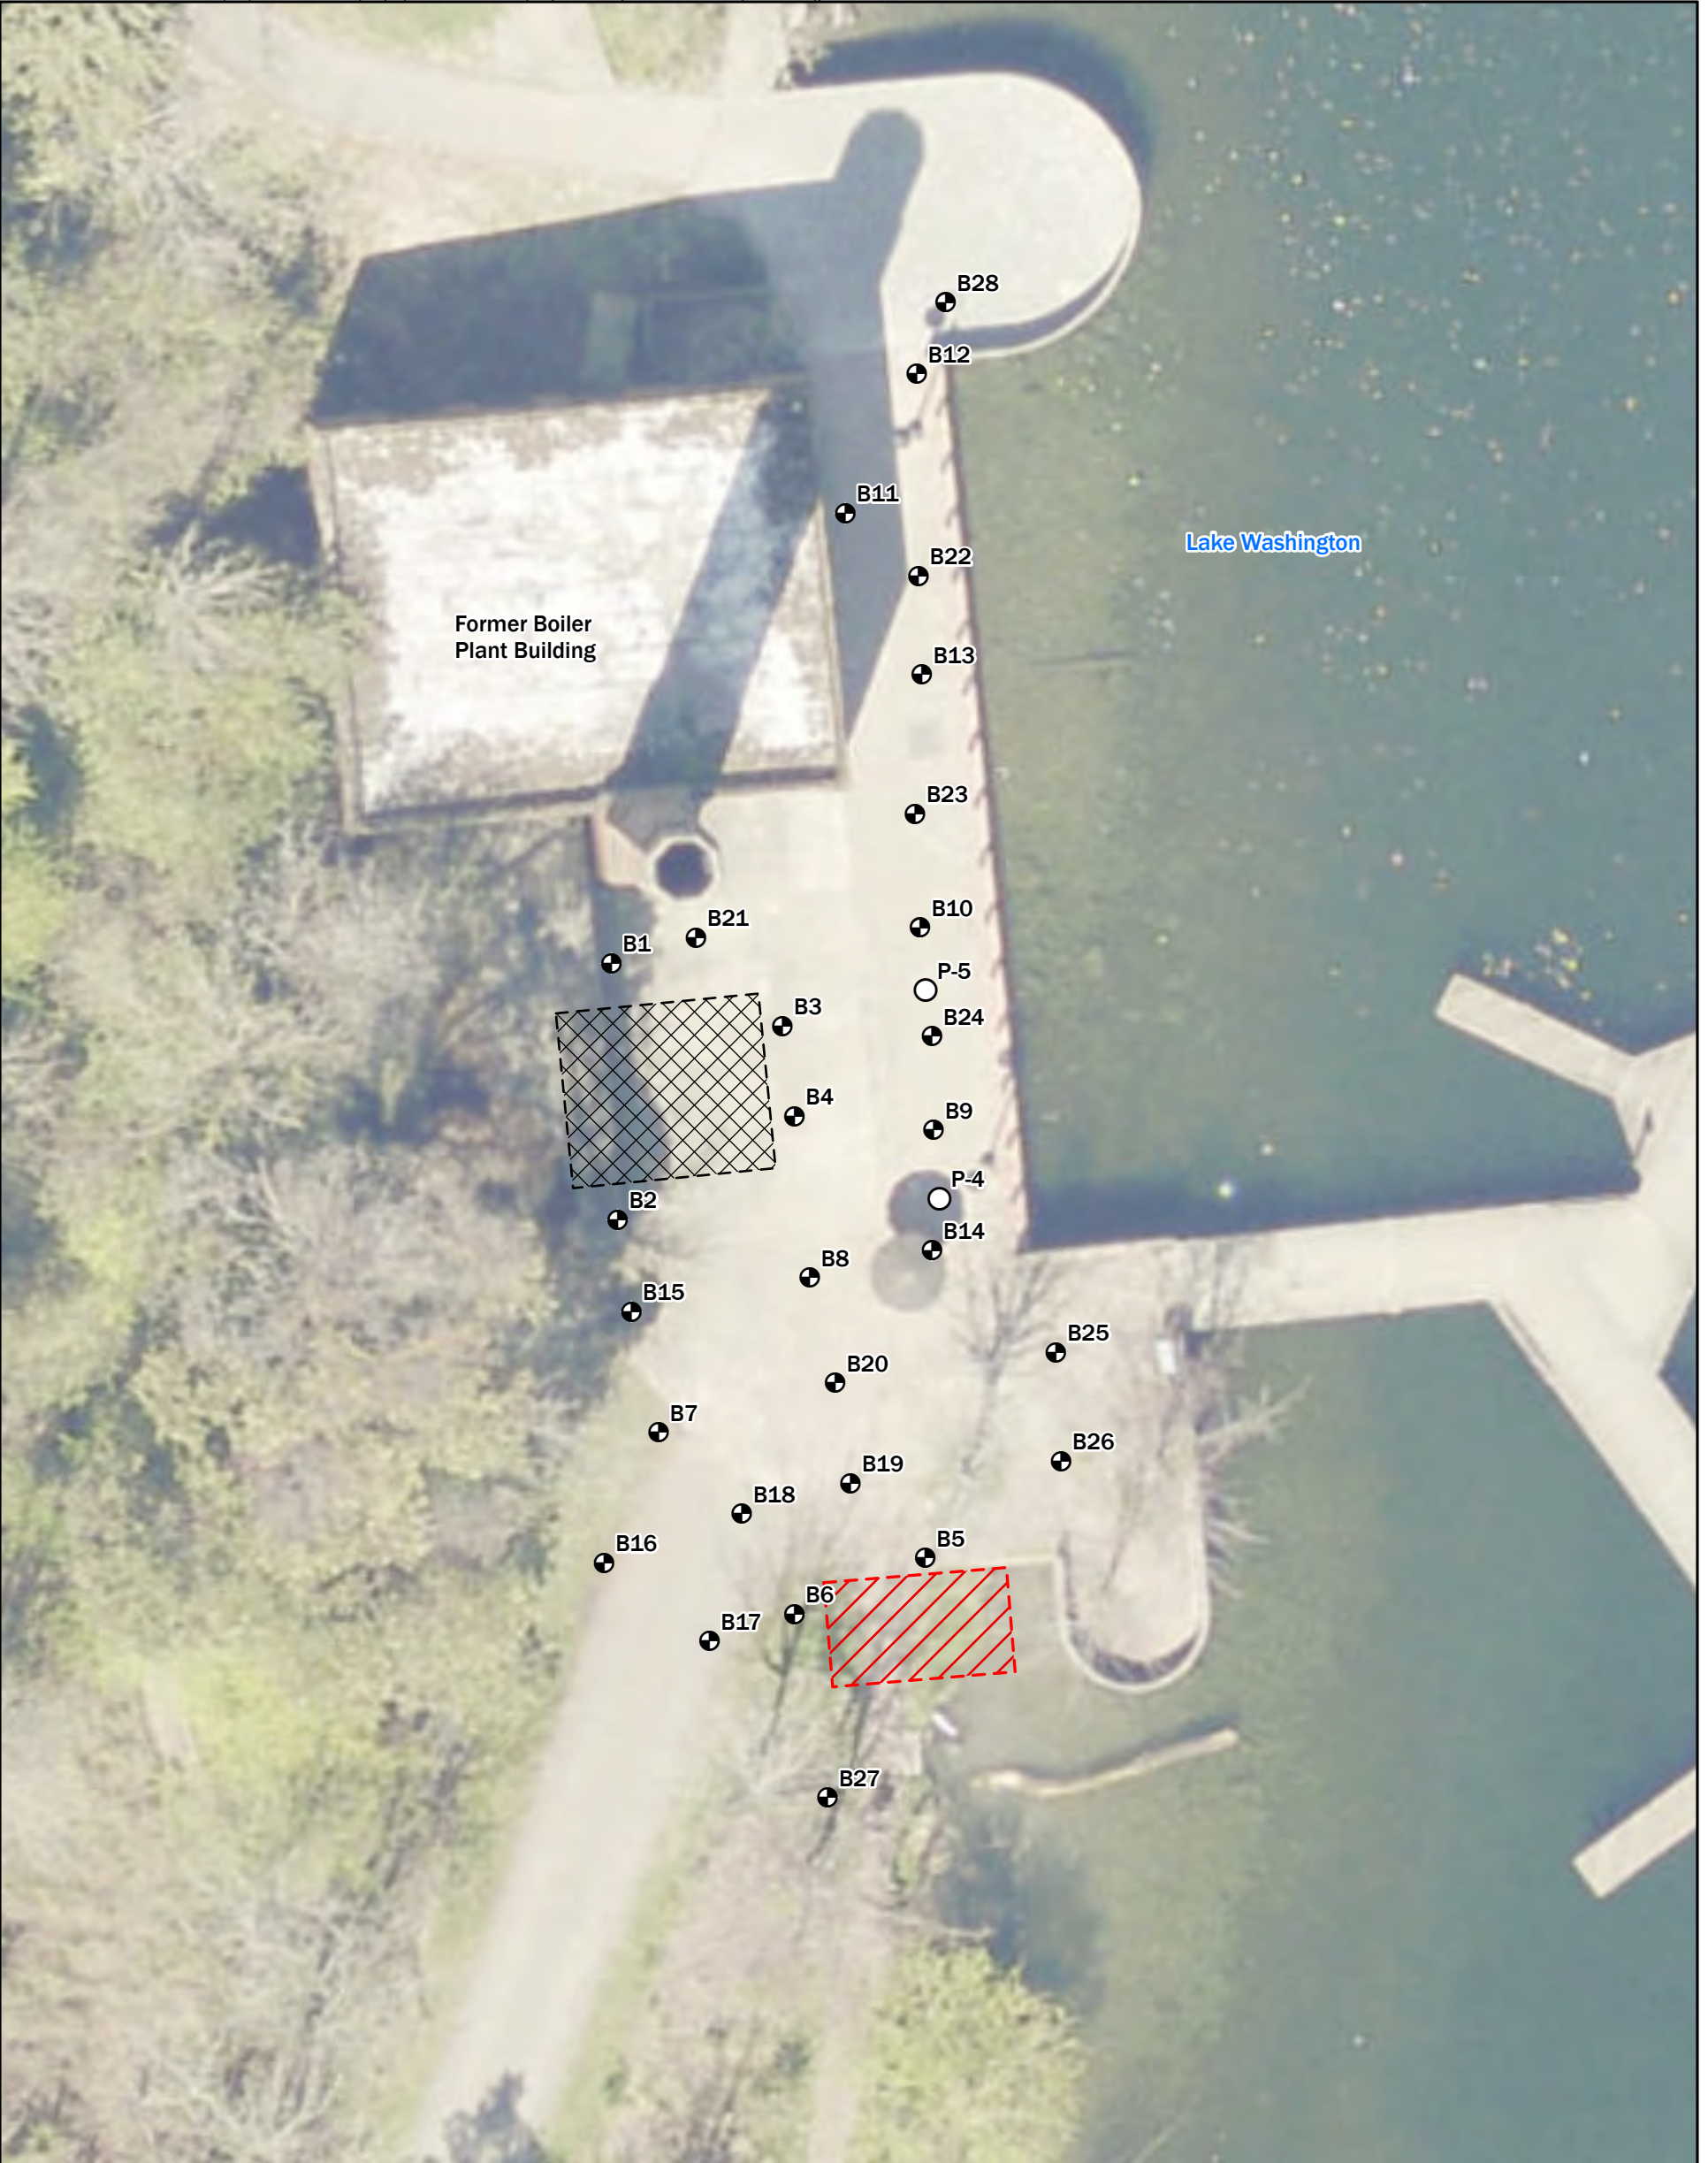
- ¹ Sample LBP-W1 was collected from water accumulated in the bottom of the excavation (area outlined in red on Figure 1).
 - ² Based on the MTCA Method B cleanup levels protective of surface water (lowest level).
 - ³ MTCA Method A Groundwater Cleanup Level.
 - ⁴ The cleanup level is 150 µg/L for "unweathered" diesel-range organics and 3,000 µg/L for "weathered" diesel-range organics. (Ecology, 2021).
- NWTPH-Dx = Northwest Total Petroleum Hydrocarbon - Diesel Extended
 MTCA = Model Toxics Control Act
 µg/L = microgram per liter
 NE = Not Established
 U = Not detected above the practical quantification limit.
- Shading indicates that the identified concentration is greater than the MTCA cleanup level.
Bold font type indicates the analyte was detected at the reported concentration.

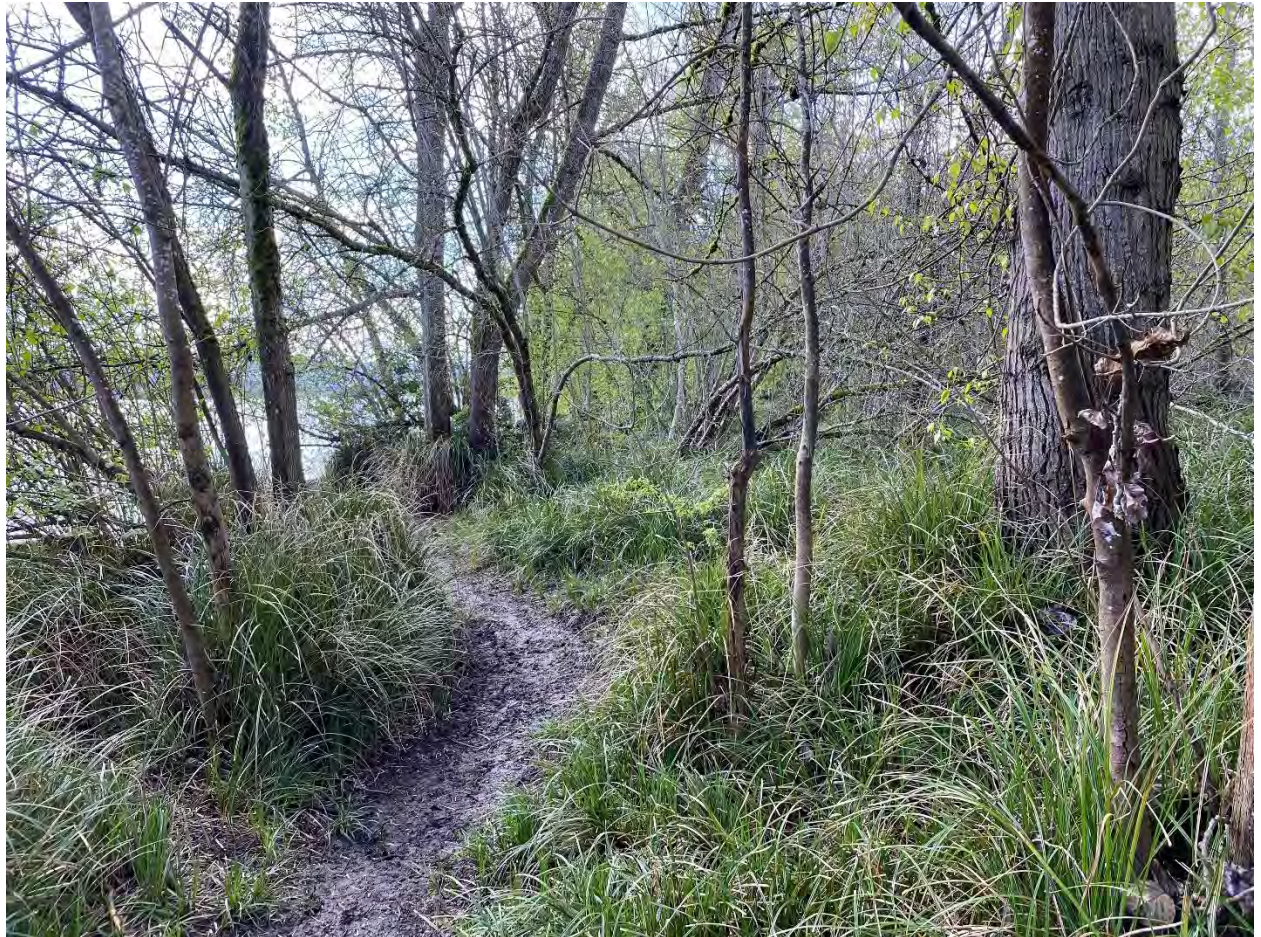
Management History: This shoreline was historically part of a farm that operated from 1906 to 1965. A dock was located at the north end of this unit until the property was purchased for a county park in 1968. There is no documentation of management of this unit during the county's ownership. The City has monitored this unit for vegetation condition.

Figure 1: Representative image of Vegetation Unit 1. Note social trail through dense sedge understory.

Proposed Action: The City will continue monitoring Vegetation Unit 1 for noxious weeds and prioritize weed removal with other vegetation management in the park.

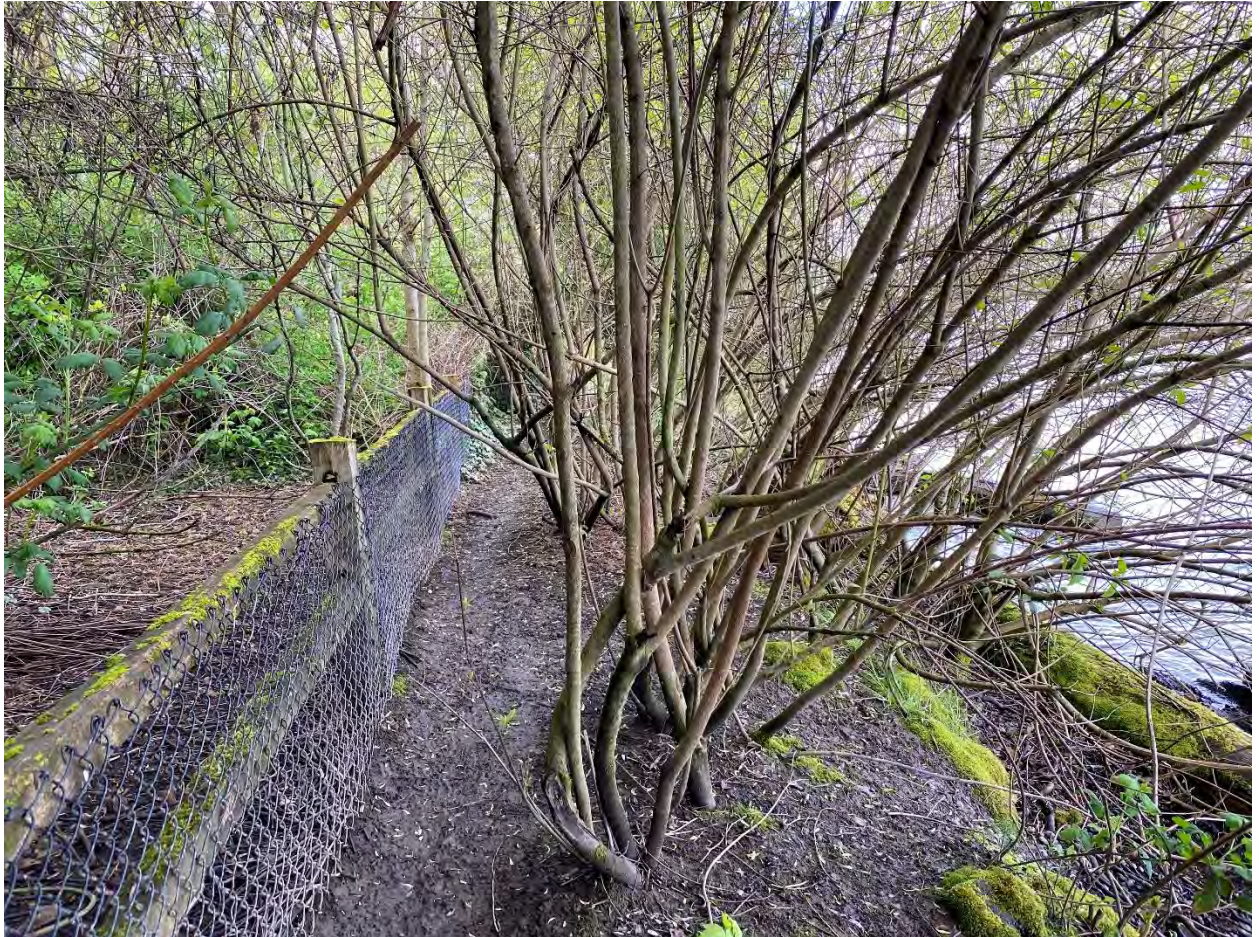
Management History: This shoreline was historically part of a farm that operated from 1906 to 1965. The property was purchased for a county park in 1968. There is no documentation of management of this unit during the county's ownership. The City identified this area as a wetland during the design of the Off-leash Area (OLA) redevelopment project in 2008. The City subsequently installed wetland enhancement plantings and fencing in this area as part of the OLA construction. It has monitored this unit for vegetation condition since then.

Figure 2: Representative image of Vegetation Unit 2. Note bare ground around mature native dogwood shrubs.

Proposed Action: The City will enhance dog exclusion along this stretch of shoreline, plant native understory plants, maintain the buffer plantings, and continue to monitor the unit.

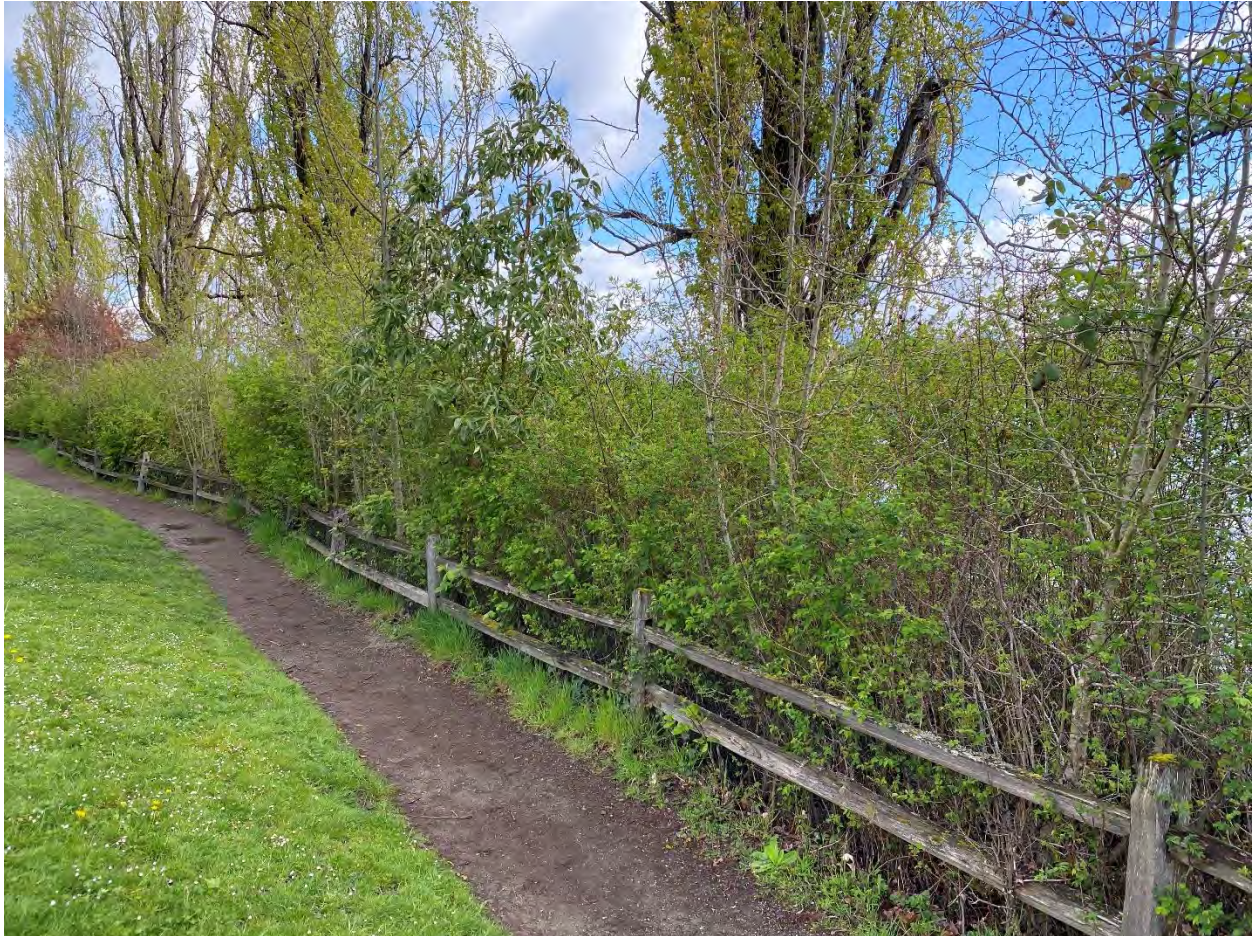
Management History: This shoreline was historically part of a farm that operated from 1906 to 1965. The property was purchased for a county park in 1968. There is no documentation of management of this unit during the county's ownership. The City installed shoreline stabilization and native buffer plantings in 2008. This buffer has been maintained since, with periodic removal of invasive non-native species.

Figure 3: Representative image of Vegetation Unit 3

Proposed Action: The City will continue monitoring for noxious weeds in Vegetation Unit 3 and prioritize weed removal with other vegetation management in the park.

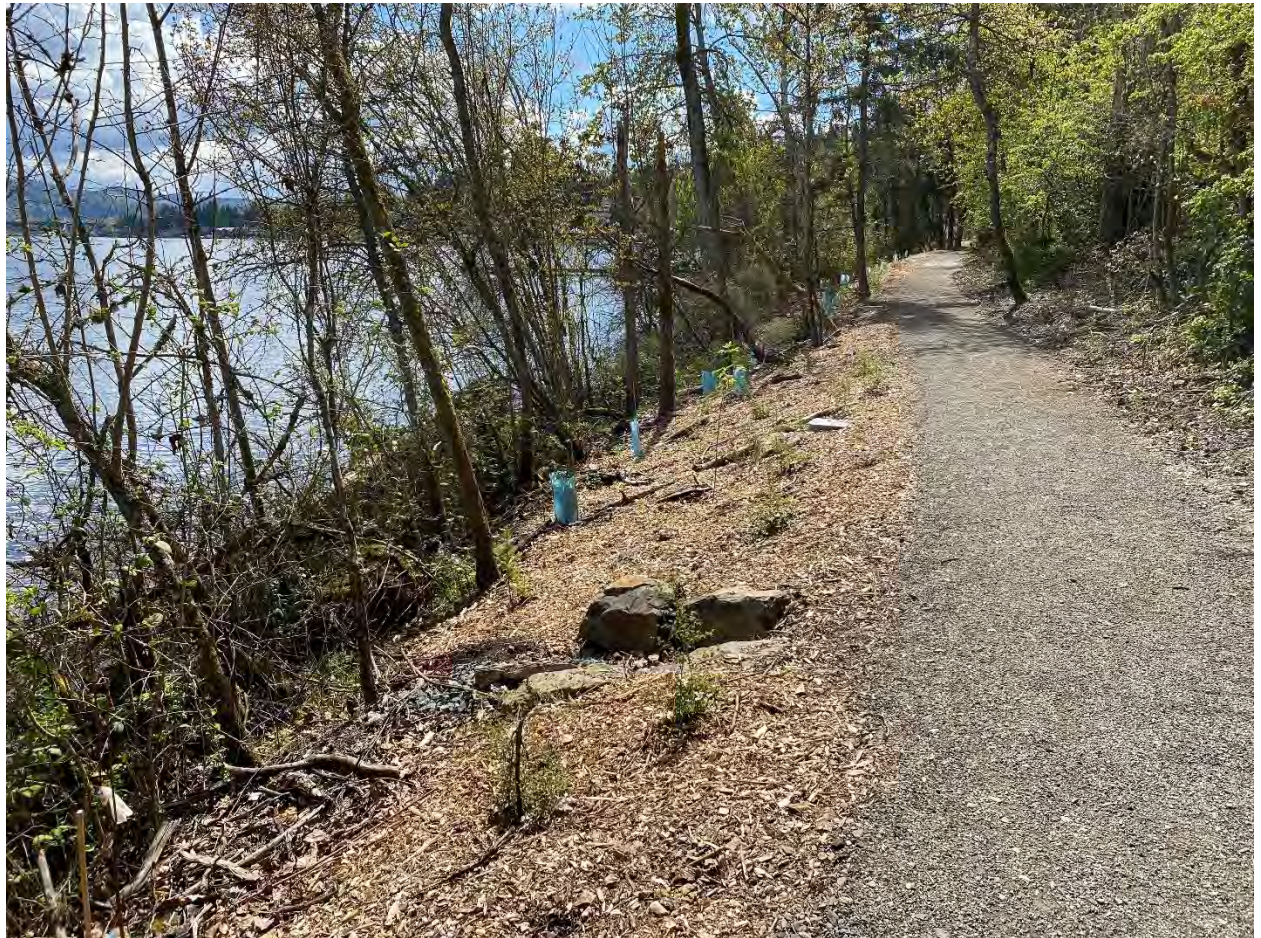
Management History: This shoreline was forested during the era when it was part of a farm that operated from 1906 to 1965. The property was purchased for a county park in 1968. There is no documentation of management of this unit during the county's ownership. The City installed shoreline stabilization and native buffer plantings in 2023. An initial step in that project was noxious weed control for the year leading up to construction.

Figure 4: representative image of Vegetation Unit 4. Blue plant covers prevent deer browse on tree seedlings.

Proposed Action: The City will maintain this buffer to ensure successful establishment of over 800 native plants installed in the fall of 2023. Maintenance will include irrigation, weeding, mulching, and deer protection. The City will install additional plants as needed to establish successful native cover throughout the buffer.
