Routos Pier, Lifts, & Stairs

Project Narrative

Repair an existing pier by splicing one pile, re-framing, and re-decking with Thruflow grated decking. Remove a 120 square foot section of the pier and the three associated piles. Install a new boat lift and platform lift. Install lake access stairs in the existing rock bulkhead.

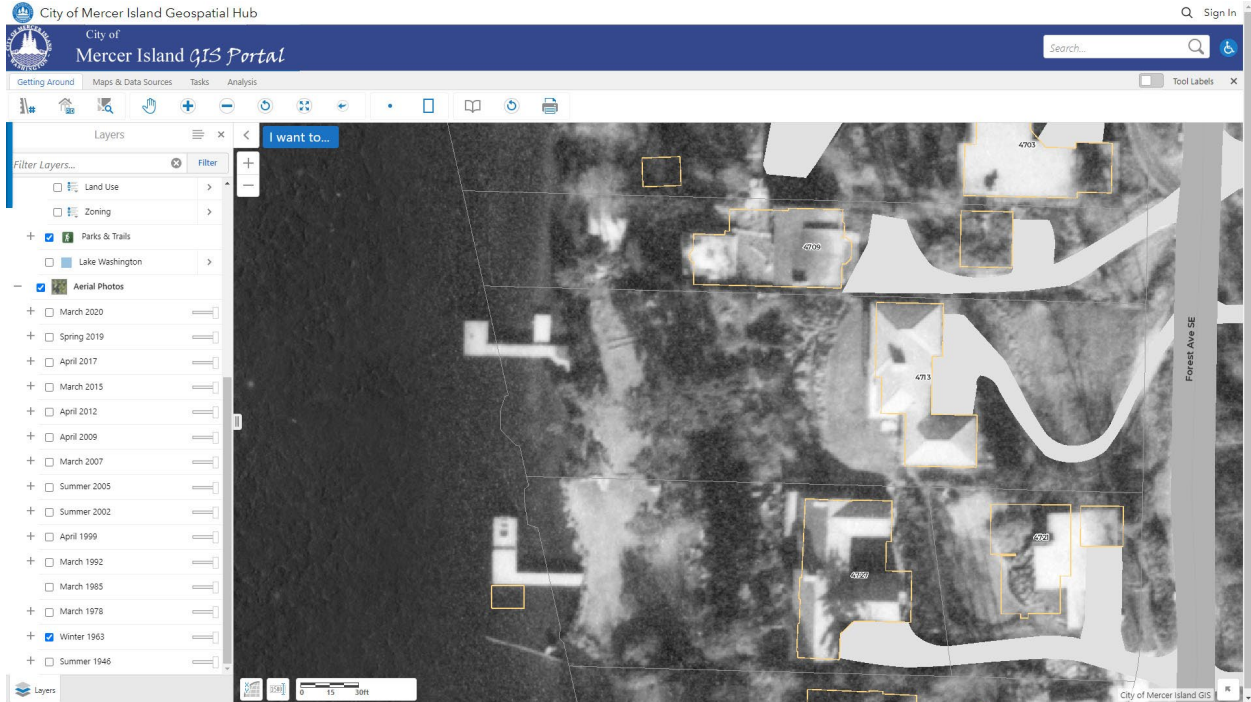
The aerial photo below is being included to show that the existing pier is legally non-conforming and that moorage facility may be allowed to be repaired, maintained, remodeled, and replaced per MICC 19.13.020(A). The photo is from 1963 and was obtained from Mercer Island GIS.
