C. Gary Schulz

Wetland/Forest Ecologist

**Re: Wetland / Stream Reconnaissance on the Mercer Island - Short Plat Property
(Parcel #1224049034): City of Mercer Island, WA # SUB 16-011.**

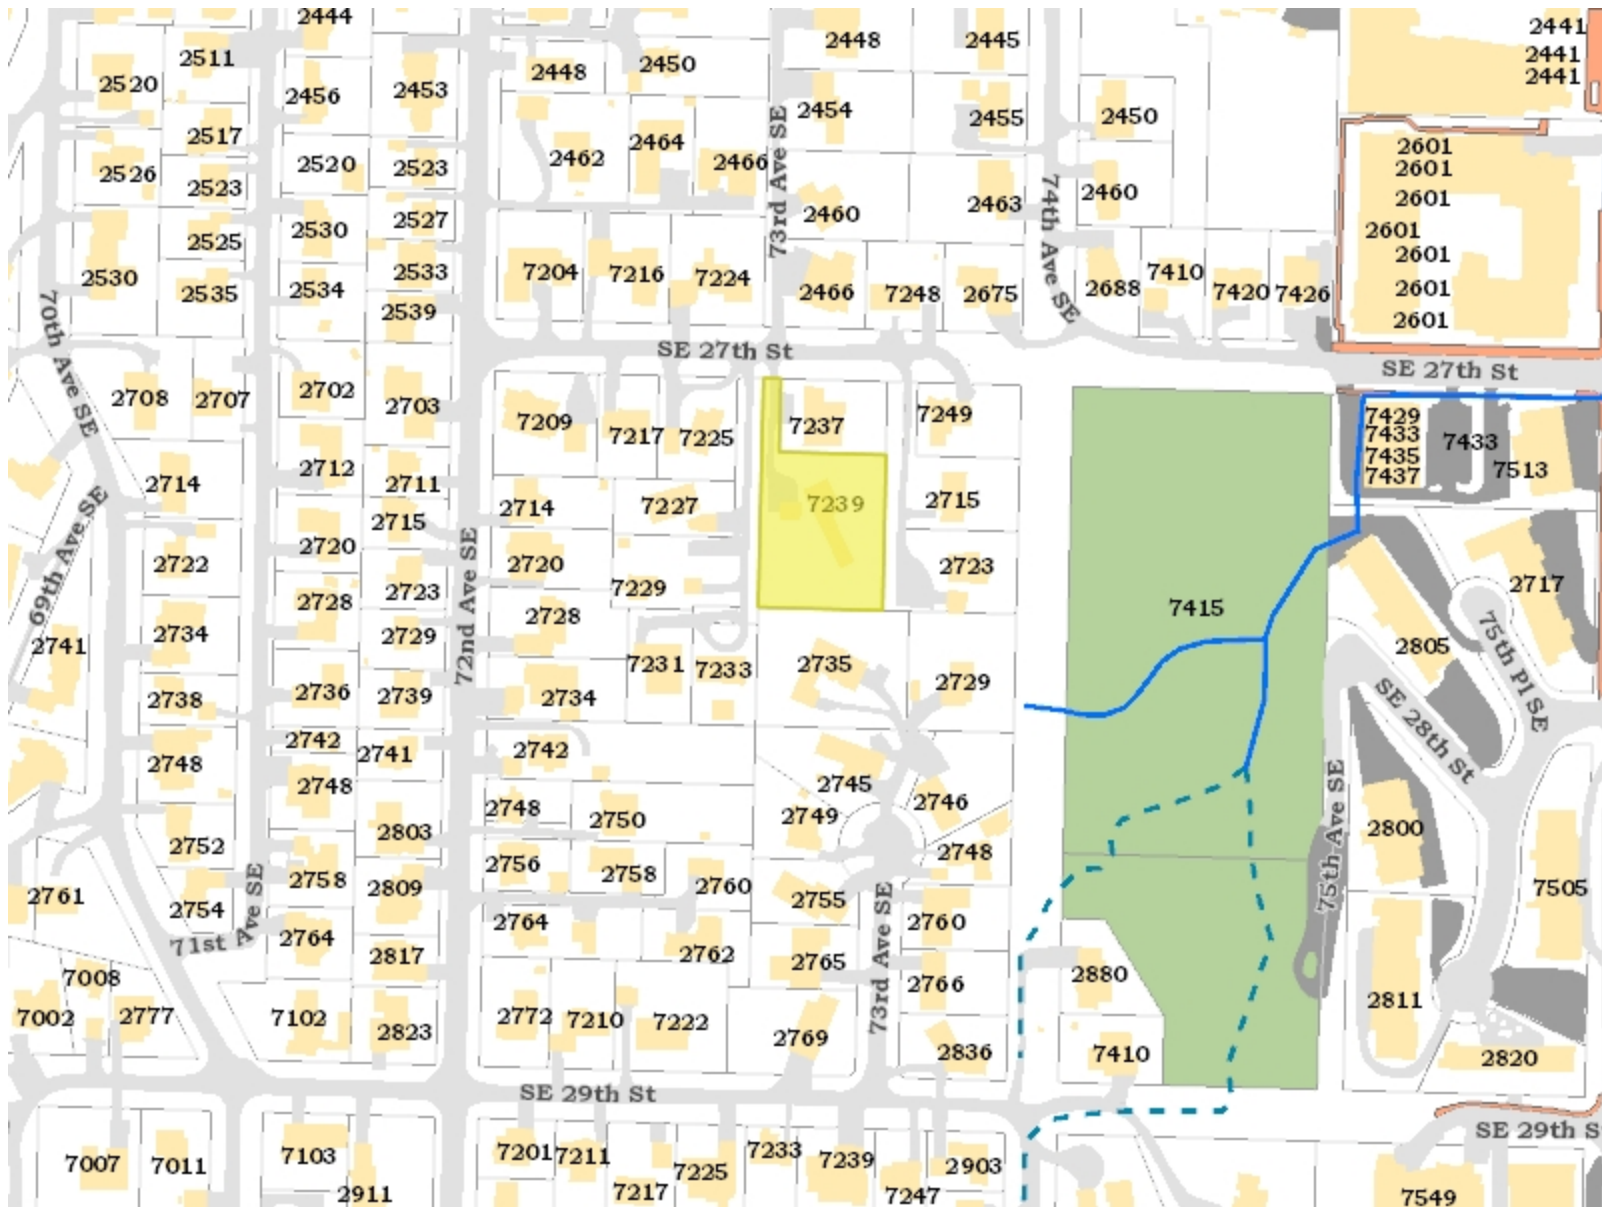
Notes
1 Figure 1

The site's topography is gently sloping to the east and drops towards a natural area that is located just off-site (Figure 1 & 2). There are no visible signs of erosion from surface water runoff or related watercourse / stream channels on the Property. Recent rainfall combined with compacted soil caused mowed lawn areas to be wet at the time of this investigation.

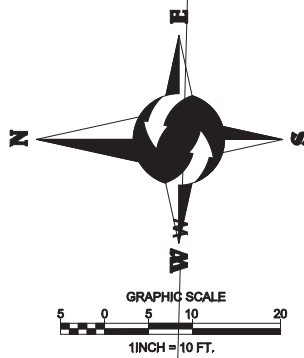
Figure 2

Wetland Data Plots - (1)

(approximate location)
