Re: Critical Area Reconnaissance Memorandum

The Watershed Company Reference Number: 181230

Site Sketch – Wetland and Stream Reconnaissance

Site Address: 2825 W Mercer Way, Mercer Island Prepared for: Eric Hansen
Parcel Number: 2174502425 TWC Ref. No.: 181230
Site Visit Date: January 15, 2019

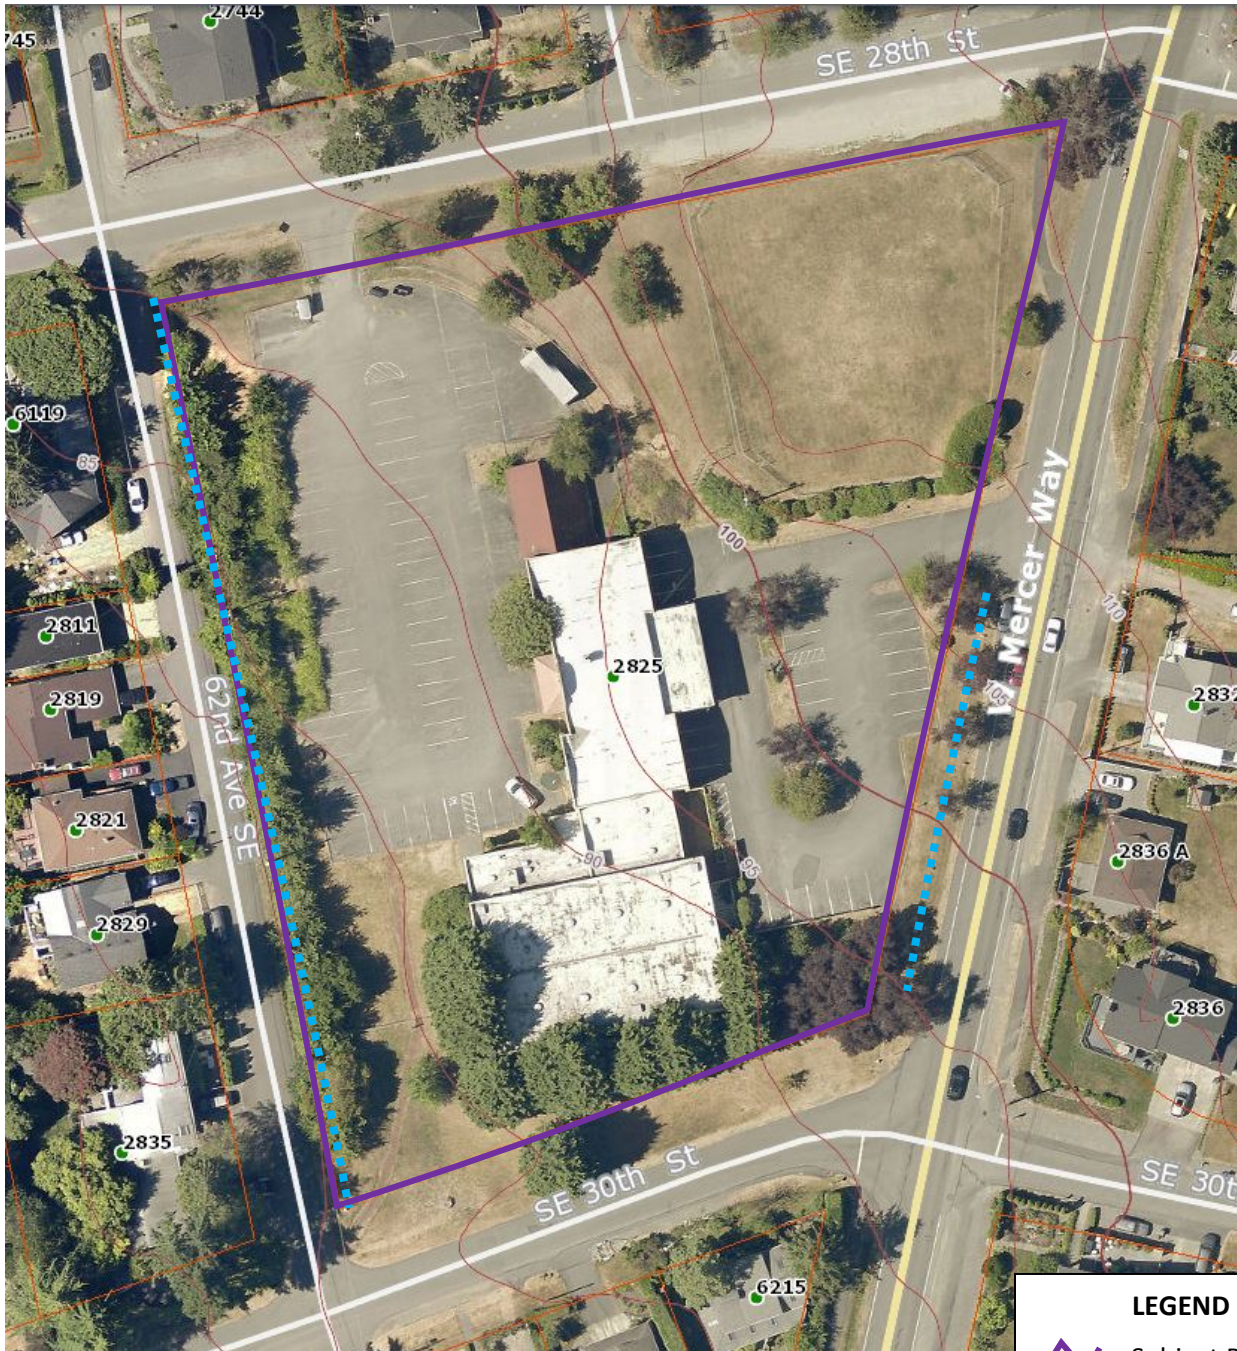
As shown on the attached sketch, there are two non-jurisdictional ditches on or near the subject parcel. One ditch is located along W Mercer Way near the eastern parcel boundary, and the second ditch is along 62nd Avenue SE at the west parcel line. No wetlands or streams were identified on the parcel and no identifiable wildlife habitat conservation areas were observed at the time of the site visit.
