# 2825 W Mercer Way

City of Mercer Island, Washington

## Preliminary Storm Drainage Report

Blueline Job No. 13-118  
Prepared by: Lucas Zirotti, EIT  
Reviewed by: Brett Pudists, PE

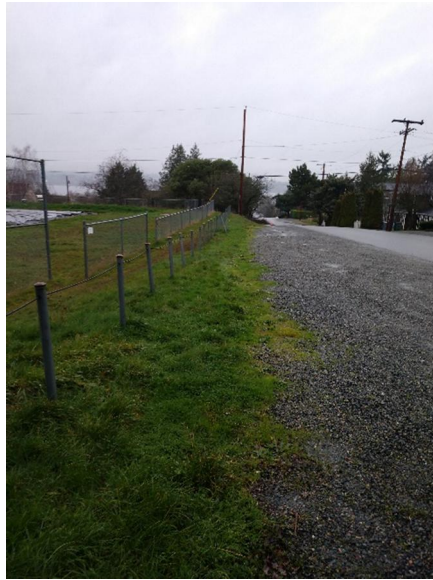
*Photo N1 – Facing west along SE 28<sup>th</sup> St. Onsite runoff sheet flows northwest toward the conveyance system on the south side of the street.*

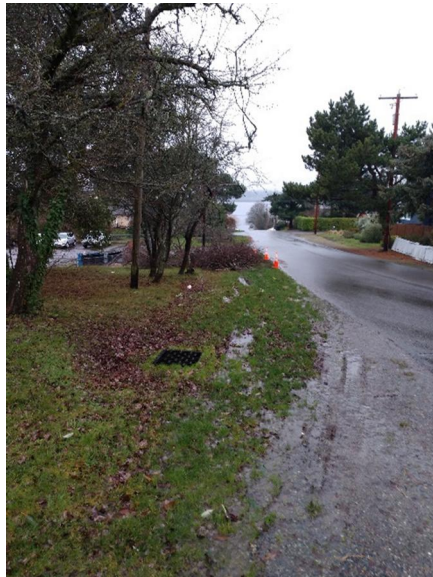
*Photo N2 – Facing west along SE 28<sup>th</sup> St approximately 170 feet west of Photo N1. Runoff continues to sheet flow northwest towards the conveyance system on the south side of the street.*

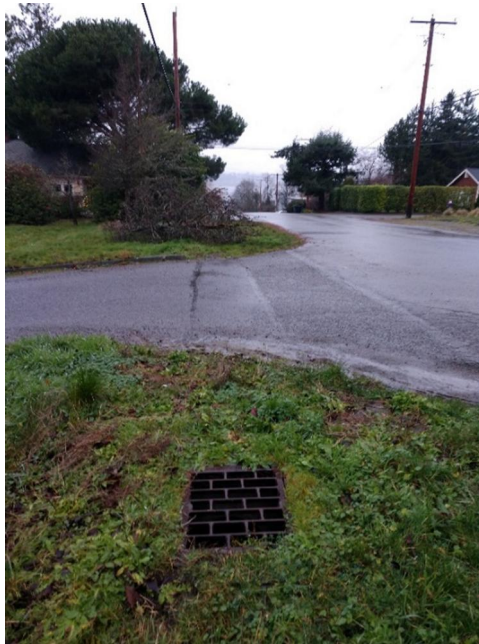
*Photo N3 – Facing west along SE 28<sup>th</sup> St approximately 145 feet west of Photo N2. This catch basin is located adjacent to the driveway into the back parking lot on the western portion of the property. Runoff continues to sheet flow northwest towards the conveyance system on the south side of the street.*

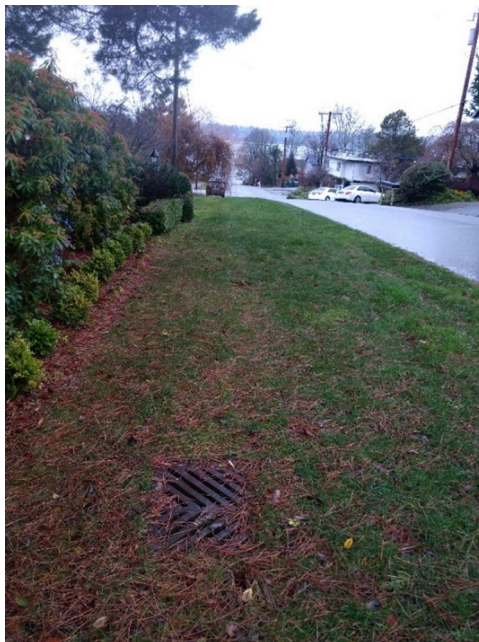
*Photo N4 – Facing west along SE 28<sup>th</sup> St approximately 130 feet west of Photo N3. Runoff is conveyed via this catch basin on the south side of the street toward Lake Washington.*

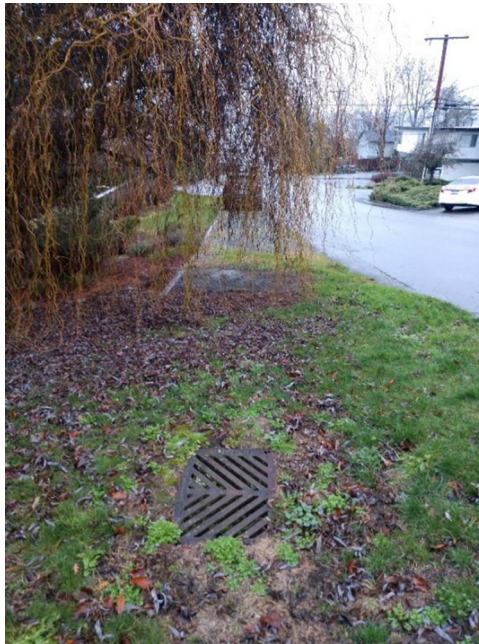
*Photo N5 – Facing west along SE 28<sup>th</sup> St approximately 95 feet west of Photo N4. Runoff is conveyed via this catch basin on the south side of the street toward Lake Washington.*

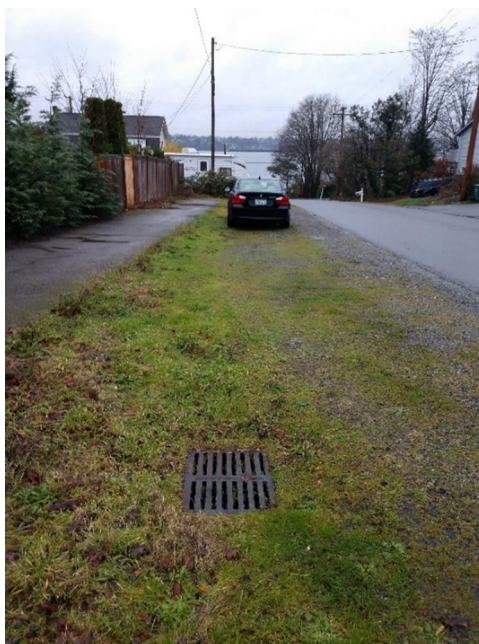
*Photo N6 – Facing west along SE 28<sup>th</sup> St approximately 150 feet west of Photo N5. Runoff is conveyed via this catch basin on the south side of the street toward Lake Washington.*

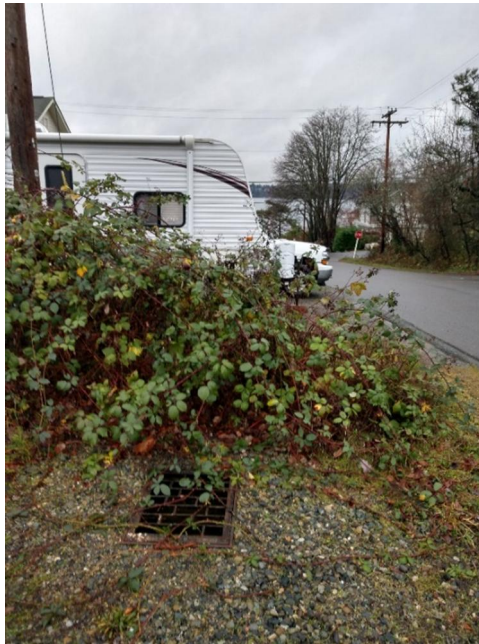
*Photo N7 – Facing west along SE 28<sup>th</sup> St approximately 90 feet west of Photo N6. Runoff is conveyed via this catch basin on the south side of the street toward Lake Washington.*

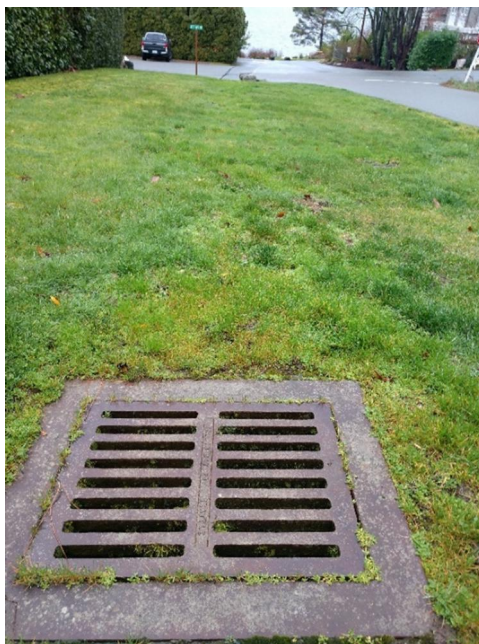
*Photo N8 – Facing west along SE 28<sup>th</sup> St approximately 40 feet west of Photo N7. Runoff is conveyed via this catch basin on the south side of the street toward Lake Washington.*

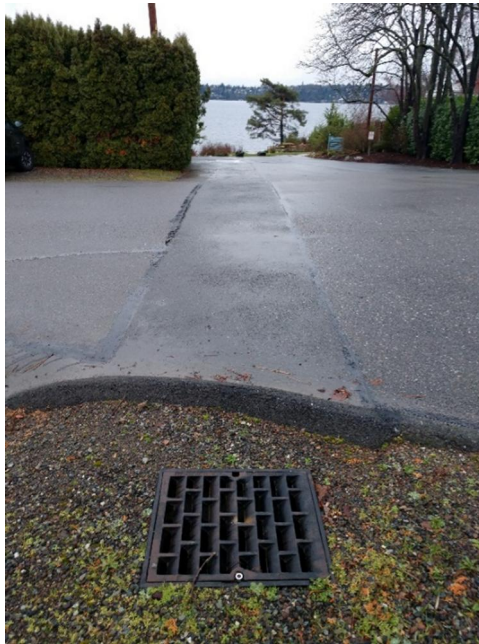
*Photo N9 – Facing west along SE 28<sup>th</sup> St approximately 95 feet west of Photo N8 at southeast corner of the intersection of SE 28<sup>th</sup> St and 60<sup>th</sup> Ave SE. Runoff is conveyed via this catch basin on the south side of the street toward Lake Washington.*

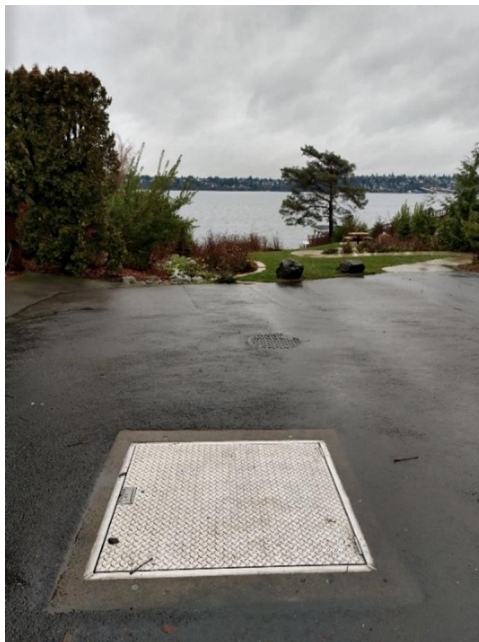
*Photo N10 – Facing west in Calkins Landing approximately 95 feet west of Photo N9. Runoff is collected in the pre-settling vault pictured before being discharged into Lake Washington.*

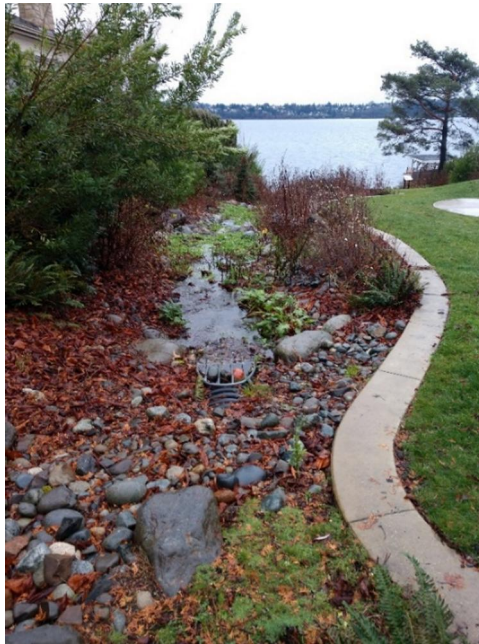
*Photo N11 – Facing west in Calkins Landing. Runoff discharges via a pipe with a trash rack to a ditch upstream of the outfall to Lake Washington.*

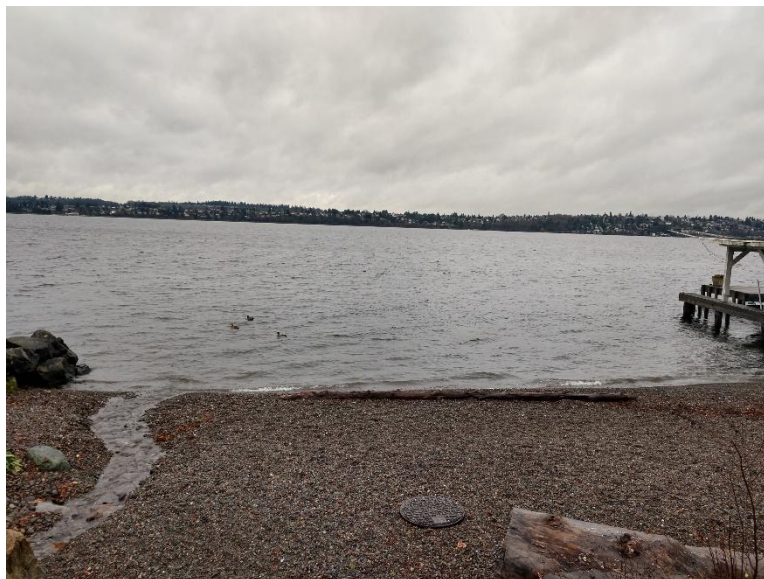
*Photo N12 – Facing west in Calkins Landing showing the outfall in Lake Washington.*

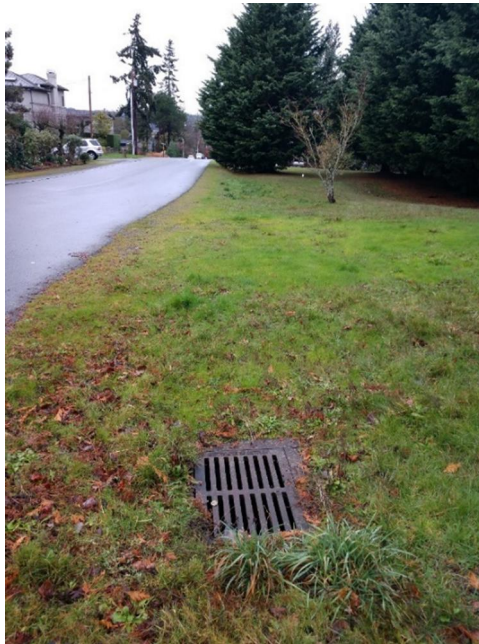
*Photo S1 – Facing west along the north side of SE 30<sup>th</sup> St. Onsite runoff sheet flows in the southwestern direction to the catch basin above and is conveyed west toward Lake Washington.*

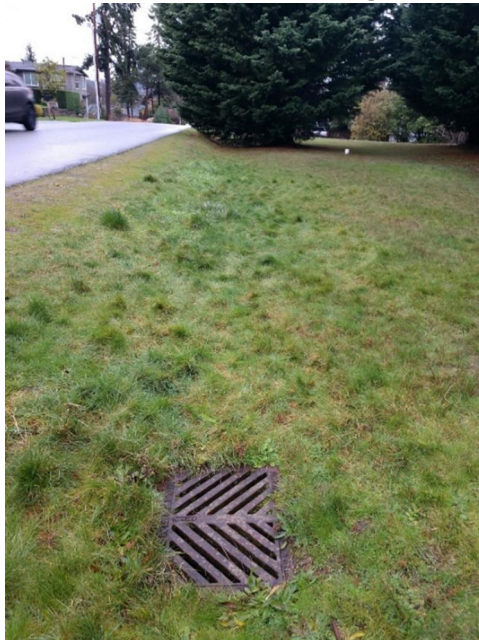
*Photo S2 – Facing west along the north side of SE 30<sup>th</sup> St approximately 55 feet west of Photo S1. Onsite runoff sheet flows in the southwestern direction to the catch basin above and is conveyed west toward Lake Washington.*

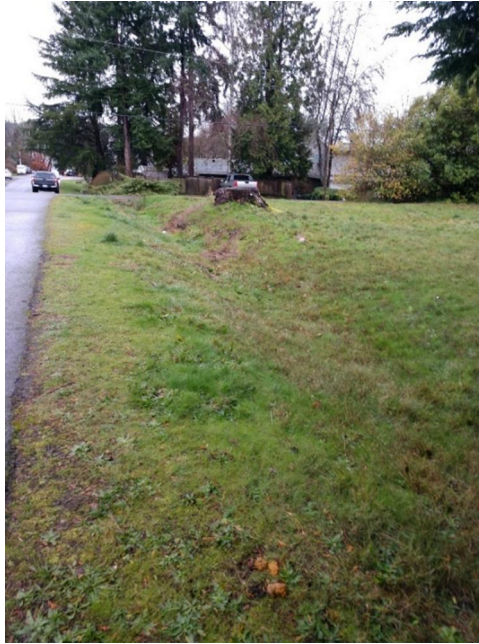
*Photo S3 – Facing west along the north side of SE 30<sup>th</sup> St approximately 35 feet west of Photo S2. Onsite runoff sheet flows in the southwestern direction to the ditch above and is conveyed west toward Lake Washington.*

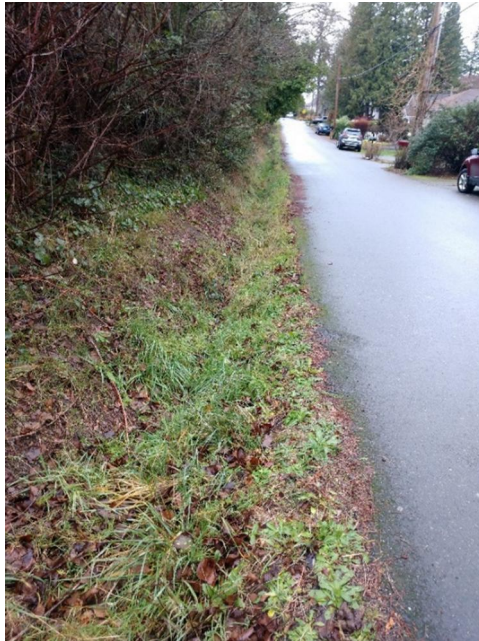
*Photo S4 – Facing south on the east side of 62<sup>nd</sup> Ave SE approximately 60 feet from Photo N4. Onsite runoff sheet flows in the southwest direction toward the ditch above and is conveyed south to be combined with the south basin downstream conveyance system.*

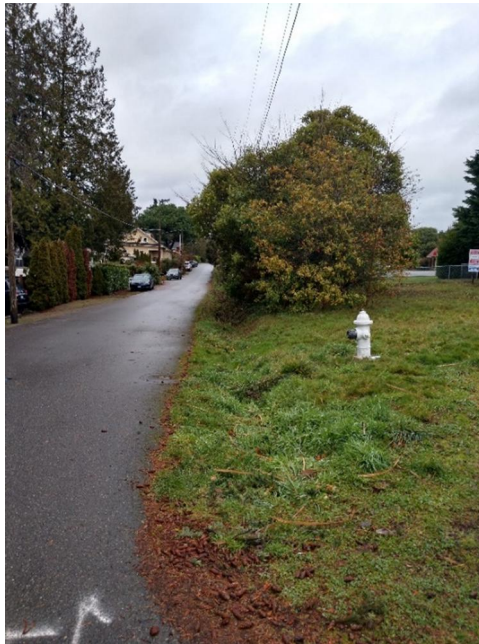
*Photo S5 – Facing north on the east side of 62<sup>nd</sup> Ave SE approximately 365 feet from Photo S4. Onsite runoff sheet flows in the southwest direction toward the ditch above and is conveyed south to be combined with the south basin downstream conveyance system.*

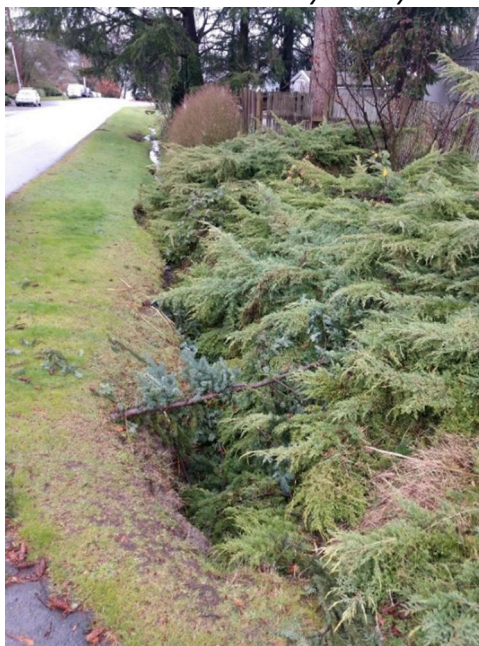
*Photo S6 – Facing west along the north side of SE 30<sup>th</sup> St approximately 40 feet west of Photo S5 at the northwest corner of the intersection of SE 30<sup>th</sup> St and 62<sup>nd</sup> Ave SE. Runoff is conveyed west from this pipe outfall toward Lake Washington.*

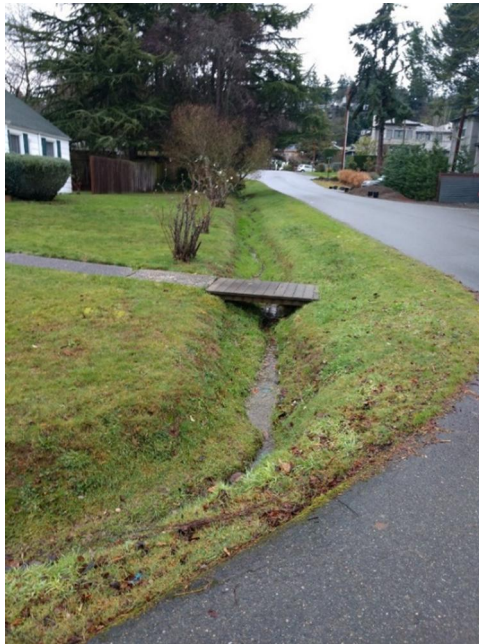
*Photo S7 – Facing east along the north side of SE 30<sup>th</sup> St approximately 210 feet west of Photo S6 at the northeast corner of the intersection of SE 30<sup>th</sup> St and 61<sup>st</sup> Ave SE. Runoff is conveyed west toward Lake Washington.*

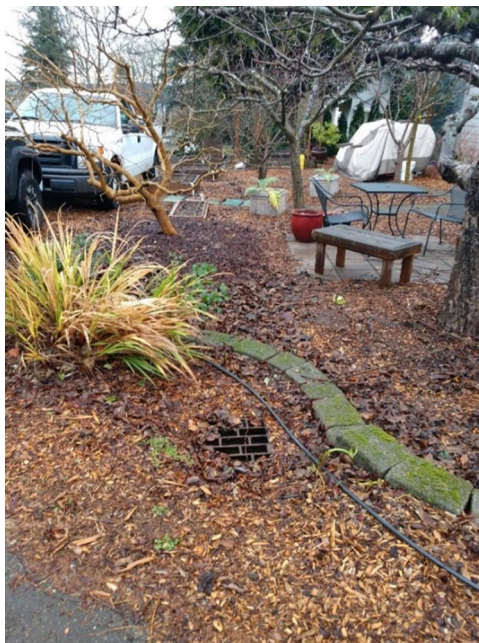
*Photo S8 – Facing west along the north side of SE 30<sup>th</sup> St approximately 30 feet west of Photo S7 at the northwest corner of the intersection of SE 30<sup>th</sup> St and 61<sup>st</sup> Ave SE. Runoff is conveyed west toward Lake Washington.*

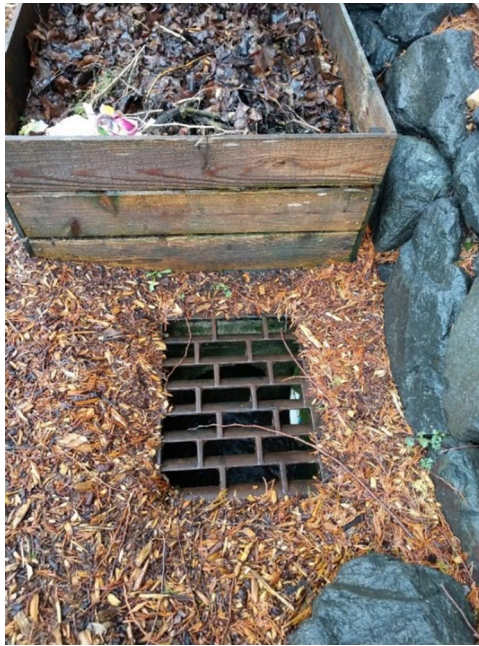
*Photo S9 – Facing west along the north side of SE 30<sup>th</sup> St approximately 65 feet west of Photo S8. Runoff is conveyed west toward Lake Washington.*

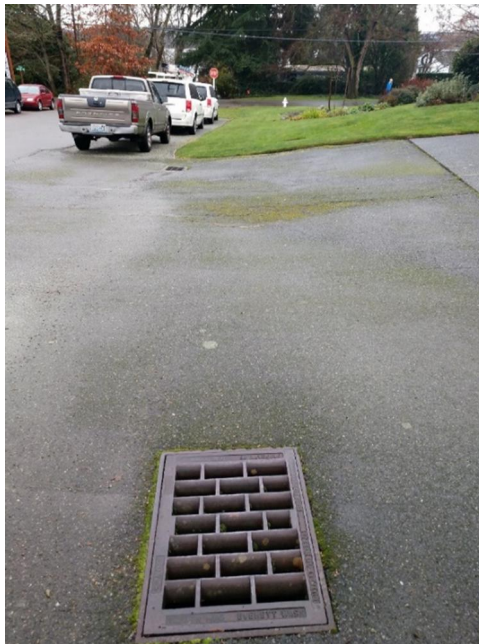
*Photo S10 – Facing west along the north side of SE 30<sup>th</sup> St approximately 30 feet west of Photo S9. Runoff is conveyed west toward Lake Washington.*

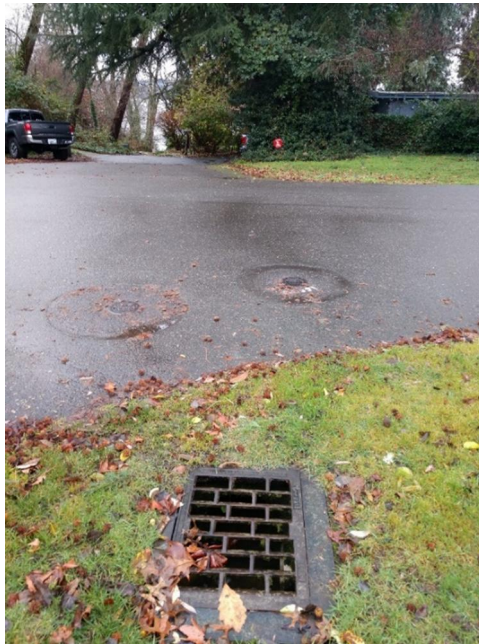
*Photo S11 – Facing west along the north side of SE 30<sup>th</sup> St approximately 130 feet west of Photo S10 at the northeast corner of the intersection of SE 30<sup>th</sup> St and 60<sup>th</sup> Ave SE. Runoff is conveyed west toward Lake Washington.*

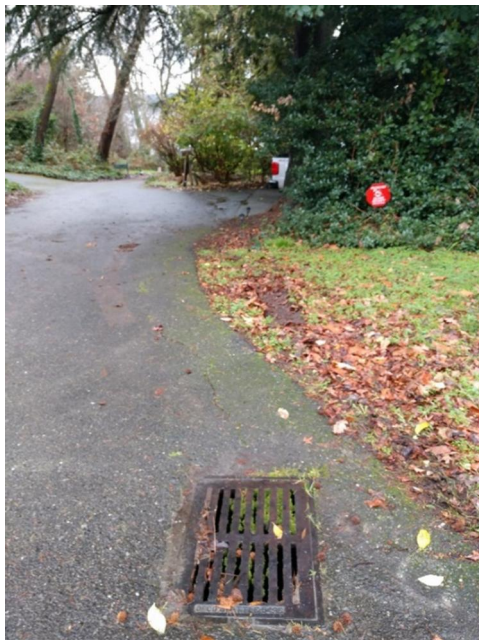
*Photo S12 – Facing west in front of the entrance to Garfield Landing approximately 35 feet west of Photo S11. Runoff is conveyed west toward Lake Washington.*

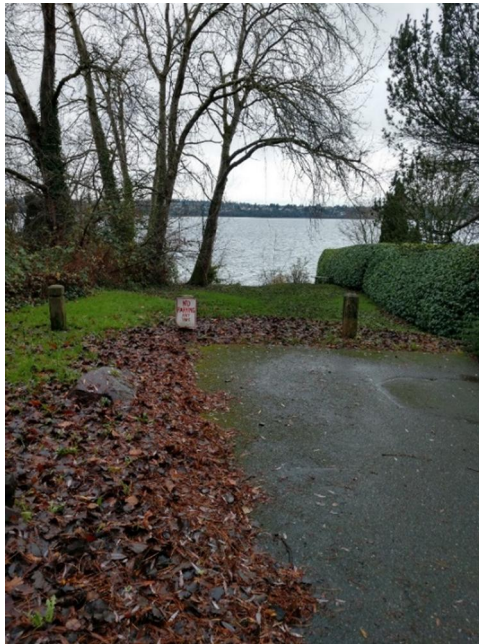
*Photo S13 – Facing west in Garfield Landing. Runoff is conveyed west to the outfall into Lake Washington.*

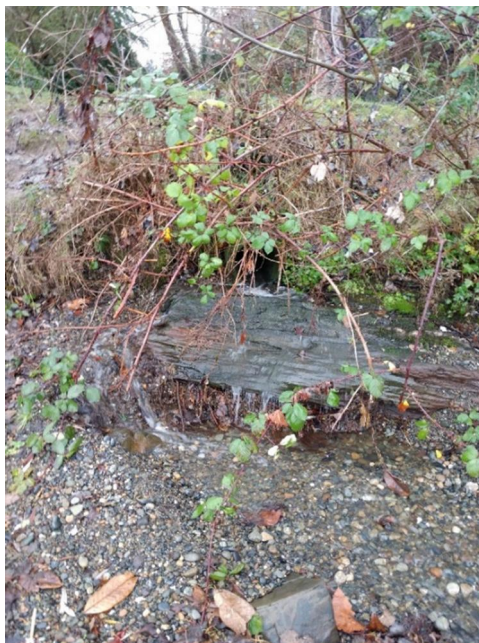
*Photo S14 – Facing east looking directly at the outfall to Lake Washington.*
