TECHNICAL MEMORANDUM

Date: February 9, 2022
To: Grace Feng
From: Justin Kay, Ecologist
Project Name: Mercer Island Feng
Project Number: 220112

Re: Feng Property, Reconnaissance Study

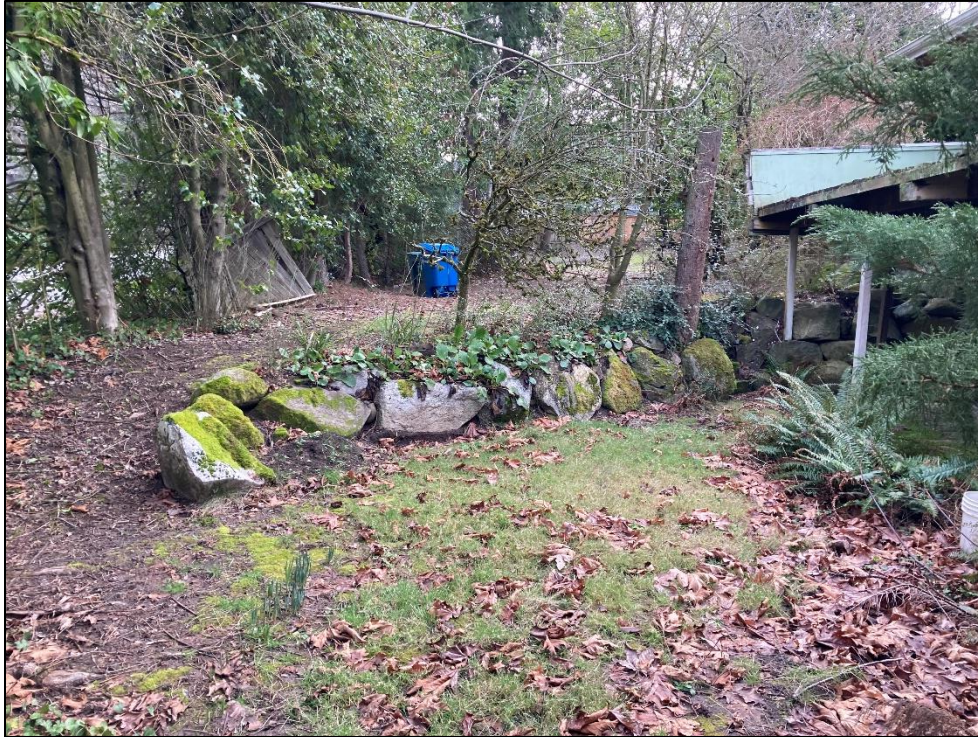
Soils north of the existing residence met criteria for hydric soils within a small, isolated, compacted depression vegetated with lawn grasses and common residential weeds. This area appears to be disturbed from regular foot traffic. It is possible this compaction has created a semi-restrictive layer occasionally impounding water during heavy rainfall. Hydric soils were not observed anywhere else within the subject property. No wetland hydrology was observed

Photo 1. Shallow depressional feature near north side of residence.

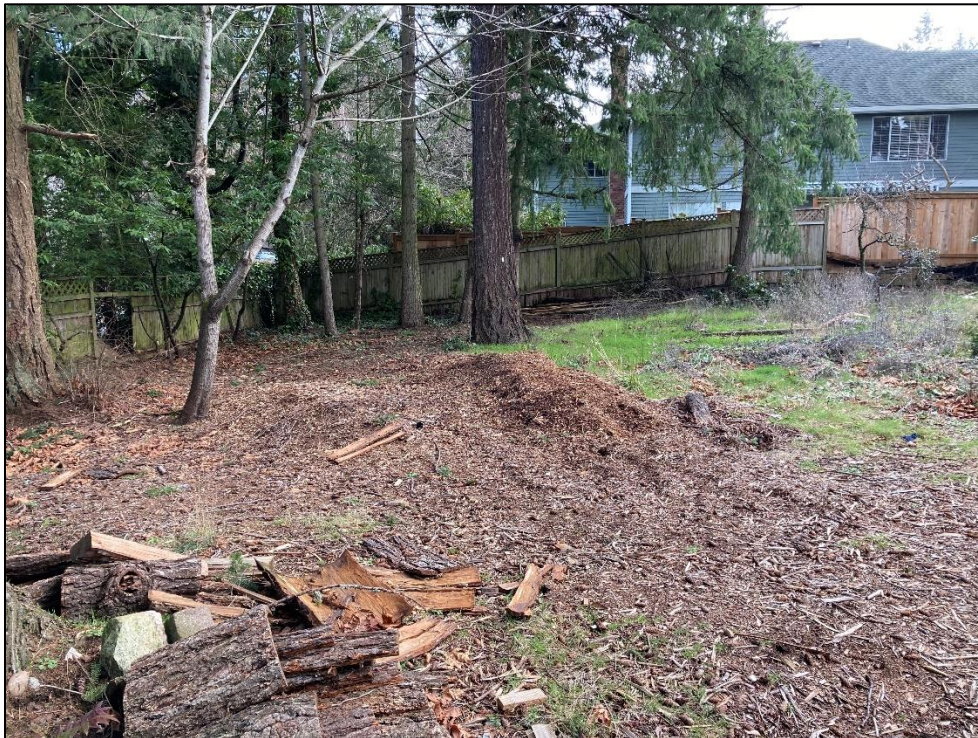
Photo 2. Undeveloped eastern half of subject parcel.

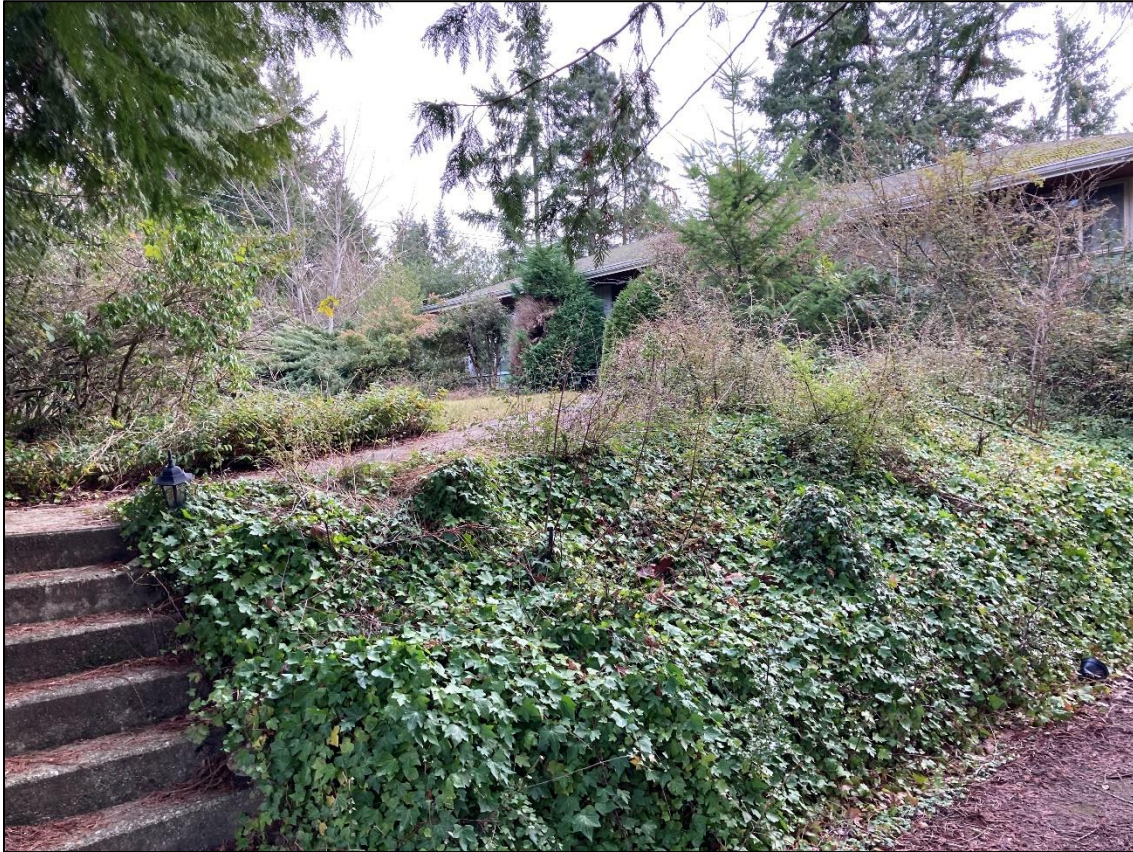
No jurisdictional wetlands or streams were found within or directly adjacent to the study area. The subject property does not meet wetland criteria for hydrophytic vegetation or wetland hydrology at any location and there are no indications of flowing water on-site. Dominant vegetation includes big-leaf maple, western red cedar, Douglas fir, Pacific dogwood, cherry, juniper, St. John’s wort, English ivy, and western sword fern. All species are indicative of either upland or neutral conditions. No hydrophytic vegetation was observed within the subject property.

Photo 3. Front yard of subject property from driveway near 78th Avenue Southeast. Note upland plant community.

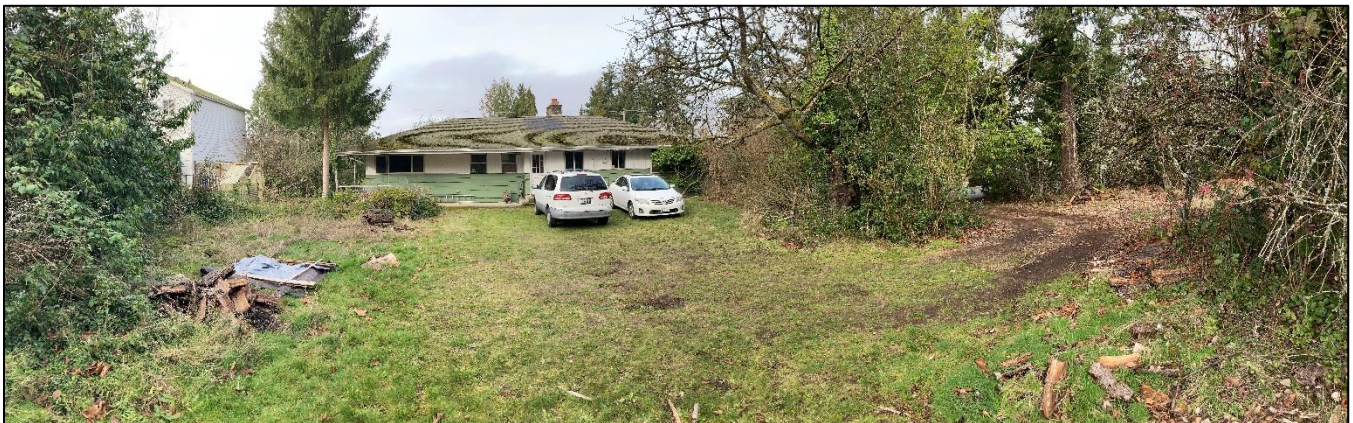
Photo 4. Backyard of subject property. 72nd Street is accessible along dirt driveway (right).
