CRITICAL AREA REVIEW 2 CAO20-003

Project No:	CAO20-003
Description:	Request to reduce piped watercourse setback from 45 feet to 10 feet pursuant to MICC 19.07.180(C)(6)(d) to accommodate future construction of a single-family home.
Applicant/ Owner:	Johan Luchsinger (Baylis Architects) / Sellapriya Ramaiyah & Subu Sankara Subramanian
Site Address:	7466 E Mercer Way / Mercer Island WA 98040
Zoning District	R-8.4
Staff Contact:	Robin Proebsting, Senior Planner
Exhibits:	<ol style="list-style-type: none">1. Development Application signed October 25, 20202. Critical Area Study prepared by The Watershed Company, dated October 21, 20203. Letter prepared by Ages Engineering, LLC dated October 7, 20204. Site plan prepared by Baylis Architects, dated October 26, 20205. Memorandum prepared by ESA, dated January 15, 2021

Subject: 7466 E. Mercer Way Critical Areas Evaluation

subject 7466 East Mercer Way (Tax Parcel 2579500136) Critical Areas Evaluation (CAO-20-003) Third Party Review

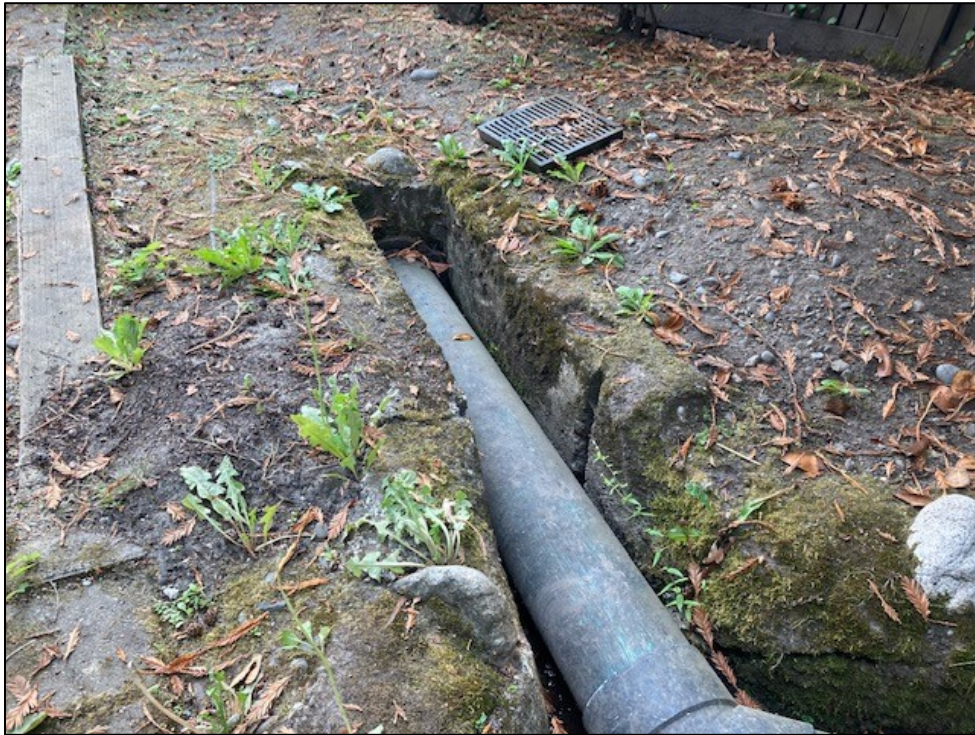
Figure 2. Watercourse A on the subject property, facing southeast (9/11/20)

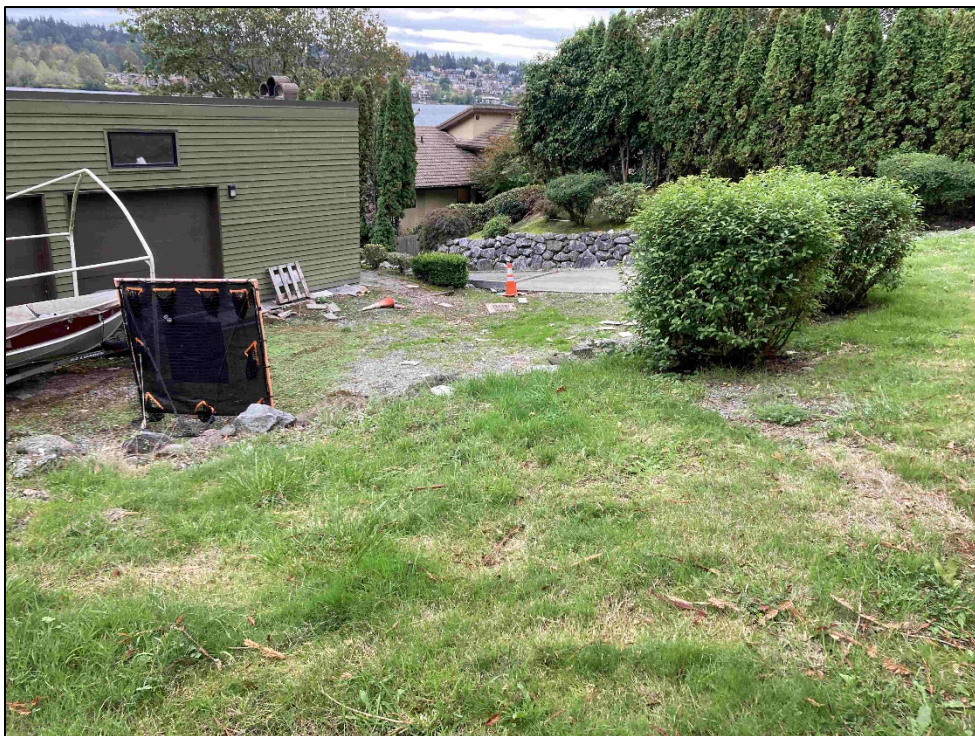
Figure 3. Location where open channel segment of Watercourse A is mapped south of subject property, facing southeast (10/16/20).

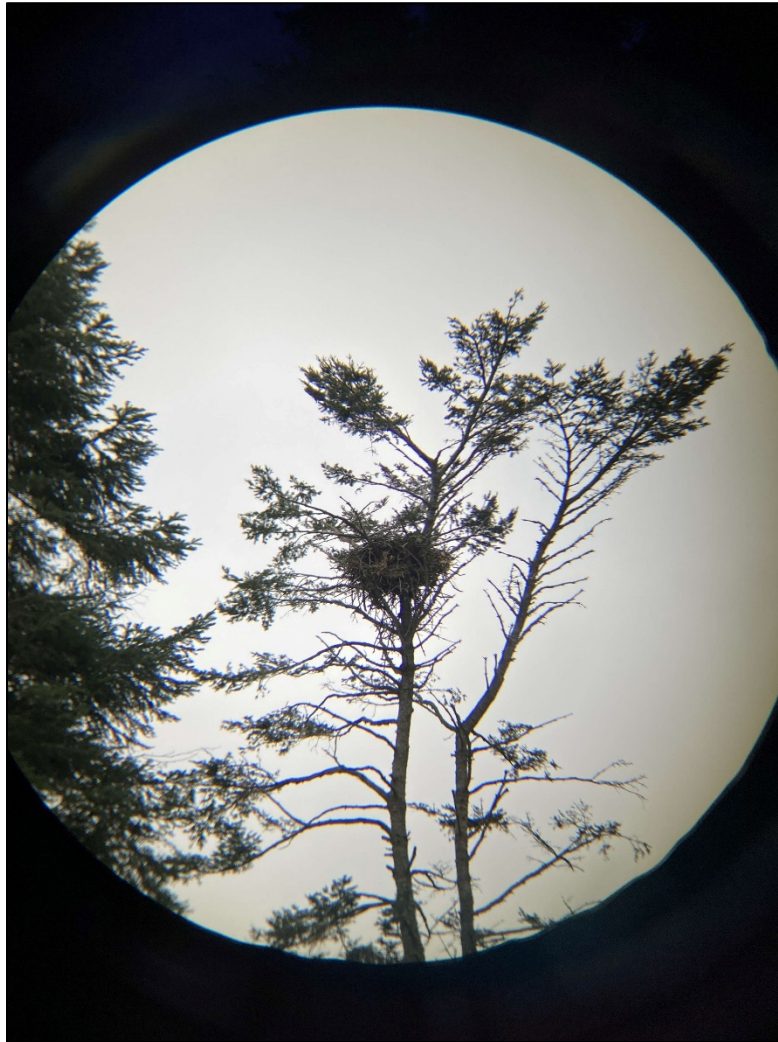
Figure 5. Bald eagle nest viewed through spotting scope from subject property (10/16/20).

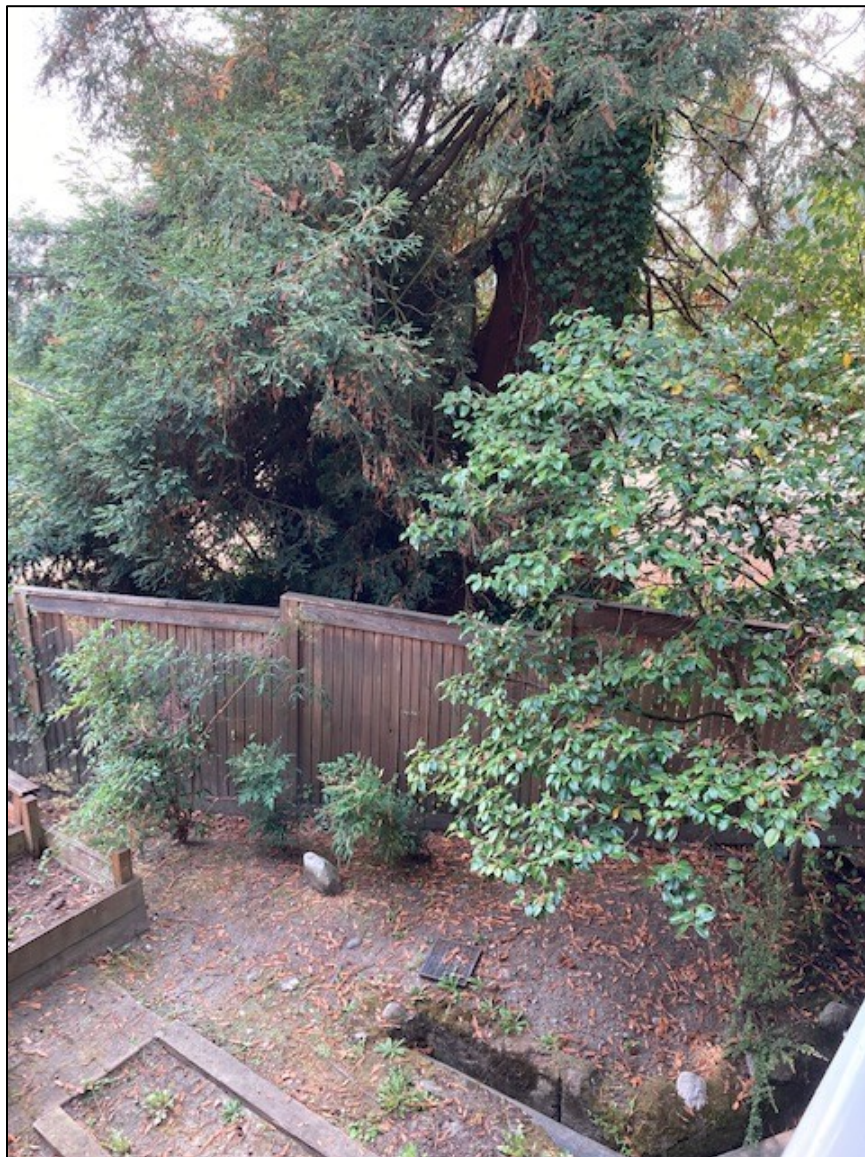
The piped segment of Watercourse A is located beneath the canopy of and within the critical root zone of an old-growth California redwood tree (*Sequoia sempervirens*) on the adjacent property to the south (Parcel #3024059114) (Figure 6). Based on visual estimates from the subject property, the redwood tree has a diameter at breast height of greater than 60 inches. Daylighting Watercourse A would necessitate the removal of this tree. The City prioritizes the retention of exceptional trees, and a redwood tree of this size and age is generally irreplaceable. The removal of the tree would represent an unnecessary risk of environmental damage due to the irreplaceable loss of habitat, soil stability, and evapotranspiration functions provided by this rare, old-growth tree, which conflicts with the requirements of MICC 19.07.180.C.6.d.ii. The environmental benefit of daylighting this short watercourse segment would not compensate for the loss of this tree, and it is not possible to completely mitigate the loss of this tree. Additionally, the redwood tree is not located on the subject property, meaning its removal would cause an additional impact on a neighboring property, which is in conflict with the requirements of MICC 19.07.180.C.6.c.ii. Daylighting Watercourse A would also create a watercourse buffer on the adjacent property where none currently exists, which conflicts with the same provision.

Figure 6. Watercourse A with old-growth redwood tree in background, facing southeast (9/11/20)

Based on the environmental damage resulting from the removal of an old-growth redwood tree, both on the subject property and the adjacent property, as well as the additional buffer encumbrance daylighting Watercourse A would create on the neighboring property, it is our opinion that daylighting Watercourse A is not feasible or environmentally beneficial at this location. Therefore, in accordance with MICC 19.07.180.C.6.d, a 10-foot setback should be required for Watercourse A.
