Memorandum

PROJECT: 41670.000

REGARDING: Mayo Property Watercourse Assessment Memorandum

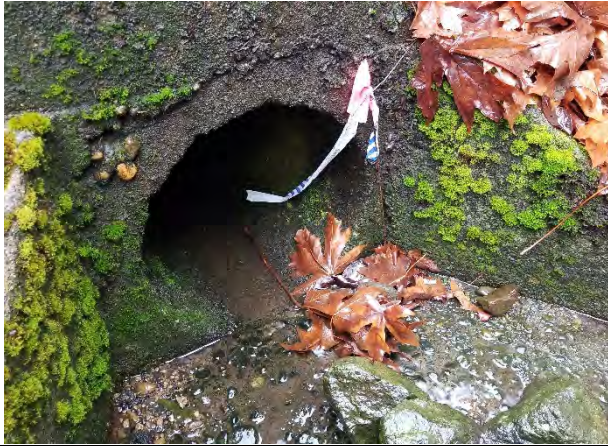
A clearly defined linear swale (Feature A) is present along the bottom of the south to north trending ravine. Feature A begins on Parcel 735570-0210 (1818 70th Avenue SE) and continues northward across Parcel 735570-0200 (1804 70th Avenue SE). The open channel ends at a concrete culvert under N Mercer Way (Figure 3, site photographs), and has a total length of approximately 100 feet.

Culvert at N Mercer Way.

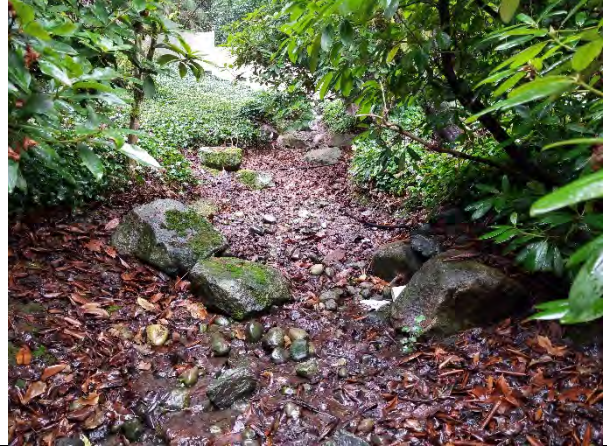
Upslope of N Mercer Way, Feature A has a distinct break in slope that differentiates the bed and bank. The ordinary high water mark (OHWM) ranges in width from approximately 48 to 60 inches. Above the OHWM of Feature A, the banks are approximately 4-6 inches high in the areas adjoining the subject property and appear to be composed of native earth or topsoil fill with no visible undercutting. Below the OHWM, the streambed is dominated by gravel and cobbles (rounded stones 0.5-inch to 6-inches in size), with eroded silts and sands deposited in the interstices. Several 12 to 24-inch angular or cut stones were present within the channel, as well as several areas of angular quarry spalls that appear to be present to stabilize the slopes and culvert mouth. These artificial features are consistent with past landscaping efforts and ongoing use of this feature as a conveyance for roadside and residential stormwater runoff.

Watercourse facing south from N Mercer Way.

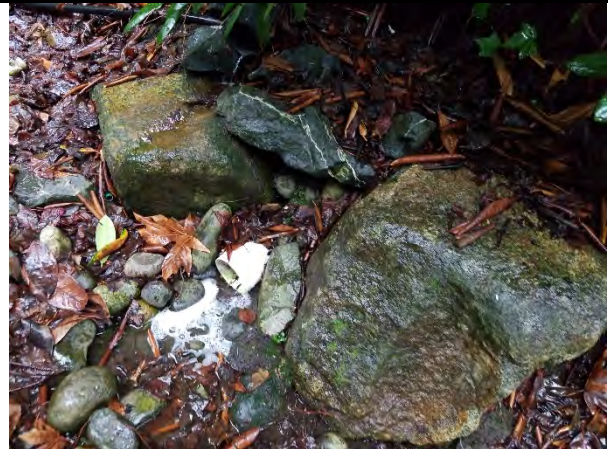
Approximately 1 inch of water was present in Feature A during all three site visits. This water enters Feature A in two forms: as runoff from surrounding residential parcels; and as stormwater collected from W Mercer Way, 72nd Avenue SE, SE 20th Street, and N Mercer Way. The residential runoff is conveyed to Feature A as overland flow and via stormwater pipes. The roadway runoff is collected in a series of open ditches and culverts that outfall to the east and west banks of Feature A at N Mercer Way.

Stormwater from 1804 70th Avenue SE .

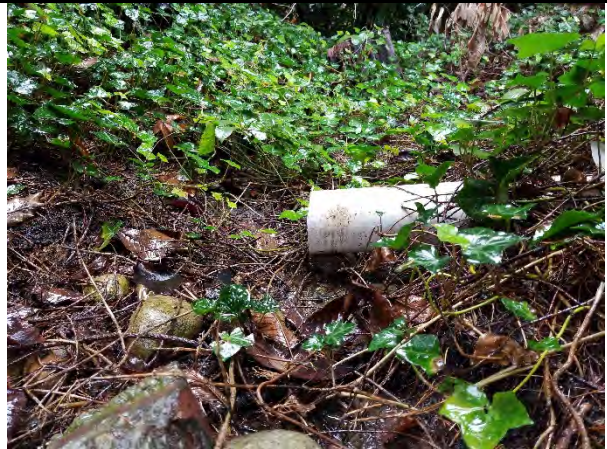
Stormwater from 1818 70th Avenue SE.

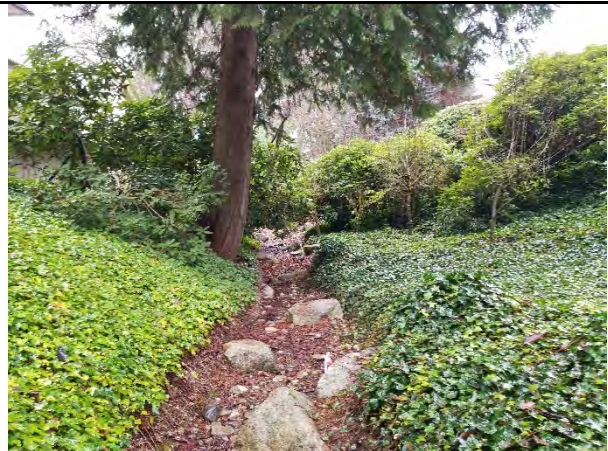
Looking north from property line.

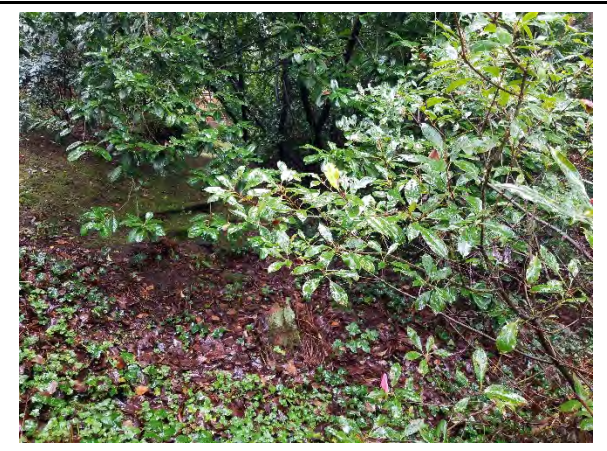
North ends of watercourse from subject property.

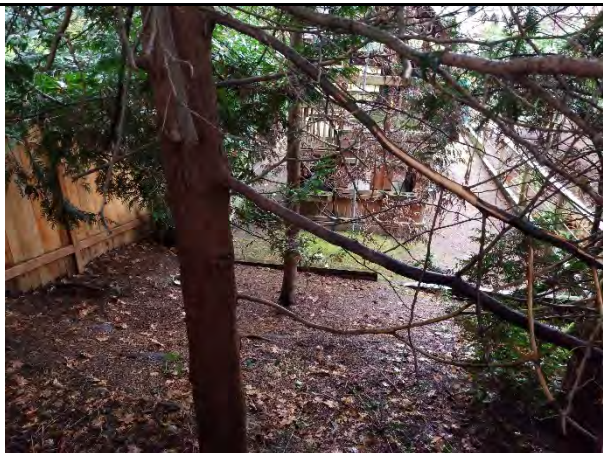
South of watercourse origin, from subject property.
