CRITICAL AREAS REPORT

HOU PROPERTY MERCER ISLAND, WASHINGTON

30 July 2007
(Revised 19 July 2017)

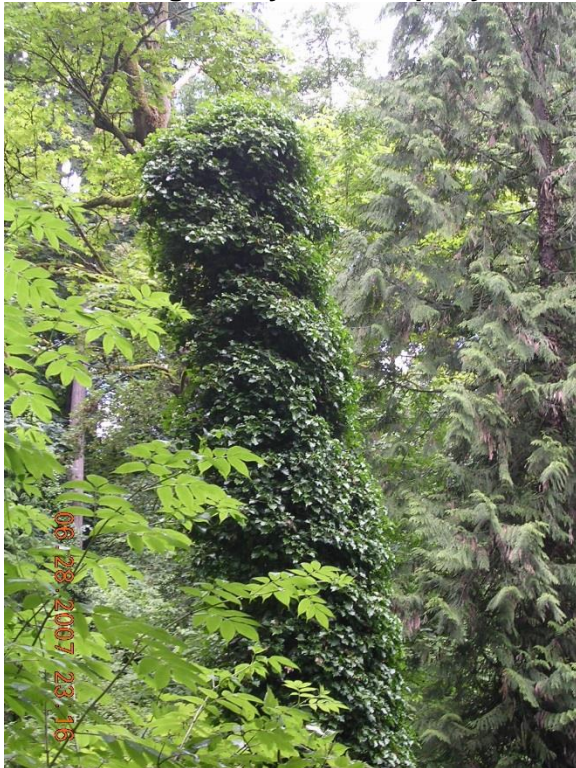
Photo 1: English Ivy, Hou Property, Mercer Island, Washington

The invasive English ivy (*Hedera helix*) is classified as a Class C Noxious Weed of Concern in King County. Removal of on-site English ivy will be achieved through manual control. Manual control consists of cutting/prying accessible vines off trees, removing all accessible flowers and seed heads, hand pulling/digging out plants, and mulching areas of ivy removal with an 8" thick mulch layer. Mulching will only occur on areas not located on steep slopes. The following photo (**Photo 1**), dated 28 June 2007, is representative of the on-site invasive species conditions.

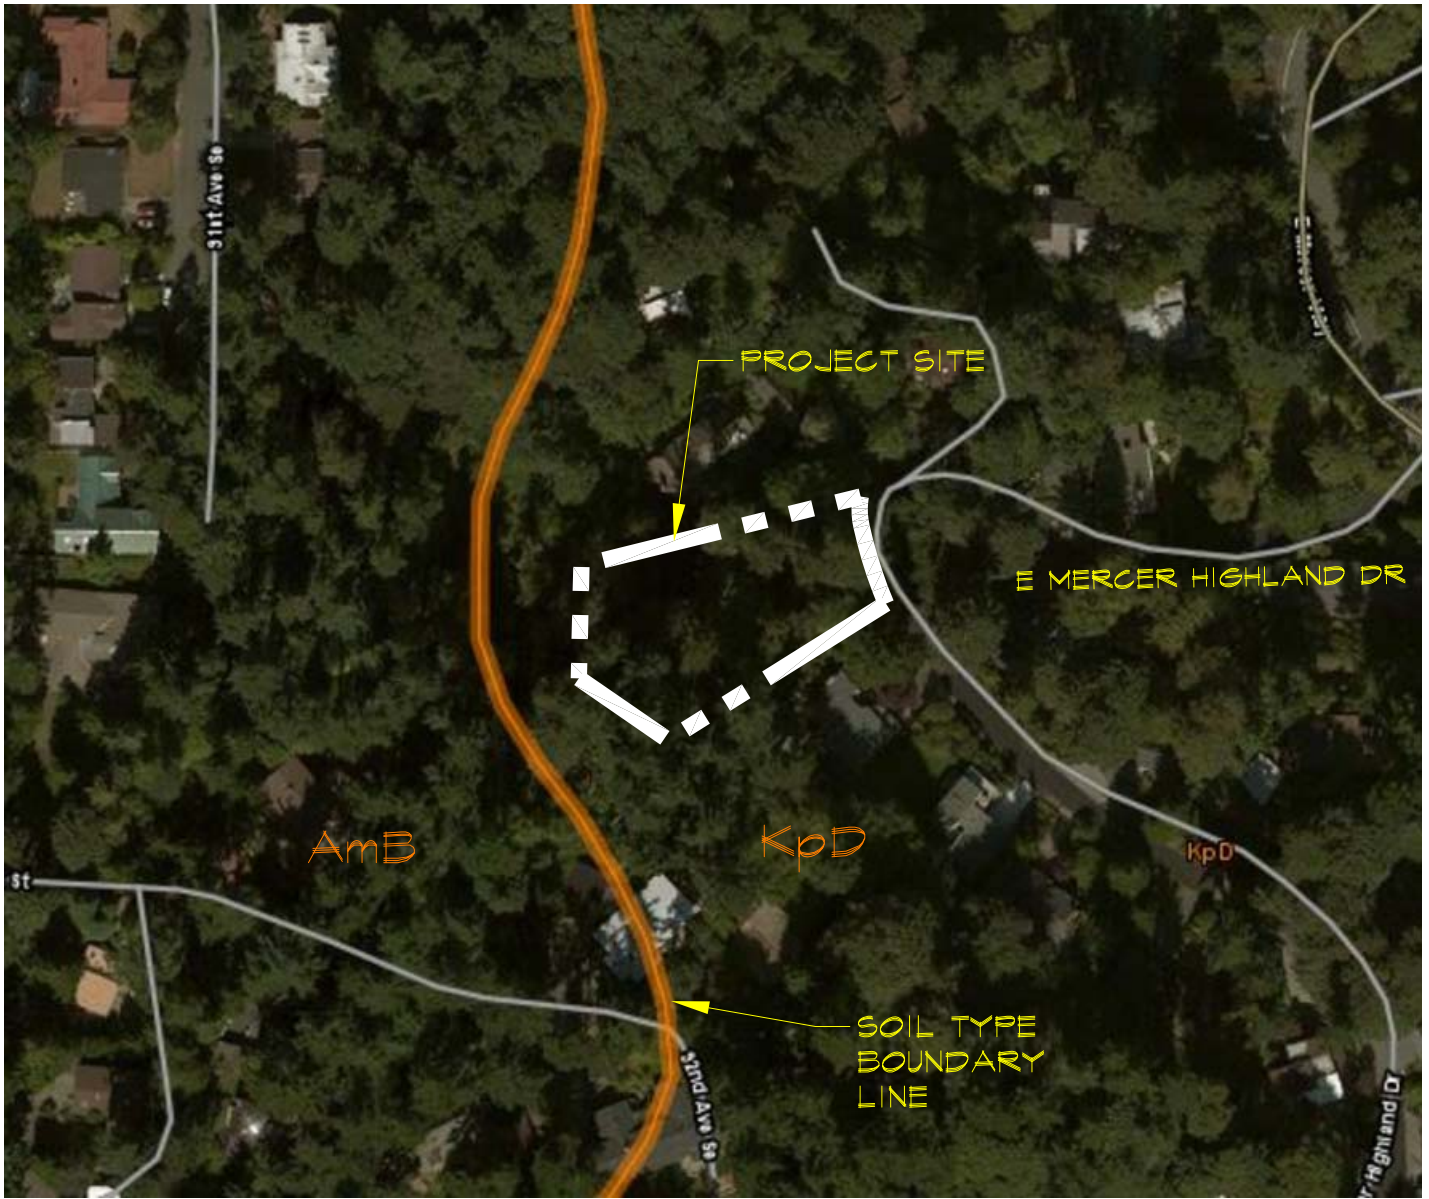
AmB ARENTS, ALDERWOOD MATERIAL, 0 TO 6 PERCENT SLOPES.
 KpD KITSAP SILT LOAM, 15 TO 30 PERCENT SLOPES.

SOILS: The Natural Resources Conservation Service (NRCS) has mapped the property as Kitsap silt loam, 15 to 30% slopes. Kitsap silt loam is not listed as hydric on either of the State or County hydric soil lists. Soils in the upland portions of the property generally appeared to correspond with the Kitsap series.

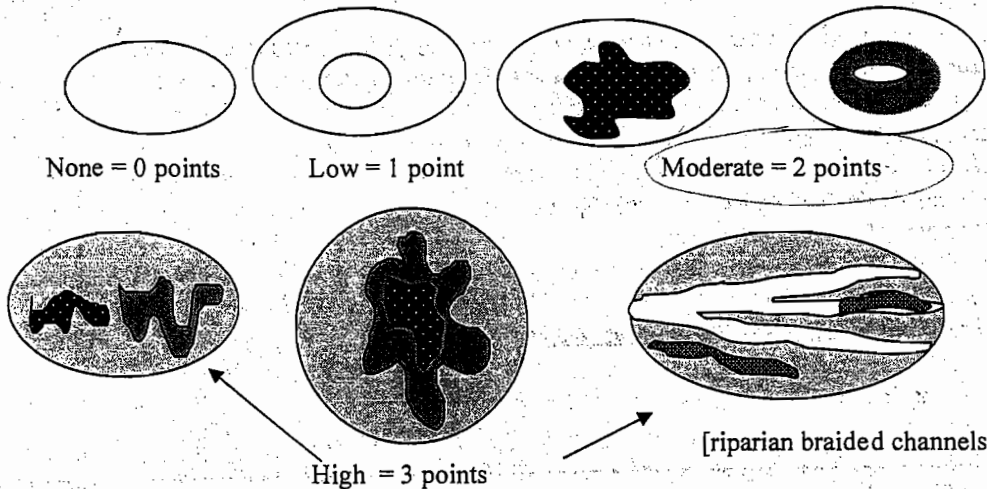
Decide from the diagrams below whether interspersion between Cowardin vegetation classes (described in H 1.1), or the classes and unvegetated areas (can include open water or mudflats) is high, medium, low, or none.

NOTE: If you have four or more classes or three vegetation classes and open water the rating is always "high". Use map of Cowardin vegetation classes

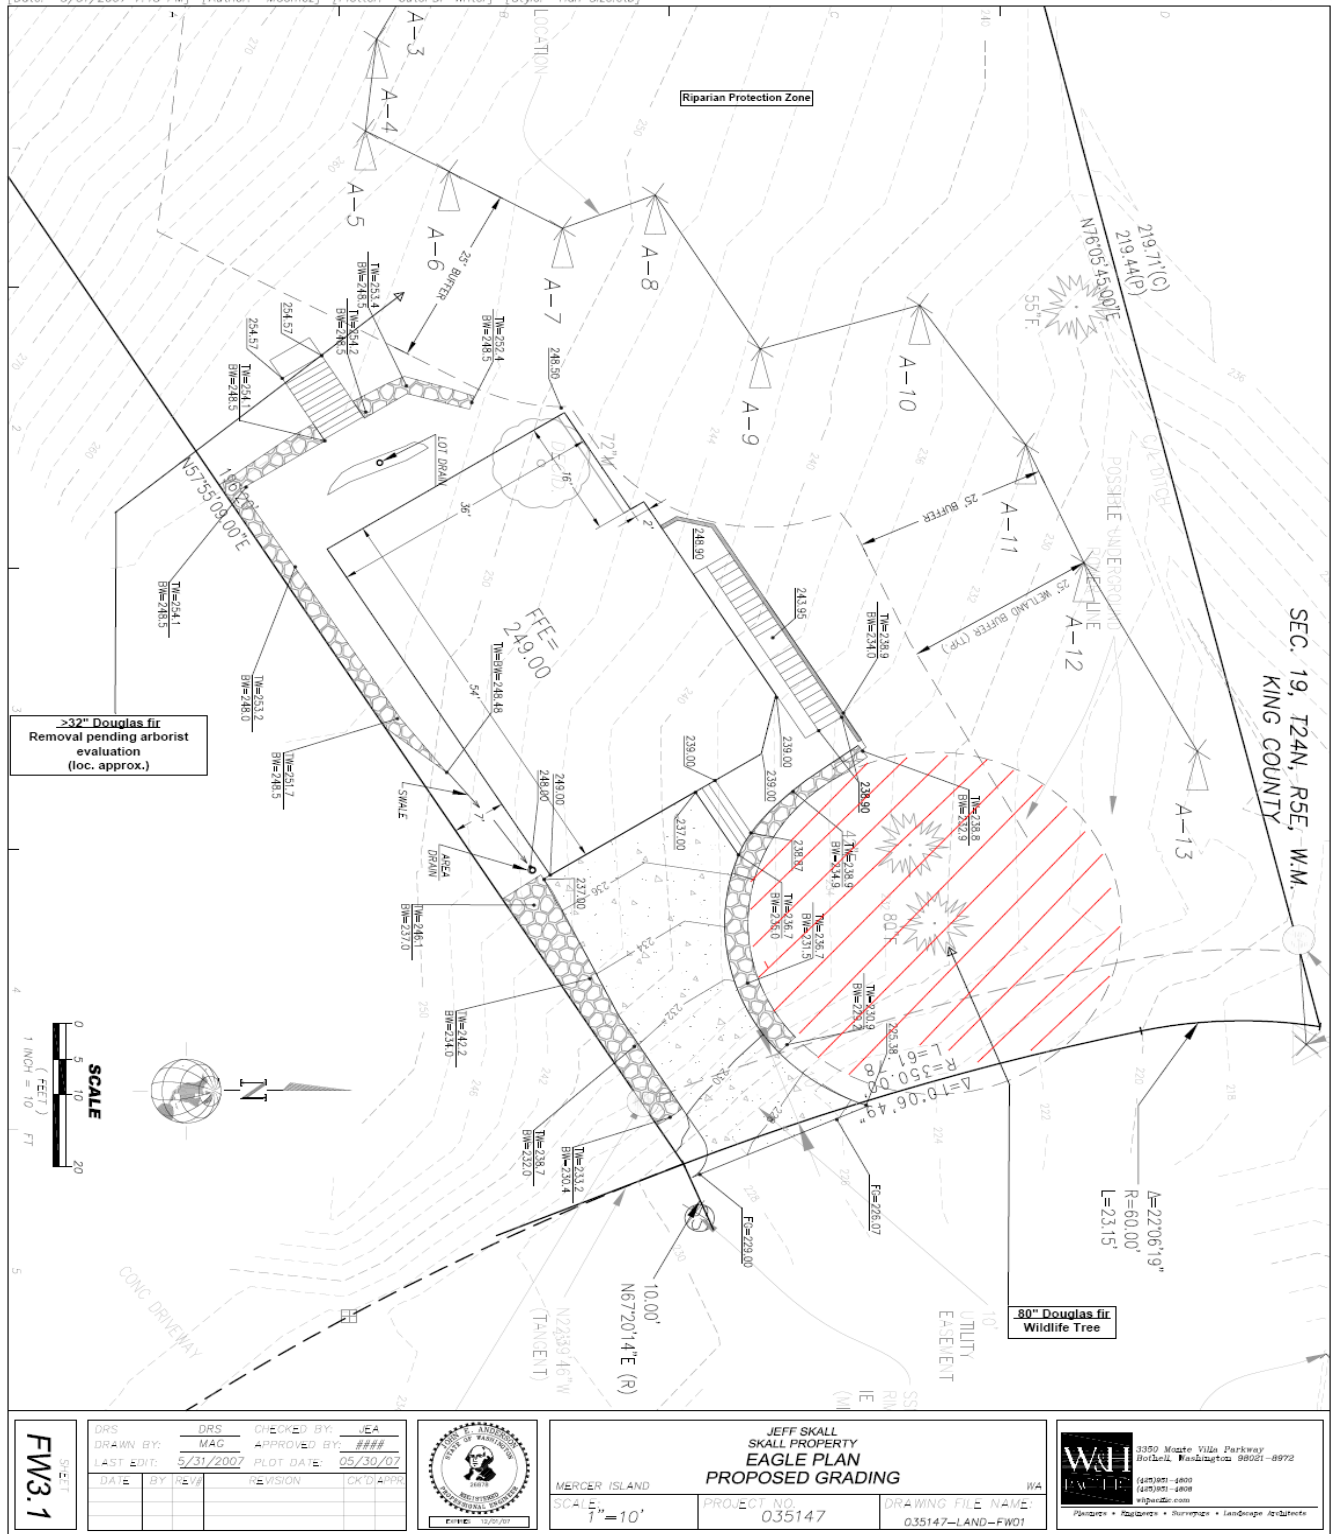
Figure 1. Topographic survey and site development plan for Skall residence construction at 4821 East Mercer Highlands Drive, Mercer Island, WA (TPN 2162000070) indicating wildlife tree (80" fir w/ eagle nest). One conifer tree (>32" fir) west of house may be removed pending arborist evaluation. The eagle tree protection zone includes an area within a 20-foot radius measured from the bole of the wildlife tree (hatched area).

The current proposal involves construction of a single-family residence and driveway accessing the property (Figure 1). The driveway must be constructed in such a way that there is no damage to the nest tree. A creek along the northern property boundary further complicates access to the parcel. This type III stream has a minimum 25-foot buffer setback required by the City of Mercer Island. A certified arborist from Northwest Arboriculture, LLC assessed the nest tree and supporting roots to determine a proposed driveway location with the least impact to the tree (see Appendix A). He found that most of the roots, including all major supporting roots, were on the downhill (north) side of the tree toward the creek. Therefore, he determined that the least impacting location for the driveway is on the uphill (south) side of the tree, even though this will require an excavation of up to 4 feet. In order to minimize damage to the tree, the 12-foot wide driveway shall be adjacent to the south property line, and the roadcut shall be nearly vertical, supported by retaining walls on either side. Drainage shall be directed to the south side of the driveway. The eagle tree protection zone shall be marked with construction fencing (to be retained throughout all phases of construction). No activities of any kind, including materials storage, shall occur within the eagle tree protection zone. After construction the fencing may be removed, and minimal intrusion is allowed for invasive plant removal.
