CRITICAL AREAS REPORT

HOU PROPERTY MERCER ISLAND, WASHINGTON

30 July 2007
(Revised 19 July 2017)
(Revised 12 March 2019)

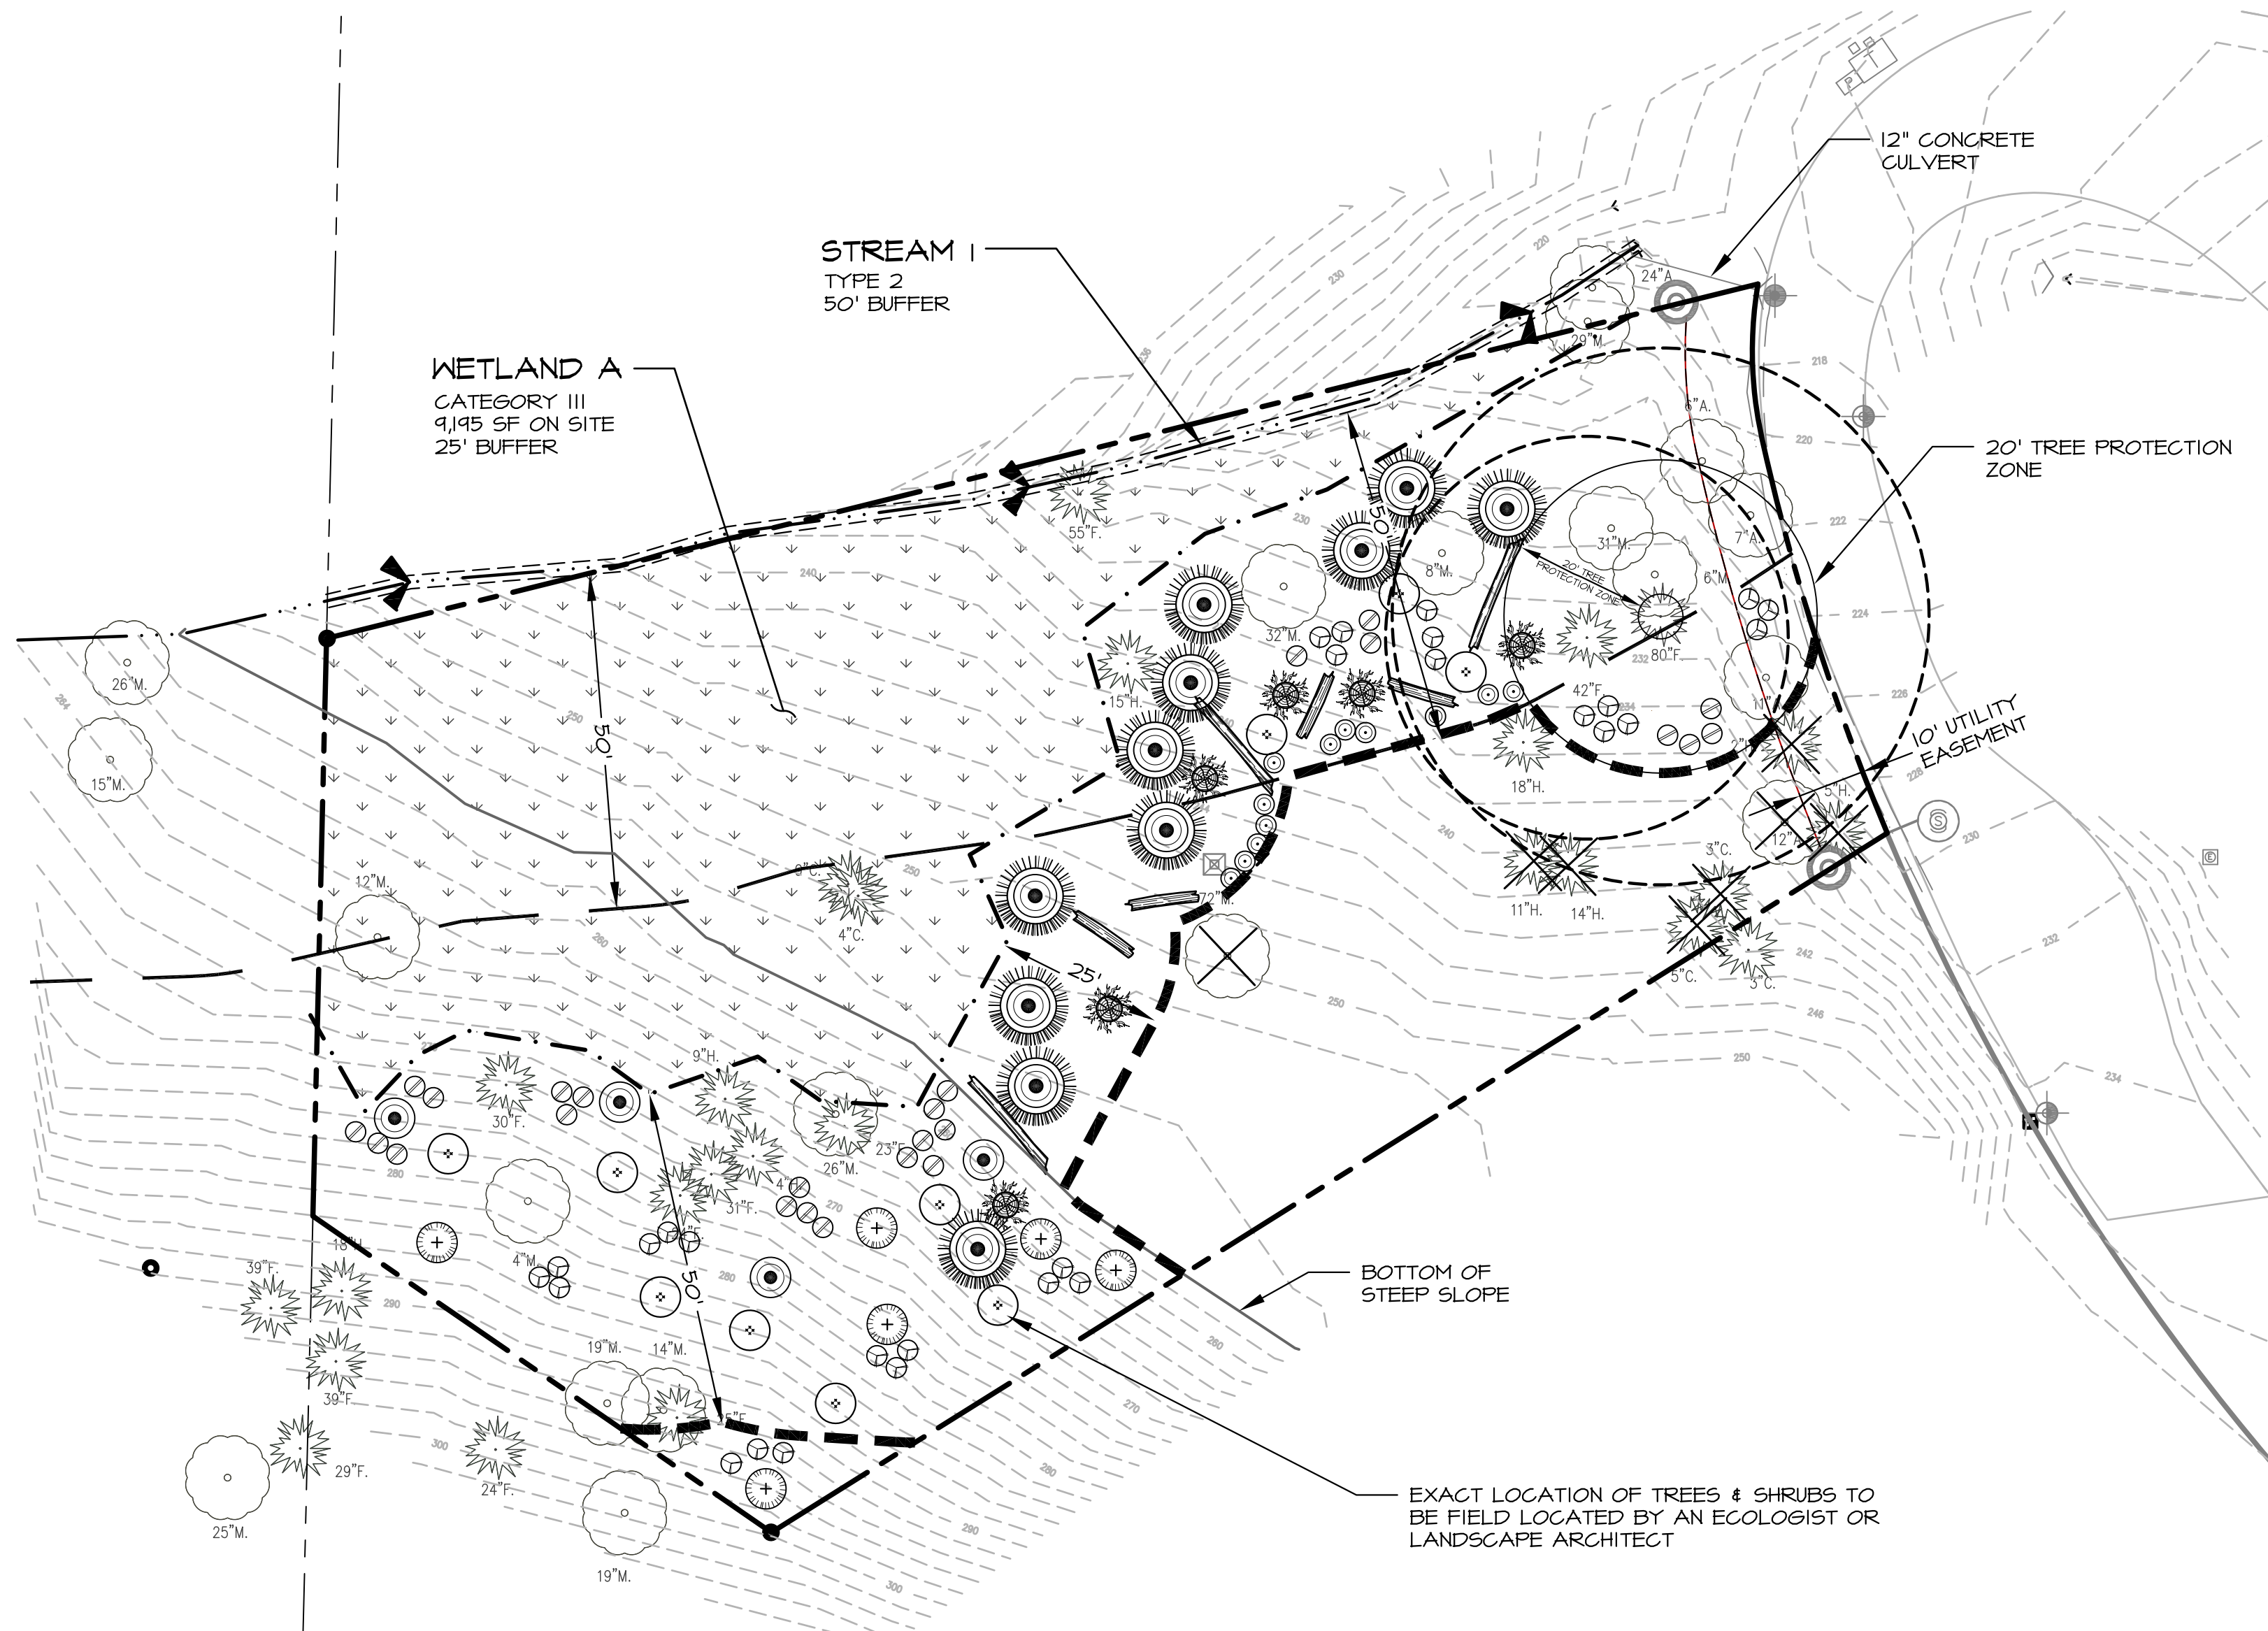
PLANTING PLAN

result in the required net improvement of critical area functions. The project proposes planting the following species: vine maple, sword fern, Douglas fir, baldhip rose, salmonberry, and western red cedar (**Sheet 1.2**). 21 replacement conifer trees (minimum 6-feet high at time of planting), will be established in the buffer areas at a 1:1 ratio for conifer trees removed during construction of the house and driveway. More smaller trees are being proposed for the enhancement (and tree replacement) plantings because we have found smaller trees establish within mature forest settings better than larger plant materials. Therefore, 21 smaller conifers are currently proposed rather than the previously proposed (7) larger conifers. Post-construction, a set of as-built plans depicting plant types and locations will accompany a compliance report submitted to the City.

- 1) English Ivy removal,
- 2) Placement of large woody debris (taken from one, on-site, decomposing large-diameter snag removed during construction) in the wetland and stream buffer areas,
- 3) Planting of 21 conifer trees in the enhanced buffer areas (greater than a 1:1 replacement ratio for conifers removed during construction of the house and driveway),
