**CRITICAL AREAS DETERMINATION****NOTICE OF DECISION****April 2, 2018**

<b>Project Number:</b>	CAO17-011
<b>Description:</b>	Request to review a critical areas study and mitigation plan to reduce the wetland buffer to the minimum 25 feet along the western portion of the wetland
<b>Applicant:</b>	David Daniel Demco Law 5224 Wilson Ave S #220 Seattle WA 98118
<b>Owner:</b>	Edith Cropp 4803 Forest Ave SE Mercer Island WA 98040
<b>Site Address:</b>	4810 Forest Ave, Mercer Island WA 98040; Identified by King County Assessor tax parcel number 4045000145
<b>Zoning District:</b>	R-15
<b>SEPA Compliance:</b>	The proposal is categorically exempt from SEPA review per WAC 197-11-800(6)(e).
<b>Exhibits:</b>	<ol style="list-style-type: none"><li>1. Development Application for a Critical Area Determination, signed date July 25, 2017</li><li>2. Critical Areas Study prepared by Confluence Environmental Company, dated November 9, 2017</li><li>3. Peer review memo prepared by ESA, dated October 12, 2017</li><li>4. Critical Areas Study and mitigation plan prepared by Confluence Environmental Company, dated March 6, 2018</li><li>5. Peer review memo prepared by ESA, dated March 19, 2018</li><li>6. Publi

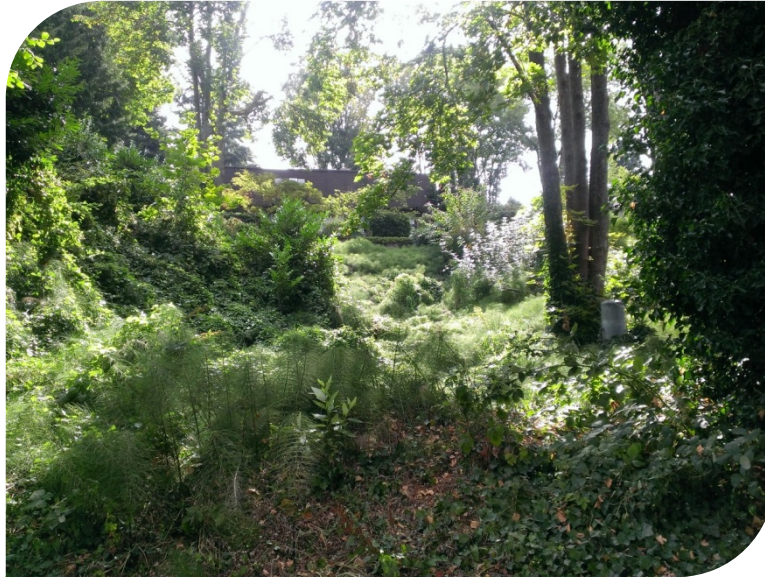
Photo 1— View to east of hillside east of proposed development; where Mercer Island IGS has mapped watercourse.

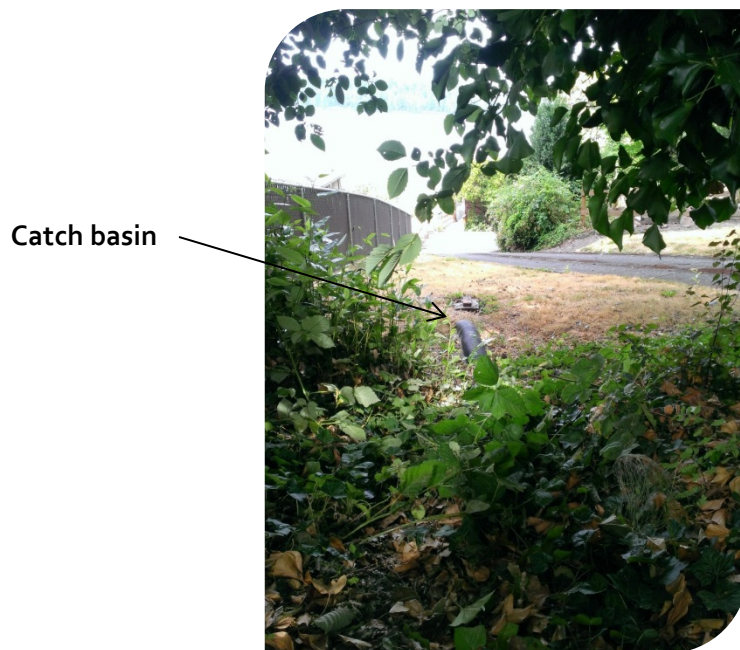
Photo 2— View to west at toe of hillside, where Mercer Island IGS has mapped watercourse.

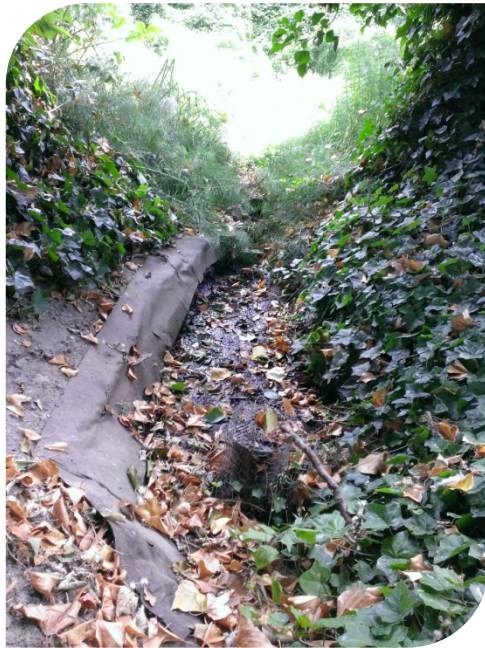
Photo 3— Concrete pond at toe of hillside. Screened, perched outlet in foreground.

At the base of the hillslope is a concrete pond (Topographic and Boundary Survey; Photo 3). The inlet of the pond is a 6-inch diameter corrugated plastic pipe (Photo 4). The pipe extended upslope approximately 30 feet east before it was no longer observed (Photos 5 and 6). The inlet of the pipe was not found. The pipe appears to have been laid in the low spot of the hillslope. No visual indicators of a watercourse were identified adjacent to the pipe or upslope of where the pipe could be seen (Photos 5, 6, 7 and 8).

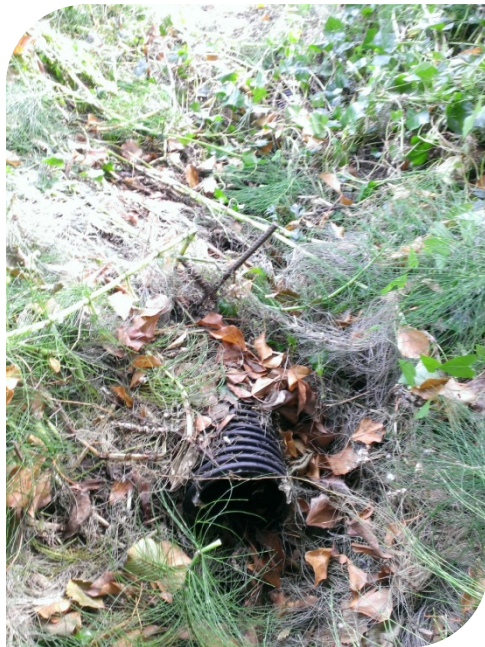
Photo 4— Inlet of runoff collection basin. Note lack of channel.

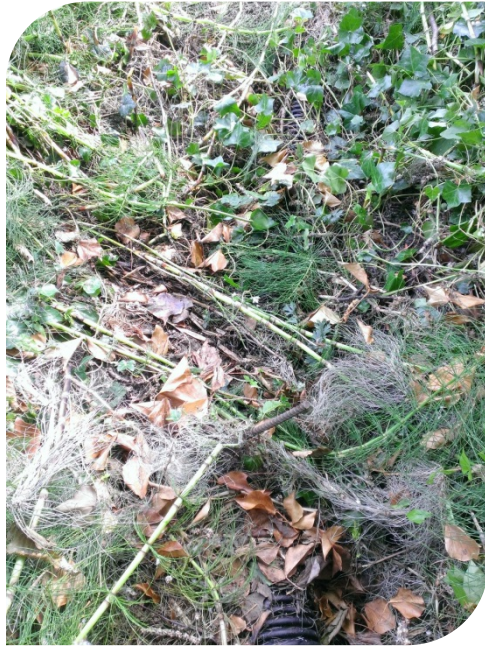
Photo 5— Upslope of inlet pipe.

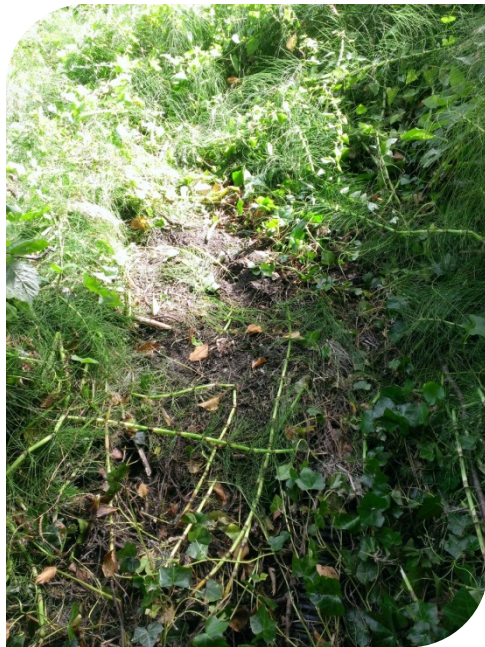
Photo 6— Upslope of inlet pipe with vegetation cleared. Note lack of channel.

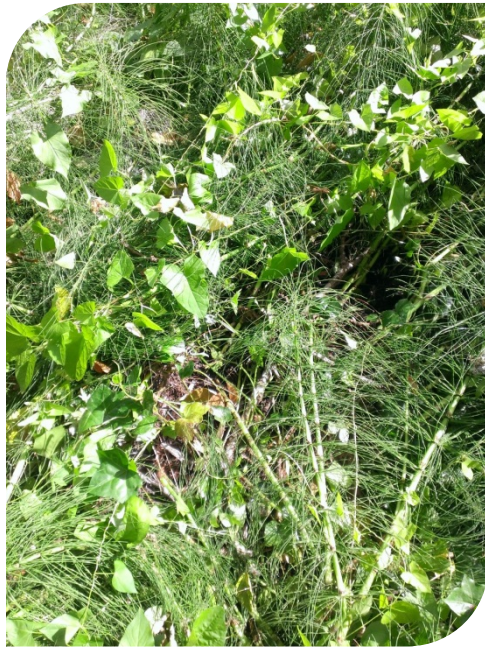
Photo 7— Upslope of Photo 6. Note lack of channel

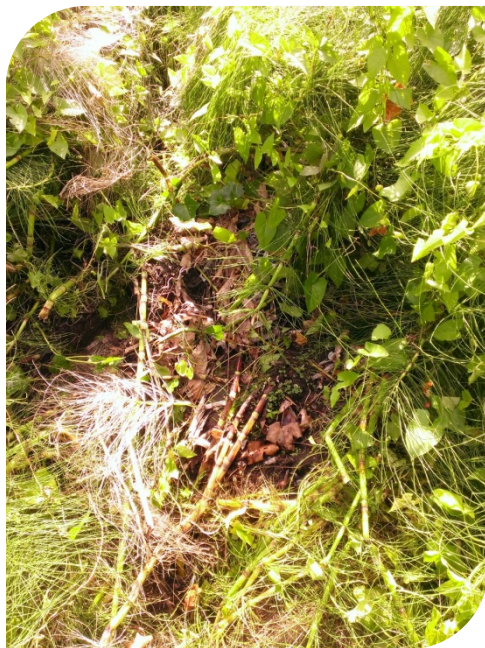
Photo 8— Upslope of Photo 7. Note lack of channel.

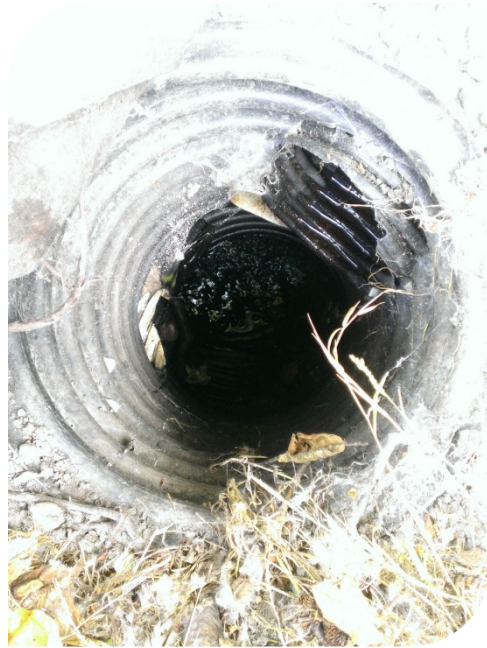
Photo 9— Catch basin collecting roof, driveway, and collection basin runoff.

During the site visit, no watercourse was observed. Runoff from the hillslope is collected into a concrete pond and discharged to Lake Washington via a series of catch basins and pipes. In addition, runoff from the properties impervious surfaces (i.e. roof and driveway) is collected into this pipe system and discharged to the Lake. The lack of a visible watercourse at the outlet of the pipe indicated that despite this collection and concentrated discharge, there is not sufficient water volume to create a watercourse at the pipe outlet. If this water volume is insufficient to create a watercourse, which includes the site's impervious surface runoff, then the volume of water generated by the hillslope is not sufficient to generate a watercourse.

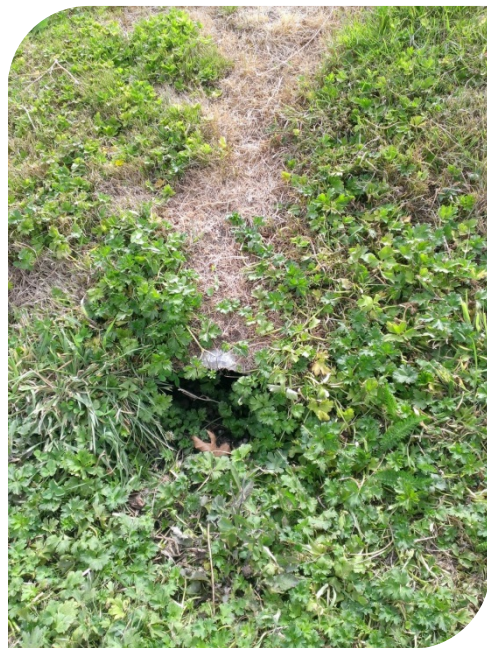
Photo 10— Outlet downslope of catch basin. Note lack of channel.

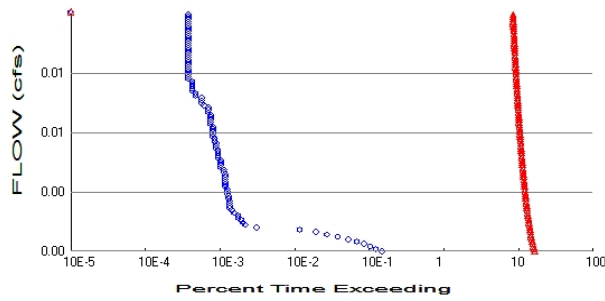
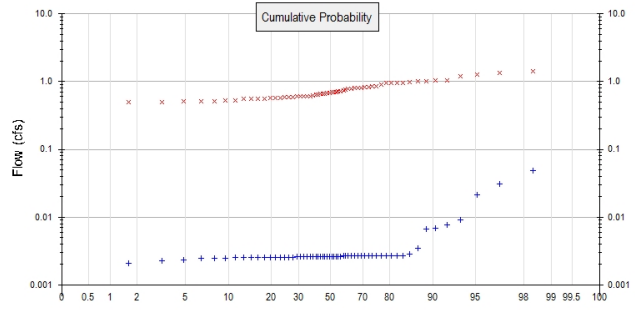
## POC 1

# Analysis Results

+ Predeveloped    x Mitigated

Based on model results using WWHM<sub>2012</sub>, stormwater runoff in the contributing basin would not have resulted in enough flow to create a defined water course. The stormwater control system that was observed during the field visit would be large enough to contain the majority of flows that would come from the developed house and driveway impervious surfaces. Therefore, it is not likely that a defined watercourse would have existed in this area prior to development and the development has been constructed such that the additional runoff from impervious surfaces is adequately contained.

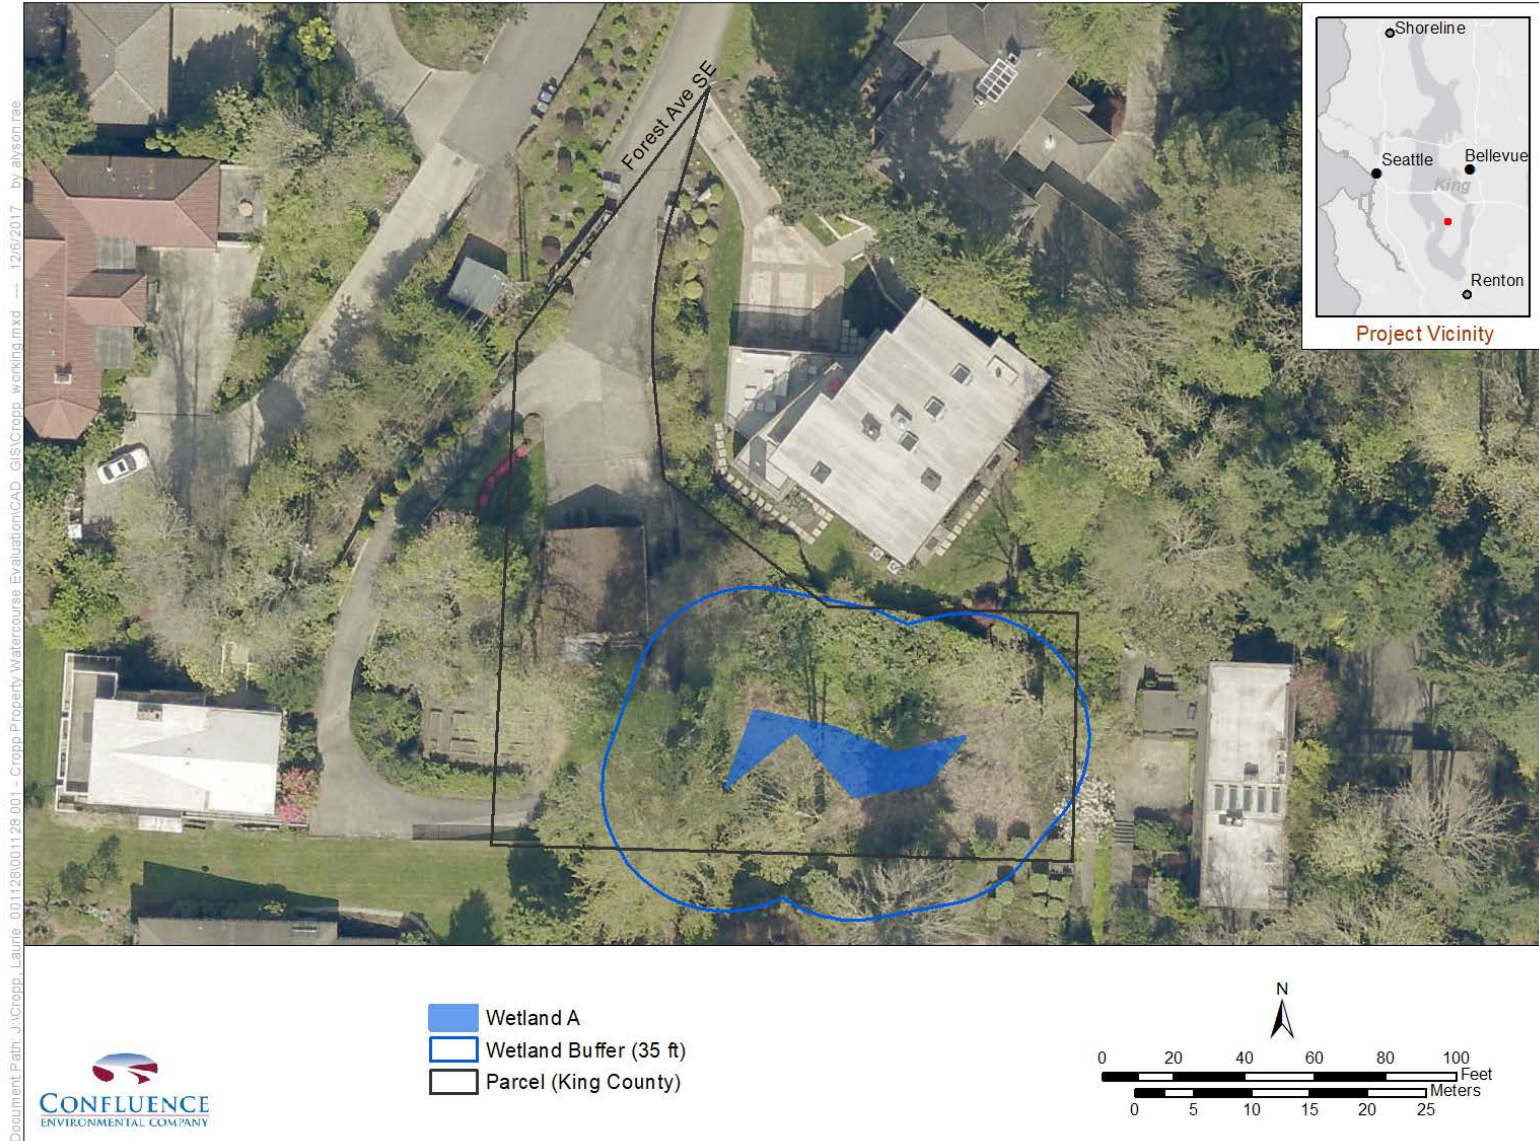
Figure 1. Site Vicinity and Delineated Wetland

According to Mercer Island City Code (MICC) 19.07.080, Category IV wetlands have a standard buffer of 35 feet but buffers can be reduced to a minimum width of 25 feet with enhancement. The upland (including the buffer) surrounding the wetland is dominated by invasive species such as Himalayan blackberry (*Rubus armeniacus*), English ivy (*Hedera helix*) and laurel (*Daphne* sp.). Figure 1 shows the wetland and the standard buffer.

Confluence Environmental Company (Confluence) conducted site visits at 4803 Forest Avenue SE, Mercer Island, Washington (tax parcel 4045000145) (Figure 1). The purpose of the site visits was to determine the presence and extent of streams and wetlands on and the property. Critical areas such as erosion hazard areas, steep slopes, and landslide hazard areas were not evaluated (Confluence 2017a, b). The site visit identified and delineated one Category V wetland on the property (Confluence 2017a, b).

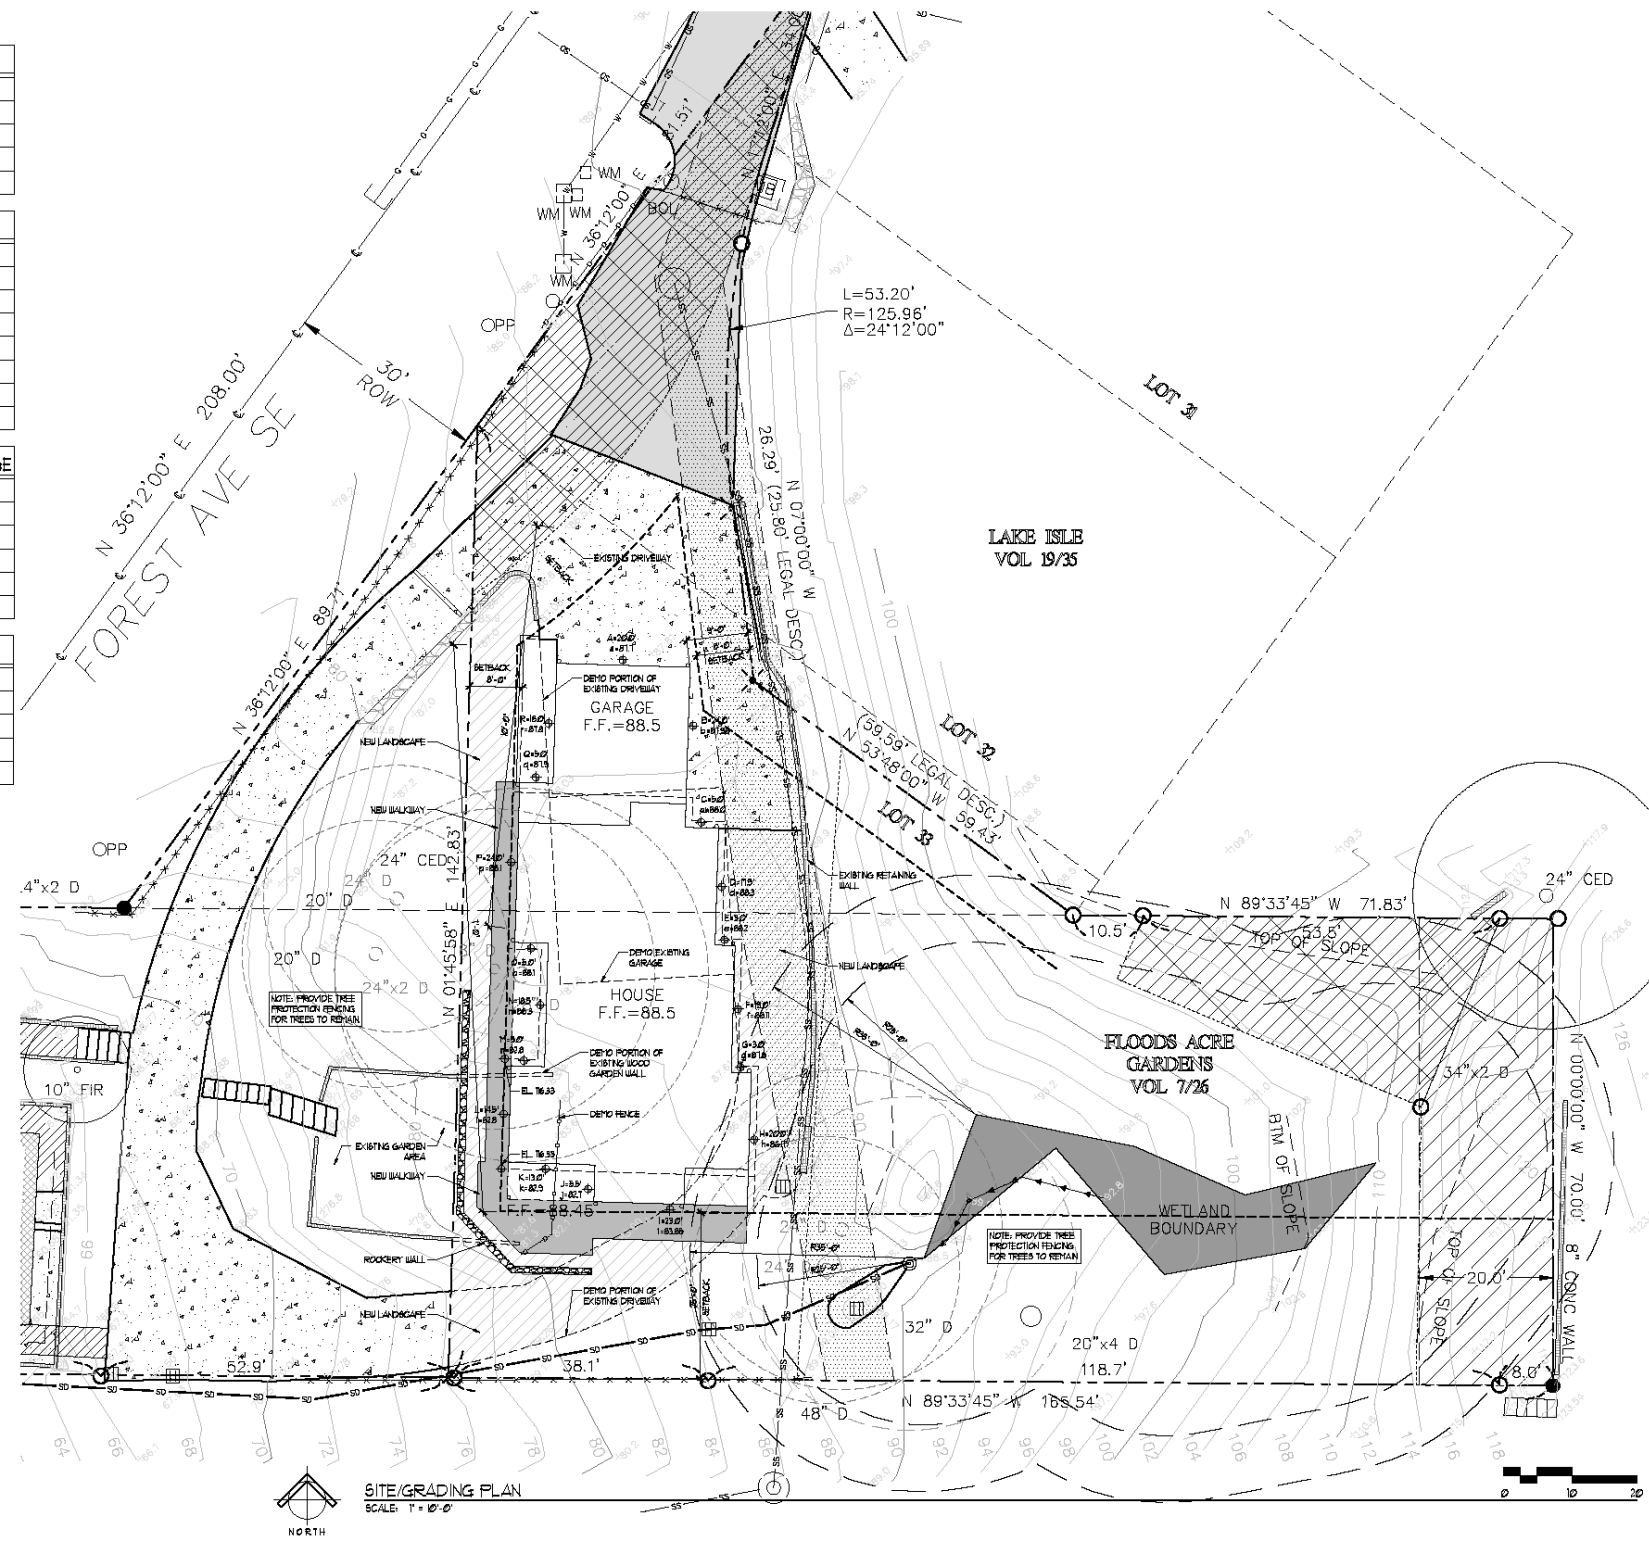
IMPERVIOUS SURFACE COVERAGE	
ALL ROOFS (INCLUDING EAVES):	2491 SF.
DRIVEWAYS:	2620 SF.
WALKWAYS:	363 SF.
TOTAL:	5474 SF.
TOTAL LOT SF:	16391 SF.
% OF LOT:	33.5 %

LOT SLOPE	
HIGHEST ELEVATION POINT OF LOT:	127.6
LOWEST ELEVATION POINT OF LOT:	76.0
ELEVATION DIFFERENCE:	51.6
HORIZ. DIFFERENCE BETWEEN HIGH & LOW:	94.44'
LOT SLOPE: 51.6/94.44	54.7%

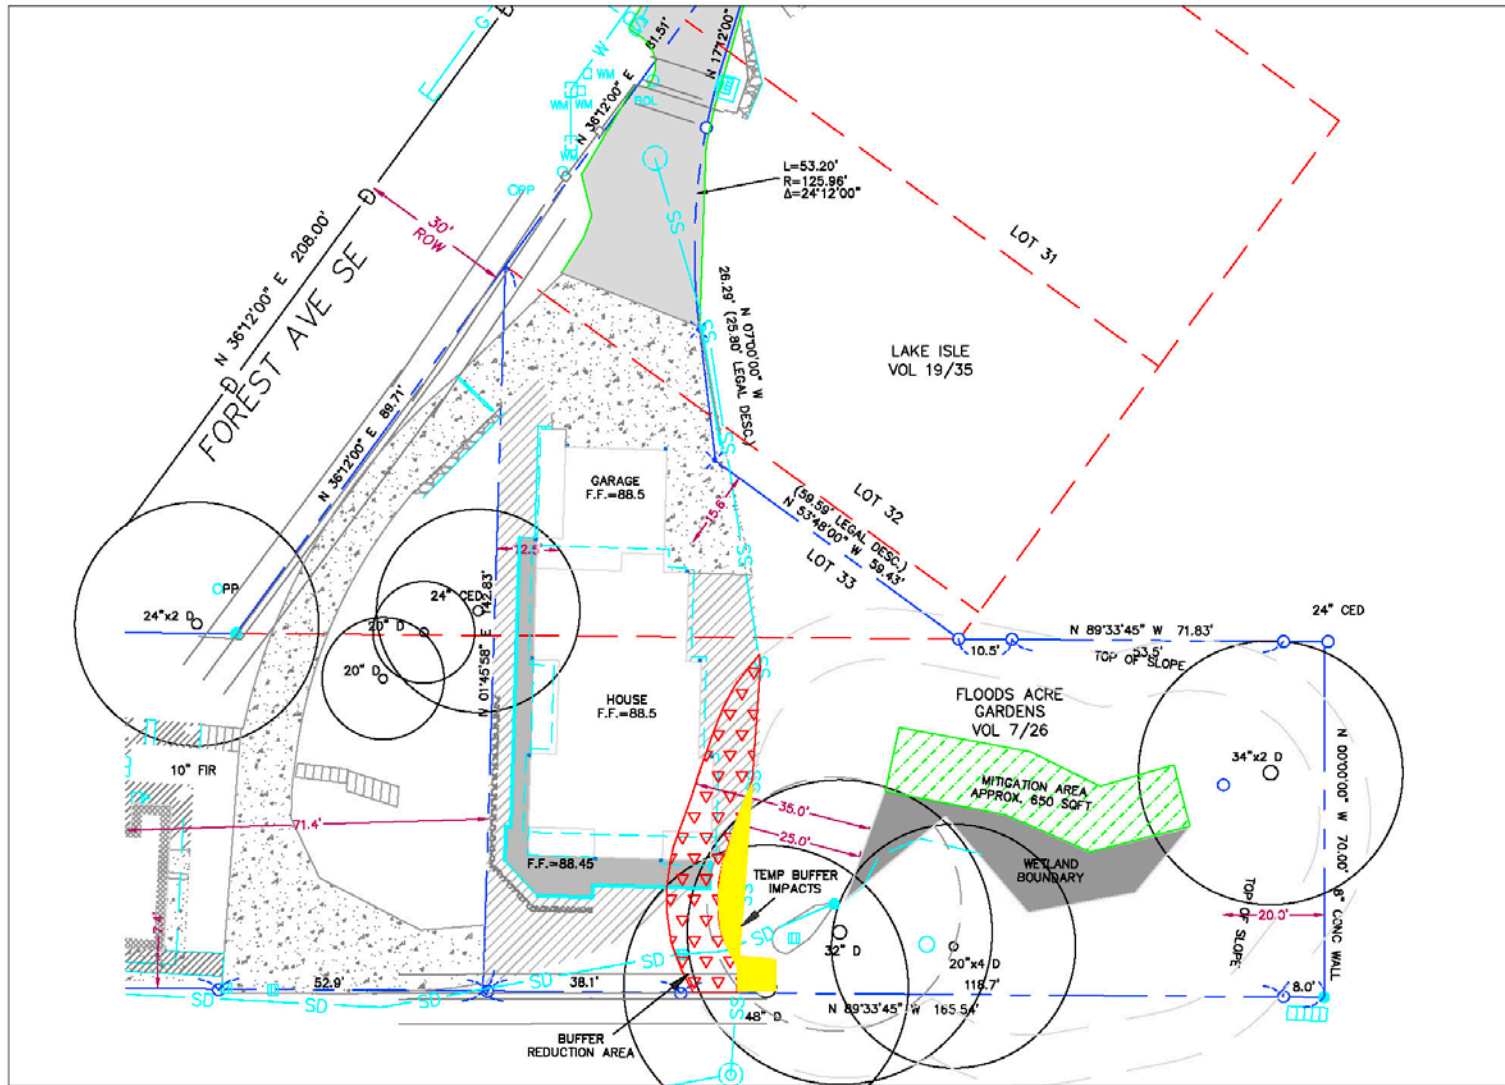
Figure 3. Buffer Reduction and Mitigation Areas

Project Element	Impact Type	Impacts Area (sq ft)	Mitigation Type	Mitigation Area (sq ft)
Proposed House	Permanent	650	Buffer enhancement	650
Construction	Temporary	160	Restore to lawn (i.e., pre-impact condition)	160
