DETERMINATION OF NON-SIGNIFICANCE (DNS) WITH MITIGATION AND USE OF PHASED SEPA DETERMINATION (WAC 197-11-060(5))

- Application Nos.:** SEP16-015 and ZTR16-002
- Description of proposal:** **This State Environmental Policy Act (SEPA) threshold determination analyzes the environmental impacts associated with two “non-project actions” proposed by the applicant, Mercer Island Center for the Arts (MICA), as part of a phased SEPA review pursuant to WAC 197-11-060(5)(b) & (c)(i).** This SEPA Determination covers the following two non-project elements of the proposed MICA project:

- Proponent:** Lesley Bain (Framework), Architect for MICA
- Location of proposal:** Mercerdale Park, 3205 77th Avenue SE, Mercer Island, WA
- Lead agency:** City of Mercer Island

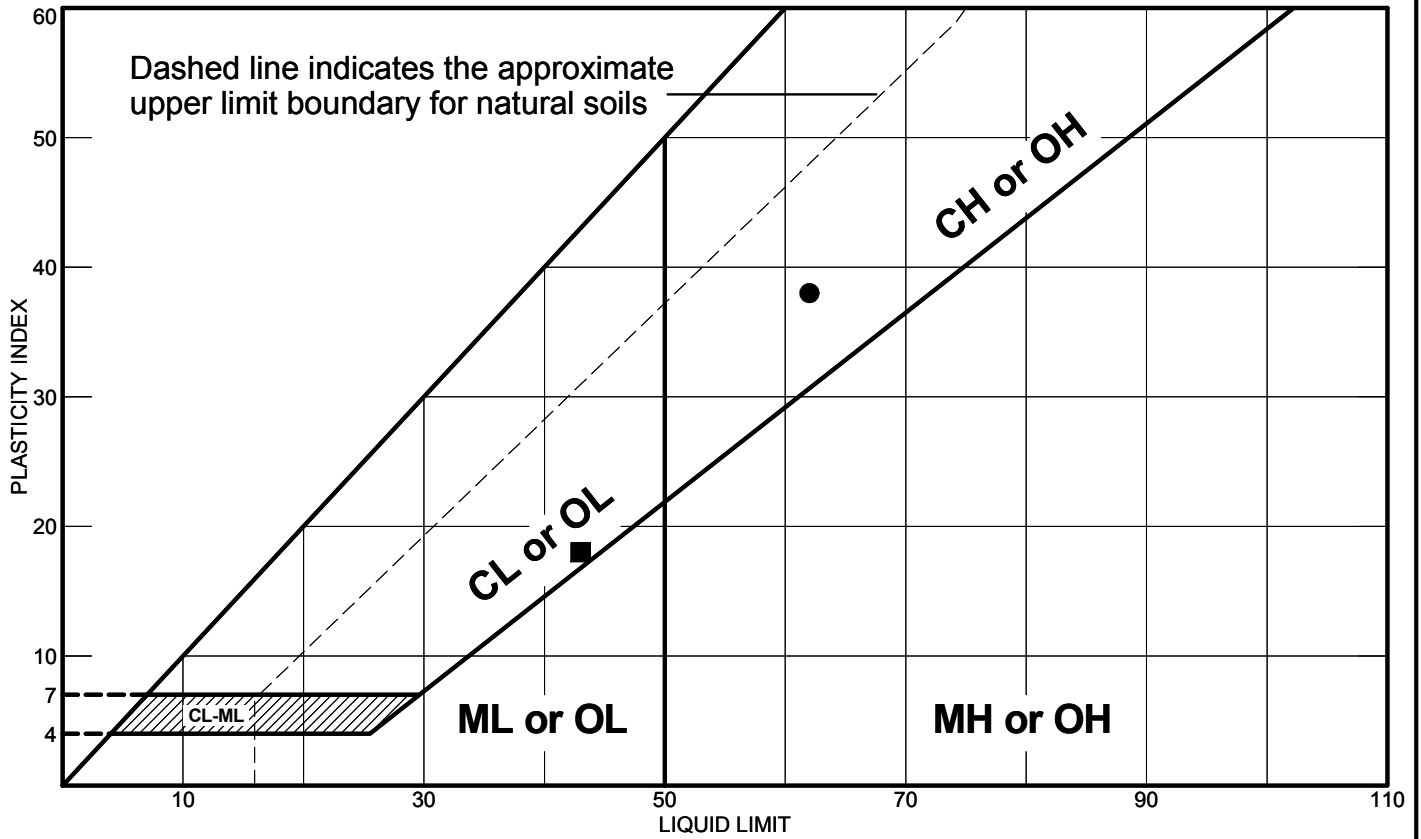
Liquid and Plastic Limits Test Report

Location + Description	LL	PL	PI	-200	USCS
● Source: HC-4 Sample No.: 7 Depth: 20 Clay	62	24	38		CH
■ Source: HC-4 Sample No.: 11 Depth: 40 Clay	43	25	18		CL

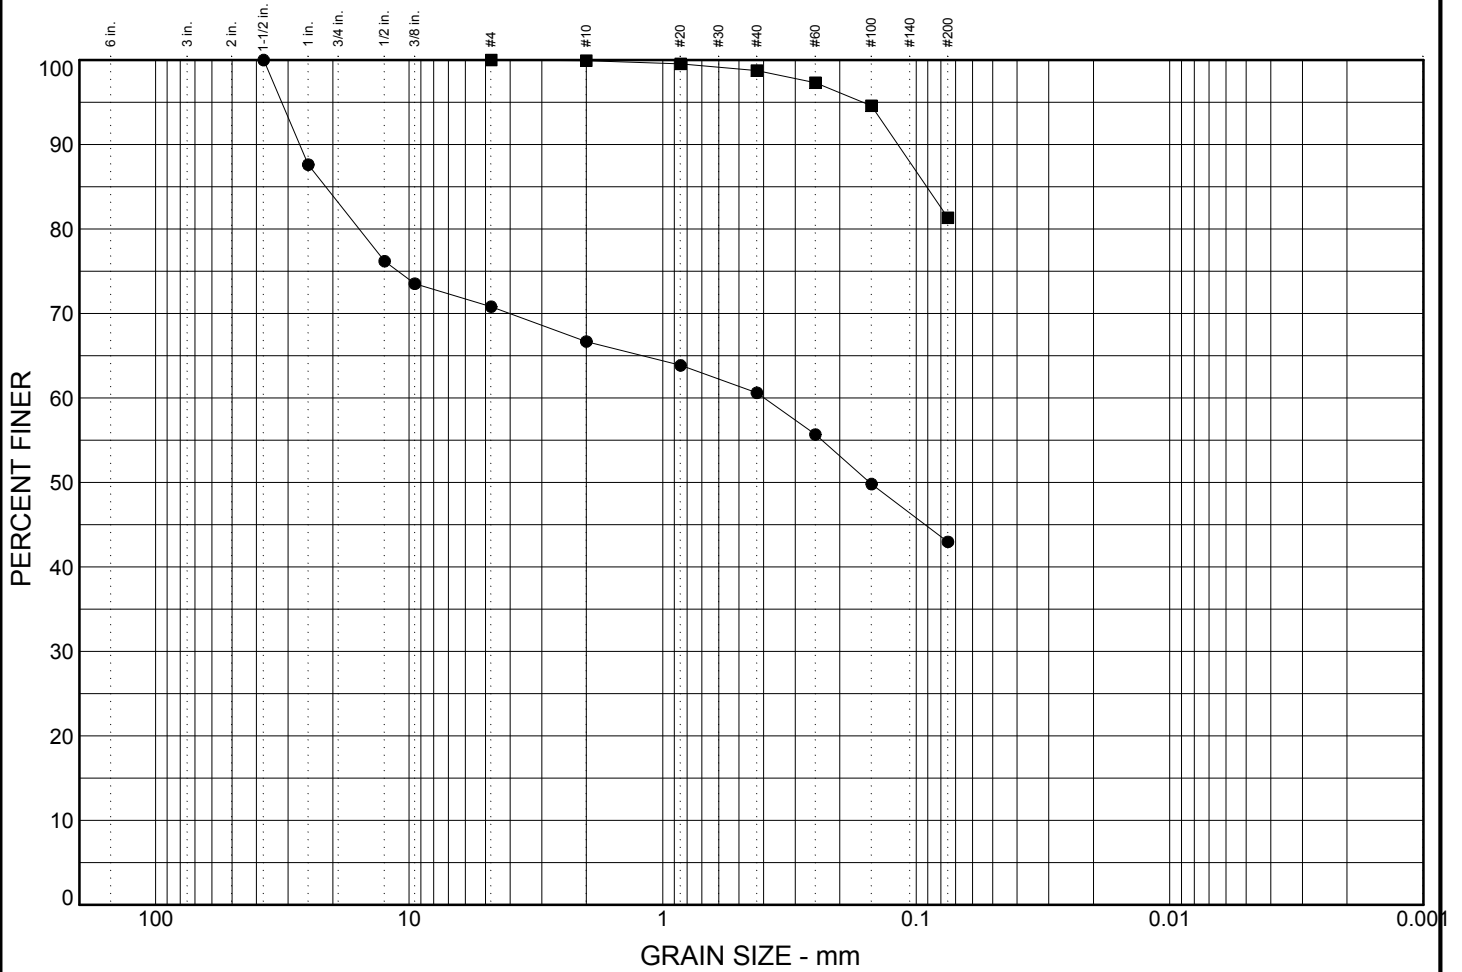
Particle Size Distribution Test Report

% COBBLES	% GRAVEL	% SAND	% SILT	% CLAY
●	0.0	29.2	27.8	43.0	
■	0.0	0.0	18.7	81.3

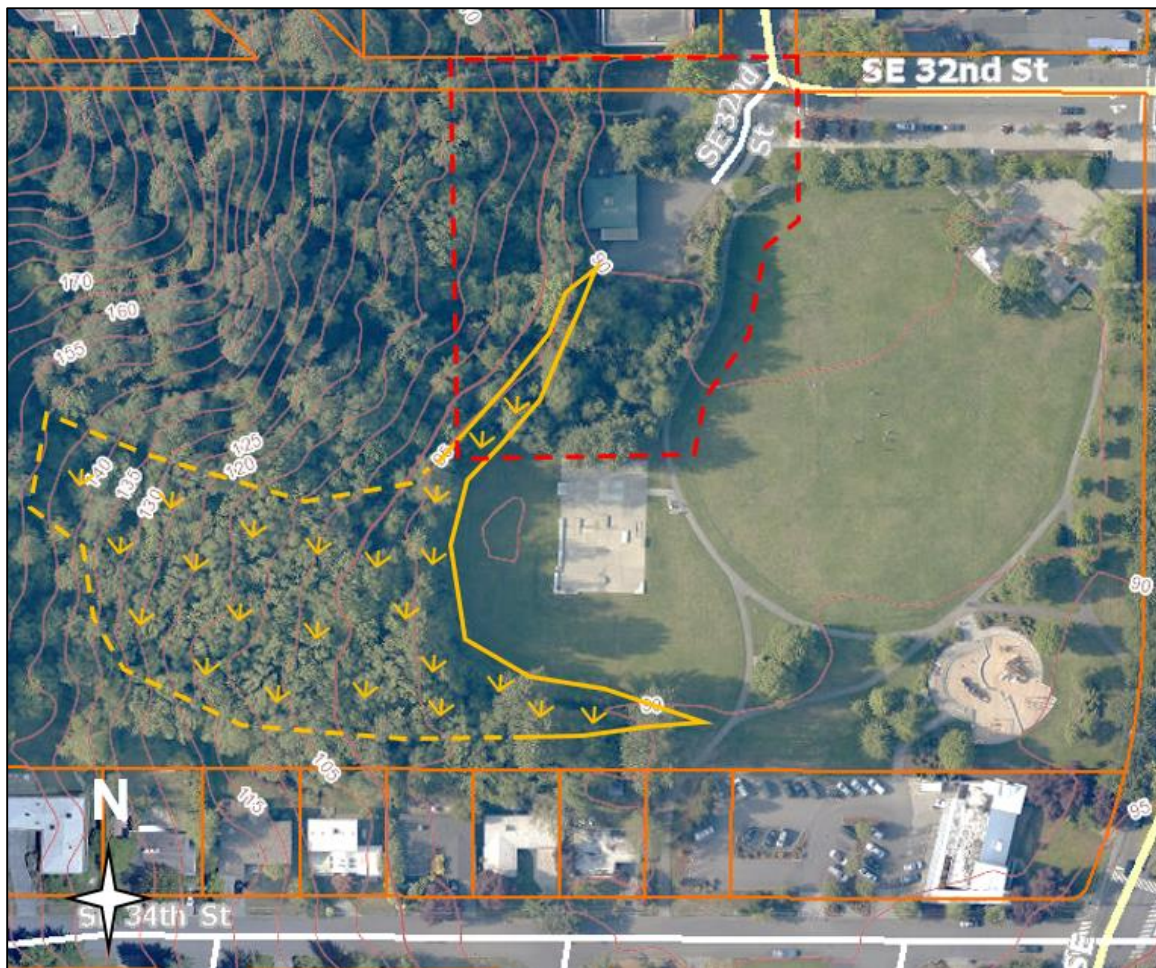
Figure 2. Approximate location and extent of Wetland A (yellow) with study area shown (red).

Wetland A is narrow and located at the toe of a forested slope within the study area. Outside of the study area, the wetland unit extends to the south, and includes a relatively large forested slope to the southwest. The approximate wetland location is depicted in Figure 2, below.

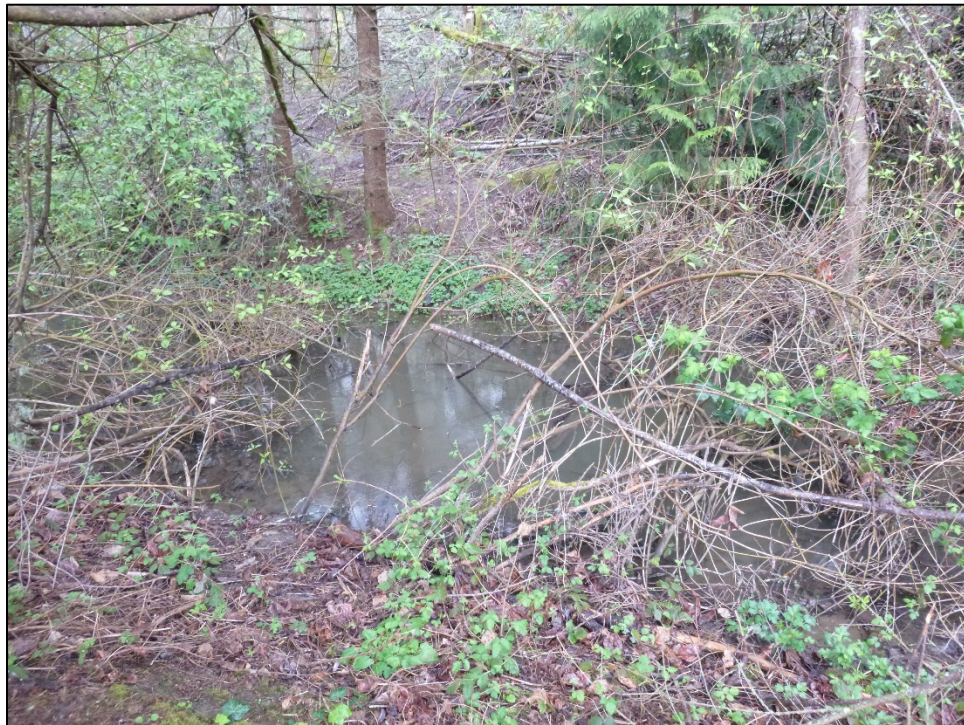
Figure 5. Wetland conditions in study area.

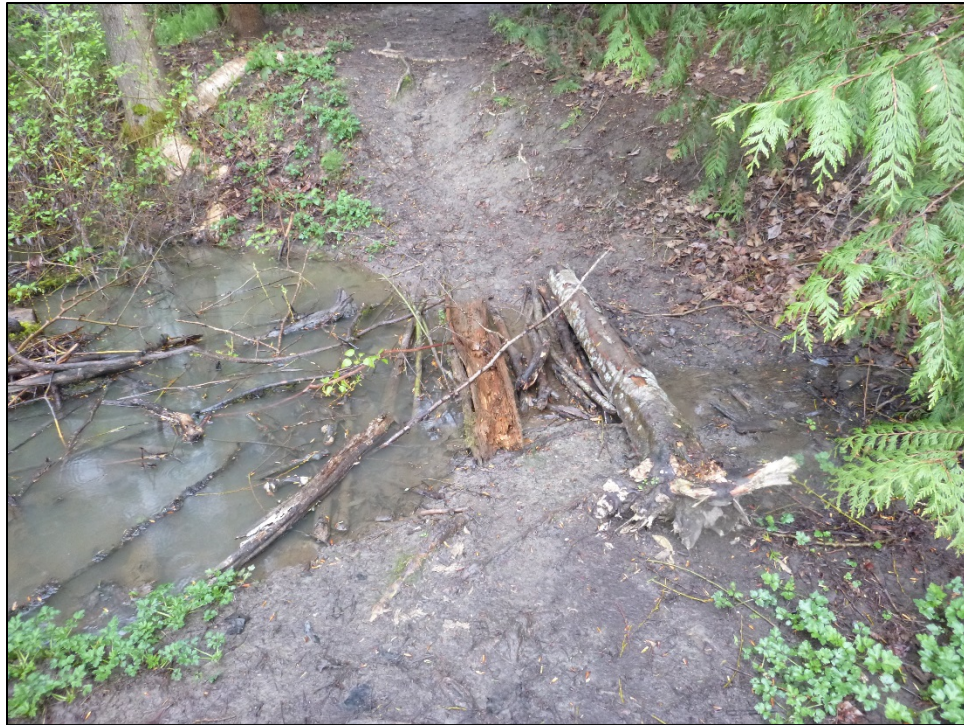
Figure 6. Wetland conditions in study area.

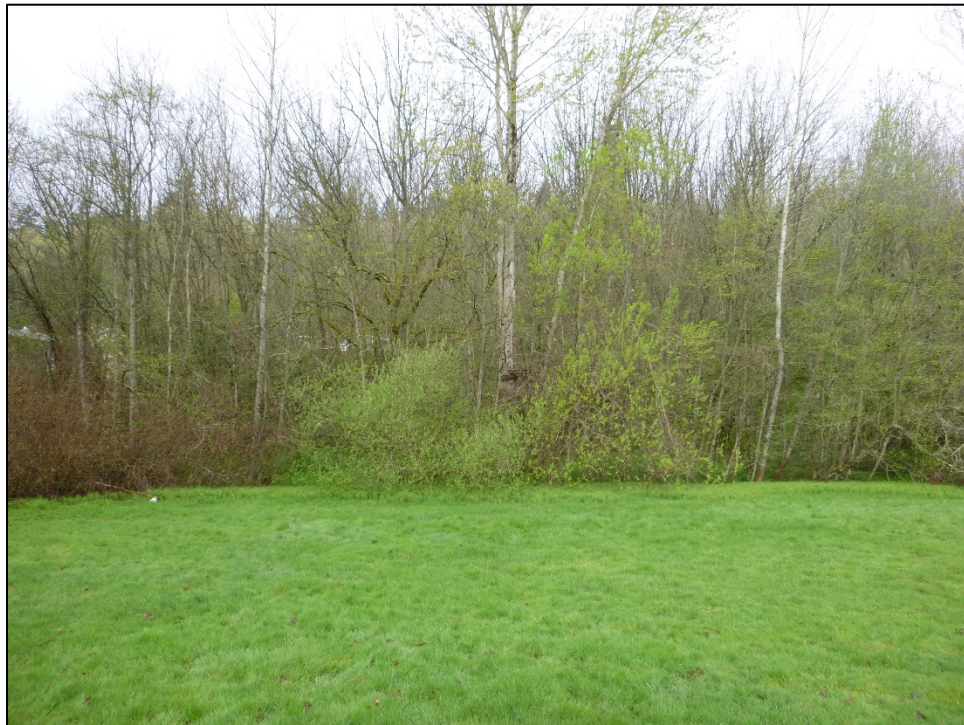
Figure 7. View of wetland from Mercerdale Park, looking west.

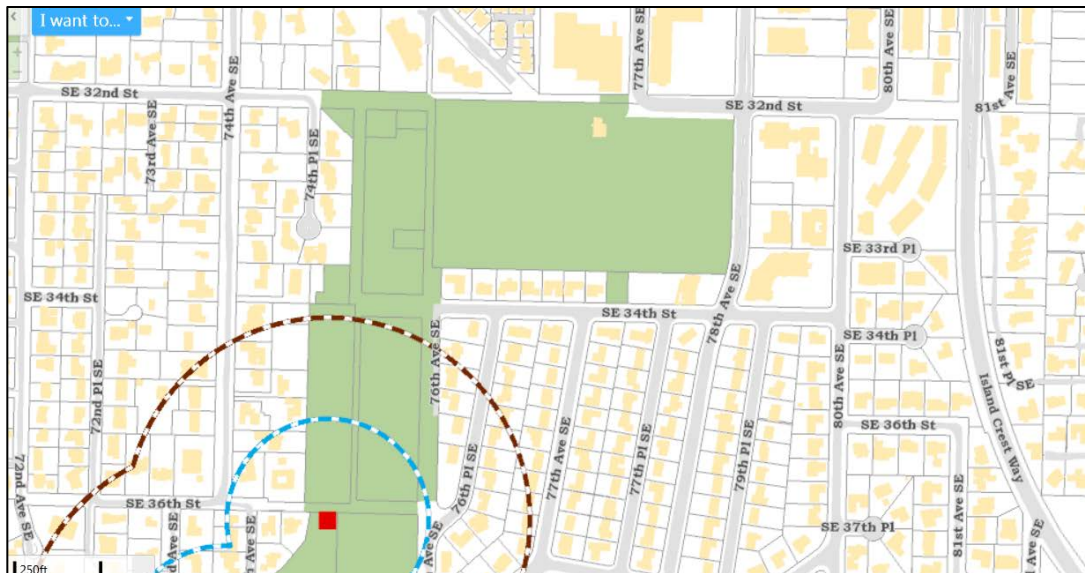
Figure 9. Mapped nest location (red square) in vicinity of subject parcel showing 330-foot buffer (blue dashed-line) and 660-foot buffer (brown dashed-line) from the nest (imagery source: Mercer Island online mapping portal).

As indicated by both the City of Mercer Island's online mapping portal and PHS maps (WDFW 2016), an active bald eagle nest is located approximately 1,000 feet southwest of Mercerdale Park, with the study area within the park roughly 1,500 feet from the nest (Figure 9). This distance places the proposed development outside of all recommended buffer management zones for the nest. No other sensitive species are known to occur within or immediately adjacent to the project area.

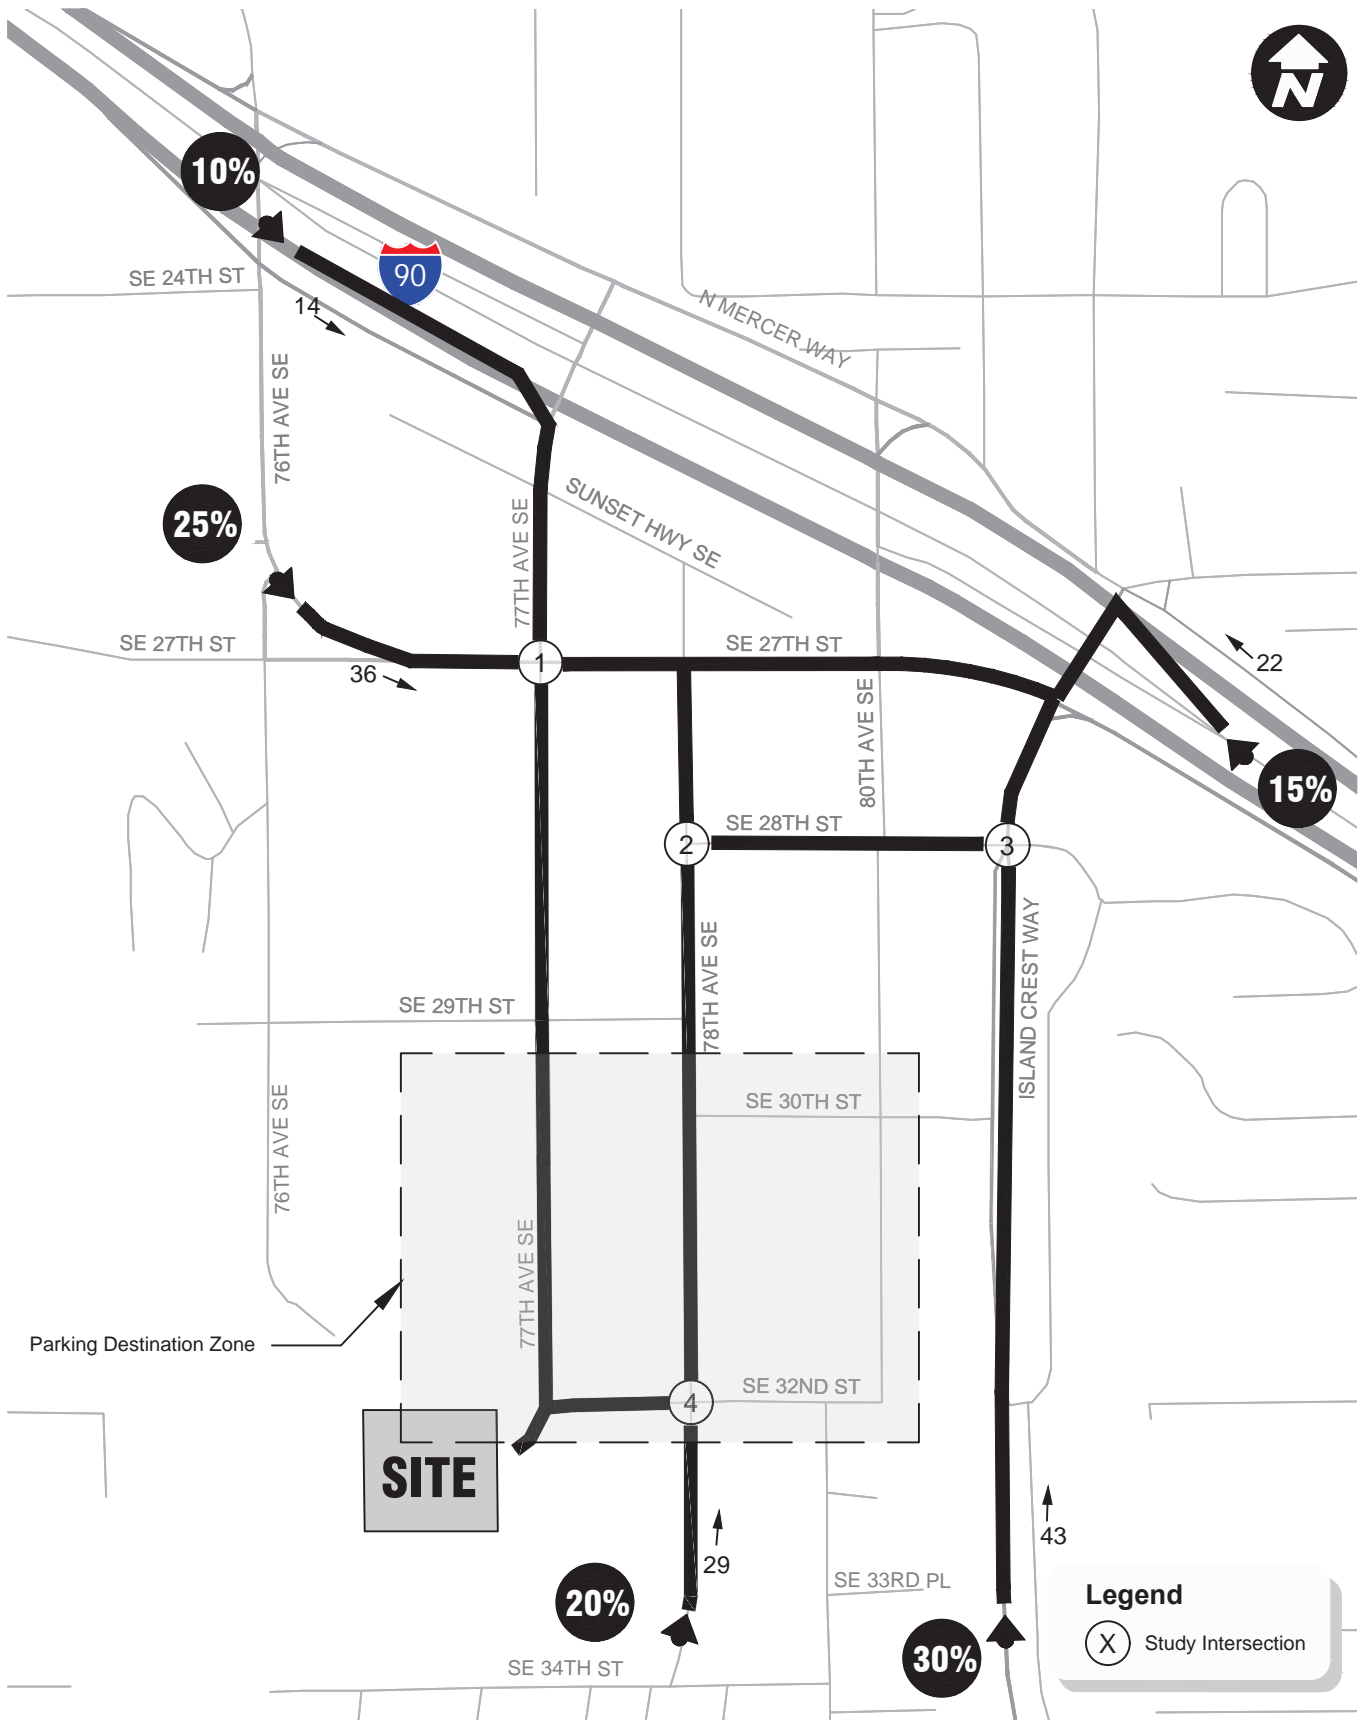
Project Inbound Trip Distribution

Trips were assigned to parking lots closest to the project site within the study area. Lots were chosen based on proximity to the project site and average evening availability, using information from MICA's Mercer Island Parking Analysis to Assess Availability (2015).

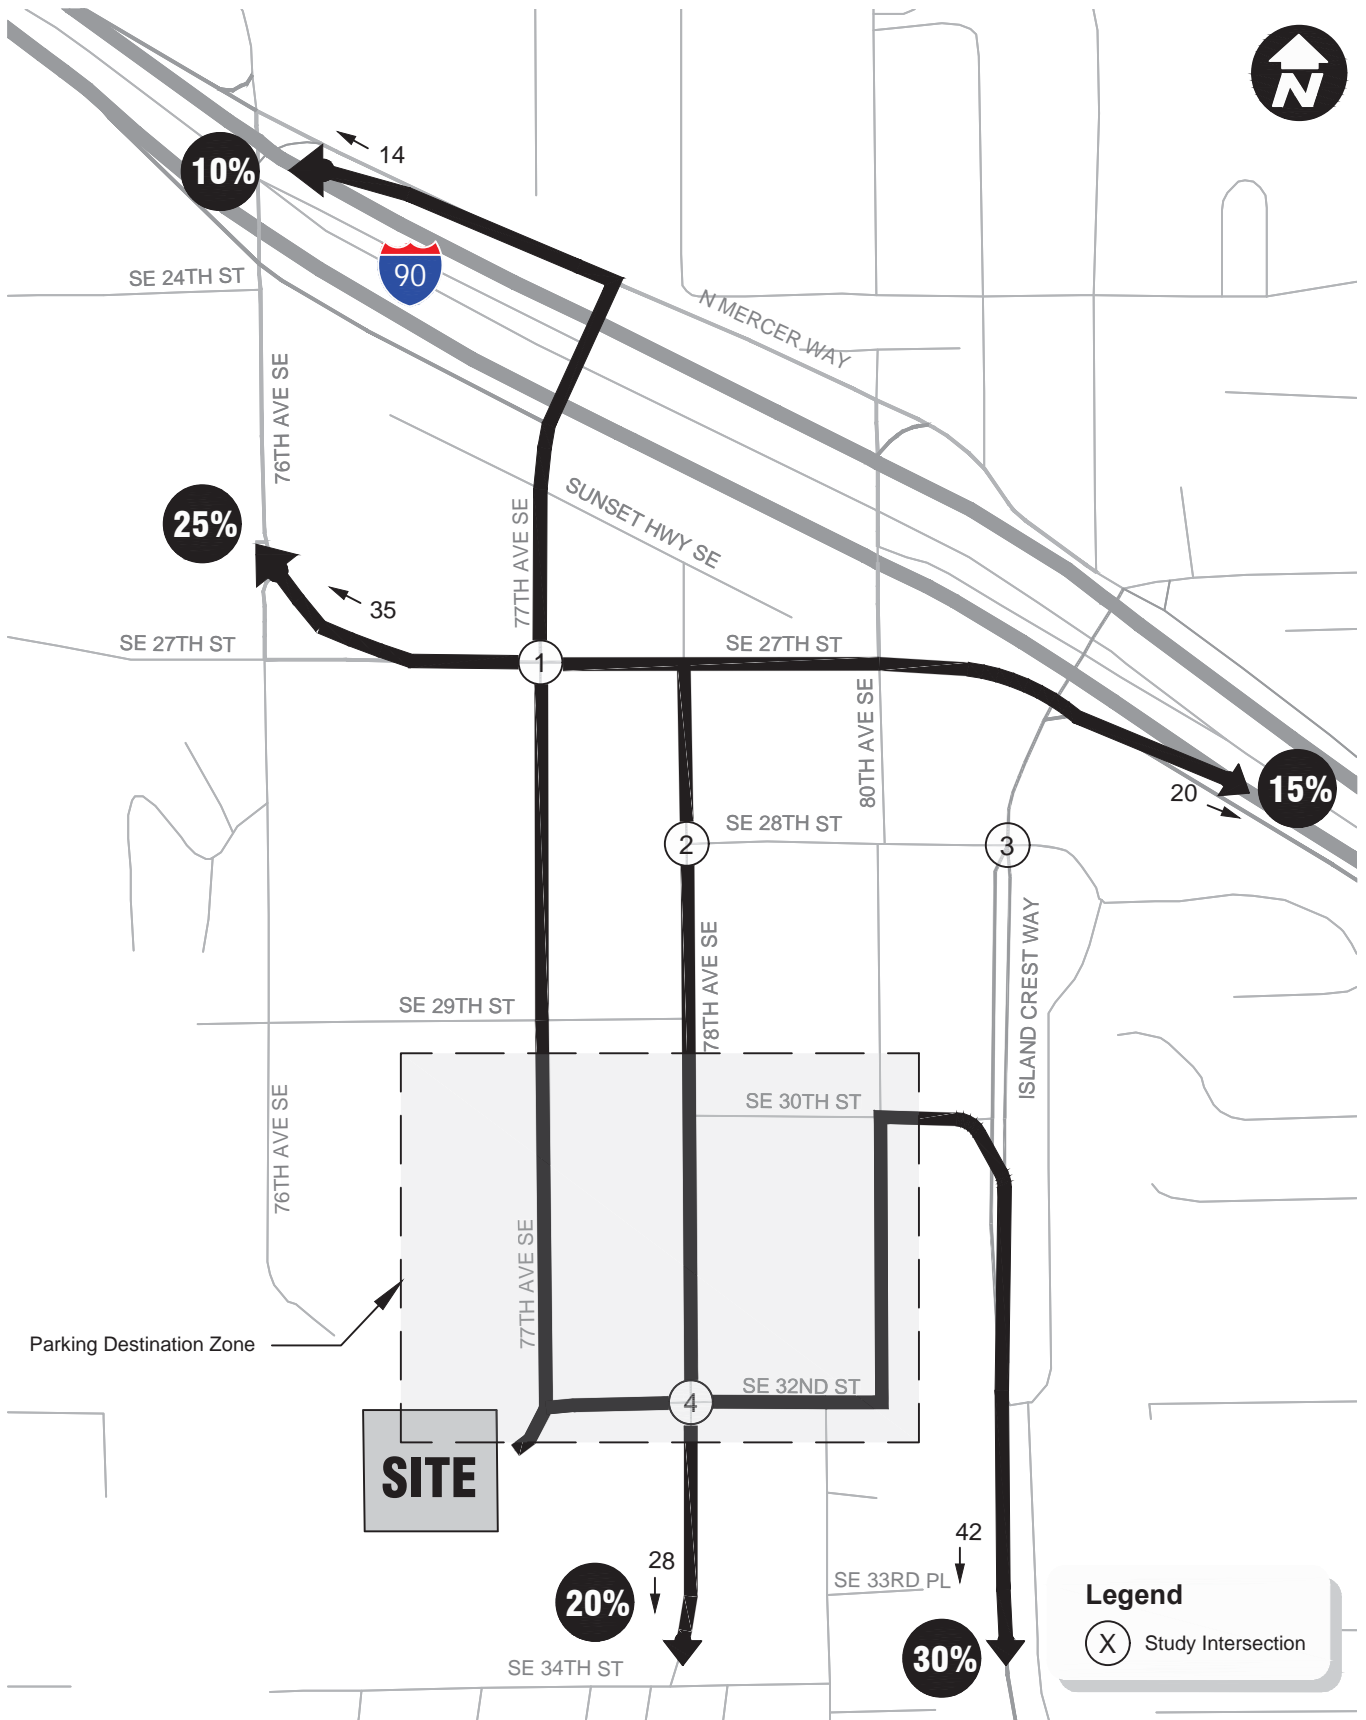
Project Outbound Trip Distribution

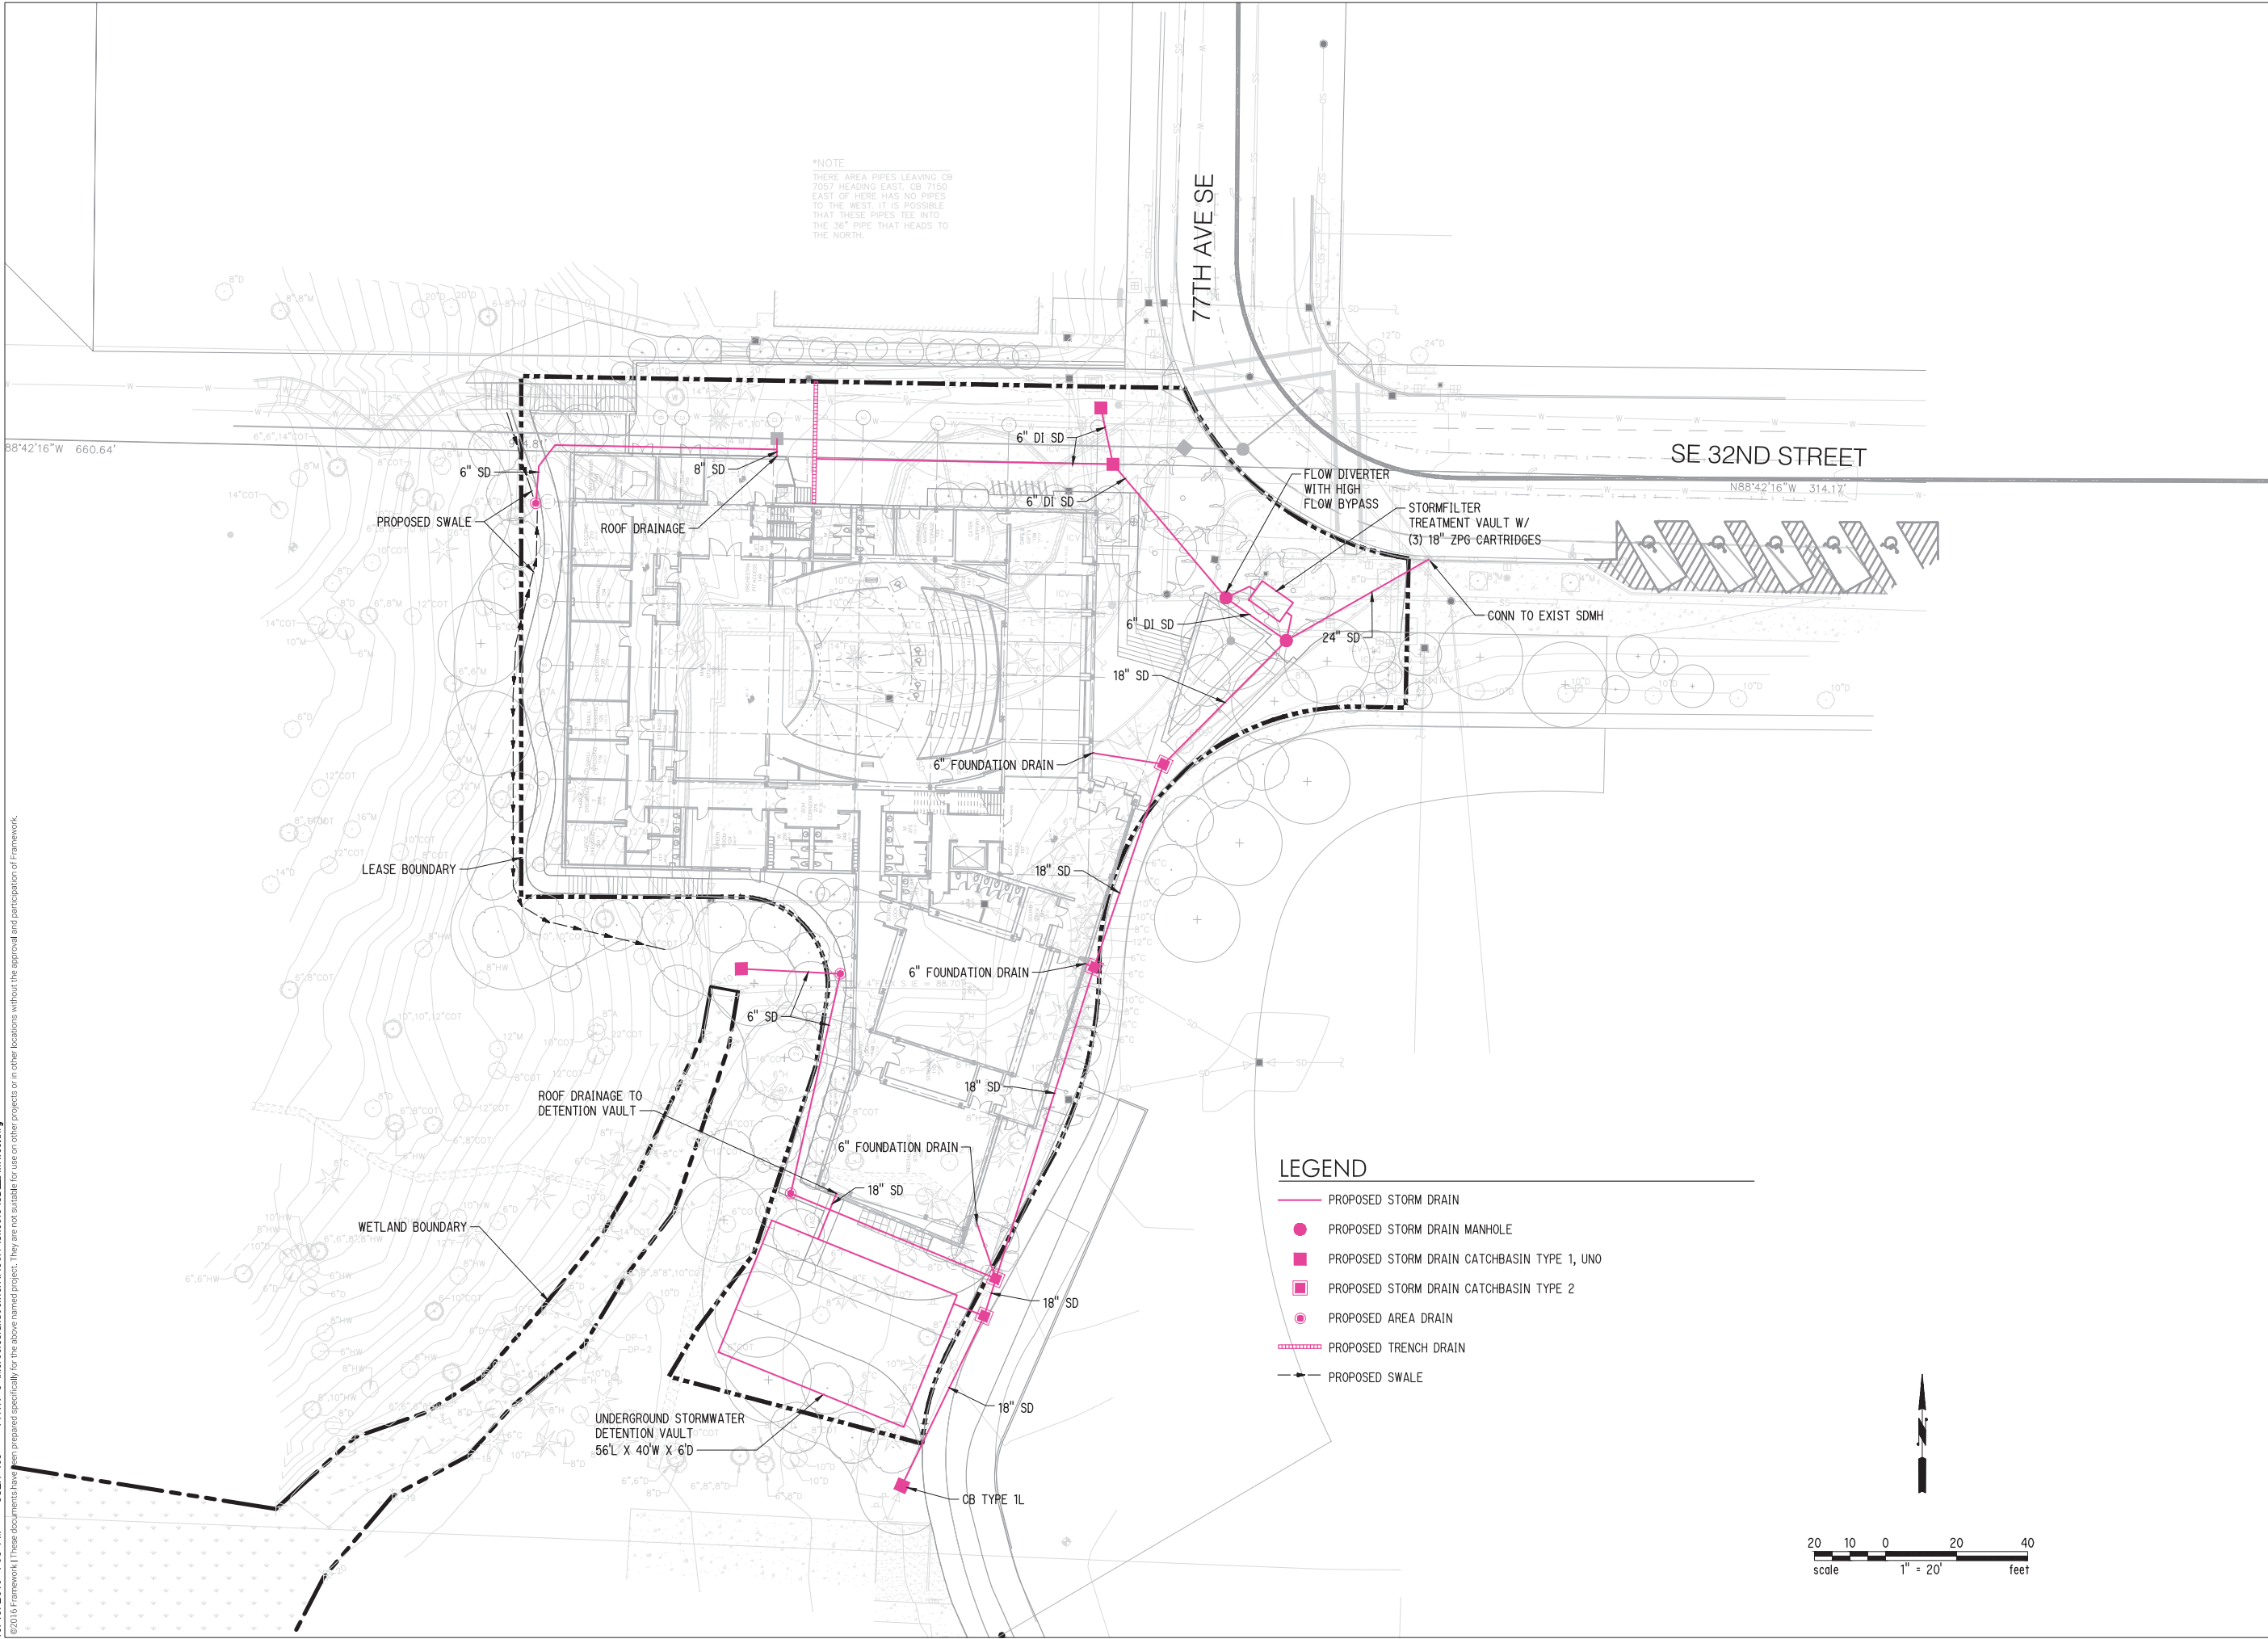
- LEGEND**
- PROPOSED STORM DRAIN
 - PROPOSED STORM DRAIN MANHOLE
 - PROPOSED STORM DRAIN CATCHBASIN TYPE 1, UNO
 - PROPOSED STORM DRAIN CATCHBASIN TYPE 2
 - PROPOSED AREA DRAIN
 - PROPOSED TRENCH DRAIN
 - - - PROPOSED SWALE

The project proposes two features that would discharge water directly into the wetland: 1) a swale located west of the proposed building and 2) a wall drain located on the south side of the building (see Sheet C302 Offsite Storm Drainage Plan). Potential impacts to the wetland resulting from these proposed discharges (e.g., altered hydrology, scour) was not evaluated in submittal materials; therefore, ESA recommends that such an analysis be included in the stormwater management plan and/or wetland buffer mitigation plan. The analysis should include the volume and quality of water expected to discharge from these structures.

Existing surface runoff from the hillside will be intercepted by the proposed swales shown on Attachment N, Storm Drainage Plan, which will be graded so existing conditions remain, thus resulting in no change to current runoff impacts or quantities. Water from impervious surfaces will pass through a stormfilter vault. MICA will also pay into the City's stormwater fee-in-lieu program.
