BLUELINE

2825 W Mercer Way

Preliminary Storm Drainage Report

Blueline Job No. 13-118
Prepared by: Lucas Zirotti, EIT
Olivia Westmoreland
Reviewed by: Brett Pudists, PE

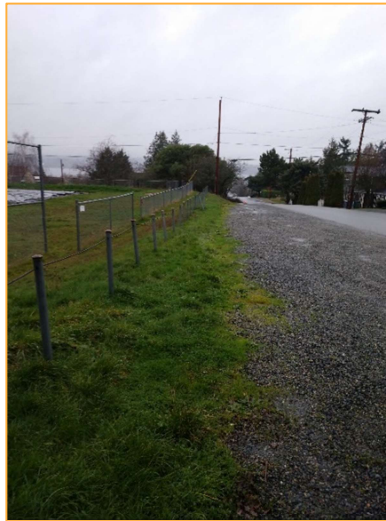
Photo N1 – Facing west along SE 28th St. Onsite runoff sheet flows northwest toward the conveyance system on the south side of the street.

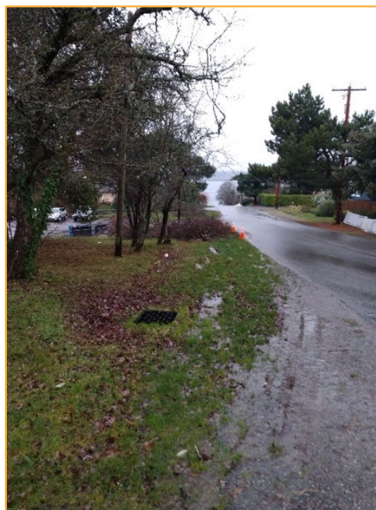
Photo N2 – Facing west along SE 28th St approximately 170 feet west of Photo N1. Runoff continues to sheet flow northwest towards the conveyance system on the south side of the street.

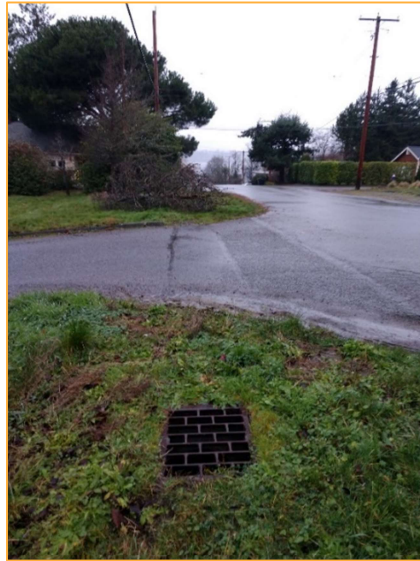
Photo N3 – Facing west along SE 28th St approximately 145 feet west of Photo N2. This catch basin is located adjacent to the driveway into the back parking lot on the western portion of the property. Runoff continues to sheet flow northwest towards the conveyance system on the south side of the street.

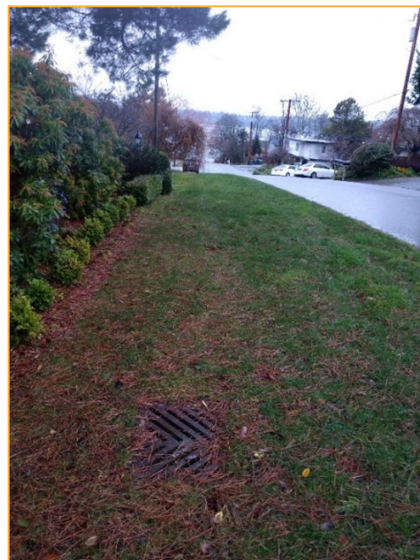
Photo N4 – Facing west along SE 28th St approximately 130 feet west of Photo N3. Runoff is conveyed via this catch basin on the south side of the street toward Lake Washington.

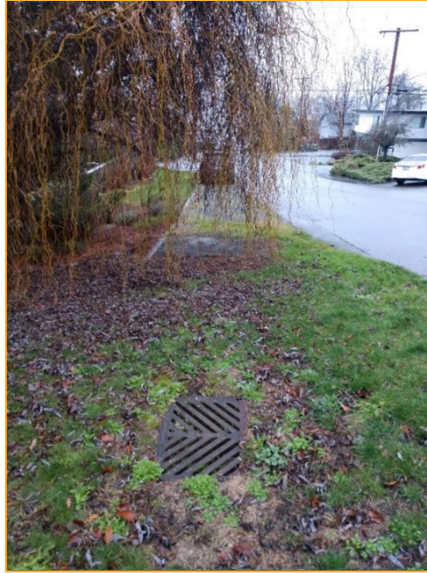
Photo N5 – Facing west along SE 28th St approximately 95 feet west of Photo N4. Runoff is conveyed via this catch basin on the south side of the street toward Lake Washington.

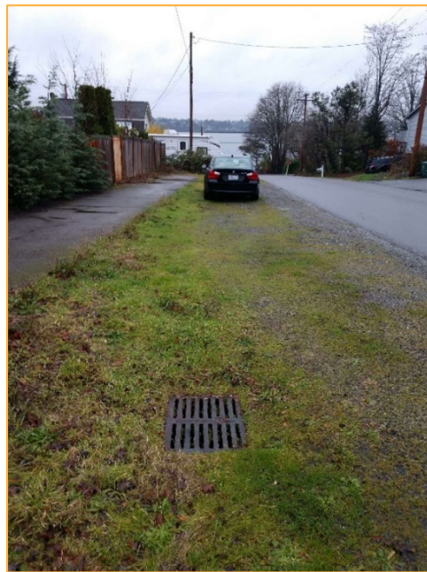
Photo N6 – Facing west along SE 28th St approximately 150 feet west of Photo N5. Runoff is conveyed via this catch basin on the south side of the street toward Lake Washington.

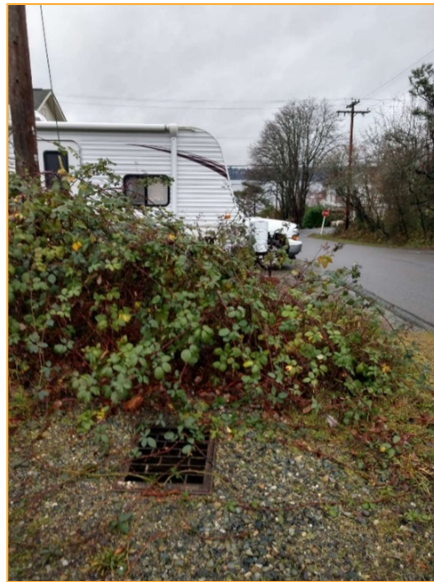
Photo N7 – Facing west along SE 28th St approximately 90 feet west of Photo N6. Runoff is conveyed via this catch basin on the south side of the street toward Lake Washington.

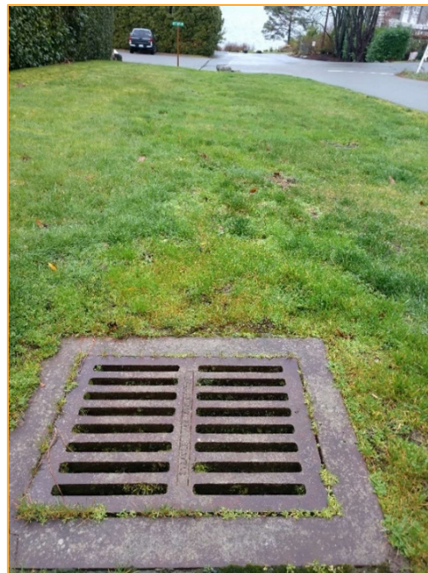
Photo N8 – Facing west along SE 28th St approximately 40 feet west of Photo N7. Runoff is conveyed via this catch basin on the south side of the street toward Lake Washington.

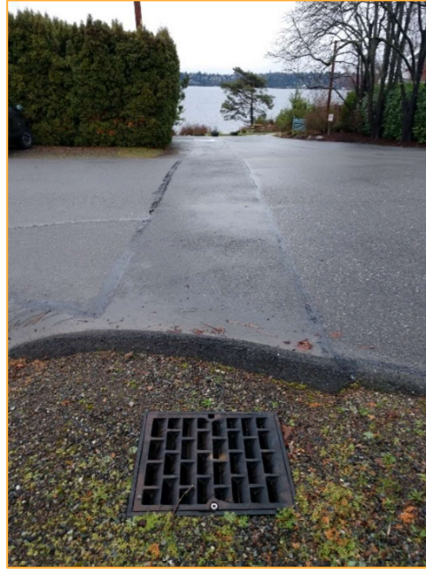
Photo N9 – Facing west along SE 28th St approximately 95 feet west of Photo N8 at southeast corner of the intersection of SE 28th St and 60th Ave SE. Runoff is conveyed via this catch basin on the south side of the street toward Lake Washington.

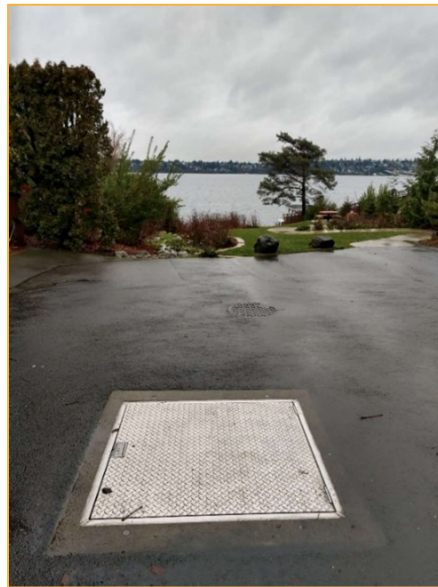
Photo N10 – Facing west in Calkins Landing approximately 95 feet west of Photo N9. Runoff is collected in the pre-settling vault pictured before being discharged into Lake Washington.

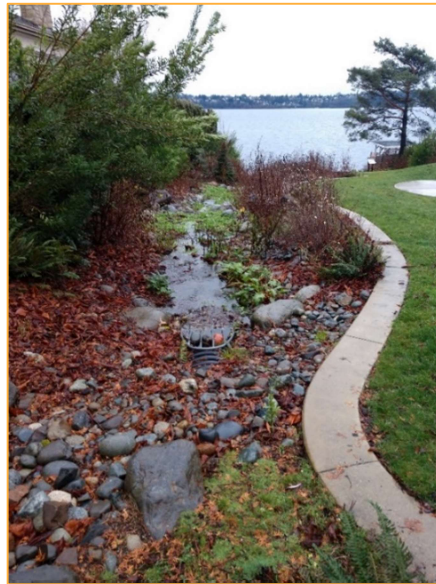
Photo N11 – Facing west in Calkins Landing. Runoff discharges via a pipe with a trash rack to a ditch upstream of the outfall to Lake Washington.

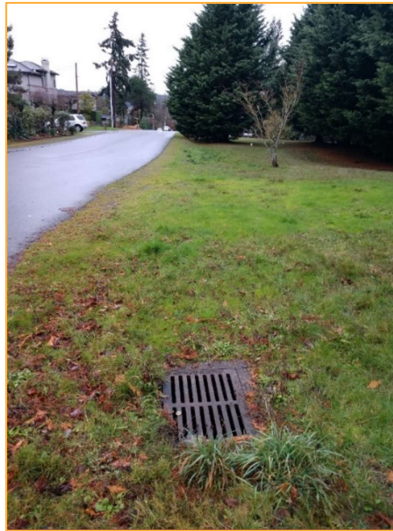
Photo S1 – Facing west along the north side of SE 30th St. Onsite runoff sheet flows in the southwestern direction to the catch basin above and is conveyed west toward Lake Washington.

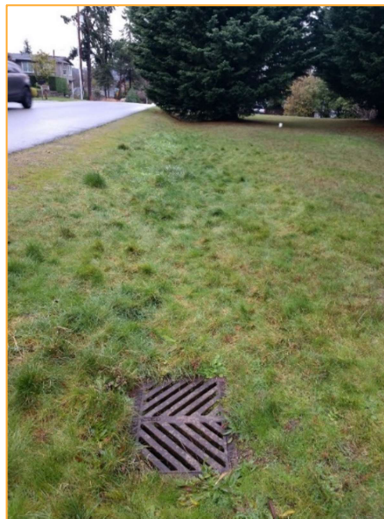
Photo S2 – Facing west along the north side of SE 30th St approximately 55 feet west of Photo S1. Onsite runoff sheet flows in the southwestern direction to the catch basin above and is conveyed west toward Lake Washington.

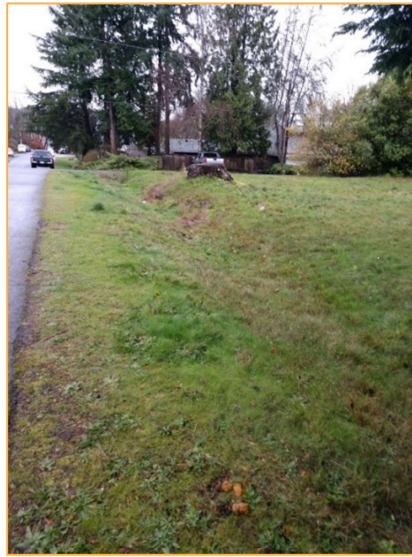
Photo S3 – Facing west along the north side of SE 30th St approximately 35 feet west of Photo S2. Onsite runoff sheet flows in the southwestern direction to the ditch above and is conveyed west toward Lake Washington.

Existing ditches will be evaluated for stability as part of this project. The existing ditch on the north side of SE 30th St between 62nd Ave SE and 61st Ave SE will be tightlined per recommendations from the City's stormwater operations team.

The existing ditch on the north side of SE 30th St between 62nd Ave SE and 61st Ave SE will be tightlined per recommendations from the City's stormwater operations team. The proposed 12-inch pipe will need to convey 5.11 cfs per the *East Seattle Neighborhood Storm Drainage Basin Study* plus the 0.25 cfs increase associated with this project, 5.36 cfs. The capacity for the 12-inch pipe was calculated using Manning's Equation. Per Manning's equation, a 12-inch pipe at 4.16% has capacity to convey 8.59 cfs. Therefore, the 12-inch pipe has adequate capacity to convey the 100-year storm. Please see calculations for the conveyance system on the following page.

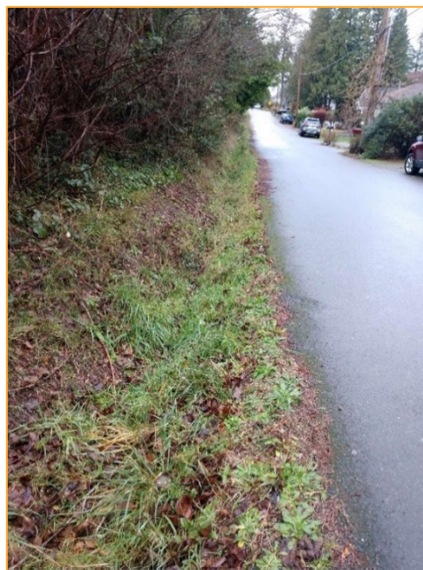
Photo S4 – Facing south on the east side of 62nd Ave SE approximately 60 feet from Photo N4. Onsite runoff sheet flows in the southwest direction toward the ditch above and is conveyed south to be combined with the south basin downstream conveyance system.

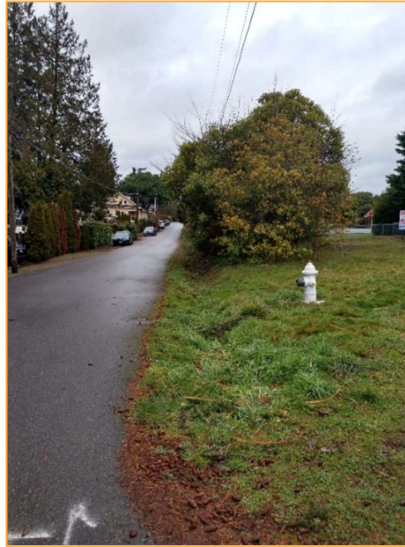
Photo S5 – Facing north on the east side of 62nd Ave SE approximately 365 feet from Photo S4. Onsite runoff sheet flows in the southwest direction toward the ditch above and is conveyed south to be combined with the south basin downstream conveyance system.

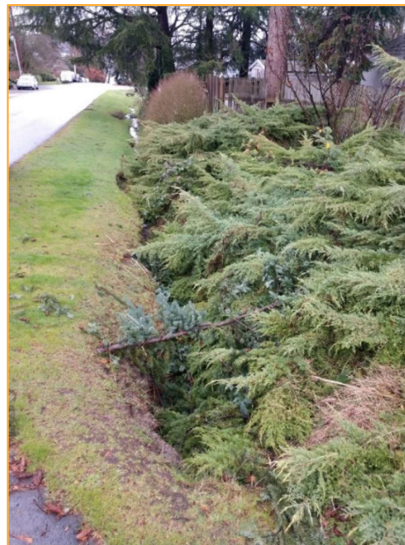
Photo S6 – Facing west along the north side of SE 30th St approximately 40 feet west of Photo S5 at the northwest corner of the intersection of SE 30th St and 62nd Ave SE. Runoff is conveyed west from this pipe outfall toward Lake Washington.

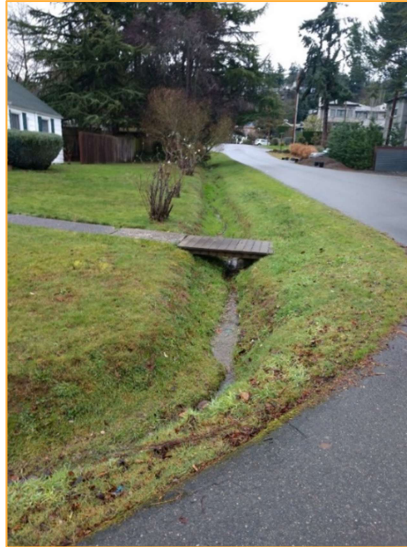
Photo S7 – Facing east along the north side of SE 30th St approximately 210 feet west of Photo S6 at the northeast corner of the intersection of SE 30th St and 61st Ave SE. Runoff is conveyed west toward Lake Washington.

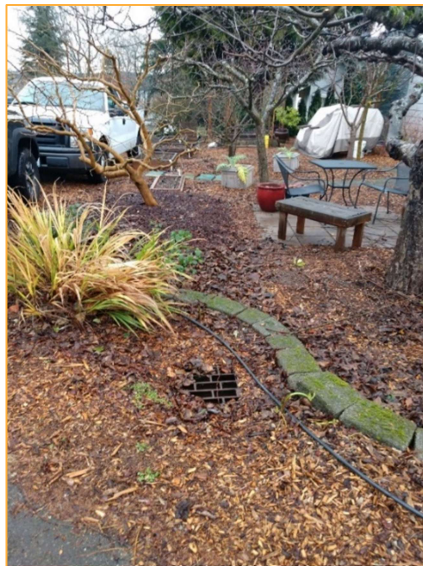
Photo S8 – Facing west along the north side of SE 30th St approximately 30 feet west of Photo S7 at the northwest corner of the intersection of SE 30th St and 61st Ave SE. Runoff is conveyed west toward Lake Washington.

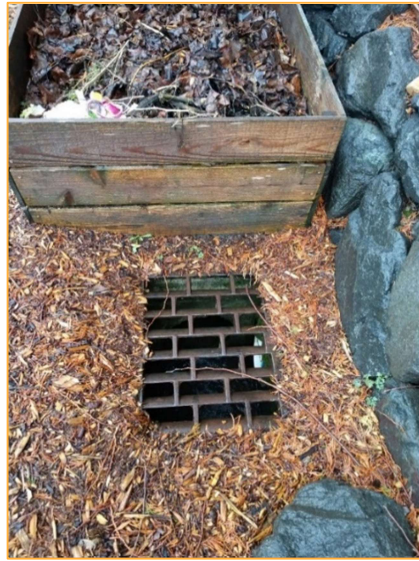
Photo S9 – Facing west along the north side of SE 30th St approximately 65 feet west of Photo S8. Runoff is conveyed west toward Lake Washington.

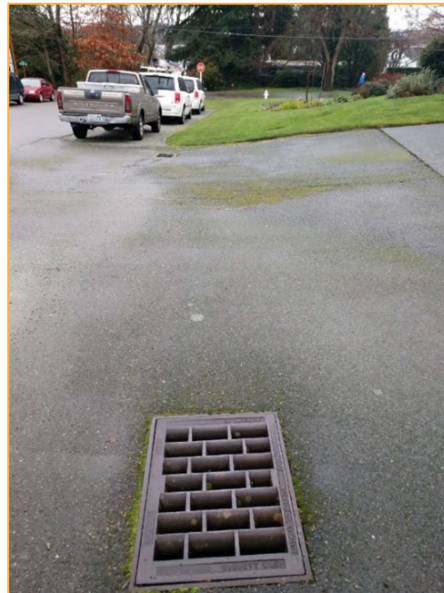
Photo S10 – Facing west along the north side of SE 30th St approximately 30 feet west of Photo S9. Runoff is conveyed west toward Lake Washington.

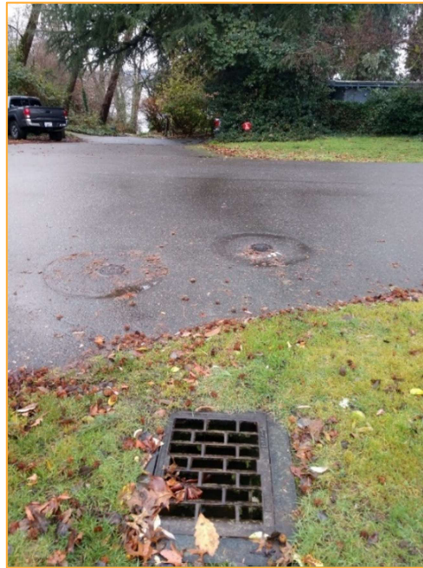
Photo S11 – Facing west along the north side of SE 30th St approximately 130 feet west of Photo S10 at the northeast corner of the intersection of SE 30th St and 60th Ave SE. Runoff is conveyed west toward Lake Washington.

Per the *East Seattle Neighborhood Storm Drainage Basin Study*, the existing 12-inch pipe across 60th Ave SE on the north side of SE 30th St needs to be replaced. This can be accomplished without any changes to the pipes immediately downstream and upstream of this segment, provided the revised pipe grade would not be in conflict with any existing utilities. The second iteration upstream IE from the backwater spreadsheet is reflected in the preliminary plans.

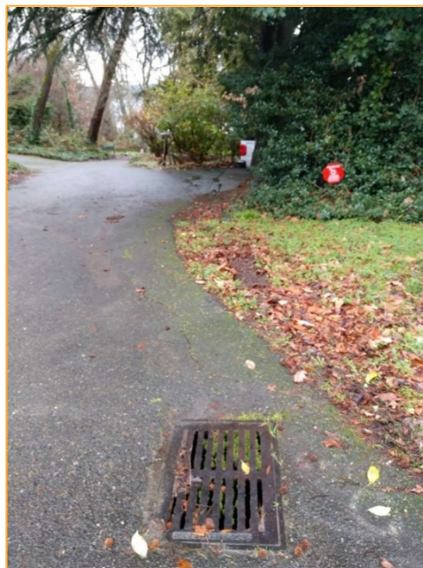
Photo S12 – Facing west in front of the entrance to Garfield Landing approximately 35 feet west of Photo S11. Runoff is conveyed west toward Lake Washington.

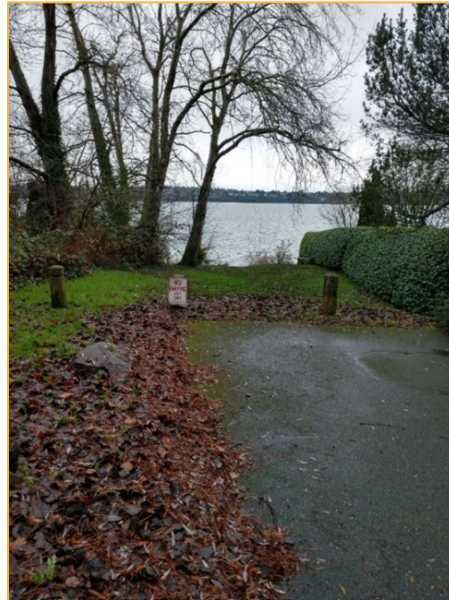
Photo S13 – Facing west in Garfield Landing. Runoff is conveyed west to the outfall into Lake Washington.

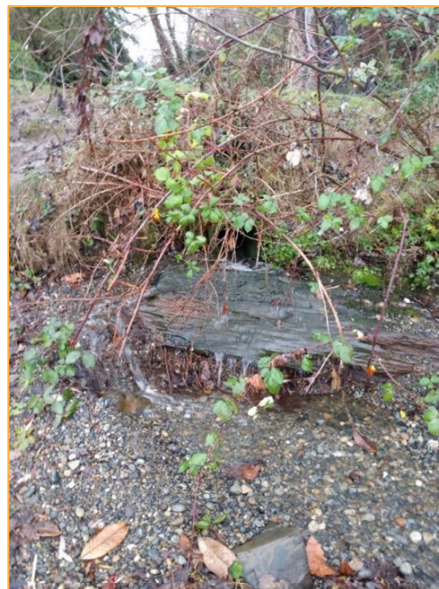
Photo S14 – Facing east looking directly at the outfall to Lake Washington.
