GEOTECHNICAL ENGINEERING REPORT

TALERMAN RESIDENCE EVALUATION & SLOPE STABILITY ANALYSIS
3879 WEST MERCER WAY
MERCER ISLAND, WASHINGTON

Project No. 1945.01
October 9, 2018

Subject: Subsurface Exploration and Geotechnical Engineering Evaluation
Proposed Single-Family Residential Project
3879 West Mercer Way
Mercer Island, Washington

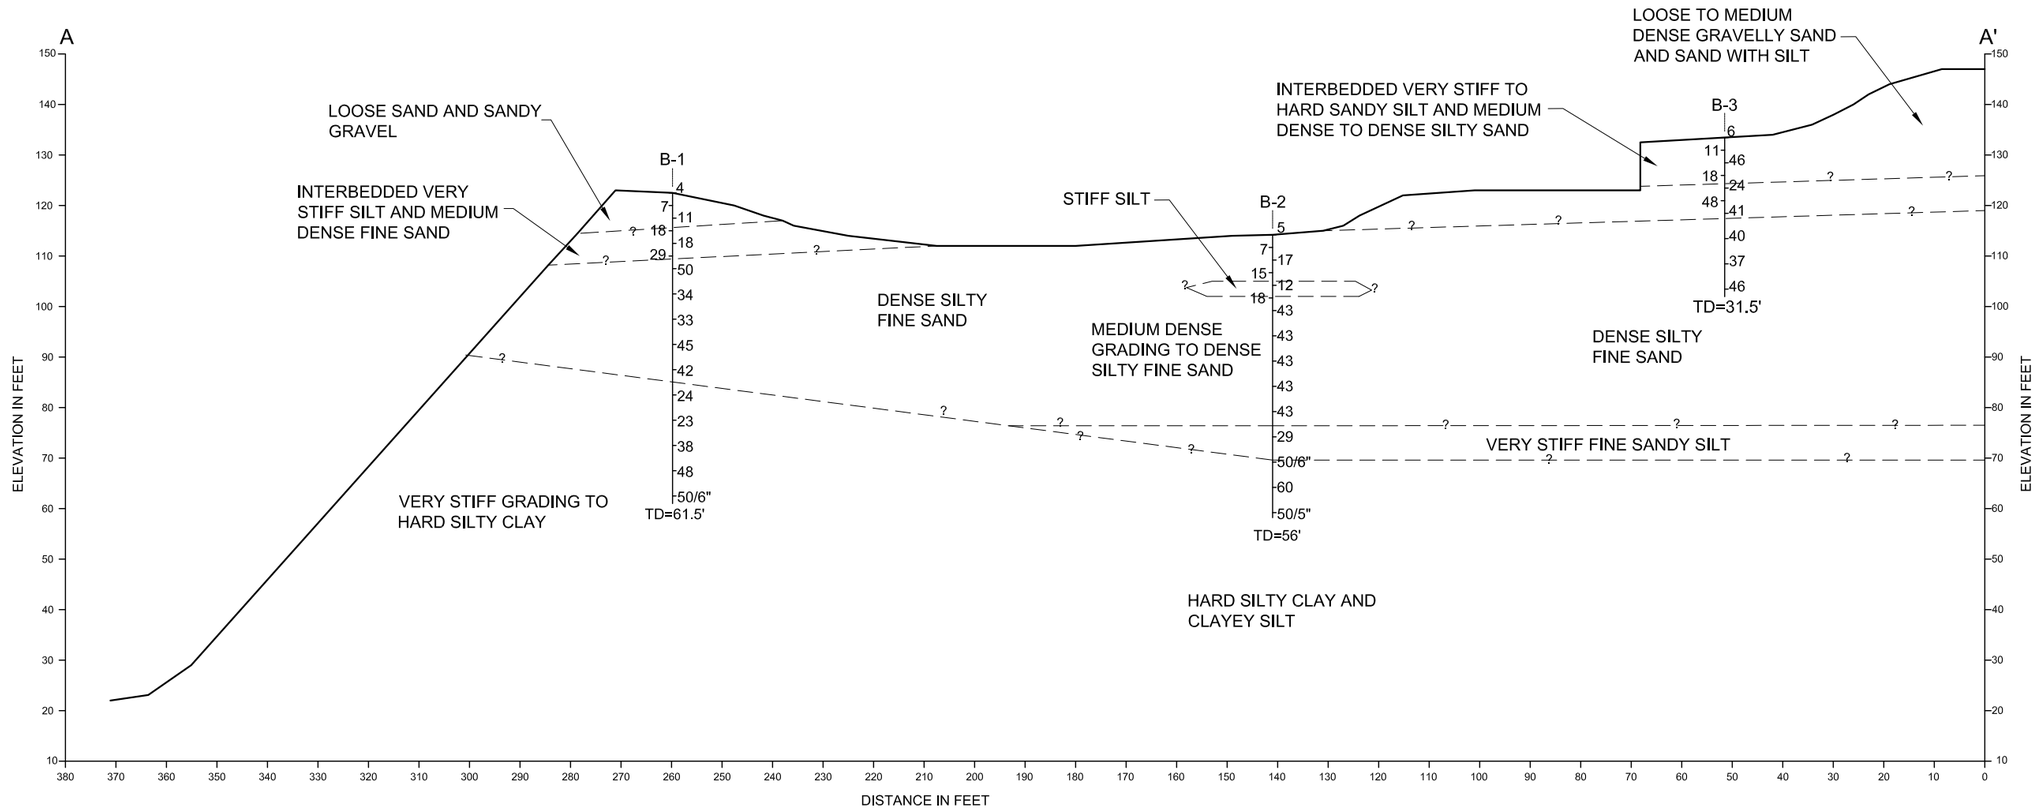
FIGURE 2
SHT.1 of 1

Figure 2 presents a generalized subsurface cross section depicting our interpretation of soil conditions beneath the site.

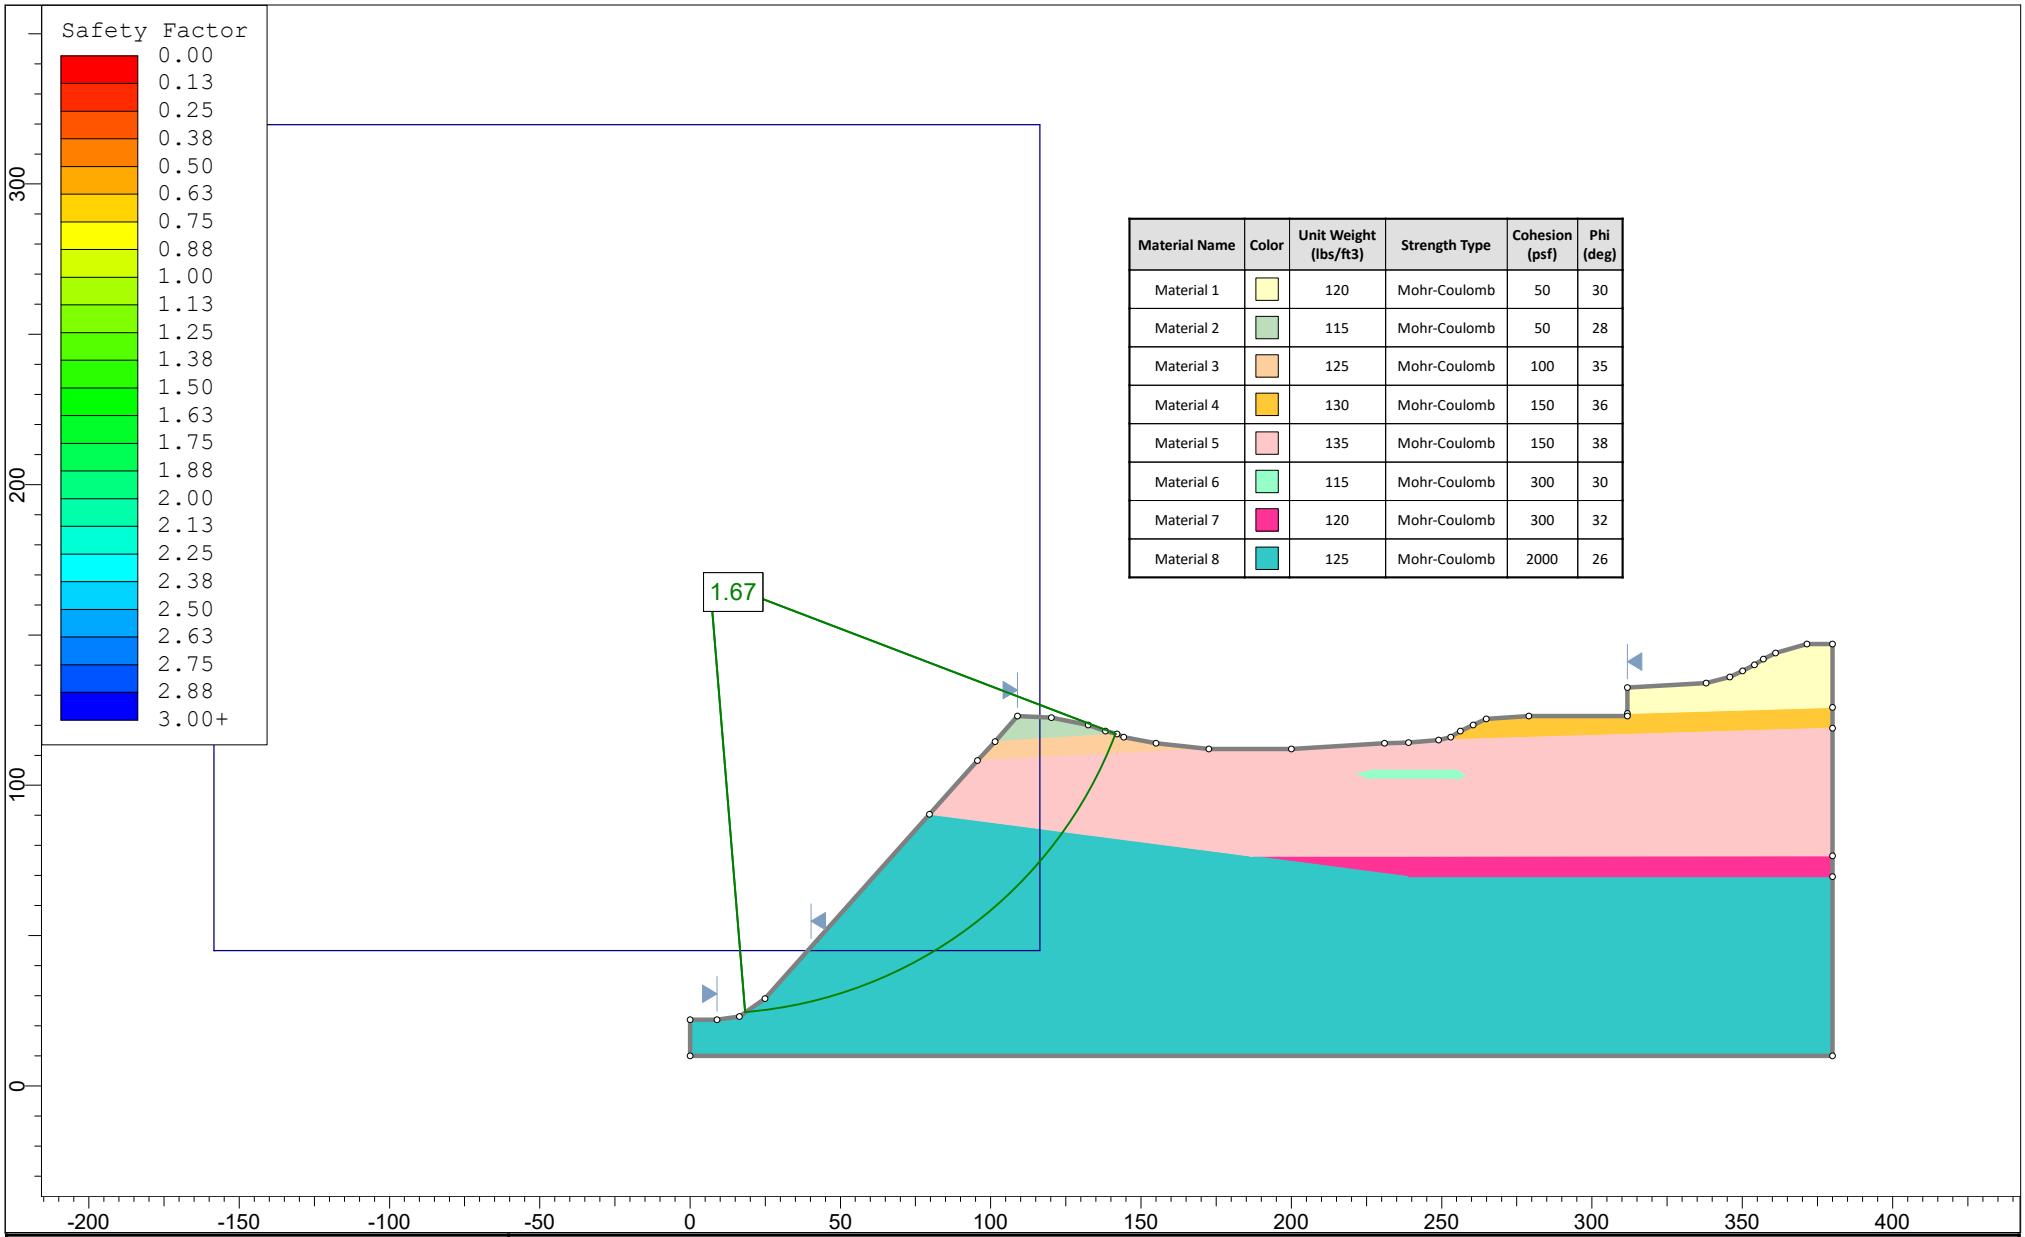
Zipper Geo Associates, LLC	*Project*	Talerman Residence		
	Analysis Description	Figure 3, Static Slope Stability Analysis A-A'		
	Drawn By JPG	*Scale* 1:766	*Company*	Zipper Geo Associates, LLC
	Date 1/30/2018, 3:50:54 PM		*File Name*	Talerman Static Analysis.slim

In general, our analyses indicate that under static conditions with the groundwater levels noted during our field explorations a safety factor of 1.5 is achieved at a distance of approximately 35 feet east of the top of the existing slope or about 135 feet west of the existing residence. The results of our static analysis are presented on Figure 3 with the predicted failure plane that exceeds a safety factor of 1.5.

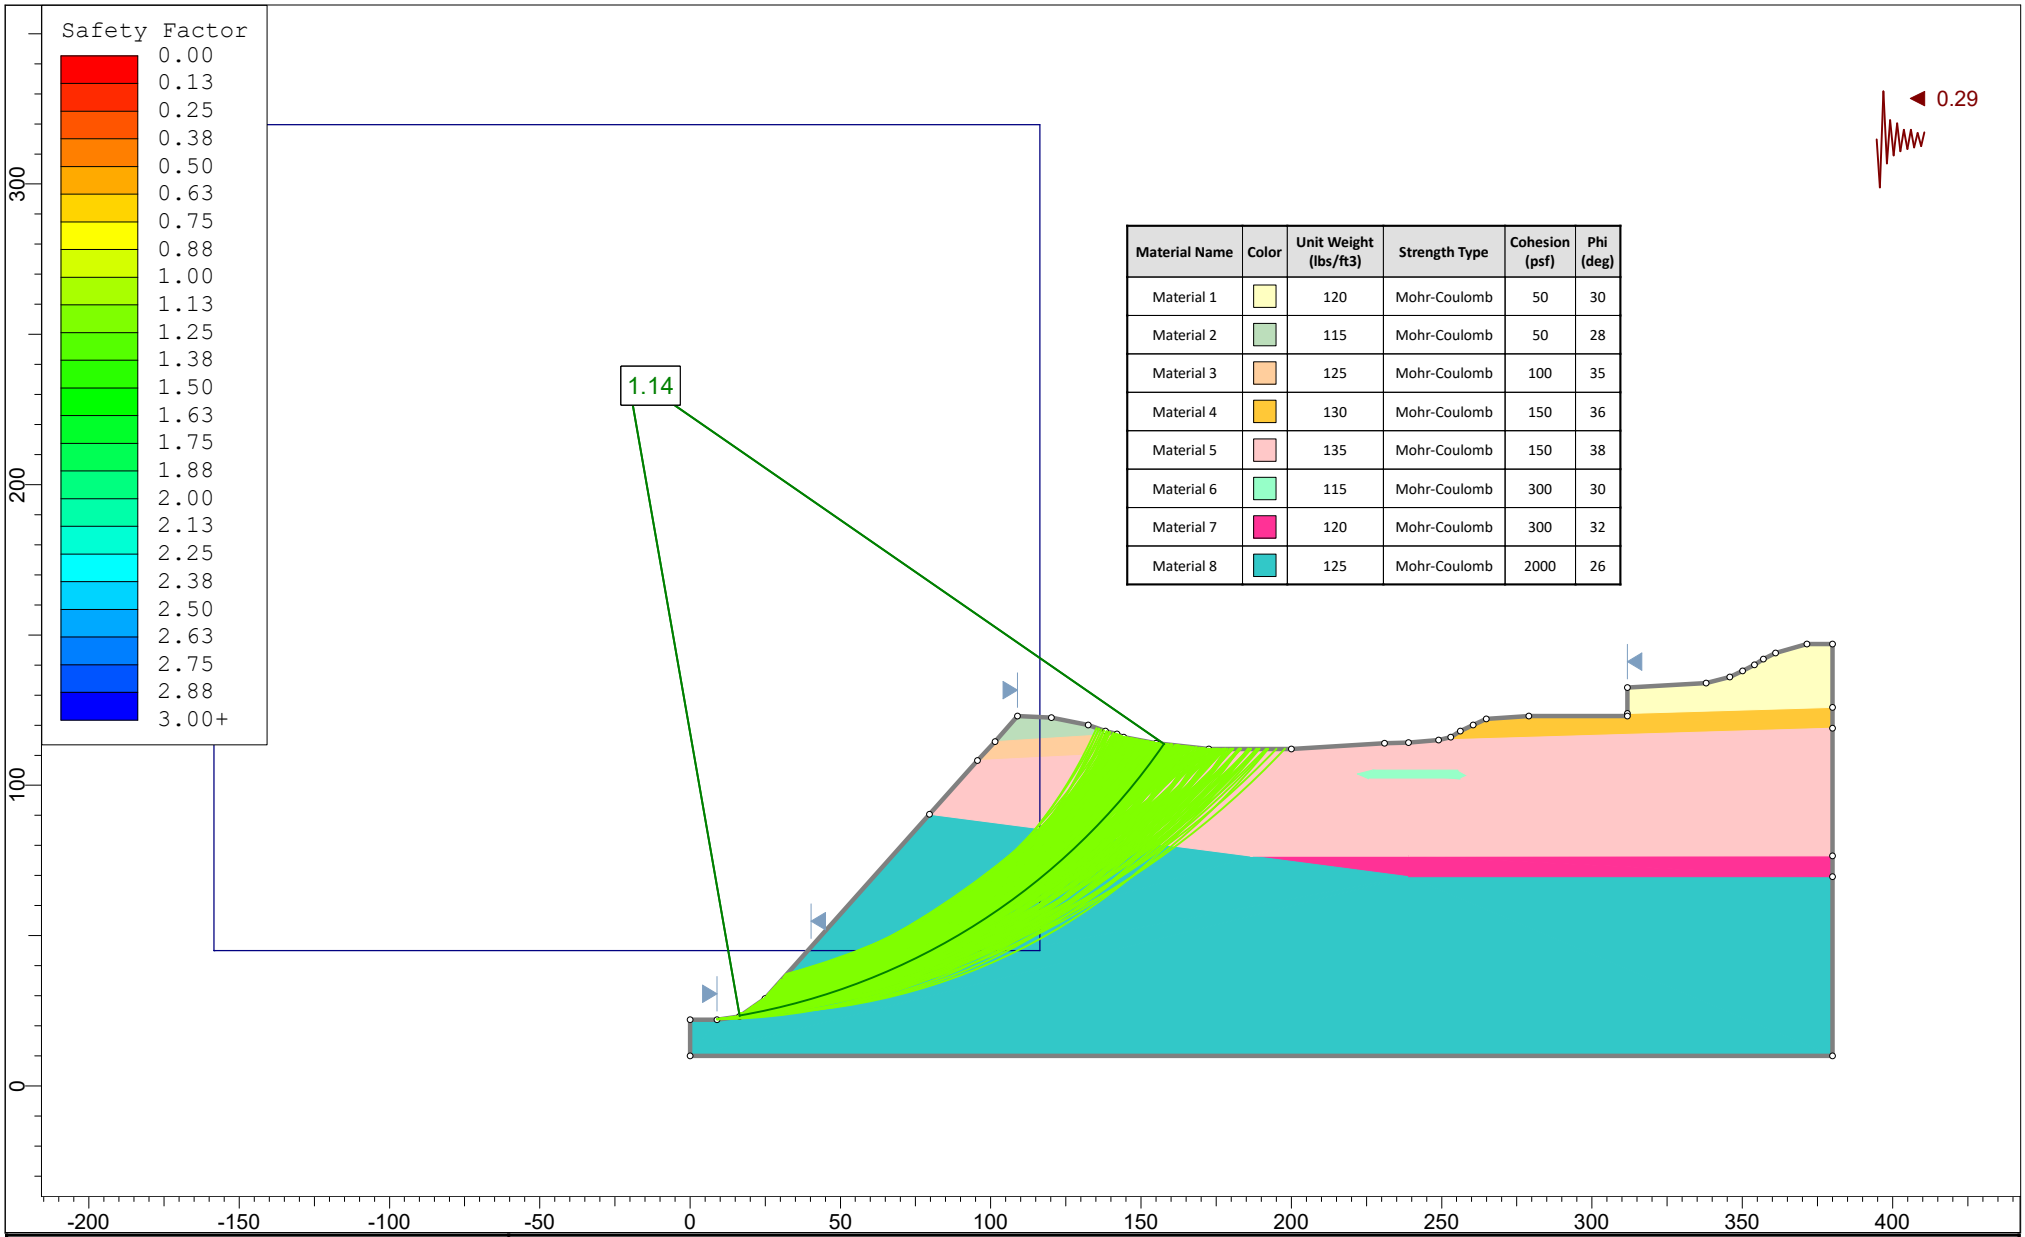
Zipper Geo Associates, LLC	*Project*	Talerman Residence		
	Analysis Description	Figure 4, Pseudostatic Slope Stability Analysis A-A'		
	Drawn By JPG	*Scale* 1:766	*Company*	Zipper Geo Associates, LLC
	Date	1/30/2018, 3:50:54 PM	*File Name*	Talerman Pseudostatic Analysis.slim

Under seismic conditions associated with the design earthquake ground motion, a safety factor of 1.1 is achieved at a distance of approximately 45 feet east of the top of the existing slope or about 125 feet west of the existing residence. The results of our pseudo-static analysis are presented on Figure 4 with the predicted failure plane that exceeds a safety factor of 1.1. The other green lines to the west and east of the predicted failure plane with a safety factor of 1.1 represent predicted failure planes with safety factors between 1.1 and 1.2. The proposed building envelope for this project is set back well to the east of the pseudo-static failure plane and should not have an adverse impact on the stability of the steep slope.
