Title: Rudolf Property Development
ISA Level 2 Basic Tree Risk Assessment
8253 West Mercer Way
Mercer Island, Washington

Prepared by: Urban Forestry Service, Inc.
Anna Heckman
ISA Board Certified Master Arborist® #PN-6153B
ISA Tree Risk Assessment Qualified

Date: September 18, 2018

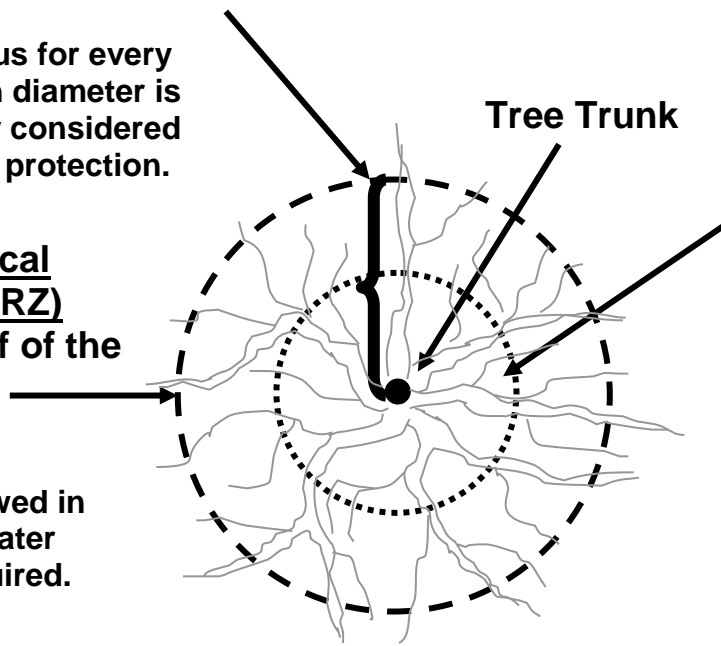
The Critical Root Zone (CRZ) of a tree is established on the basis of the trunk diameter. The CRZ is a circular area which has a radius of 12 inches for every inch diameter of trunk measured at 4.5 feet above grade. Root systems will vary both in depth and spread depending on size of tree, soils, water table, species and other factors. However, this CRZ description is generally accepted in the tree industry. Protecting this entire root zone area should result in no adverse impact to the tree, except for potentially increased exposure.

The above CRZ drawing has been further differentiated into the 'Perimeter' (PCRZ) and 'Interior' (ICRZ) to help define potential impact and required Post Care.
