# Earth Solutions NW LLC

## DAILY FIELD REPORT

| Project Name<br>Foo SFR | Job Location<br>3453 74 <sup>th</sup> Ave SE, Mercer Island | Client/Owner<br>JayMarc Homes, LLC | |

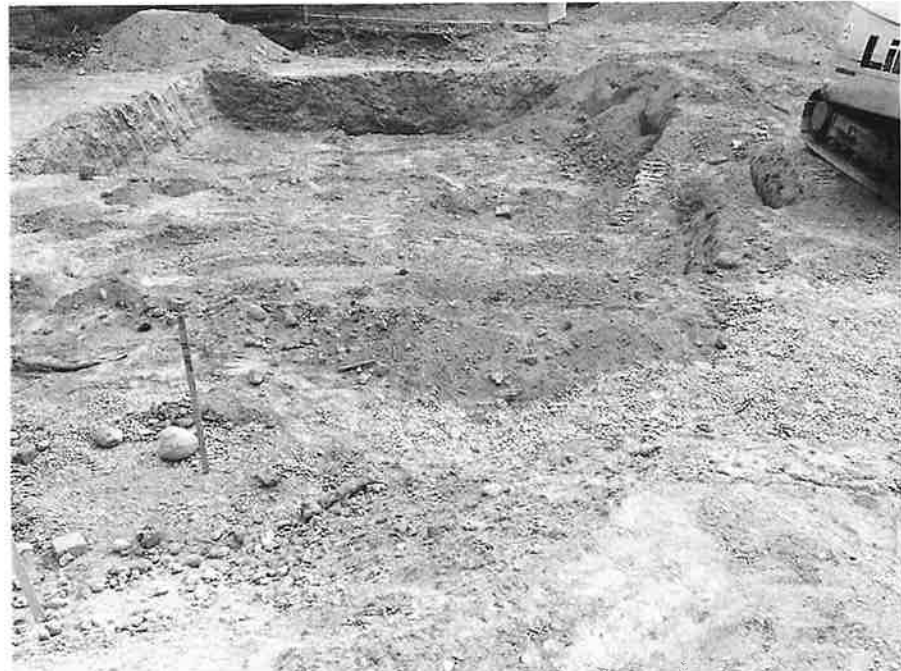
While onsite, ESNW rep obtained a soil sample from the stock pile on the western side of the site. The soil sample was tan silty sand with gravel (SM), and is considered suitable material to be used as slab backfill. ESNW rep recommends the contractor contact ESNW for density test of backfill.

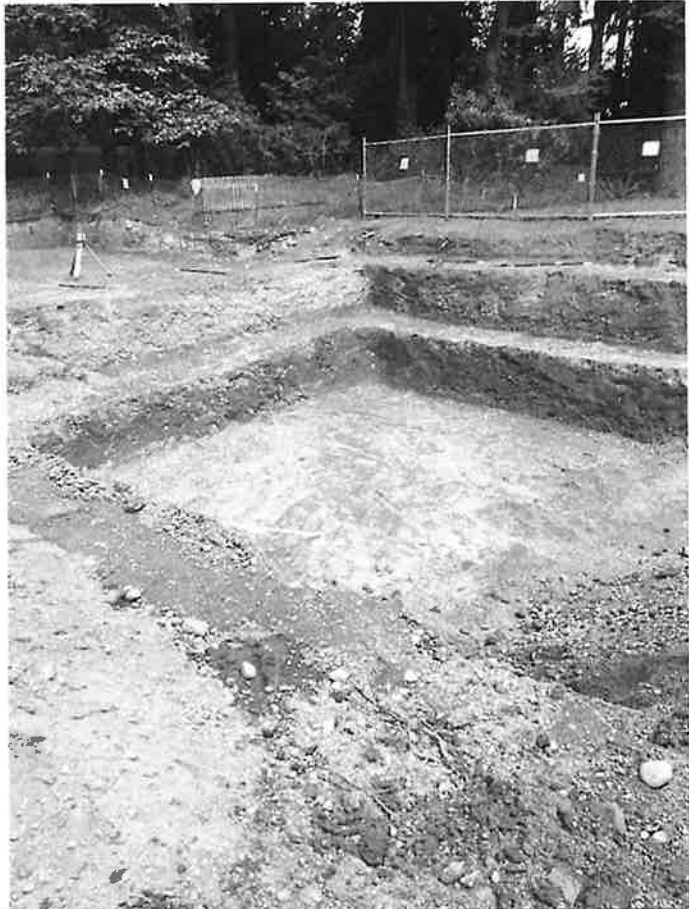
ESNW rep observed the contractor had partially excavated to soil subgrade for a single-family residence foundation. ESNW rep used a half-inch diameter steel T-probe to probe locations of half the basement foundation. ESNW rep observed dense soil conditions, considered suitable for the allowable soil bearing of 3,000 psf.
