**Project:** Pre-construction assessment for lot development at Villa Marbella Lot 6, Mercer Island, WA. Parcel number 8944220060.

**Objectives:** Evaluate health of existing trees and establish criteria for the preservation of those to be retained. Update original inventory report from 11/24/19.

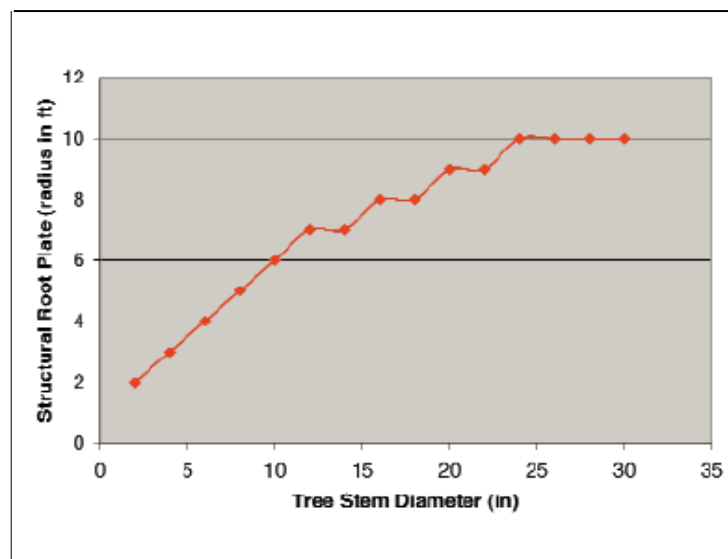
Figure 8. Size of the Structural Root Plate in relation to tree stem diameter. Note that the SRP levels off at 10' for any tree over 24" in diameter. (Coder, 1996)

In the case of the #8 cedar mentioned above, while the excavation for the proposed foundation will be at least 14' from its base, the cut for the driveway curves to within 10' in the NE quadrant, and the storm drain is shown coming as close as 7' from the base of the tree. From Figure 8 the Structural Root Plate for a 33" DSH tree is given as 10' so the foundation excavation work will be clear of the SRP, the driveway work will just graze it, and the trenching for the drain line will potentially cut 3' into it. This is not ideal for a large tree on the south side of the home and will likely create a destabilizing event.

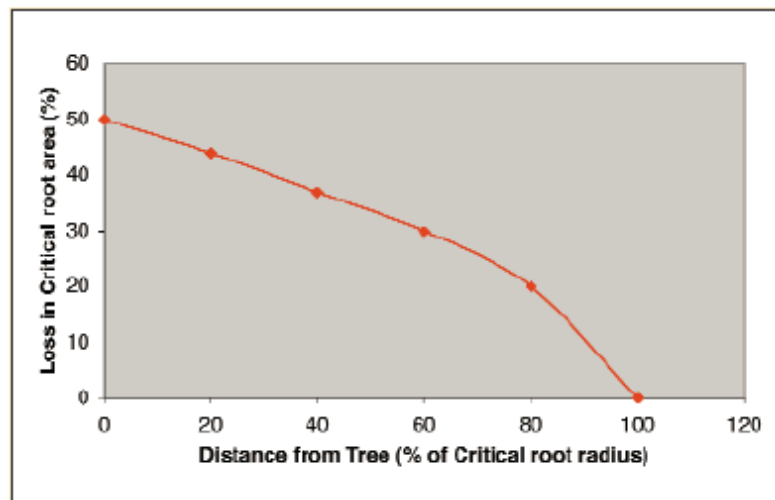
Figure 9. Chart giving the loss in critical root area as a function of the radial distance to the CRZ disturbance. (Coder 1996)

Using the #8 cedar as the example, if the trenching for the storm drain is 7' from the tree's base and it having a 33" DSH, there will be impact at a linear distance equal to 21% of the tree's CRZ (7'/33'). The chart shows that this could equate to a 45% loss of the cedar's Critical Root Area. But then the driveway work would notch out a chunk to the east side of the tree and the combination results in a loss of CRA in the neighborhood of 60%. Even if there was a way to install the storm drain without damaging the roots the foundation cut combined with the driveway work would still push the loss past 50% CRA.

The same can be said for the #15 maple. Not trenching for the drain line helps preserve close to 34% of its Critical Rooting Area according to the chart in Figure 9.

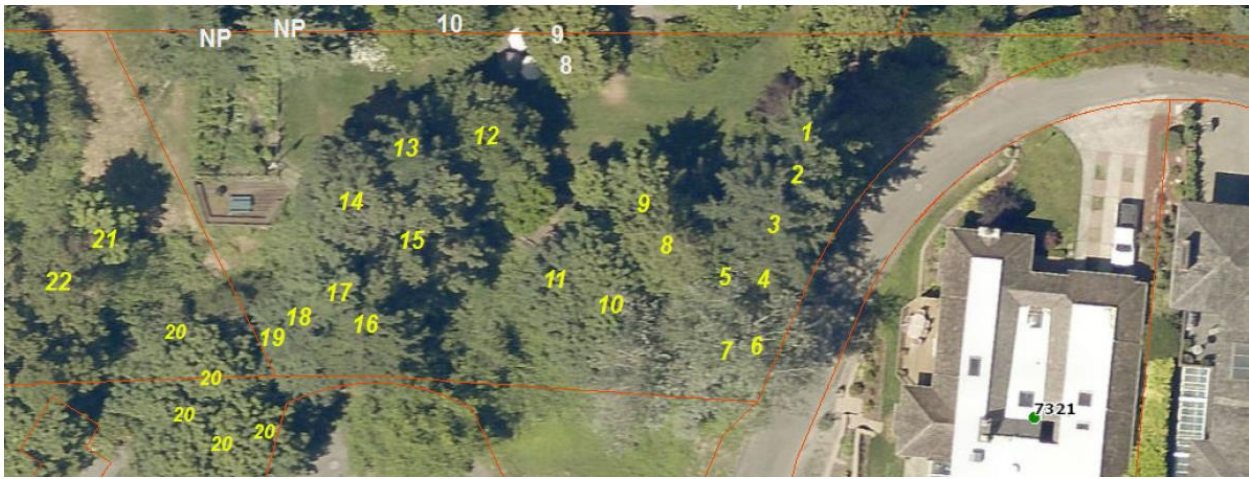
Figure 1. Aerial view showing the Villa Marbella Lot 6 property. The yellow numerals roughly indicate the locations of the trees listed in the Description section. Note that the #20 tree grove straddles an area designated as a TRCT lot and the 7301 property to the west. This grove was not indicated in the survey. The #21 and #22 trees are also located on the 7301 parcel. Three other trees, connoted as #8, #9, and #10 in white are listed in the report completed for the 7275 parcel. They stand quite close to the existing house on that lot.

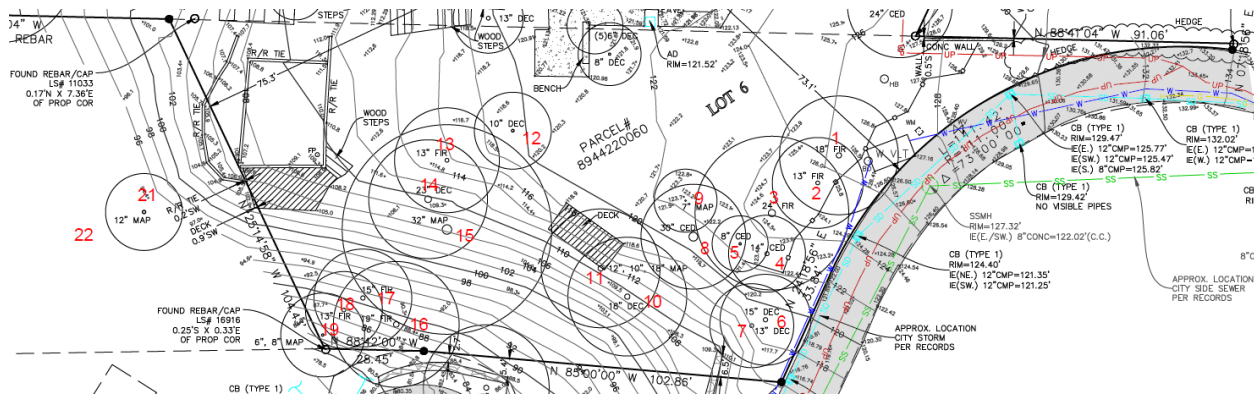
Figure 2. Excerpt from survey showing the rapid drop of the slope to the south. Note the two decks in the center of the image.

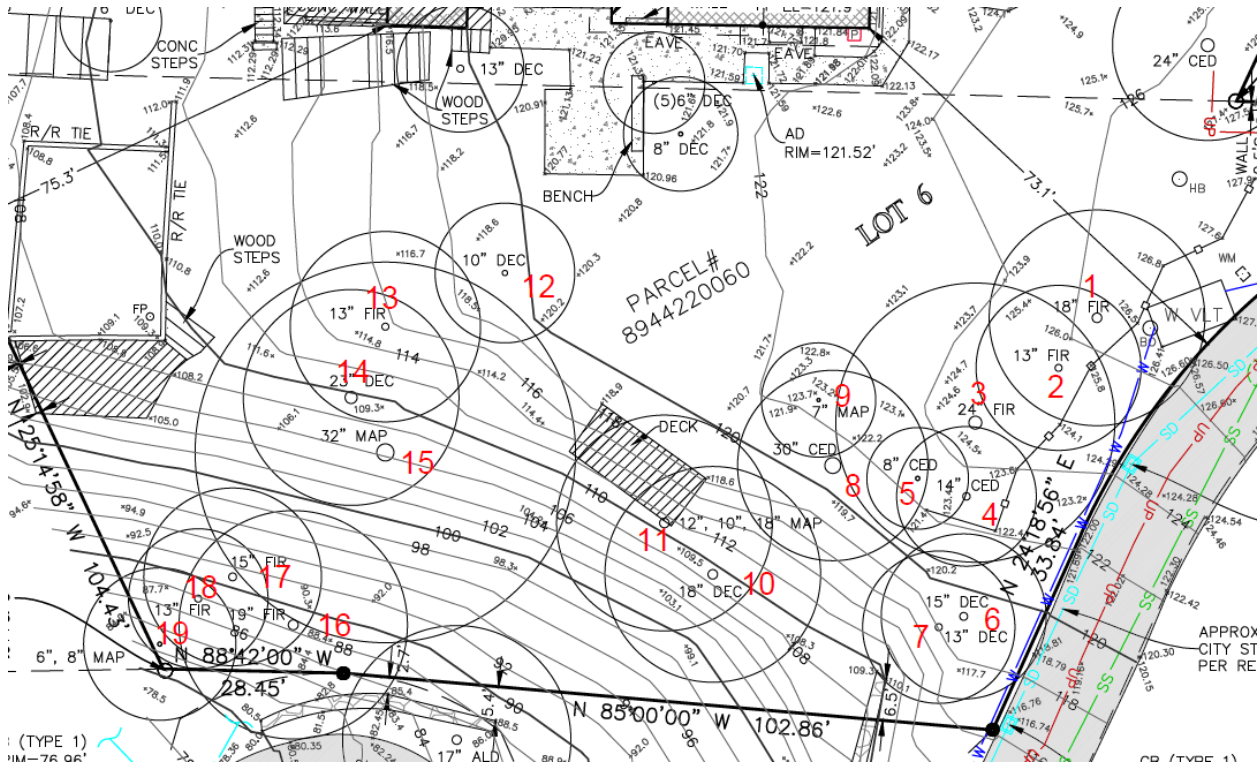
Figure 3. Enlargement of the formal survey with the trees labeled in red. Decks are more clearly seen in this image.
