Memorandum

To: Brandt Design Group c/o Bree Medley
Site: 8163 W Mercer Way, Mercer Island, 98040
Re: Tree Inventory and Assessment
Date: March 11, 2021; revised May 5, 2021
Project Arborist: Connor McDermott,
ISA Certified Arborist #PN- 8704A
ISA Qualified Tree Risk Assessor
Reviewed By: Haley Galbraith,
ISA Board Certified Master Arborist #PN-7512BM
ISA Qualified Tree Risk Assessor
Referenced Documents: Topographic Survey Seaspect Short Plat (Core Design Engineers, 4/20/2015)
Site Plan: Kahn Spec Home (Brandt Design Group, 11/30/2020)
Attached: Tree Table (Tree Solutions Inc., April 30, 2021)

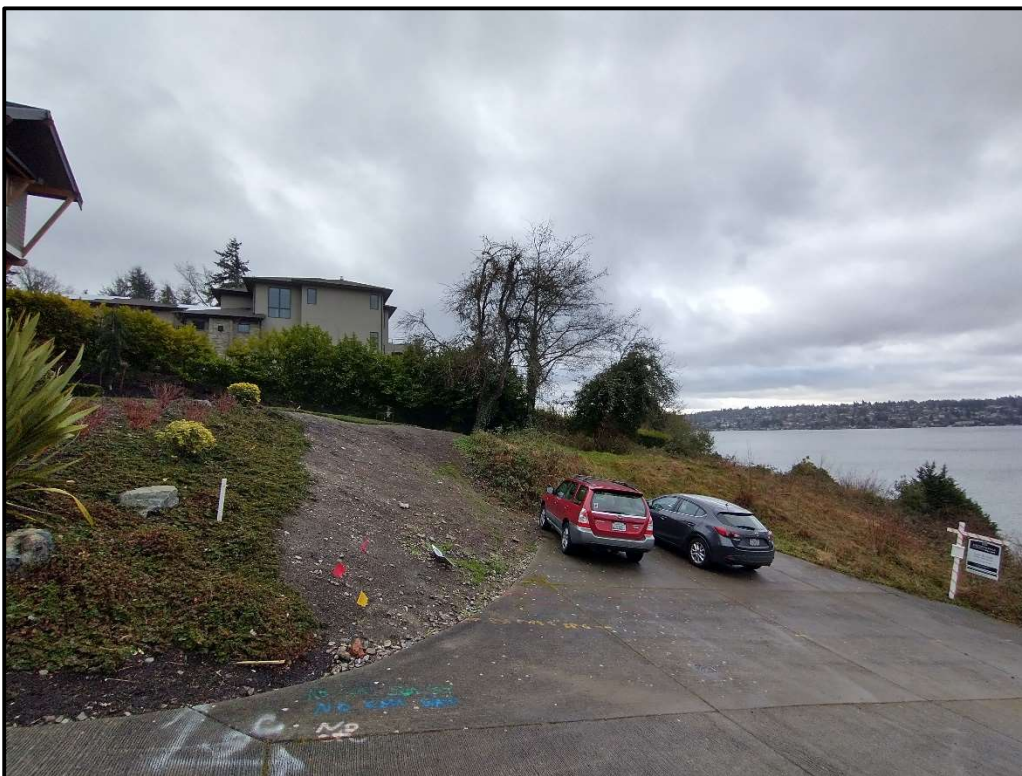
Photograph 2. Looking south at the site from the private drive off of W Mercer Way.

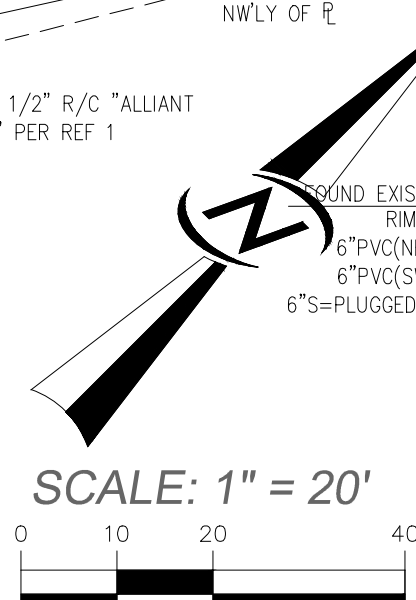
Tree Site Map
Tree inventory took place on February 25, 2021 and included all significant trees on site (numbered). Drip line measurements are listed in the table of trees produced by Tree Solutions Inc. and should be added to drawings prior to any design relating to tree protection.
