**SONDERGAARD GEOSCIENCE, PLLC**  
13012 65<sup>TH</sup> Avenue SE  
Snohomish, Washington 98296

Subject: Critical Area Report

7216 93<sup>rd</sup> Avenue SE

Mercer Island, Washington

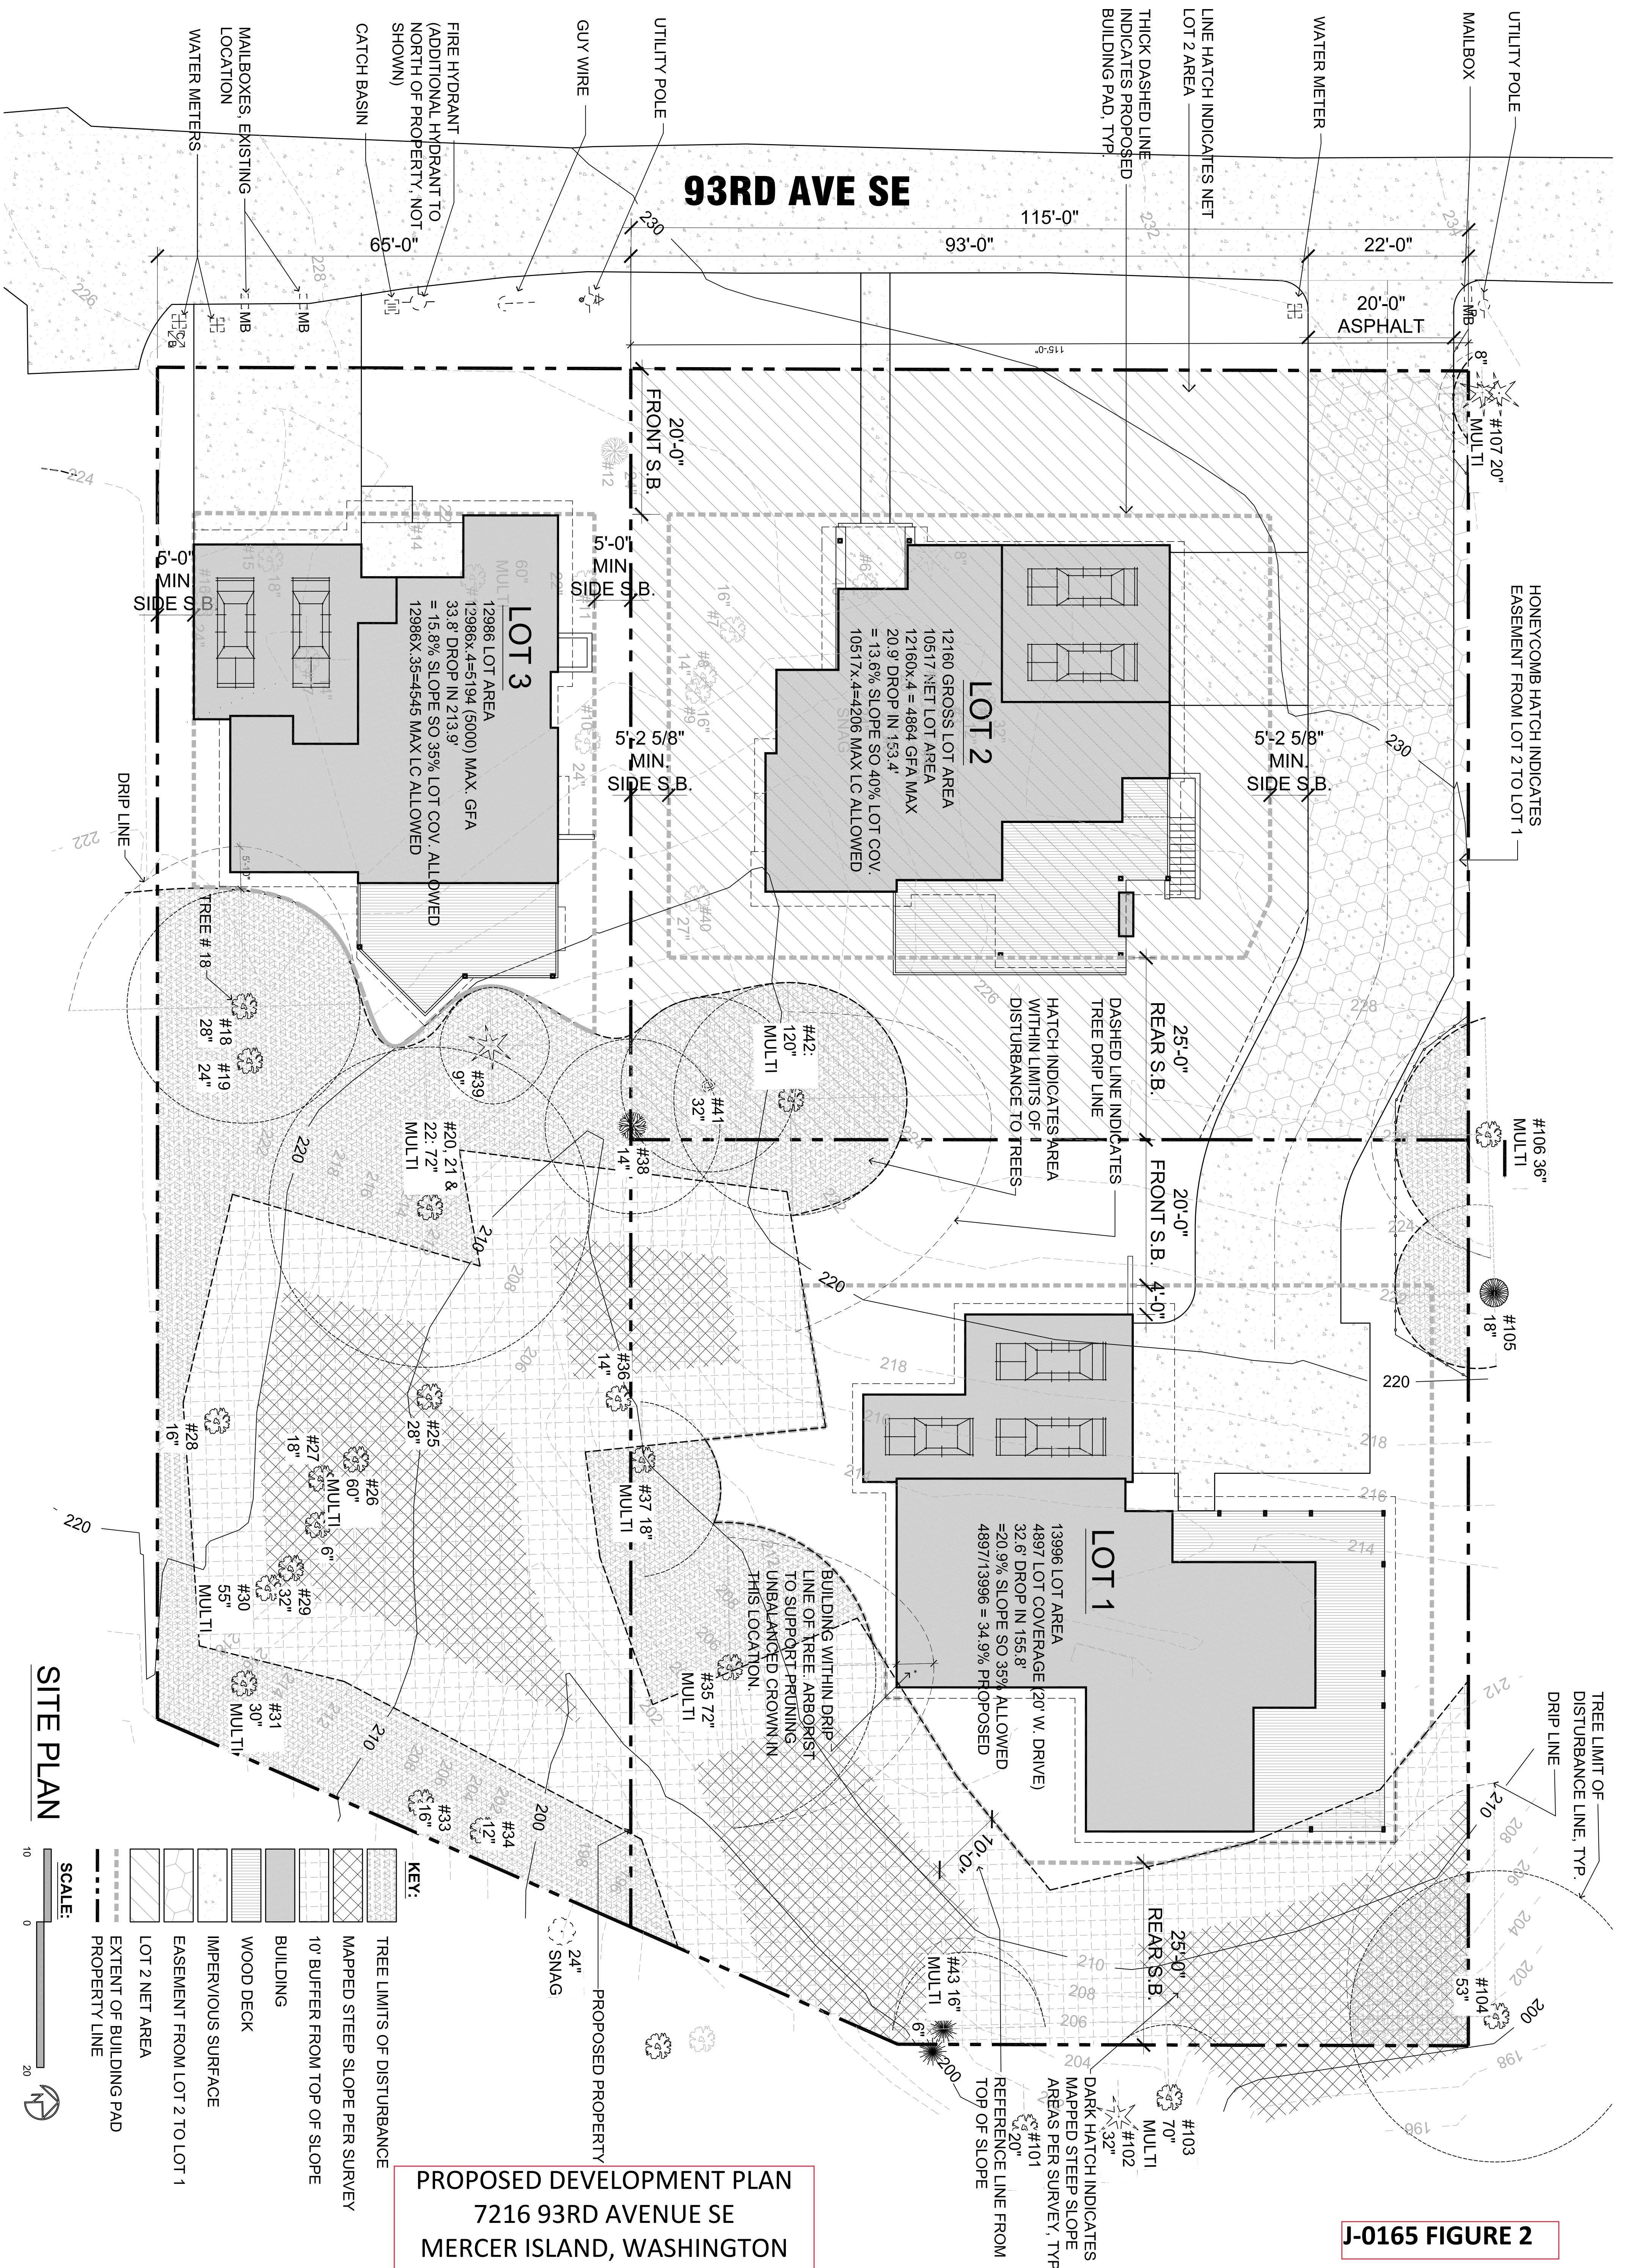
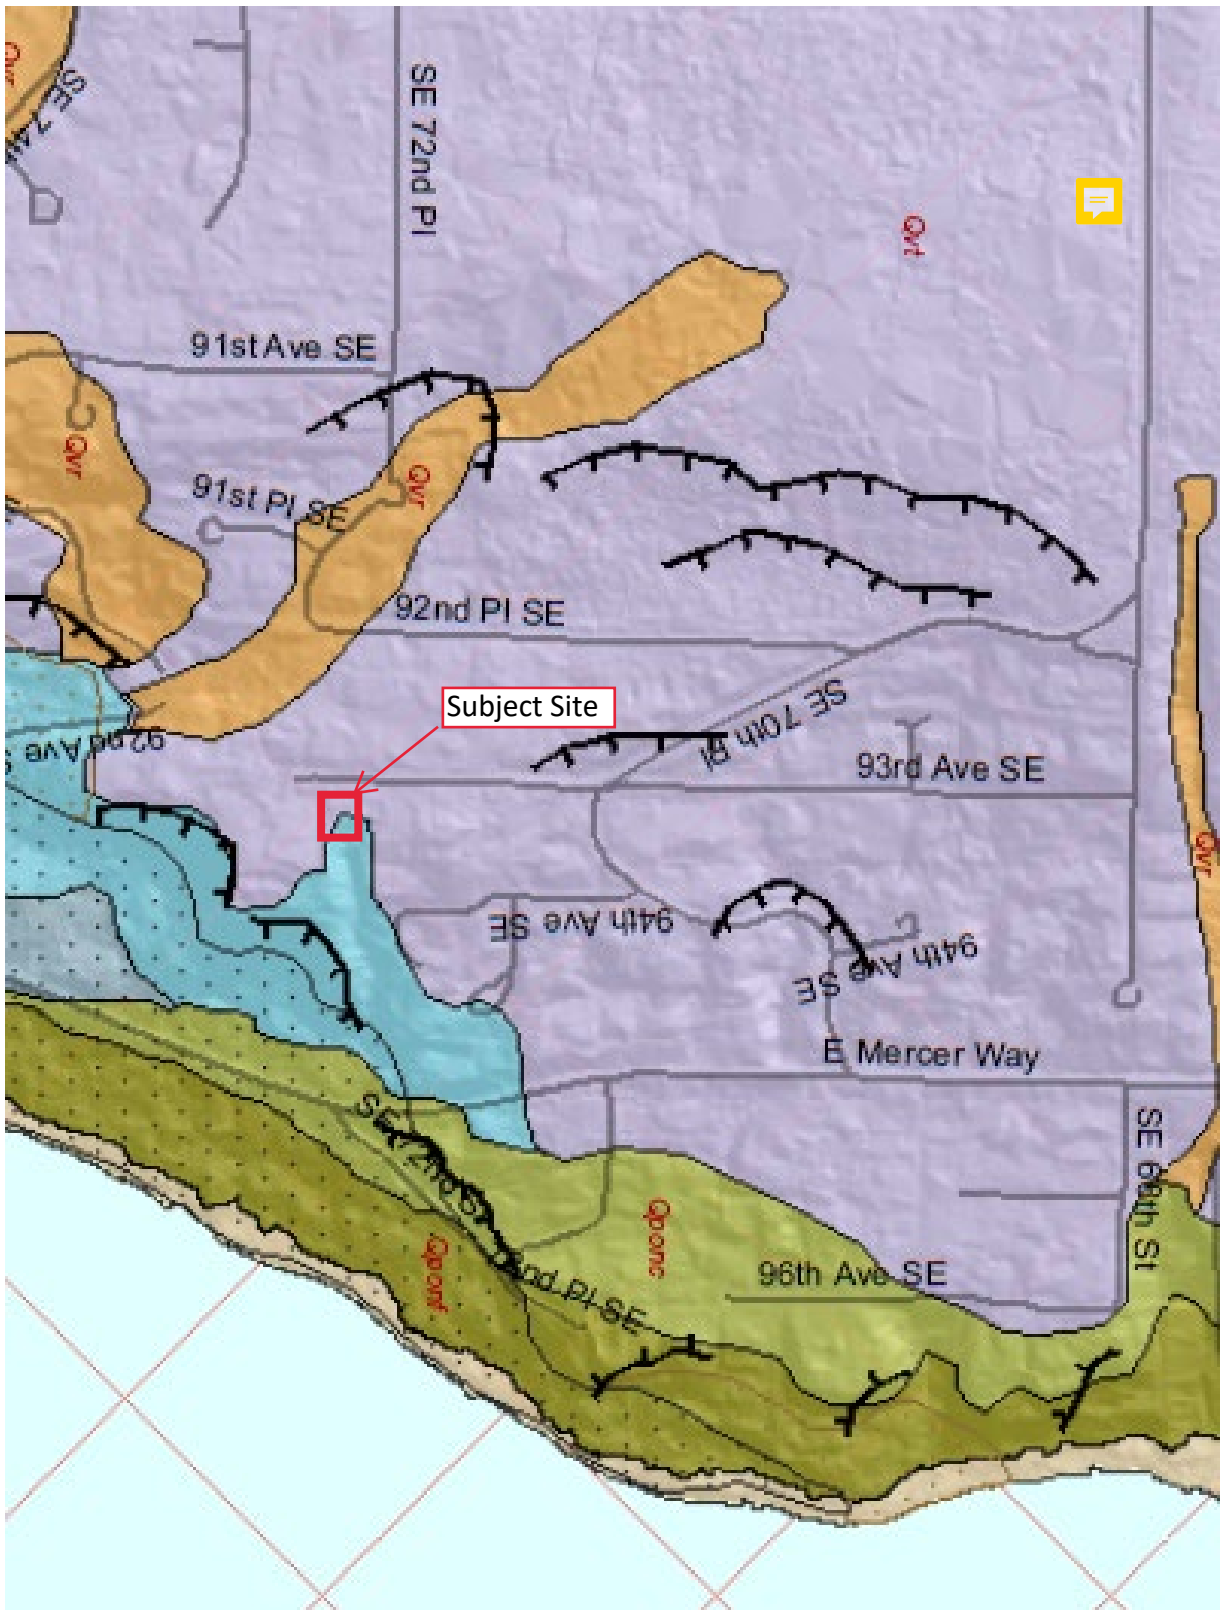
The identification of the geologic units underlying the parcel was determined by review of the published geologic map of the area (K.G. Troost and A.P. Wisher, 2006) and of site-specific geotechnical reports prepared for the proposed project (R.M. Pride, 2020a and 202b). The geologic map of the area (Figure 3) indicates that the west portion of the site is underlain by Vashon glacial till and the east half of the site is underlain by Vashon advance outwash. Vashon glacial till typically consists of dense to very dense, gray, silty, gravelly sand that exhibits high strength and low permeability. Vashon advance outwash typically consists of medium dense to very dense, brown to gray, sand, gravelly sand and silty sand that exhibits a moderate to high phi angle and low to high permeability. The findings on the geologic map were confirmed by subsurface explorations completed at the site and that encountered soils generally consisting of medium dense to dense, brown, silty sand underlying surficial topsoil and fill interpreted to be weather glacial till. Testing completed at the site (R.M. Pride, 2020b) determined infiltration rates ranging from 3.75 to 30 inches per hour for soils at depths ranging from 4 to 8 feet below the existing site grade. Groundwater was not detected to depths of 9 feet in soil explorations completed in February 2020.

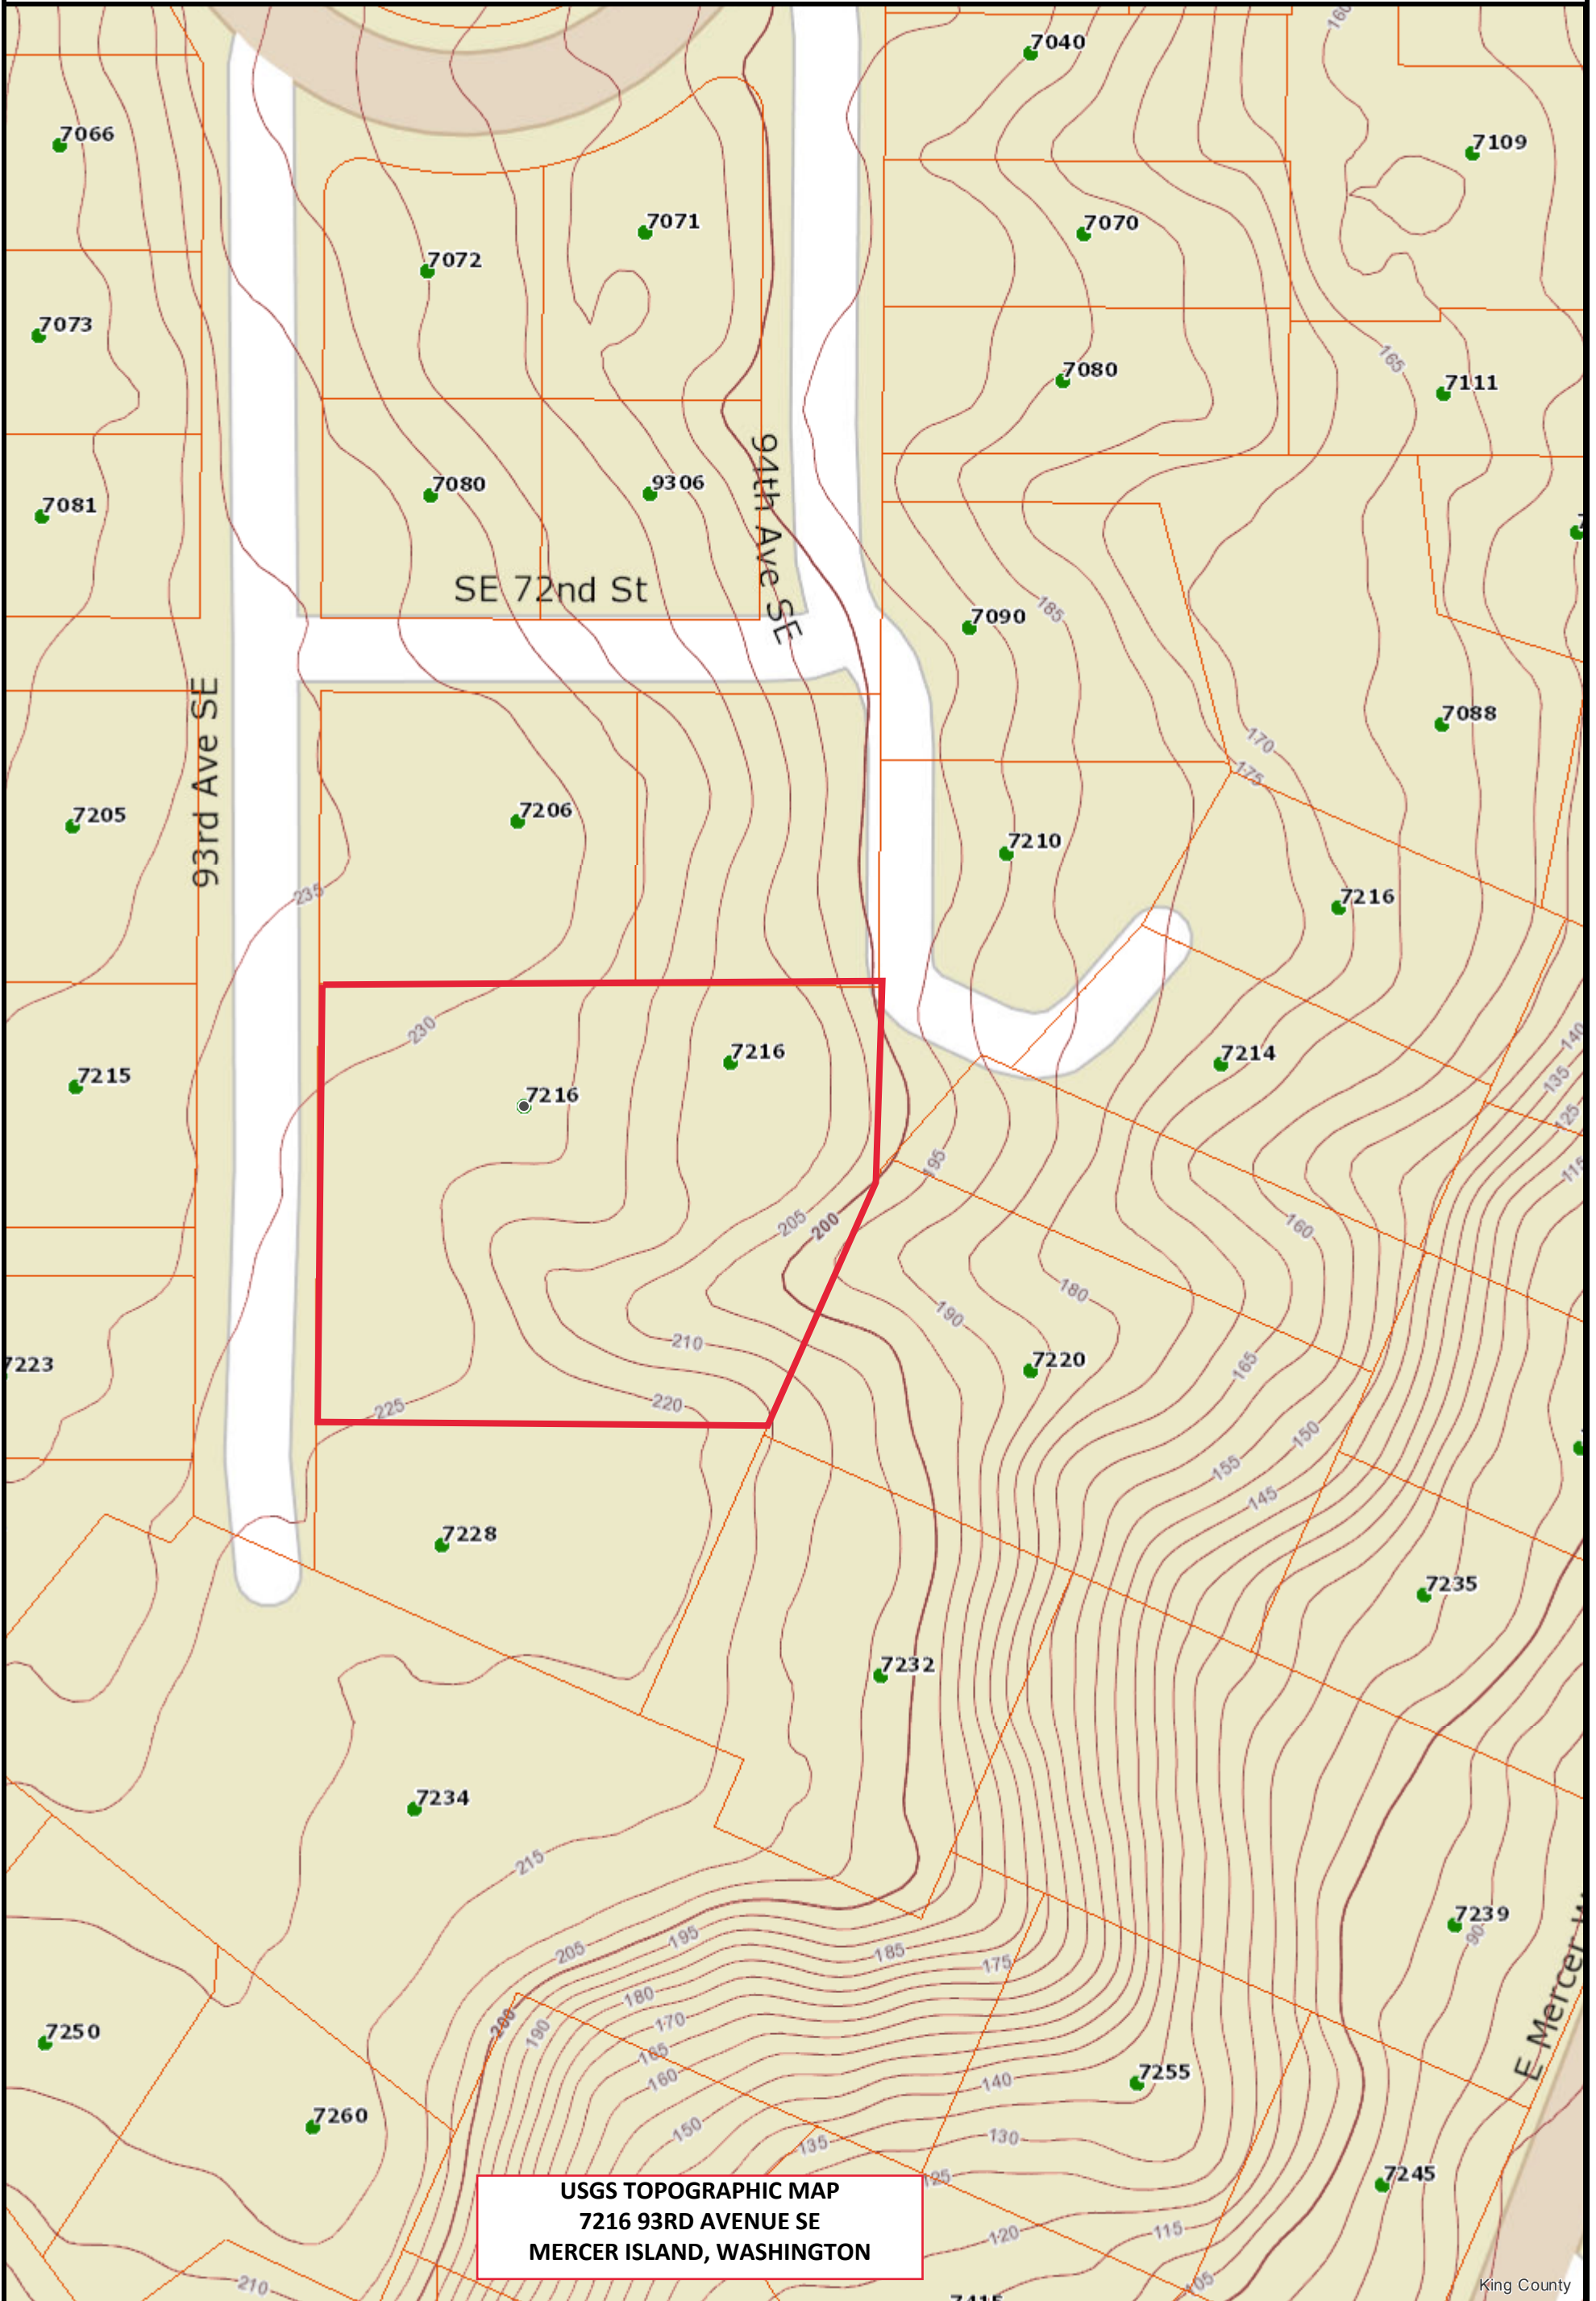
**J-0165 FIGURE 4**

The site is characterized by a slight slope down to the east on the west half of the property and on most of the northeast portion of the property. A gully runs along the southeast portion of the lot and along the east property line (Figure 4). Review of the Mercer Island Landslide Hazard map (K.G. Troost and A.P. Wisher (2009), Mercer Island Landslide Hazard Assessment prepared for Geomap Northwest and the City of Mercer Island indicates the east portion of the property contains slopes greater than 15 percent inclination (Figure 5). The topographic survey of the property shows that the slopes along the gully range height from about 8 to 20 feet with slope inclinations ranging from approximately 38 to 53 percent. According to MIMC Title 19, Chapter 19.16, Section 19.16.010(L) the gully slopes meet the definition of a landslide hazard area by having slope inclinations greater than 40 percent over a horizontal distance of 30 feet or greater (Figure 6). Based upon observation of the existing site conditions, including the large trees that remain on the site, in our opinion, there is no obvious evidence of past or present shallow or deep landslide movement at the site.
