August 2, 2021

Project: Pre-construction assessment for property re-development at 9611 SE 72nd Street, Drive East, Seattle, WA. Parcel number 2579500040.

Objectives: Evaluate health of existing trees and establish criteria for the preservation of those to be retained.

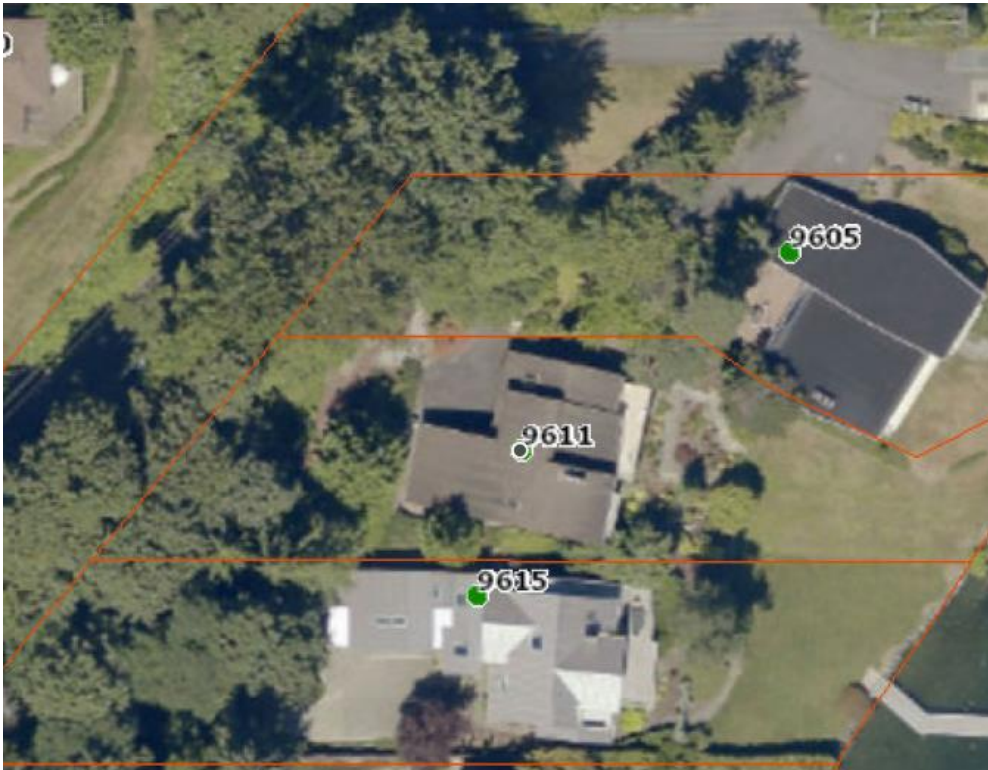
Figure 5. Aerial image from 2013 showing changes to the 9615 property. Note changes to the east garden area of the 9611 property.

The 9615 house to the south was substantially remodeled in 2009 (Figures 4 and 5). Changes to the conformation of its garage and driveway would have had some impact on the trees along the border between the two properties. No substantial changes occurred on the 9605 property over the time period.

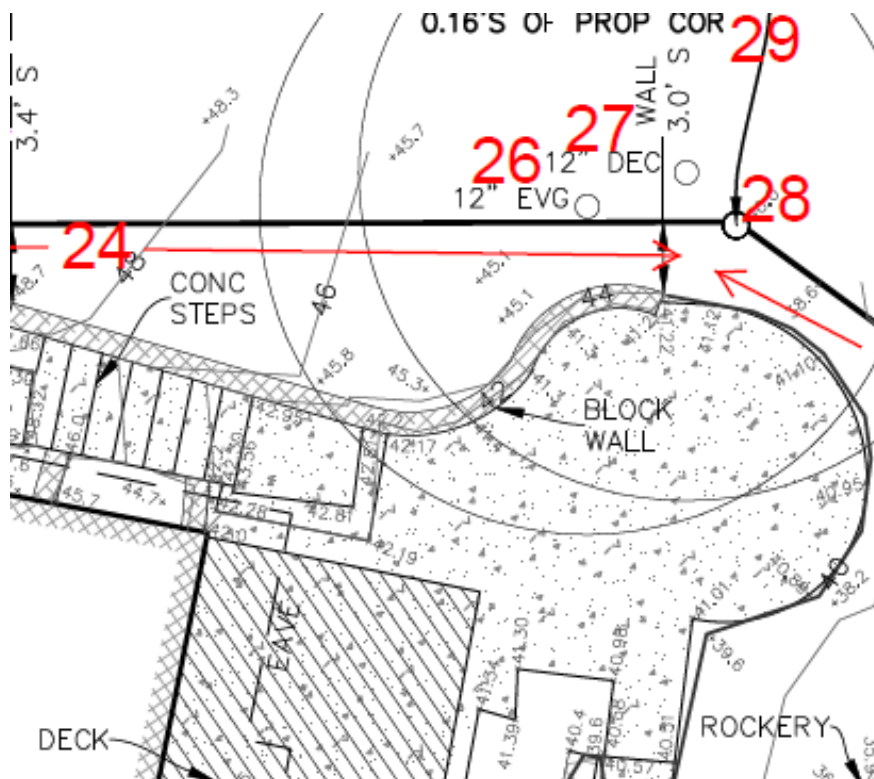
Figure 28. Enlarged excerpt from the tree plot showing how the survey drew the keystone wall formation. Compare to Figure 21.

The 11" DSH #26 pine has a 6.5' SRP according to Figure 27. According to the proposed plan and field measurements the pine sits just 3.5' back from the end of the brickwork at the NE corner which is slated to be demolished. While the survey shows the wall curving south of the pine (Figures 8 and 28) the photo in Figure 21 shows the end of the wall pointing directly at the base of the pine. There is a high likelihood that the pine has structural roots reaching into the soil above the wall.
