**Project:** Pre-construction assessment for lot re-development at 4220 91<sup>st</sup> Avenue SE, Mercer Island, WA. Parcel number 4457300070.

**Objectives:** Evaluate degree of impact for three neighboring firs and establish criteria for their preservation. Assess dying hemlock for risk.

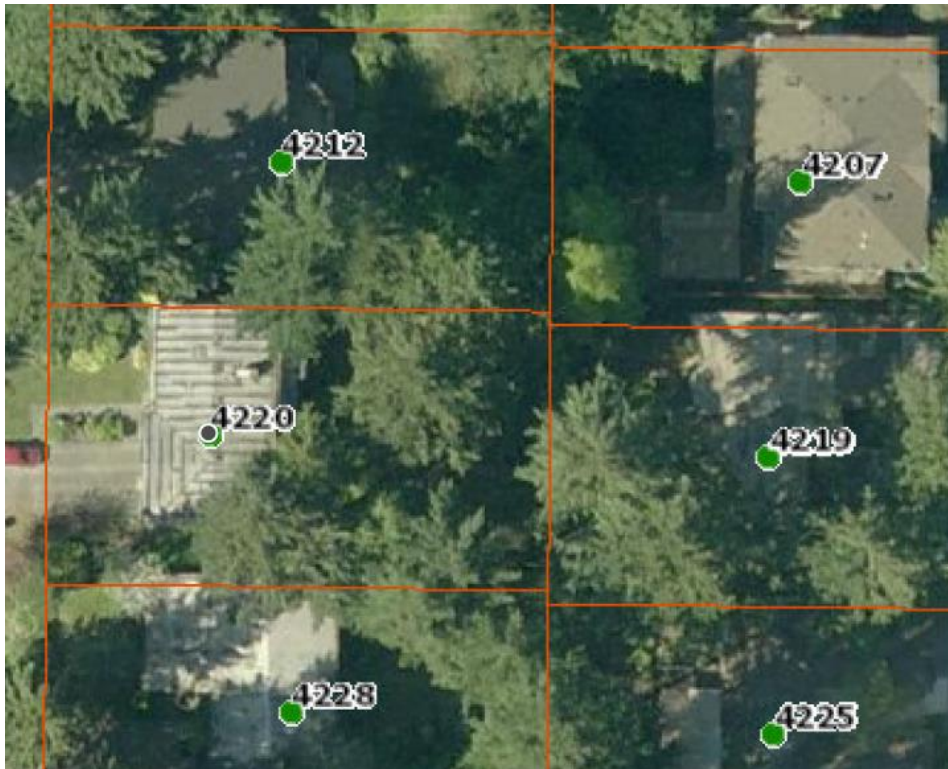
Figure 1. Aerial photo from 2009 showing the heavy tree canopy in the 4220 yard.

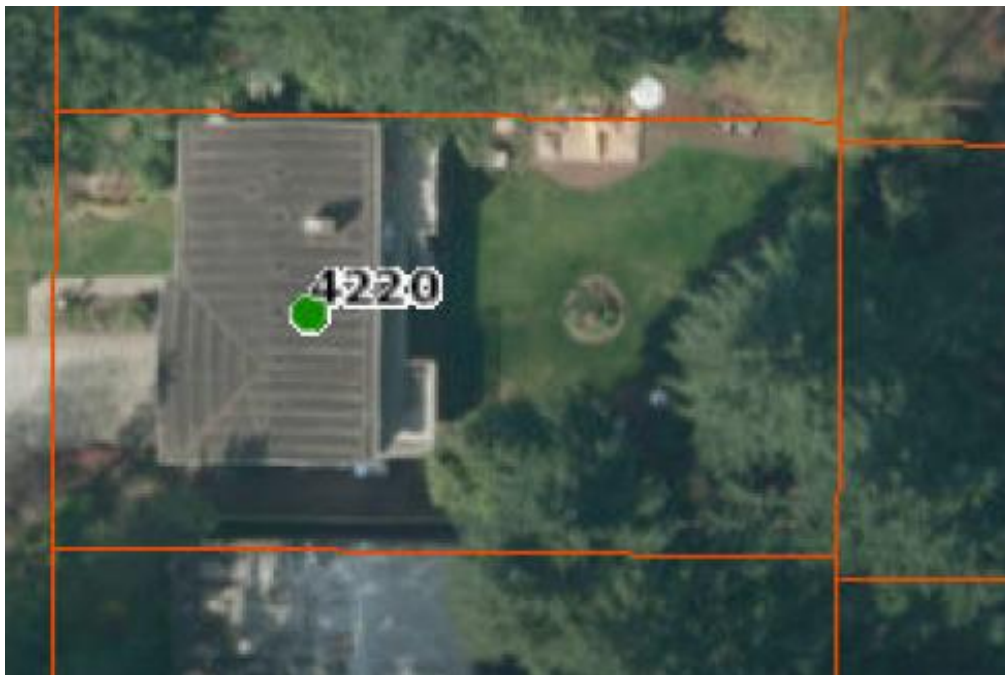
Because of the work which happened between 2009 and 2012 when the large trees in the yard were removed and their roots obviously ground out (because no stumps are present) and especially from the work done around 2015 to create the large planting bed it is likely that this Douglas Fir experienced some level of root disturbance. It is hard to tell whether the tree's structural roots were damaged or their growth retarded from the ground work but based on observation it is more likely than not.

Figure 2. Aerial photo from 2012 showing the trees removed from the rear yard of the 4220 property. The angle of incidence of the satellite puts the tops of the neighboring trees within the yard.

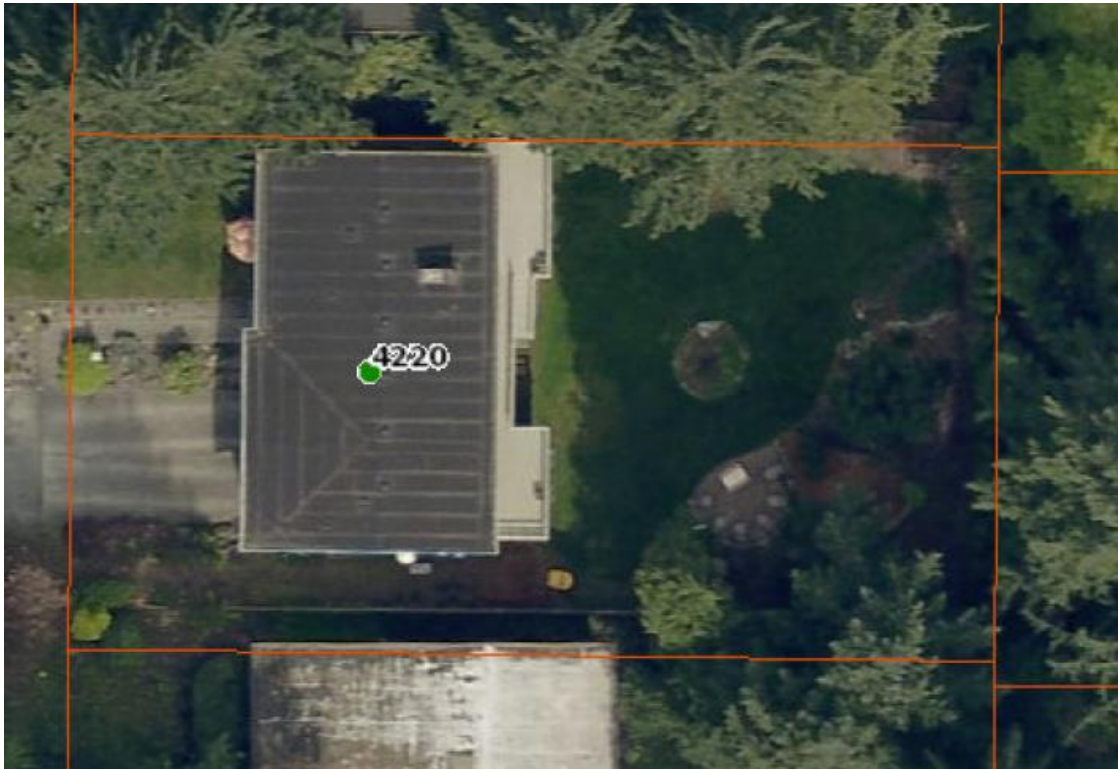
Figure 3. Aerial photo from 2015 showing the clearly landscaped section in the SE corner of the subject yard. Note the evergreen tree in the west corner of this area.

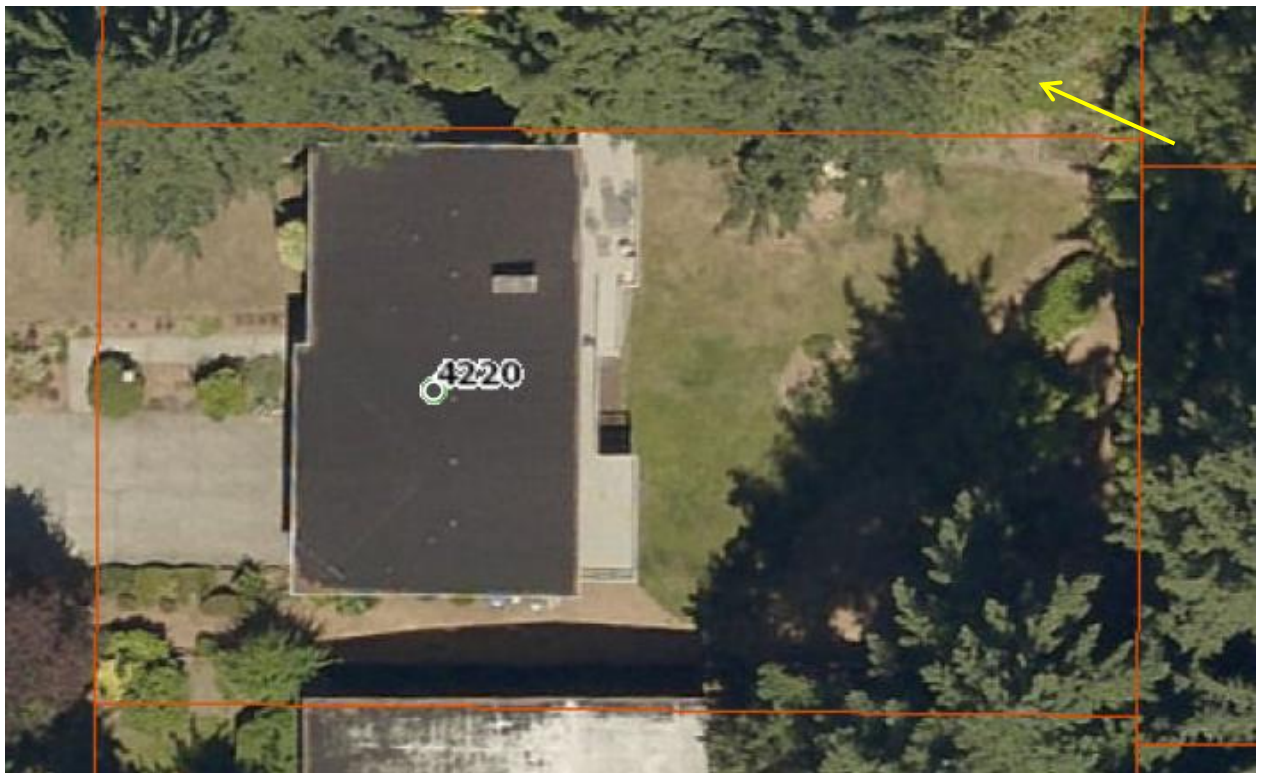
- 4) Western Hemlock (*Tsuga heterophylla*) 18" DSH, 65' tall standing near or on the north property line 20' W of the NE corner of the property. The tree is in advanced decline and the upper half of the canopy is dead (Figure 11). It appears mostly live in the 2017 aerial (Figure 12) and mostly dead in the 2019 aerial (see Figure 5). This tree is Non-Exceptional under the City definition.

Figure 4. Aerial photo from 2017 showing the missing evergreen at the west corner of landscaped region. Also note that at this time the hemlock is still green (yellow arrow).

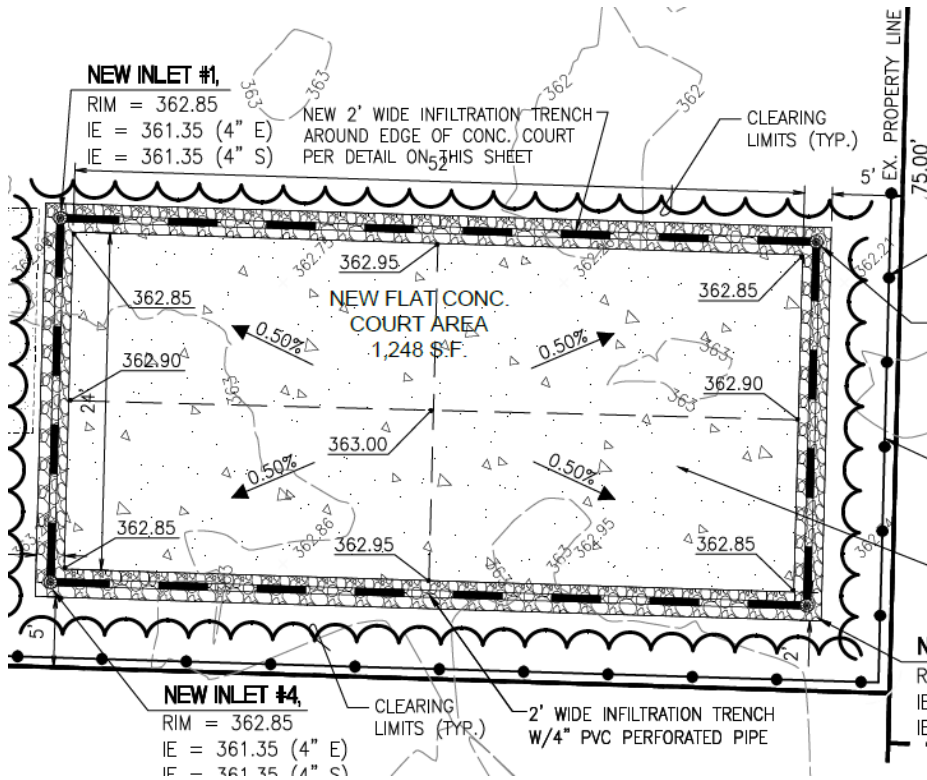
In the case of the #1 tree mentioned above, the excavation for the proposed sport court, including that of the infiltration trench, could come as near as 9.5' to the base of the tree. From Figure 15 the Structural Root Plate for a 27" DSH tree is given as the full 10' so the excavation technically slices through the edge of this tree's SRP.

Using the #1 fir again as the example, with the excavation being 9.5' from the tree's base and it having a 27" DSH, there would technically be impact at a linear distance equal to 35% of the fir's CRZ ( $9.5'/27'$ ). The chart shows that this roughly equates to a potential 40% loss of the tree's Critical Root Area (CRA). If this was the first impact to a pristine rooting space it would be well beyond the maximum recommended impact guideline.

Figure 6. Excerpt from the survey plans showing footprint for proposed sport court.

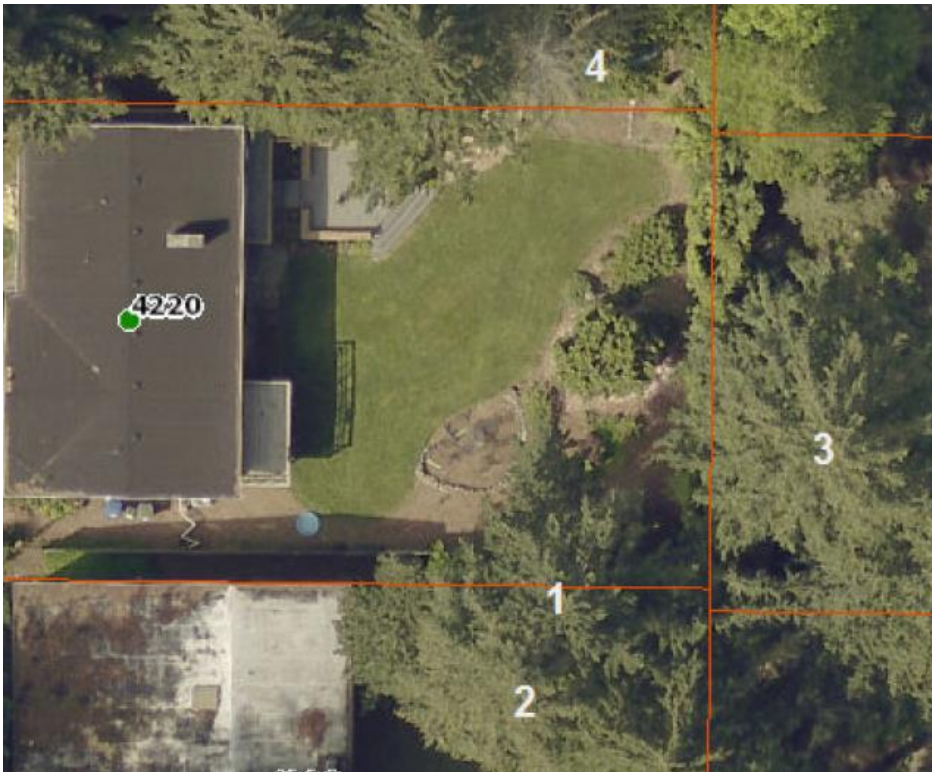
- 2) Douglas Fir 25" DSH, 75' tall standing 18'S of the fence and about 6' W of the #1 tree. It is in fair condition. Its canopy extends down below the halfway point but is almost entirely in the SW quadrant. This tree is Non-Exceptional under the City definition.

- 3) Douglas Fir 34" DSH, 90' tall standing 18' E of the east border line and 18' N of the SE fence corner. Tree is in fair condition. Its canopy is fairly evenly spread and extends down below the halfway point. This tree is Exceptional under the City definition.

Figure 7. Aerial showing rough location of subject trees (labeled in white).
