October 20, 2021

Project: Pre-construction assessment for lot re-development at 7208 N Mercer Way, Mercer Island, WA. Parcel number 5315100025.

Objectives: Evaluate health of existing trees and establish criteria for the preservation of those to be retained.

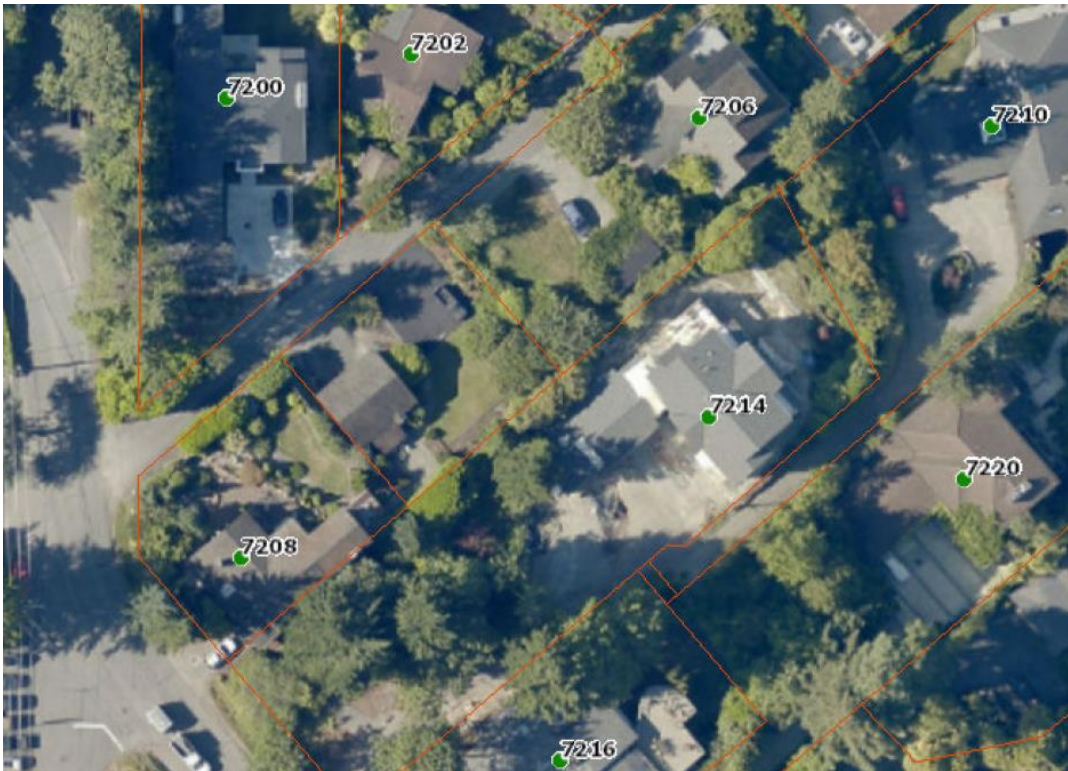
Only one of the nearby properties showed significant changes over the last twenty years. The 7214 parcel which runs along the SE border line of the subject was sold to a new owner in the fall of 2011. They demolished the old house in 2012 and built a new one in nearly the same location (Figures 2 and 3). During this process several large evergreens were removed to allow for major conformational changes to the driveway (Figure 4). Several other large trees standing between the new driveway and the subject property had to have had their root systems significantly disturbed based on their sizes and location.

Figure 3. Aerial photo circa 2013 showing the large evergreens missing in the path of the new driveway for the 7214 home.

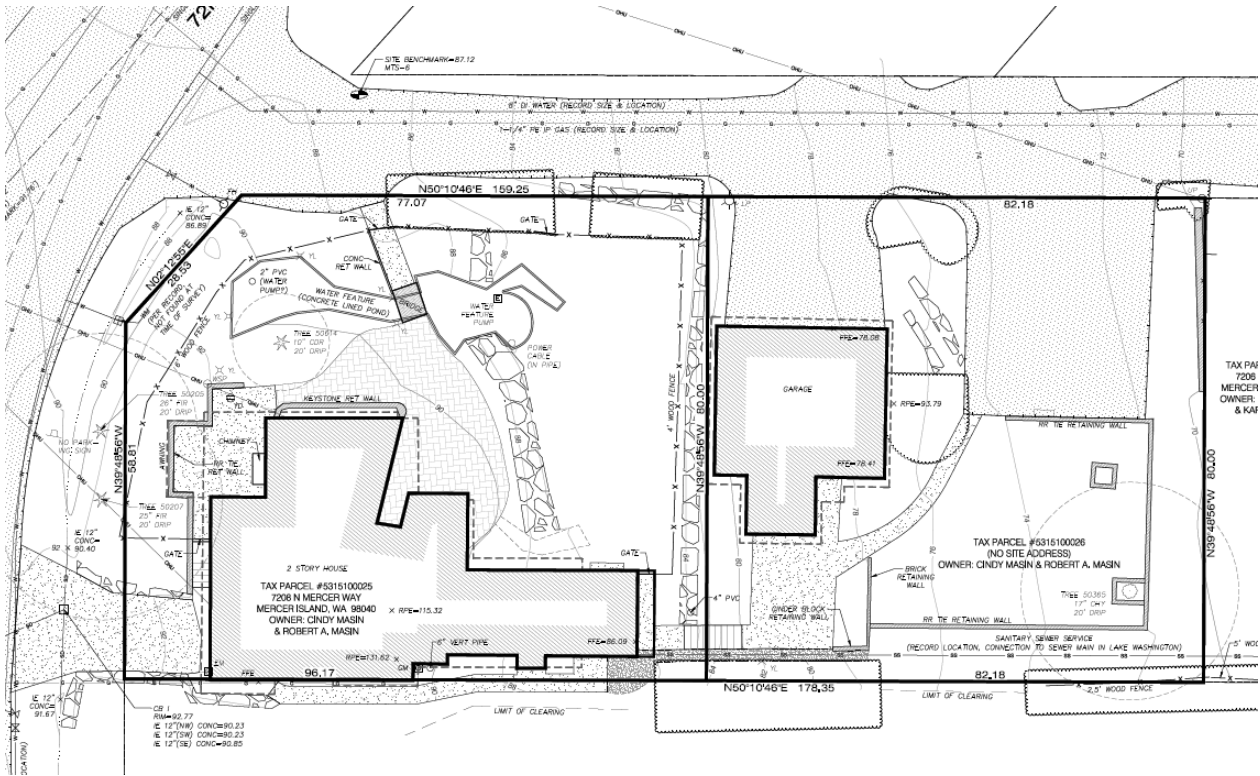
Figure 5. Excerpt from the survey showing the current layout of the subject property. Note how the house is set right on the property line.

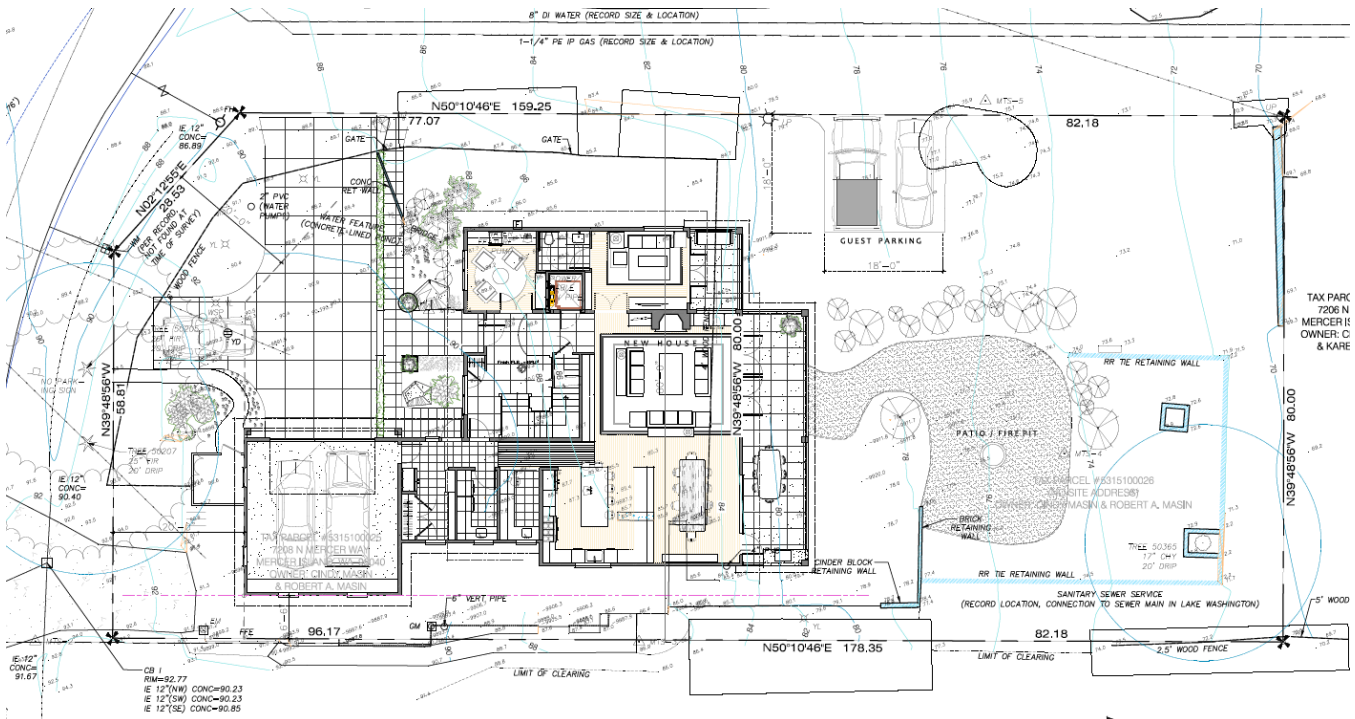
In the case of the #2 fir mentioned above the plan shows a hammer head turn around point for the driveway coming to within 12' the tree. From the chart a 16" DSH tree has an 8' SRP. Because the proximity of the ditch at its base may have hampered SRP formation on that side the fir may have compensated by extending structural roots in to the yard. But even with a 25% adjustment factor the proposed new driveway will be significantly outside the fir's SRP and not interfere with the structural stability of the tree.

Using the #2 fir as the example, with the proposed new driveway hammerhead 12' from the tree's base and it having a 16" DSH, if the cut for the driveway ran all the way across the fir's rooting space it would result in impact at a linear distance equal to 75% of the tree's CRZ (12'/16'). The chart shows that this could equate to a 22% loss of the fir's Critical Root Area. As the timber frame retaining wall is quite close to the area for the driveway it is more likely than not that the #2 tree will realistically lose less than 15% of its CRA.

Figure 6. Excerpt from the proposed plan set showing the layout of the new house and driveway. Note the hammerhead extending to the left of the image. The foundation for the house is set at least 6' off the line now creating more rooting space for the large trees on the south side.

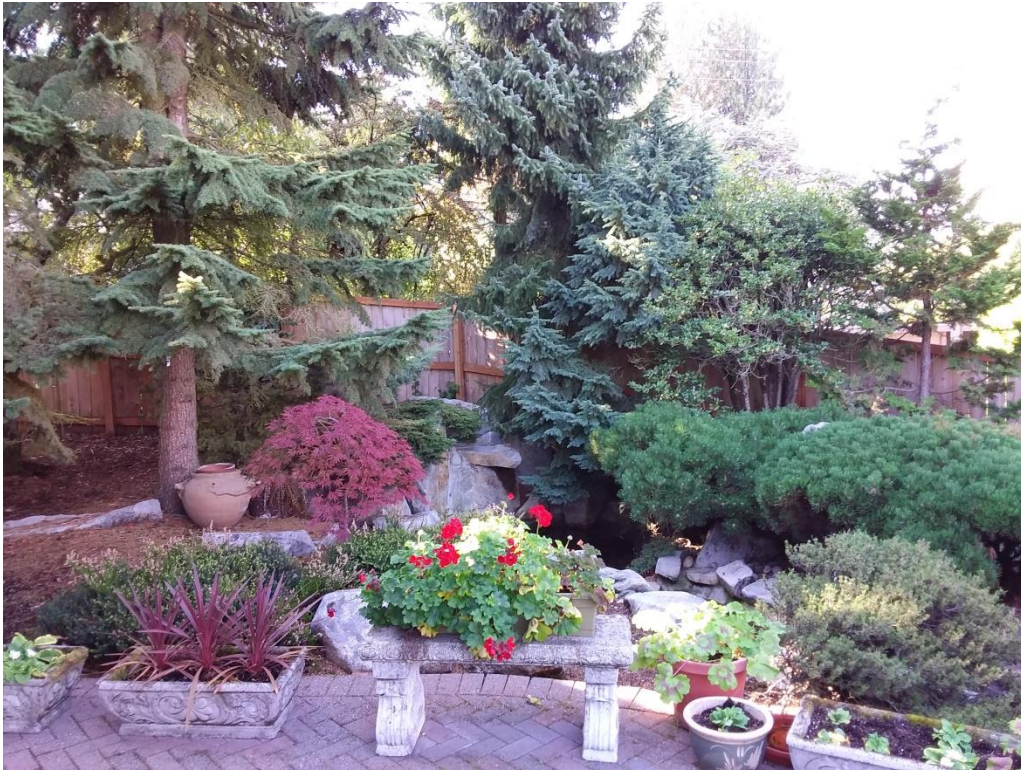
9. Serbian Spruce (*Picea omorika*) 5.5" DSH, 22' tall standing between the fence and the north side of the water feature. It is in good condition.

There is a 3.5" DSH Mountain hemlock standing 6' E of the #9 spruce that is in good condition. Several other mature landscape shrubs stand around the water feature including Mugo pines, a Bird's Nest hemlock, and a smaller Laceleaf Maple varietal (Figure 14).

Figure 14. Looking northwest across the courtyard and water feature. The #8 tree is at the left of the image and the #9 spruce is rear center.
