August 18, 2021

**Project:** Pre-construction assessment for lot re-development at 7845 SE 62<sup>nd</sup> Street, Mercer Island, WA. Parcel number 4094800130.

**Objectives:** Evaluate health of existing trees and establish criteria for the preservation of those to be retained.

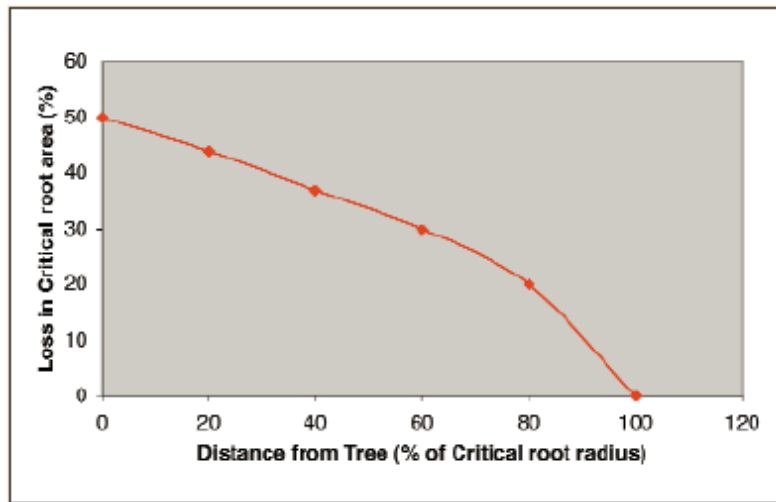
Figure 17. Chart giving the loss in critical root area as a function of the radial distance to the CRZ disturbance. (Coder 1996)

Using the #2 cedar again as the example, with the excavation for the new section of spa foundation located 19' from the tree's base and it having a 40" DSH, there will be impact at a linear distance equal to 48% of the maple's CRZ (19'/40'). The chart in Figure 17 shows that this would theoretically equate to a 32% loss of the cedar's Critical Root Area (CRA) if the cut continued completely across the circle of the root system.

The spa excavation will also intersect with the CRA for the #1 fir. The west side cut could be as close as 13' to the base of the tree a 37% CRZ linear impact. If the cut continued fully over the arc of the circle then there would be close to a 36% CRA loss. Even assuming a 3' setback to allow for the foundation forms the cut out space is only 7% of the total rooting space for the tree by calculation. Taking into account the lower retaining wall's limiting influence on the fir's actual root spread there could be as little as a 3% CRA impact. It should experience no long term ill effects.

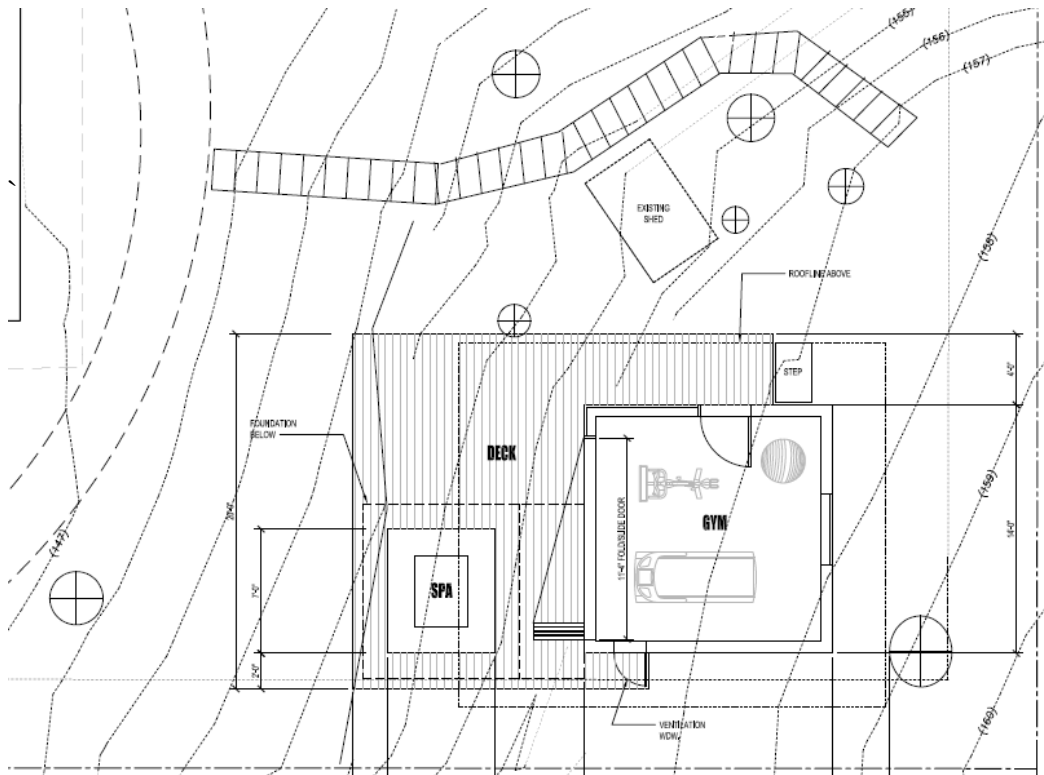
Recently the McConnells have been working with Heliotrope Architects to design an accessory unit for a spa and workout space. The small building will be set in the SE corner of the yard and its footprint will overlay the existing garden beds (Figure 7). Because there are several large evergreen trees standing around the space the architects contacted Superior NW Enterprises and asked for a formal assessment of the trees. The report was to include tree health, stability, suitability for retention, degree of construction impact, and means of mitigation.

Figure 7. Excerpt from the plans showing the proposed location of the building.

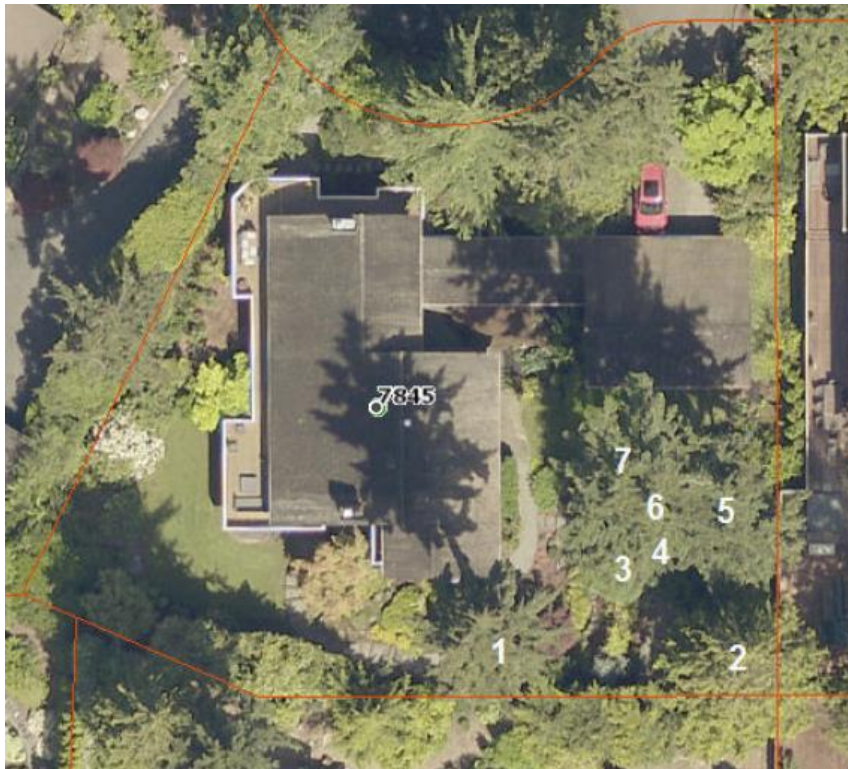
1. Douglas fir (*Pseudotsuga menziesii*) measured at the mid slope average level and found to be 35.5" DSH. Bark is rather heavy low on the column and the more realistic diameter is probably closer to 32 inches. Tree goes to 80' tall. The canopy is above the halfway point, rather dense, and exhibits abundant new growth and good color as shown in Figure 10. The top of the tree has a rather flattened aspect and may have broken out or the tree might have been topped. Tree stands 9' N of the fence, 13' W of the lower stone retaining wall. This is an Exceptional tree.

2. Western Red Cedar (*Thuja plicata*) 40" DSH, 75' tall, stands in the SE corner of the yard 6' W of the east fence, 7' N of the south fence, and 18' E of the upper stone retaining wall (Figure 11). The yards on the other sides of the fences have mulch type coverings rather than lawns for at least 18' in either direction and little by way of contour changes. Tree exhibits good new growth and color, canopy comes down to within 14' of the ground. There is a low limb on the north face that is trying to curl vertical to form a subordinate spar. This is an Exceptional tree.

3. Sequoia (*Sequoia sempervirens*) 21.5" DSH, 45' tall standing 7' E of the lower wall, 4' NW the upper wall as it turns to the east, 6.5' S of the entry stairs, 5.5' SW of the garden shed, and 25' N of the south fence line. Tree is in good condition with a low canopy coming down to within 6' of the ground. Abundant new growth and decent color, canopy is a little one-sided to the southwest due to crowding.

6. Douglas fir 29" DSH, 95' tall standing 5' N of the #4 cedar, 5.5' NW of the #5 fir, and the stair path wraps passes 18" N of its base. Tree has an area on the northwest face where sap is currently oozing. More likely to be a surface torsion fracture than a beam fracture as there is no indications on the off-side of a fracture plane. Average new growth and color throughout the canopy that comes down below the half way mark.

Figure 8. Aerial photo circa 2019 showing the existing house and the rough locations of the trees noted in the report.

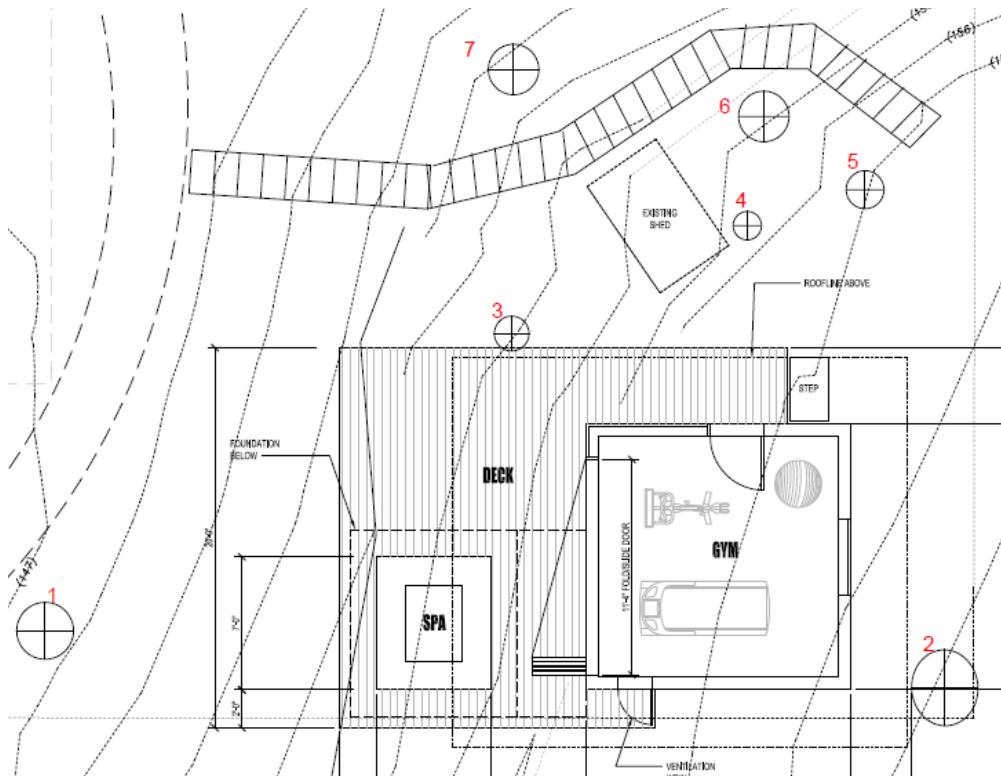
Figure 9. Excerpt from the plan with the trees labeled in red.
