Consulting Arborist Services

To: JayMarc Homes, Jay Mesistrano  
Reference: Tree Inventory Report  
Updated with Tomography Results  
Date: September 28, 2021  
Site Address: 45XX 90th SE, Mercer Island 98040  
Parcel: 0191100190

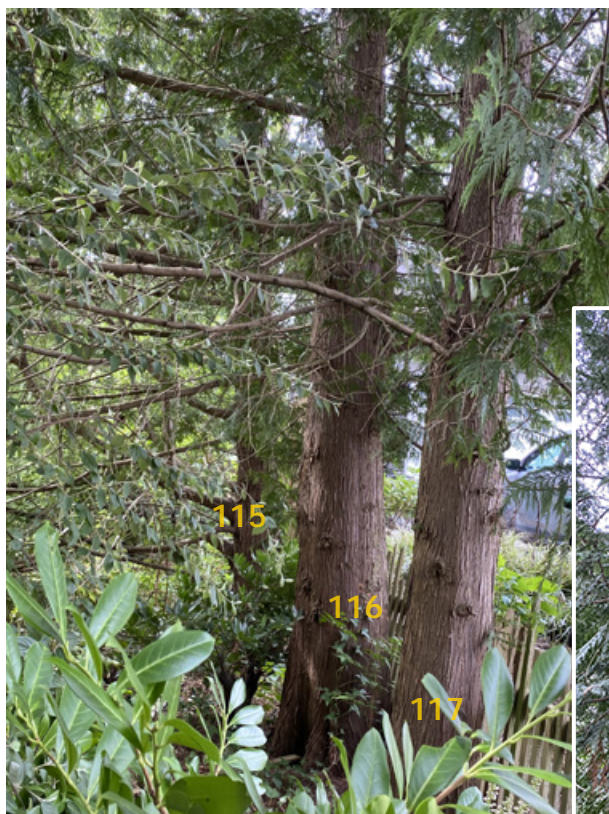
Above: Looking west. Trees #115-117.

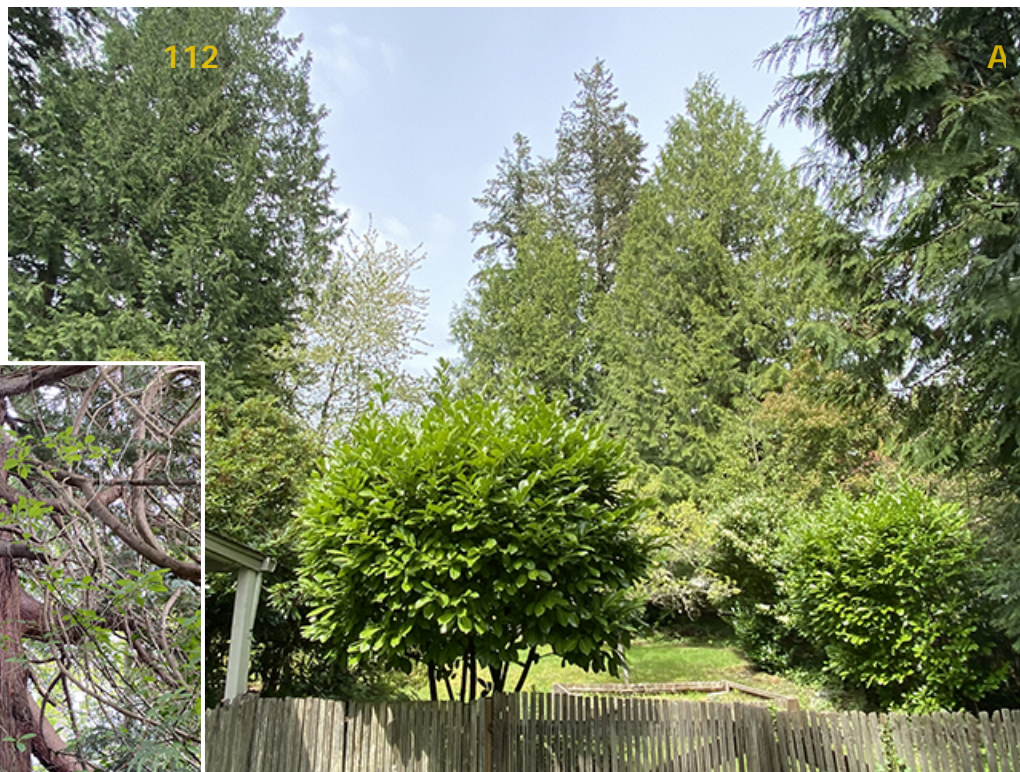
Above: Looking north. Tree A in foreground (R), Trees #115-119 in background (R), and Tree #112, an exceptional Western red cedar, located west of a break in continuous canopy.

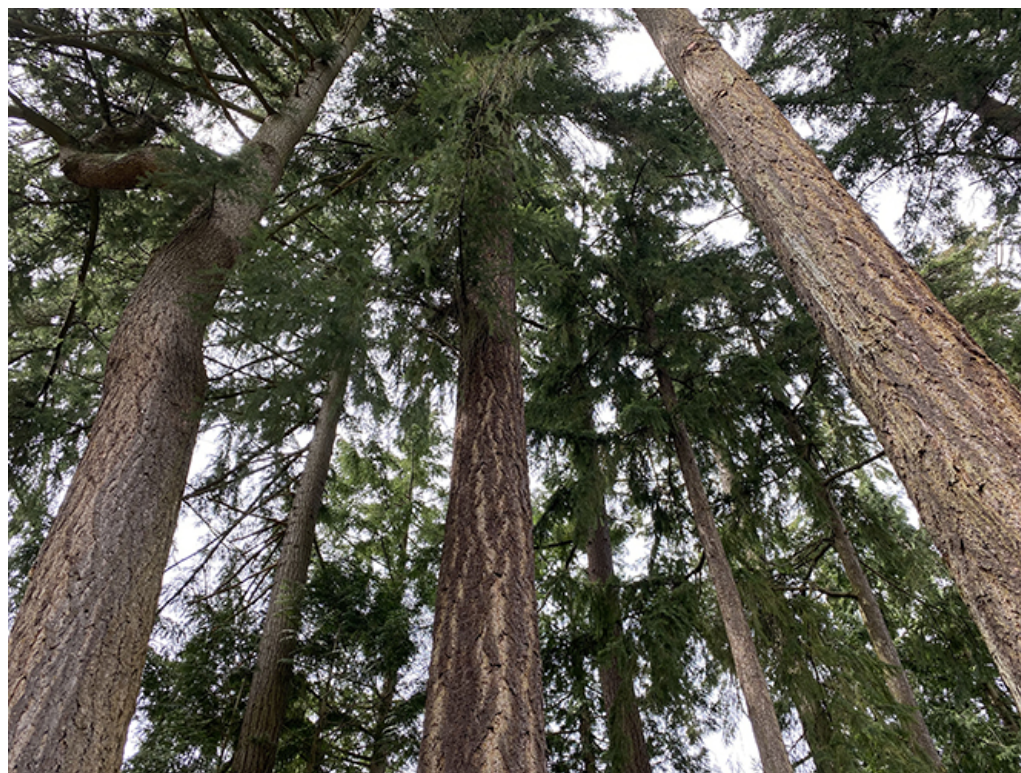
Tree 102 has two superficial cracks in the north and southwest quadrant, and some sapwood decay in the eastern quadrant. Reassessment in five years recommended.

Tree 103 has sapwood decay in its northeast and southwest quadrants, and some heartwood decay emanating to the southeast. Reassessment after planned construction or two years from initial test recommended.

Tree 104 has sapwood decay on its northwest and northeast quadrants, and some centralized heartwood decay. The decay in the tree is estimated to be causing a 13% strength loss. Provide appropriate tree protection during construction. Reassessment after planned construction or two years from initial test recommended.

Above: Looking west at back of parcel. Trees #102, #103, #104 (partial view).
