Arborist Report

To: JayMarc c/o Rob de Clerk
Site: 3745 77th Ave SE, Mercer Island, WA
Re: Tree Inventory
Date: February 4th, 2022
Project Arborist: George White
ISA Certified Arborist #PN-8098A
ISA Qualified Tree Risk Assessor
Reviewed By: Joseph Sutton-Holcomb
ISA Certified Arborist #PN-8397AM
Municipal Specialist, ISA Qualified Tree Risk Assessor
Referenced Documents: Preliminary Site Plan: Piha Residence (JayMarc Homes 1/31/2022)
Attached: Table of Trees
Tree Site Map

Table of Trees
3745 77th Ave SE, Mercer Island, WA

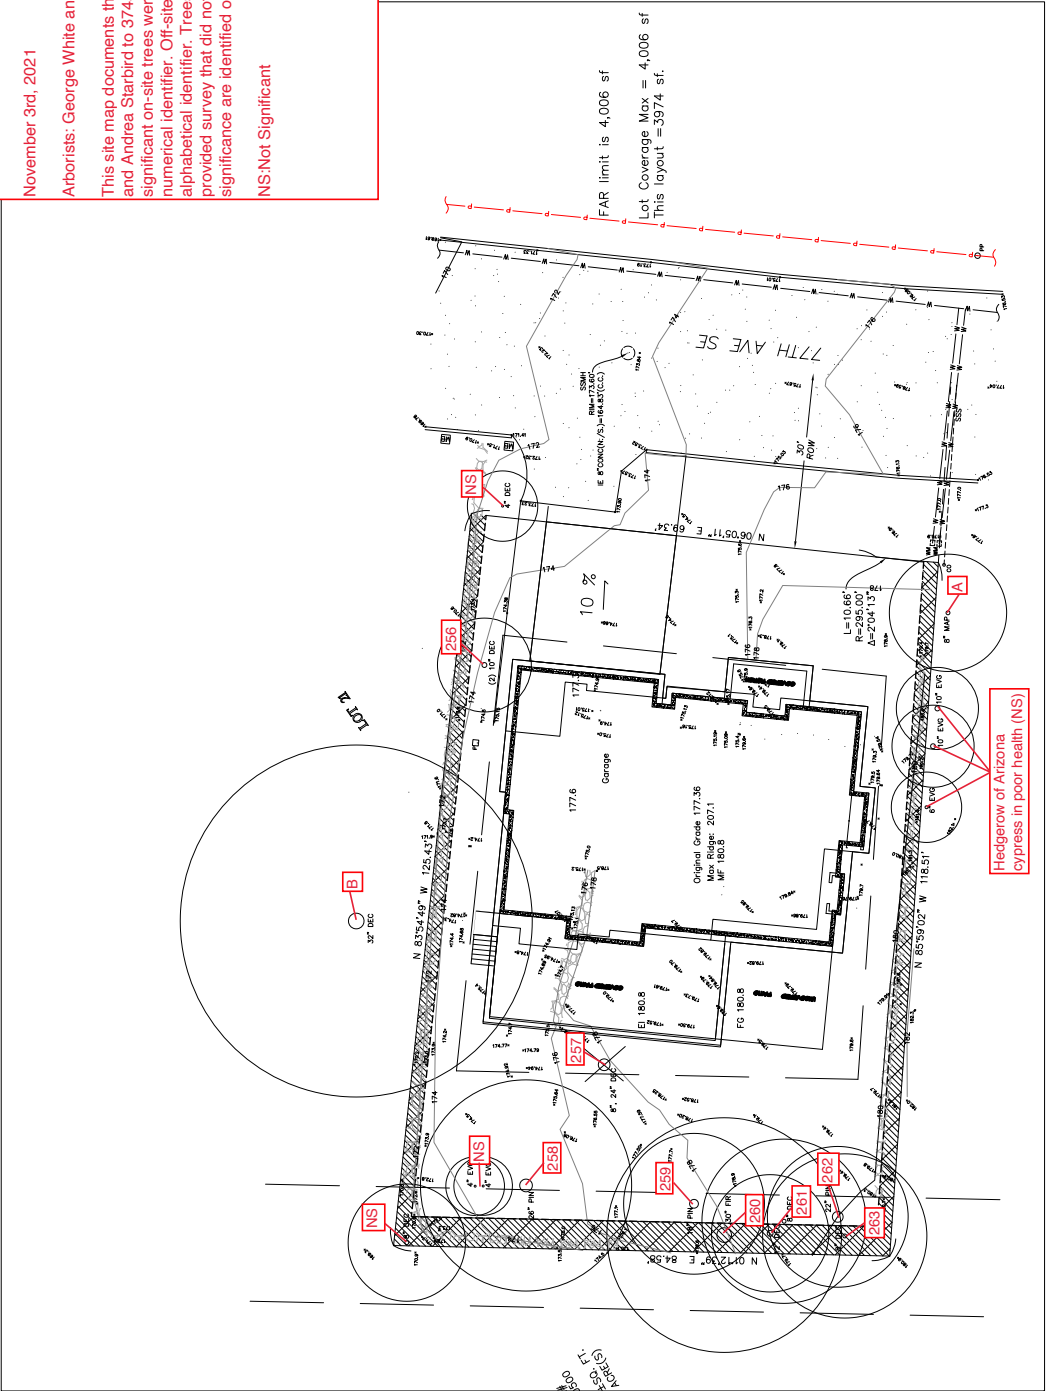
This site map documents the visit of George White and Andrea Starbird to 3745 77th Ave SE. All significant on-site trees were tagged with a numerical identifier. Off-site trees were assigned an alphabetical identifier. Trees identified on the provided survey that did not meet the criteria for significance are identified on this map as NS

NS: Not Significant

Hedgerow of Arizona
 cypress in poor health (NS)
