June 1, 2021

Project: Tree review and assessment at 8480 85th Street SE, Mercer Island, WA.
Parcel number 0736100155.

Objectives: Evaluate health of existing trees and establish criteria for the preservation of those to be retained.

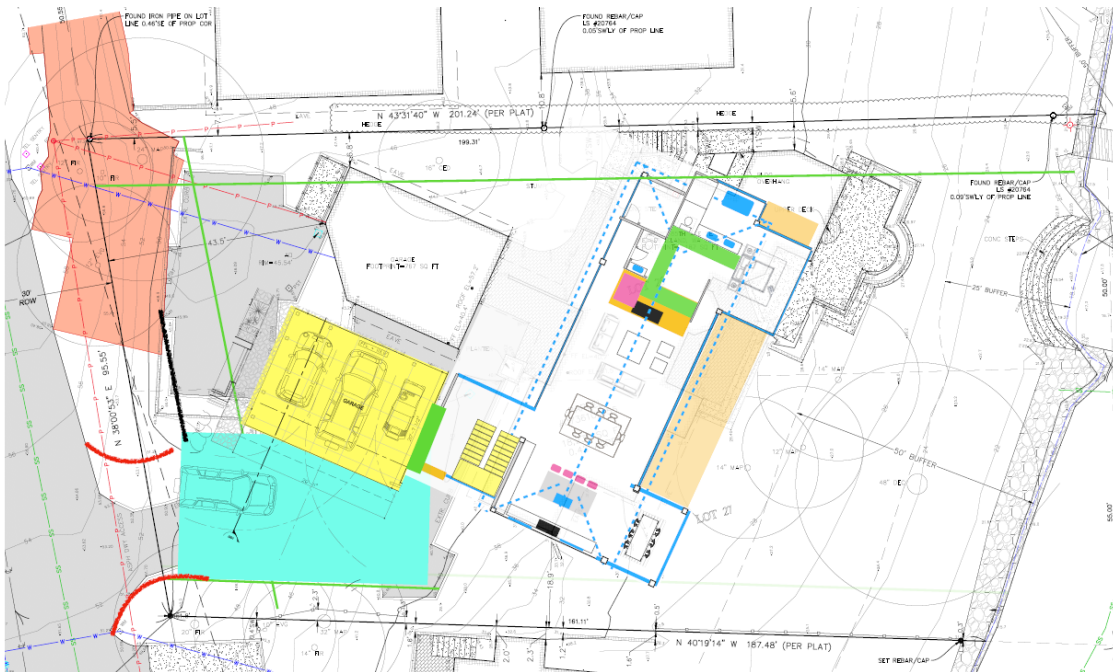
The property most recently changed hands in October of 2020. The new owners are currently developing plans to remove the existing house and replace it with one nearly in the same footprint as shown in Figures 2 and 3. Understanding that the City of Mercer Island requires onsite trees to be formally evaluated the client contacted Tree Harmony Arborists and requested assistance. They in turn contracted with Superior NW to assess all the trees present on the lot as to their health, stability, and overall suitability for retention.

Figure 3. Excerpt from the plan set showing the proposed layout of the new home hardscaping. The existing sport court and garage are to be removed and the area brought back to pre-original construction grade.

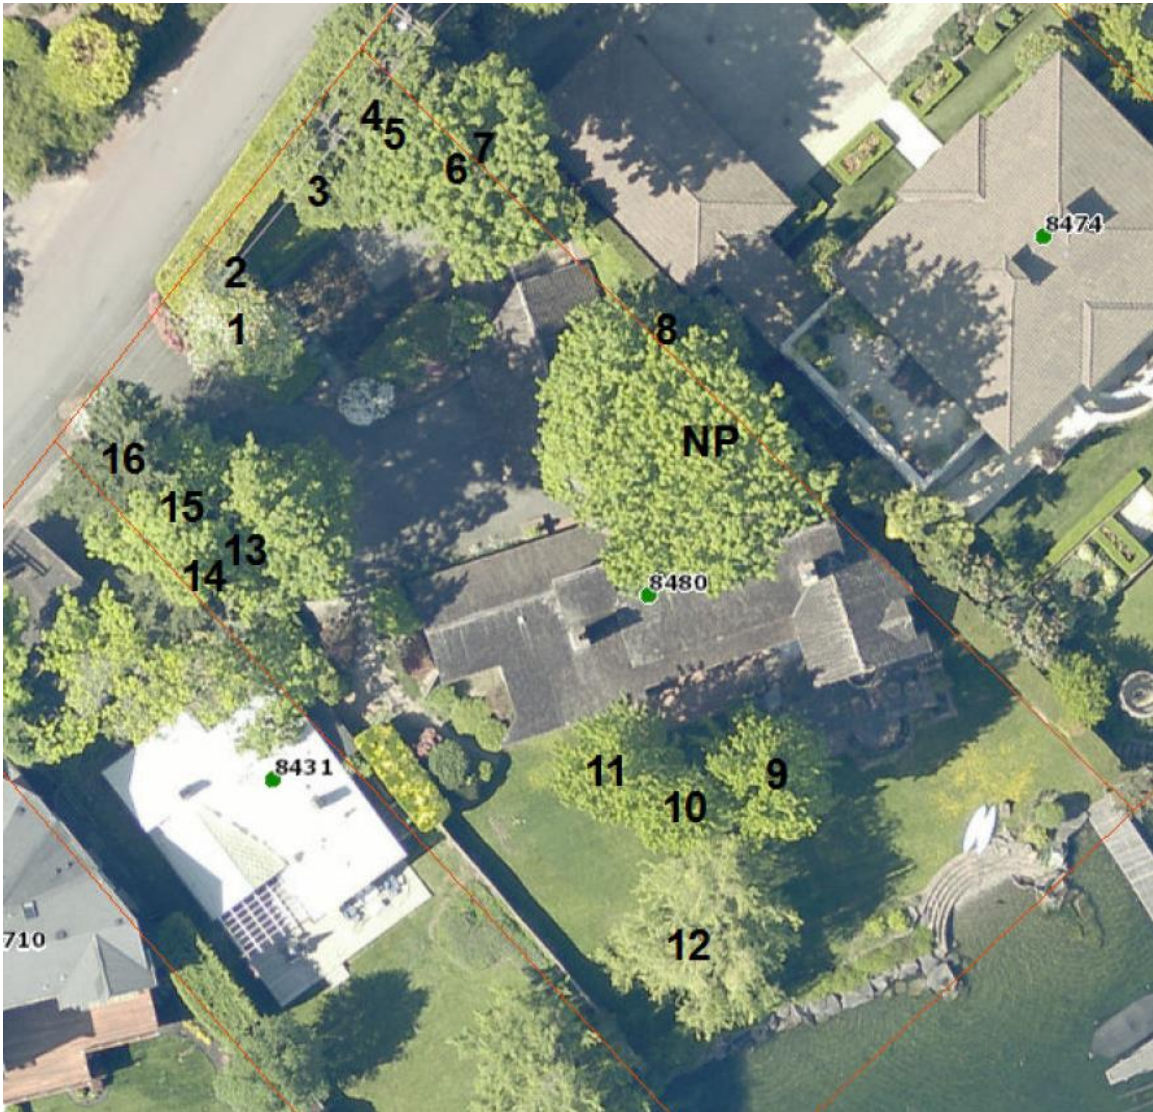
Figure 4. Aerial view of the subject property showing the rough locations of the trees listed in the description section. 'NP' stands for 'not present'.

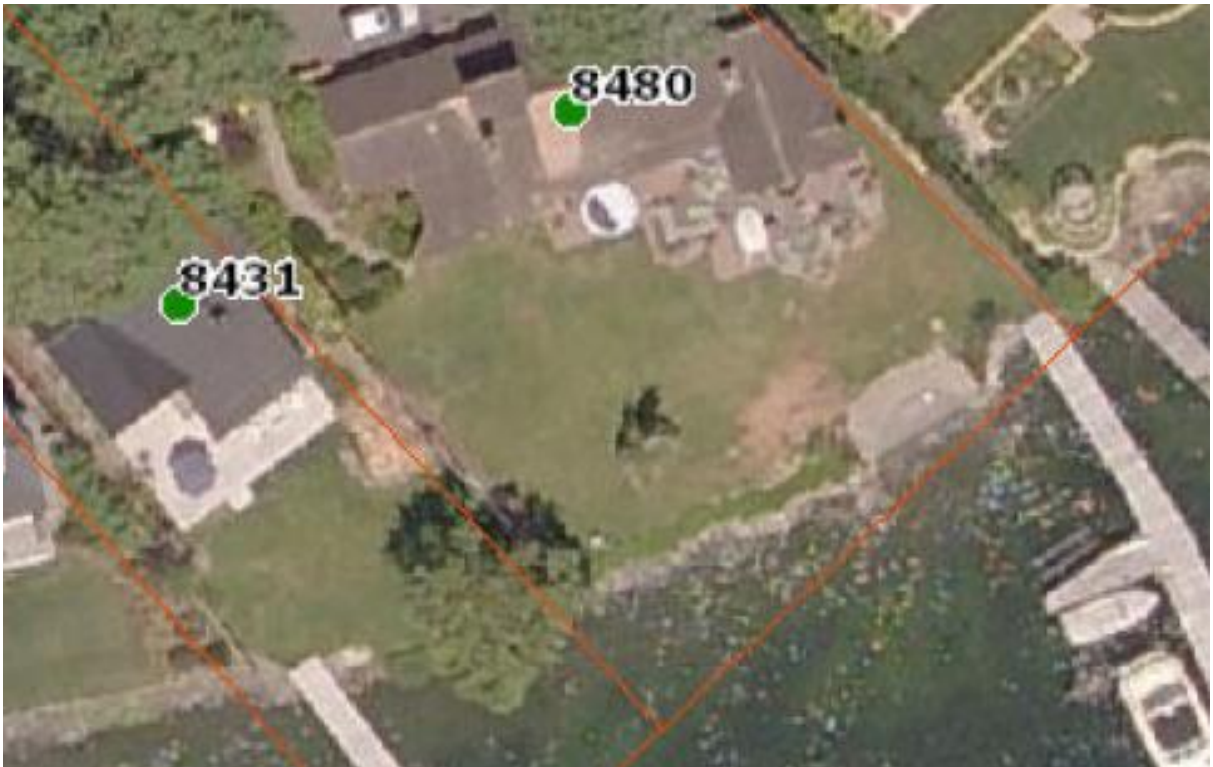
12) Weeping willow (*Salix babylonica*) stub 18' tall, 50" DSH, with epicormic shoots that reach another 10-15' above the break point (Figure 18). The tree has advanced decay from base to stub crown as shown in Figures 19-21. The large exposed surface roots also show extensive rot present (Figure 22). It is highly likely that the entire willow collapsed during the 2006 storm. Figure 14 shows a quite large canopy presence at this tree's location in 2002 and then just a dot in its place in 2007 (see Figure 12). The largest viable section of the existing canopy comes off the very tip of the north face of the tree and has no more than 8" of viable wood supporting it at that point (Figure 23). The tree stands within 15' of the seawall in the SE corner of the yard. Size notwithstanding this is in no way an Exceptional tree.

Figure 12. Aerial from 2007 showing the stub of the #12 willow left after the 2006 storm. Note the #9-11 maples are not present.

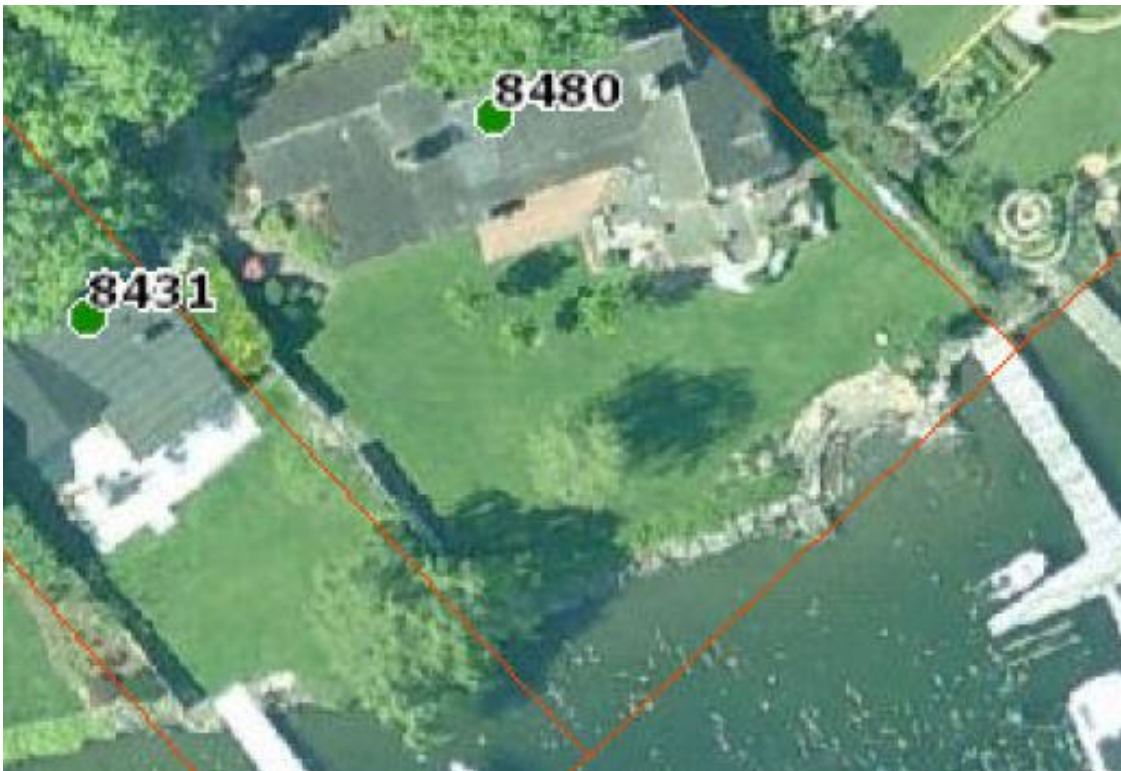
Figure 13. Aerial from 2009 showing the #9-11 maples at the back of the house and the #12 tree with sprouts on it.

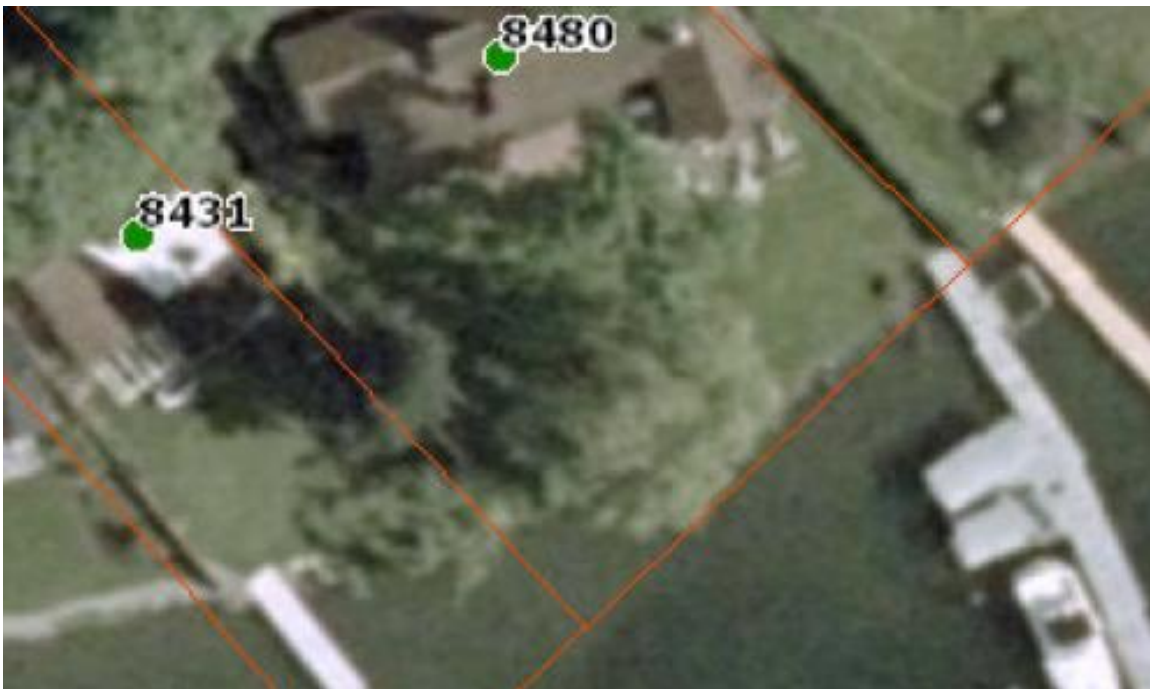
9) Columnar Norway maple (*Acer platanoides* 'Columnare') 17" DSH, 45' tall, 12' radial spread. Tree stands almost in a corner of the existing rear concrete patio. It's 6' E of the outer planter wall and 8' S of the steps (Figure 10). Tree exhibits fair health but has the heavy root crown plate and associated girdling roots common to the species (Figure 11). This tree and its sisters were planted between 2007 and 2009 (Figures 12 and 13). It is likely the trees that had been present (Figure 14) were lost in the 2006 winter storm. The #9-11 maples may have been planted as replacements.

Figure 14. Aerial circa 2002 showing the massive canopy on the #12 willow and what might be other trees between it and the house.

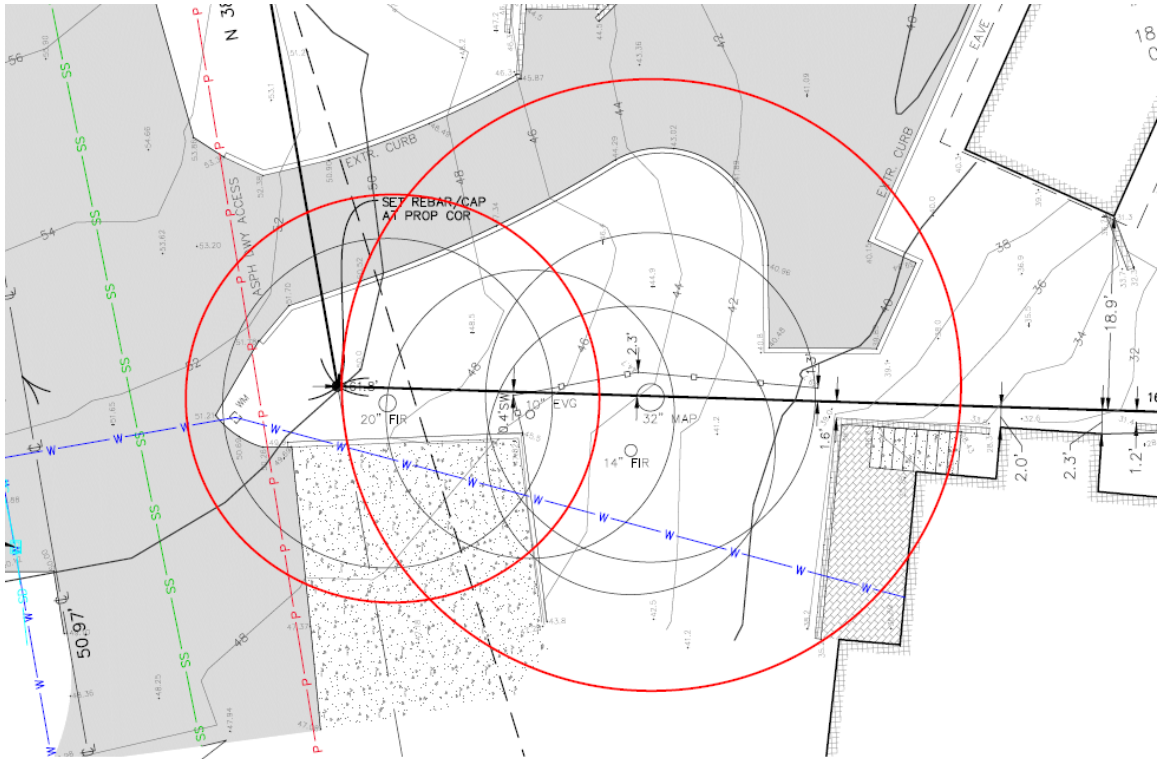
13) Big Leaf maple 32" DSH, 65-70' tall, with a mixed spread width. The tree stands 12.5' WSW of the SW corner of the driveway hammerhead/parking space (Figure 24). Sighting from the SW property corner marker the tree appears to be on or just over the south property line. The survey shows it straddling the line (Figure 25). The tree has large caliper deadwood throughout and the center stem has atrophied and/or broke out as shown in Figure 26. The maple separates into four main leaders at this level. Two of these stretch north over the subject property for at least 20'. A third goes nearly horizontal to the SW and the fourth hooks away from the die off point and goes vertical to form the uppermost canopy. There is epicormic sprouting along the lower trunk and a handful of smaller scaffolding branches below the separation point. Overall the tree is in fair health but exhibits a quite weak structural condition. There are signs of root uplift in the little hammerhead/parking space area and it is more than likely that these roots are from the maple (Figures 27 and 28). Exceptional by definition.

The secondary impact zone includes those regions where the demolition work or excavating for the new foundation and other hardscaping will cross into the Critical Root Zone (CRZ) of the surrounding trees. This region is defined as a radial distance equal to one foot per inch of tree diameter. For example the #13 maple, with a 32 inch DSH, theoretically has a 32 foot radial root spread. The trees in this zone include #3, #12, and #14. The #7, #8, #13, #15, and #16 trees will be considered as setting in this zone as they are ideally to be retained.

Figure 25. Excerpt from the survey with the correctly sized CRZs for the #13 and #16 trees overlaid. This is the extent that the trees would have if left alone in nature. Note that the maple encompasses the hammerhead completely.
