Tree Report

4045 W Mercer Way

August 27, 2020

Prepared By: Russell + Lambert
Mary Ellen Russell
WA Landscape Architect #1149
ISA Tree Risk Assessment Qualified
(206) 898-6312

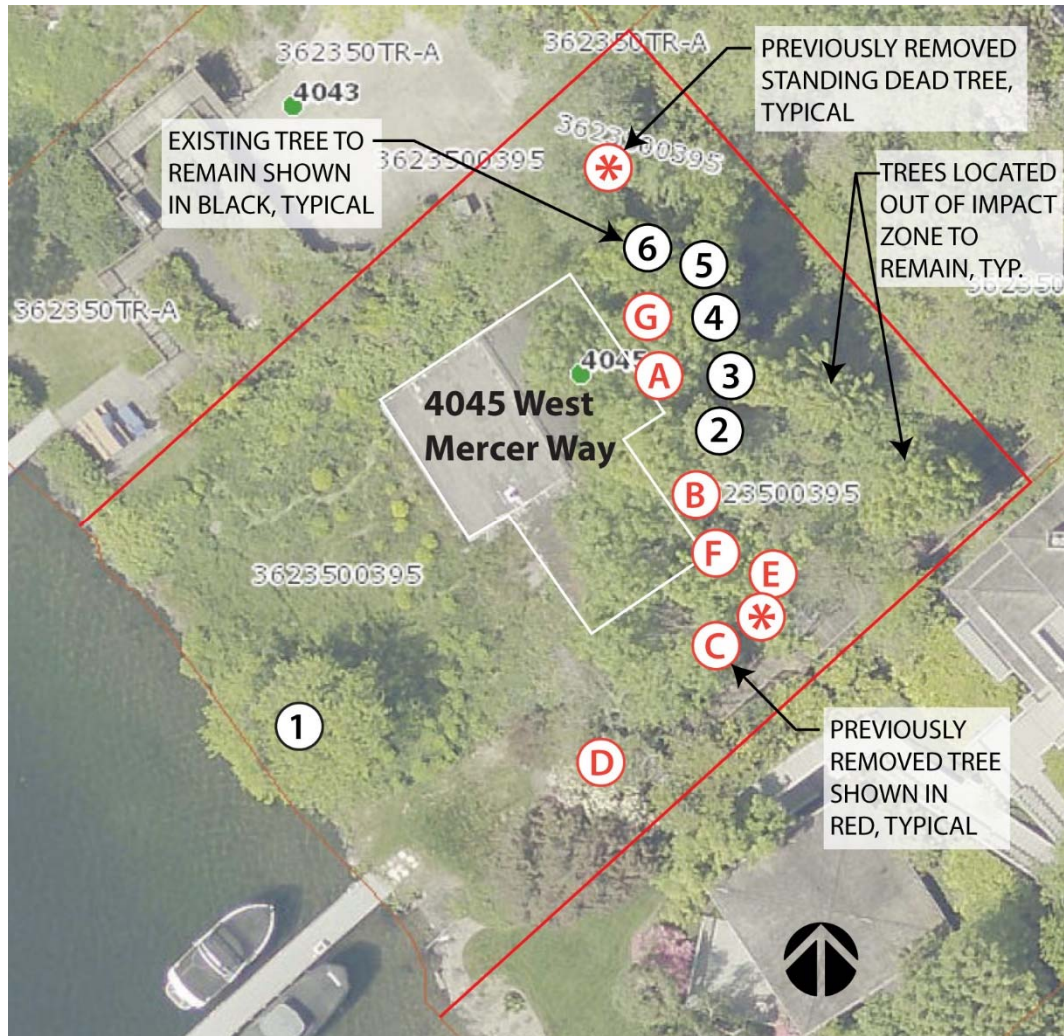
Tree Map

All of the remaining trees are proposed for retention. (7) existing trees located around the base of the existing house have already been removed. None of the remaining trees or previously removed trees are/were Exceptional.
