## AMENDED ARBORIST REPORT FOR THE NGUYEN PROPERTY AT

8937 SE 56<sup>th</sup> Street  
Mercer Island, WA 98040

**Re-Revised October 18, 2022,  
Revised/Amended October 13, 2022**

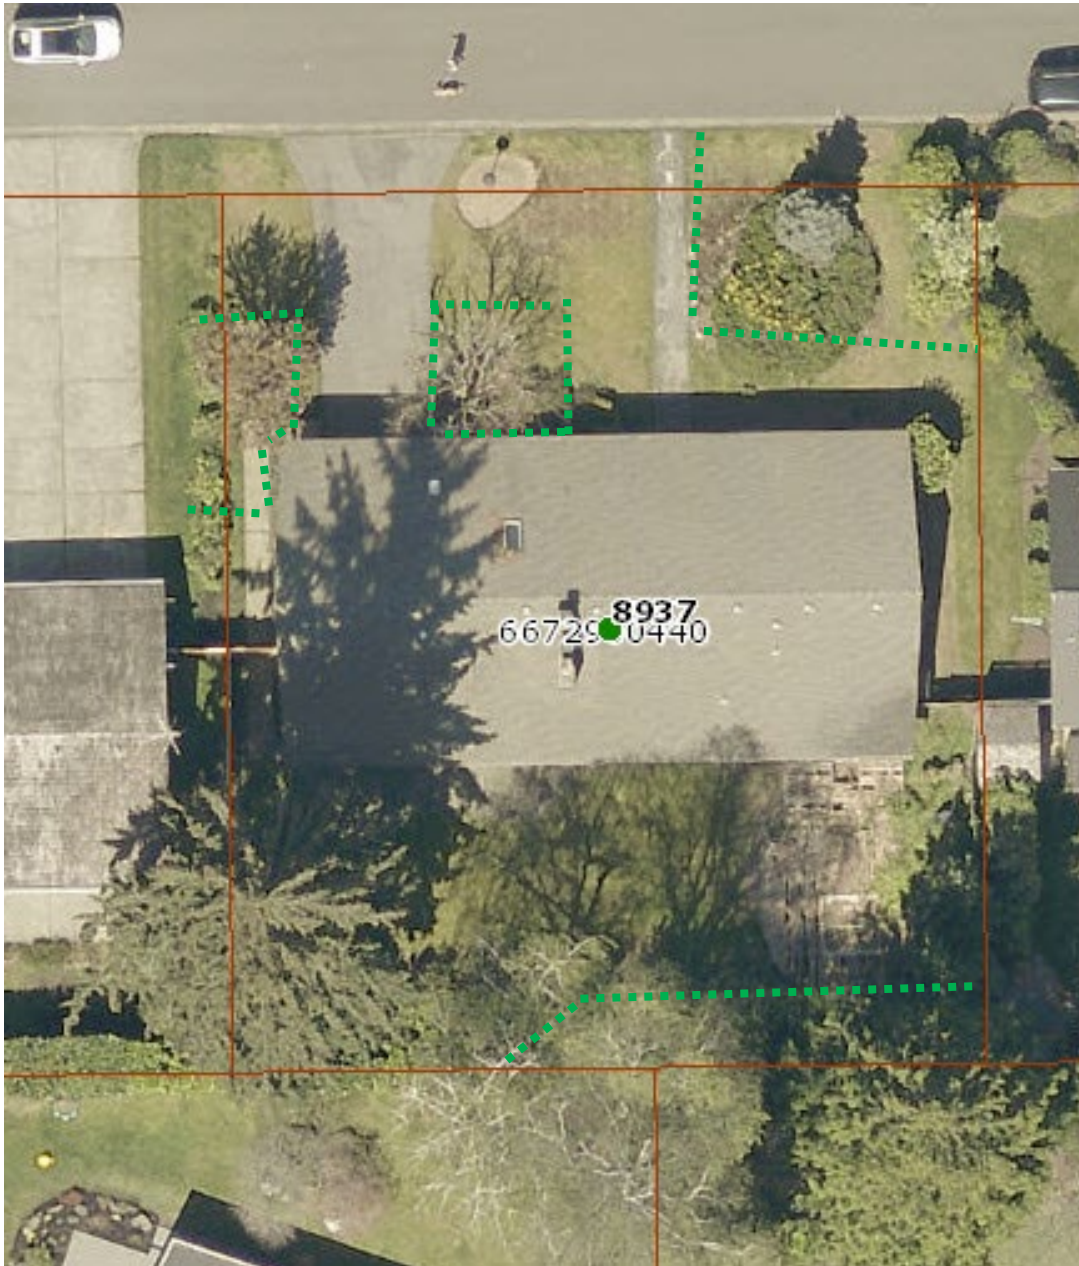
Approximate Tree Protection Fence Locations: ■■■■■■

There is proposed a 2-foot gap between the garage walls and the *Tree Protection Fence* location to provide safe walking passage for workers
